**Subject:           Closure Letter Report  
                      ConocoPhillips  
                      1RP-3951  
                      EVGSAU Satellite #3 Trunk line Release  
                      Adjacent Well Name: EVGSAU 3202-11  
                      Lea County, New Mexico**

**EVGSAU 3202-11**  
(1RP-3951)

**Corrective Action Plan**

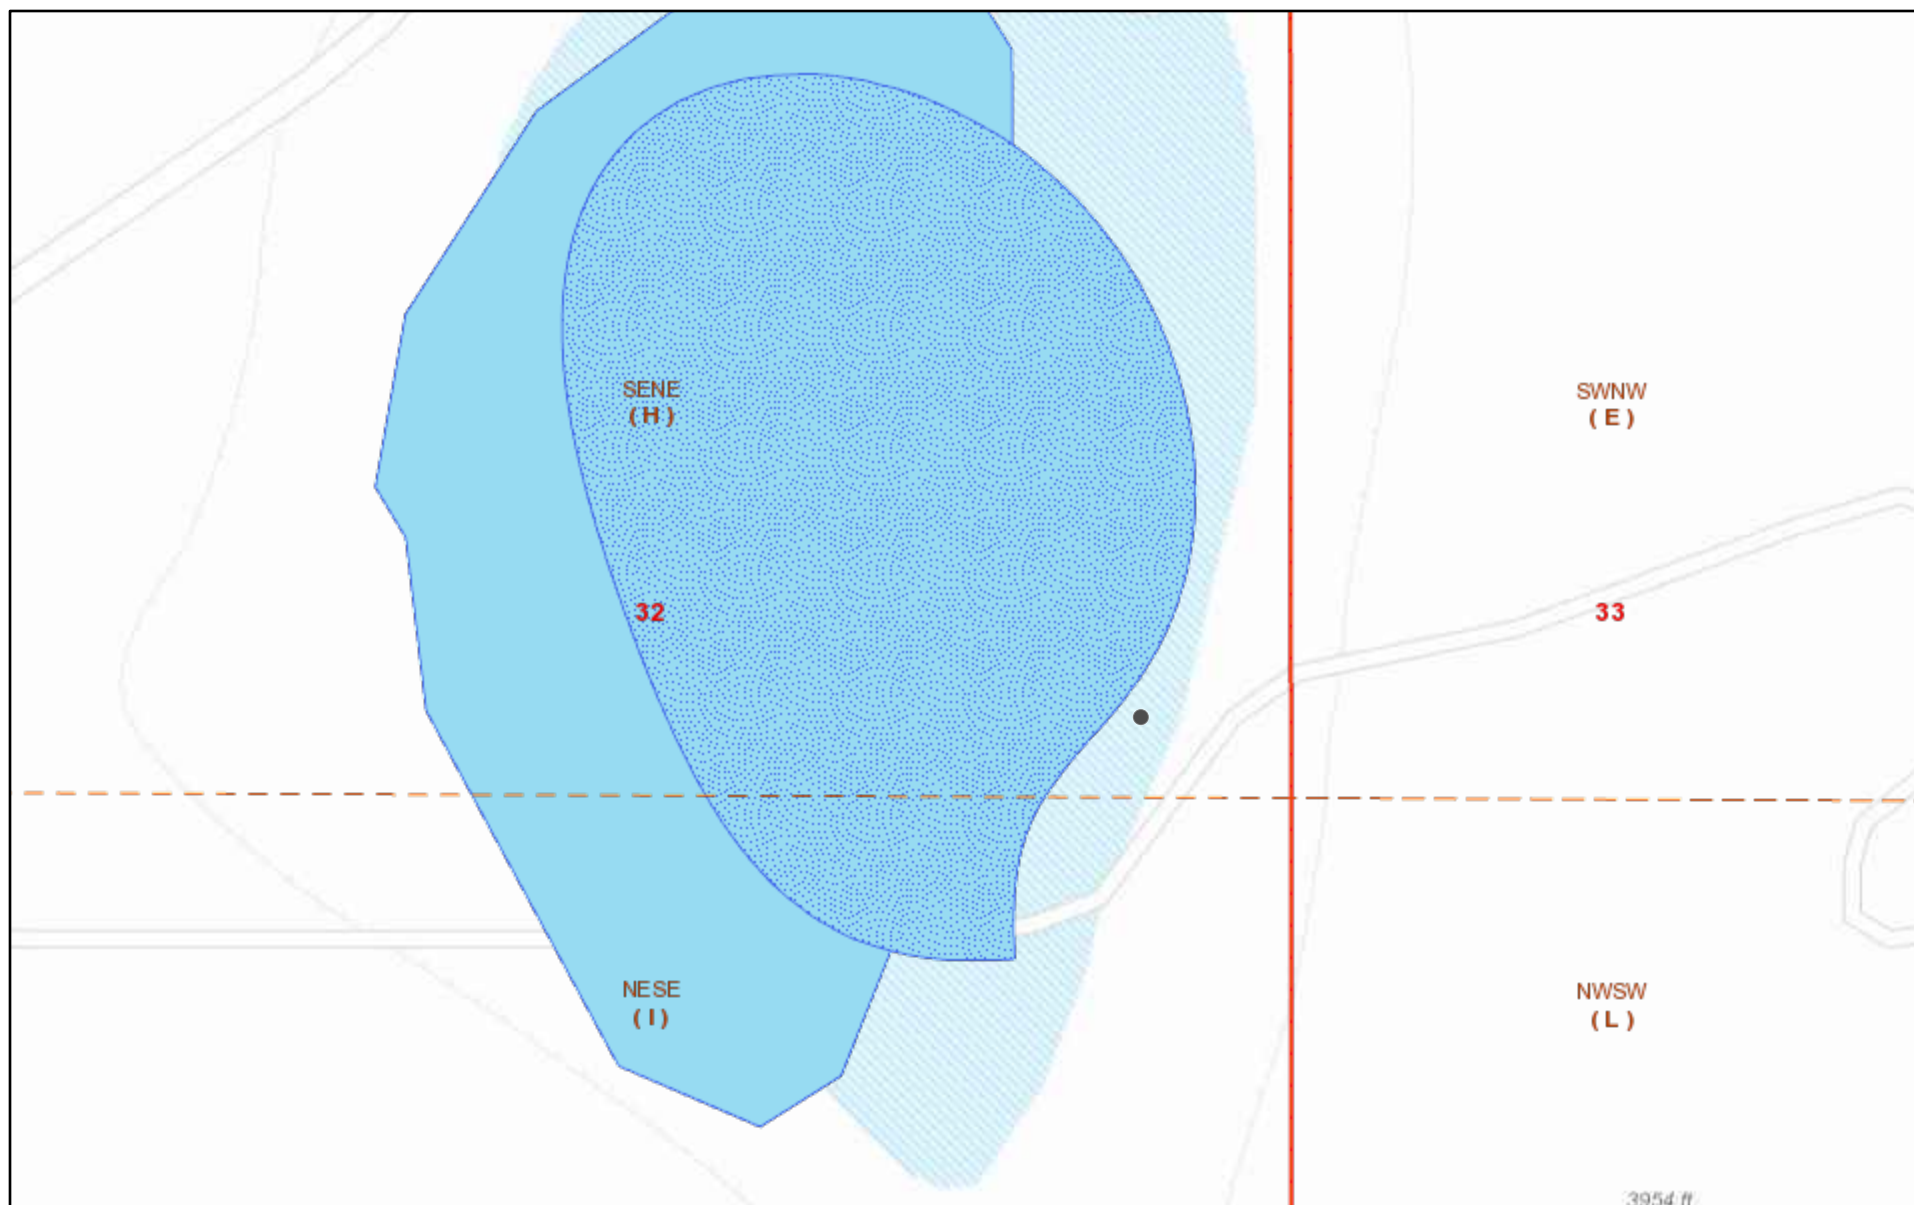
# Water Bodies

A site characterization was performed and no watercourses, sinkholes, residences, schools, hospitals, institutions, churches, springs, public or private domestic water wells, springs, wetlands, incorporated municipal boundaries, subsurface mines, or floodplains are located within the specified distances. The Site is located in a low karst potential area. However, the site appears to be located immediately adjacent to a playa lake.

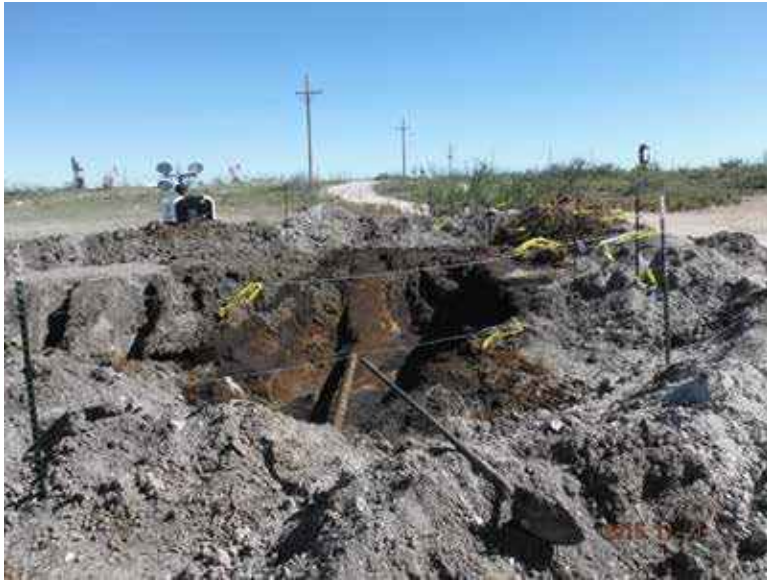
Initial release, facing East

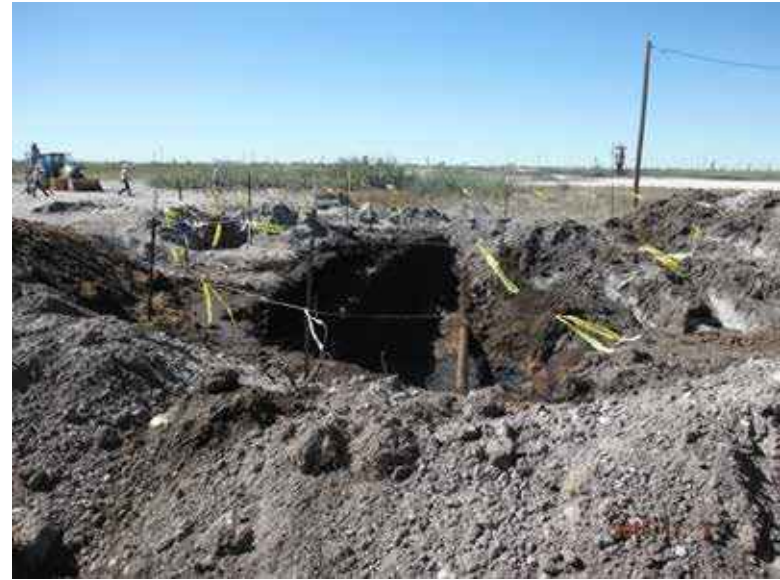
Initial release, facing West

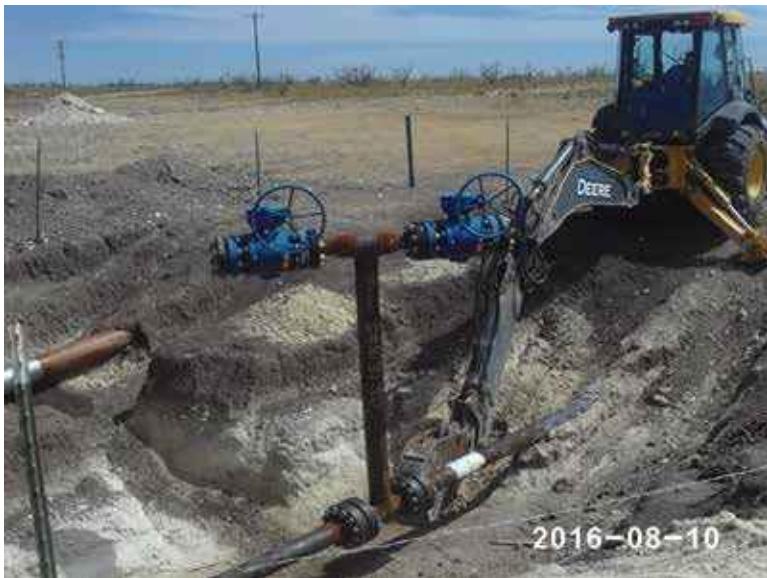
Analytical results from the August 2016 event (Table 1) from soil samples collected at the base of the bell hole exceeded the established RRALs for chlorides down to 8 feet bgs in the area of bottom point 1 and to 9 ft bgs in the area of bottom point 2.

Bottom point 1, facing NE

The corrective action plan, as proposed in the approved CAP, consisted of excavating the release area around bottom points 1 and 2 to a depth of 8 feet bgs (1 foot below the previously excavated 7-foot bell hole). The conditional approval of the CAP stipulated that the excavation at "Bottom #2" (referred to as "Pt. 2 Bottom" in Table 1) needed to be at 9 feet bgs. It also stipulated that sidewall sampling needed to be conducted at 9 feet bgs.

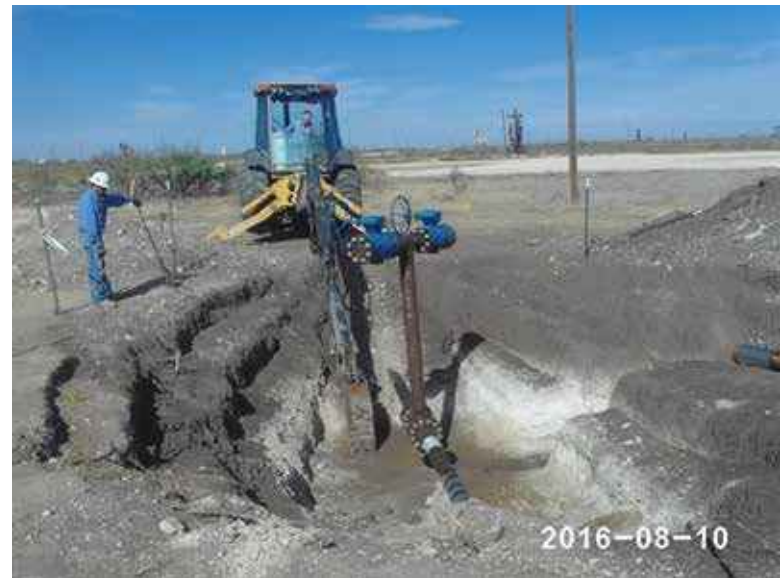
Bottom point 2, facing SW
