### Release Notification and Corrective Action

### **REMEDIATION SUMMARY & SITE CLOSURE REQUEST**

**PLAINS PIPELINE, LP  
TAYLOR POLY SUCTION 4-INCH  
Plains SRS #2012-140  
Eddy County, New Mexico  
Unit Letter "H" (SE/NE), Section 34, Township 23 South, Range 31 East  
Latitude 32. 26083° North, Longitude 103.75771° West  
NMOCD Reference #2RP-1259**

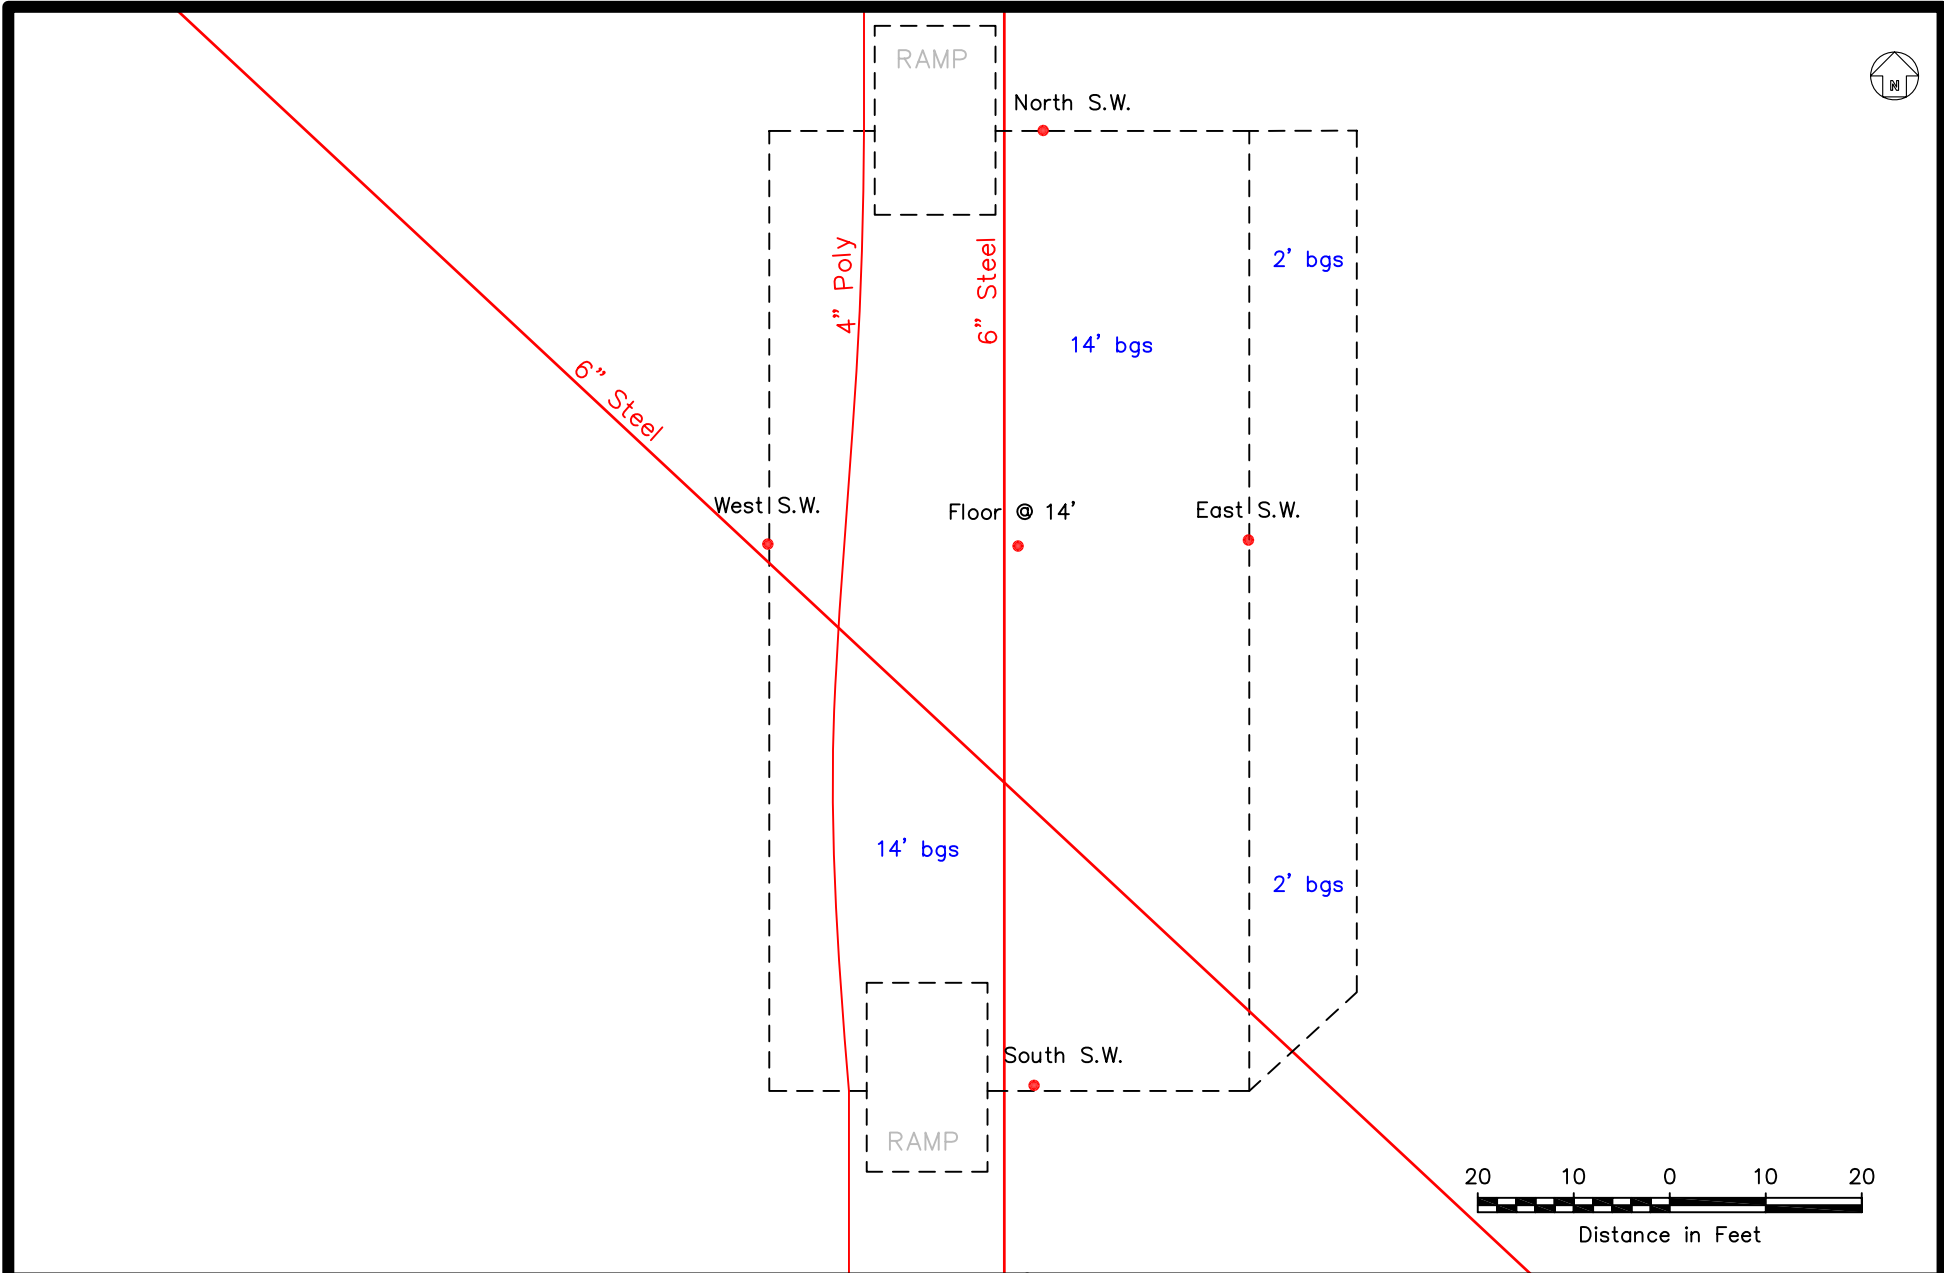
<b>Legend</b>	
● Sample Location	— Pipeline
--- Excavation Extent

<b>Figure 2</b>	
Site & Sample Location Map	
Plains Pipeline, LP	
Taylor Poly Suction 4-Inch	
NMOCD Ref #2RP-1259	
Eddy County, New Mexico

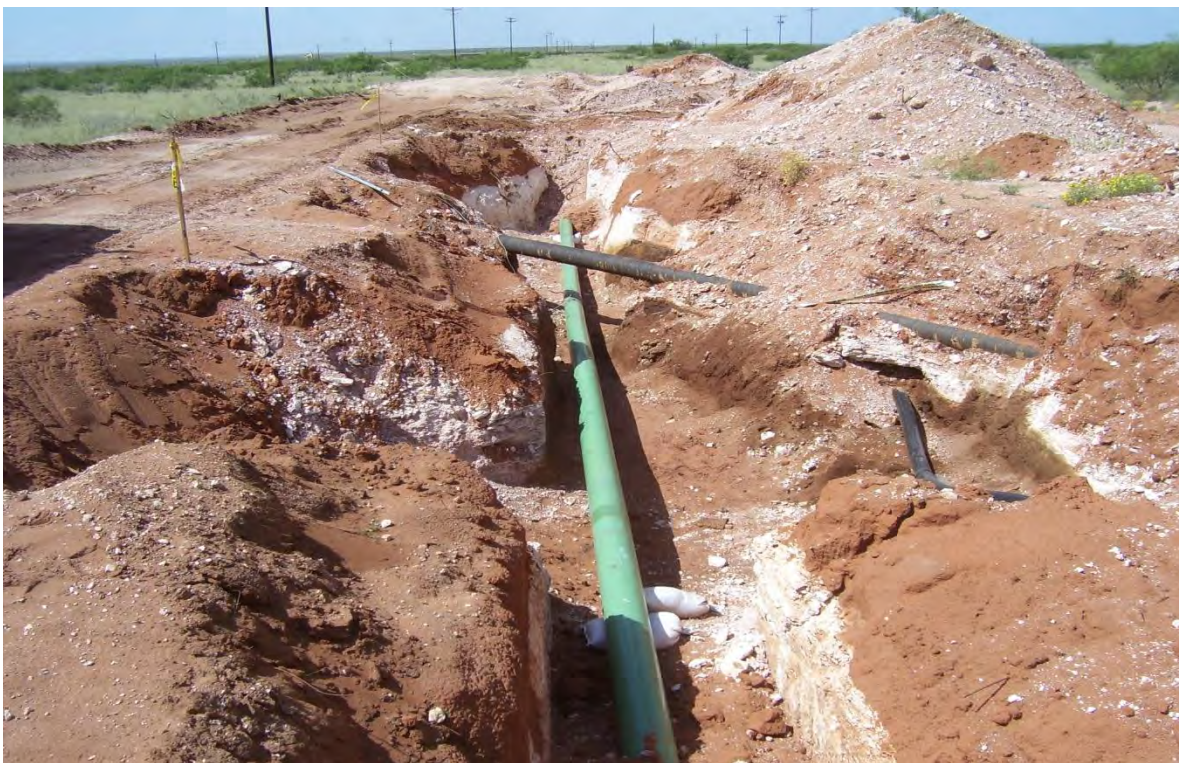
Taylor Poly Suction 4-Inch - Release Site (Looking North)

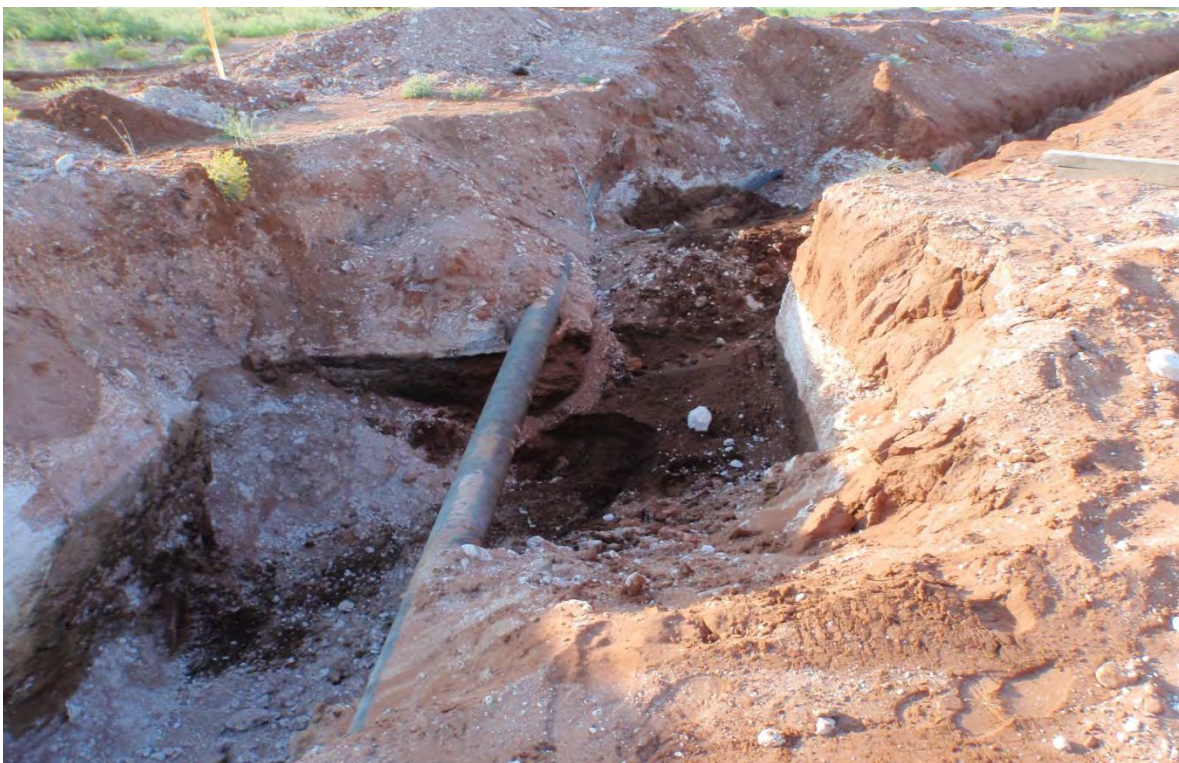
Taylor Poly Suction 4-Inch - Release Site

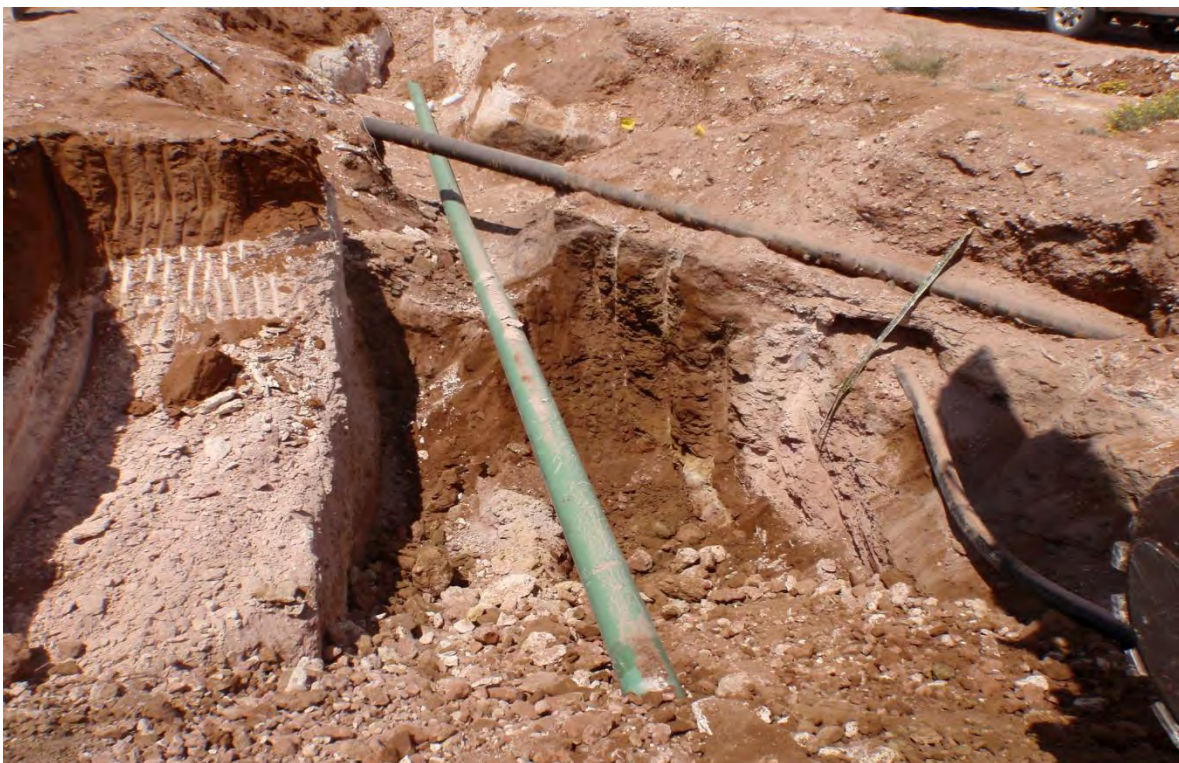
Taylor Poly Suction 4-Inch - Release Site (Looking North-northeast)

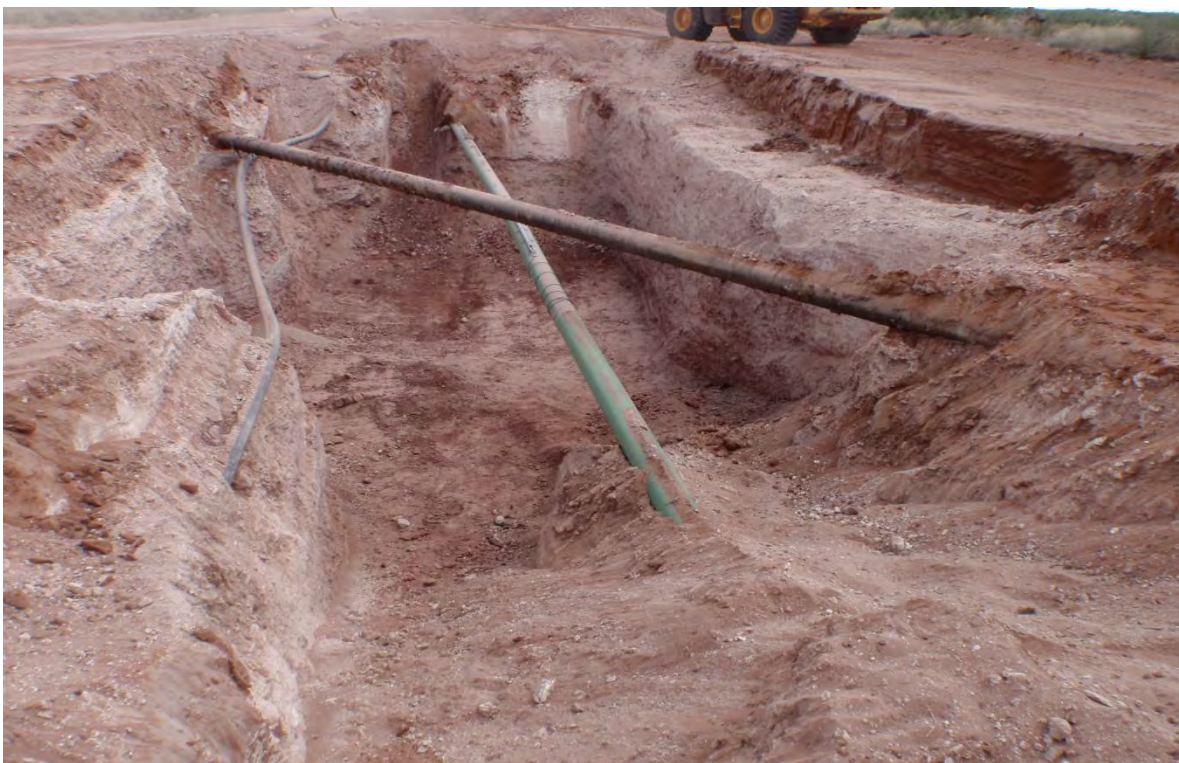
Taylor Poly Suction 4-Inch - Excavation (Looking North-northeast)

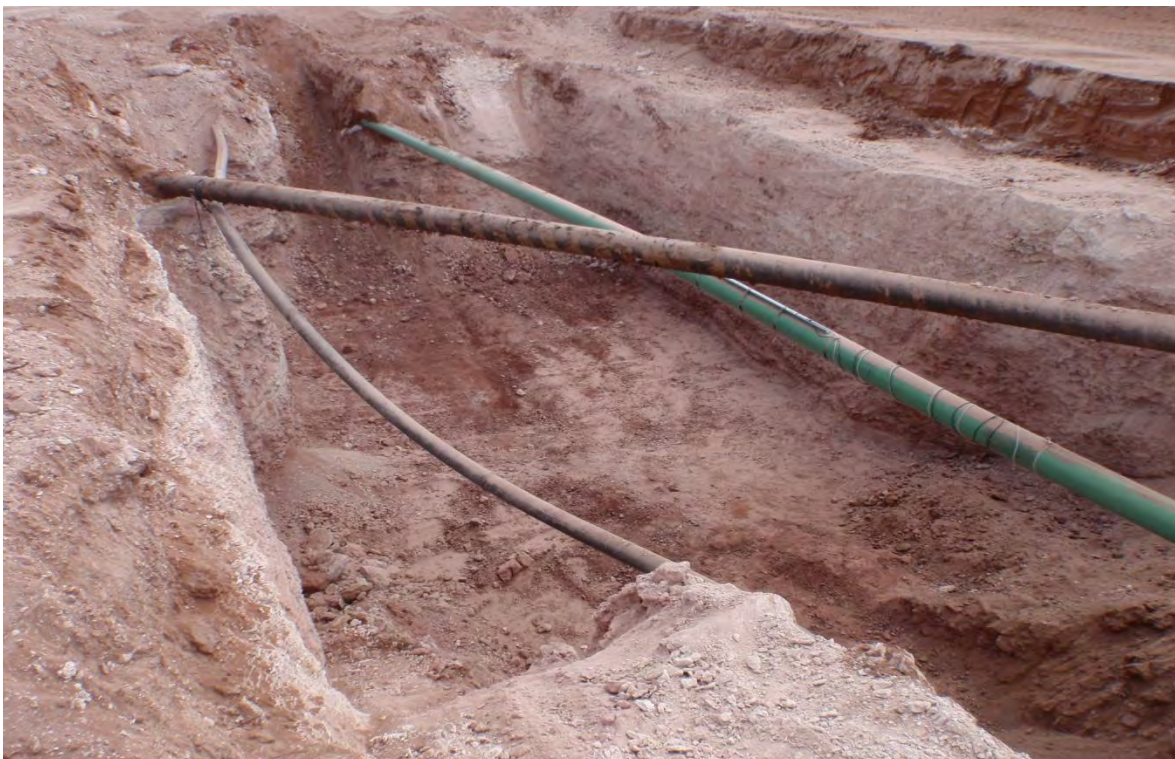
Taylor Poly Suction 4-Inch - Excavation (Looking Northeast)

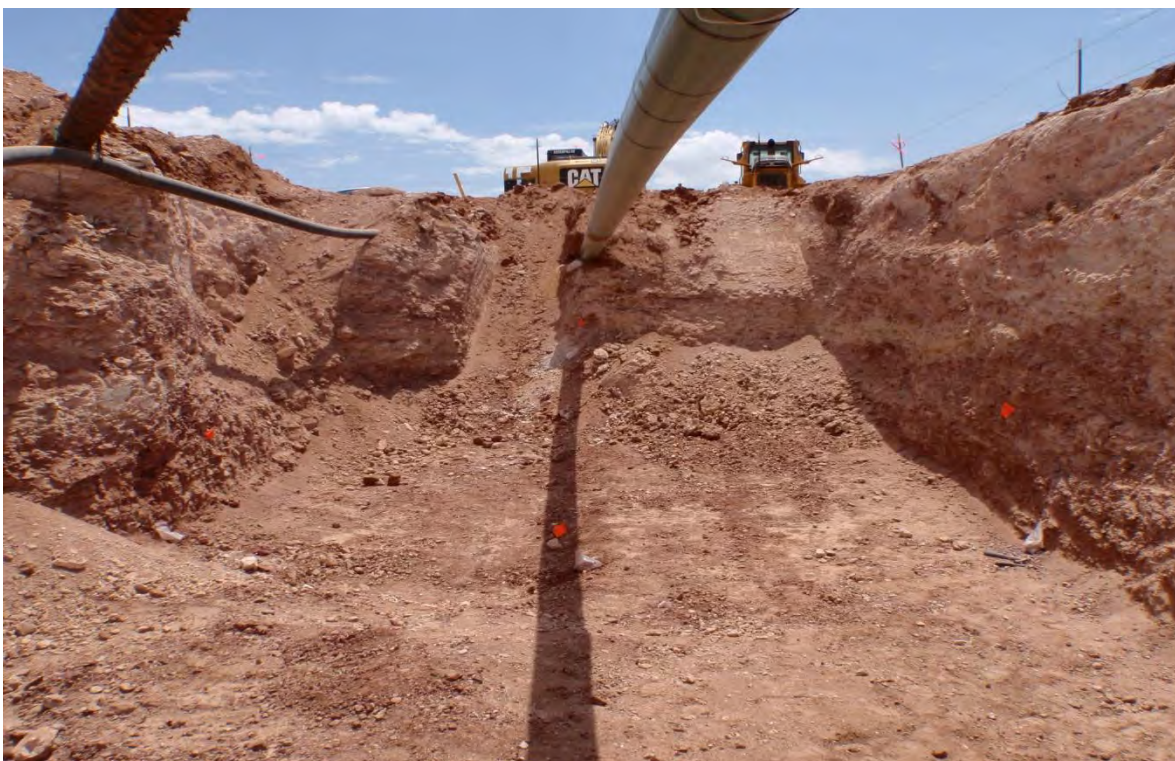
Taylor Poly Suction 4-Inch - Excavation Floor  
(Looking North; Sample Locations Flagged in Orange)

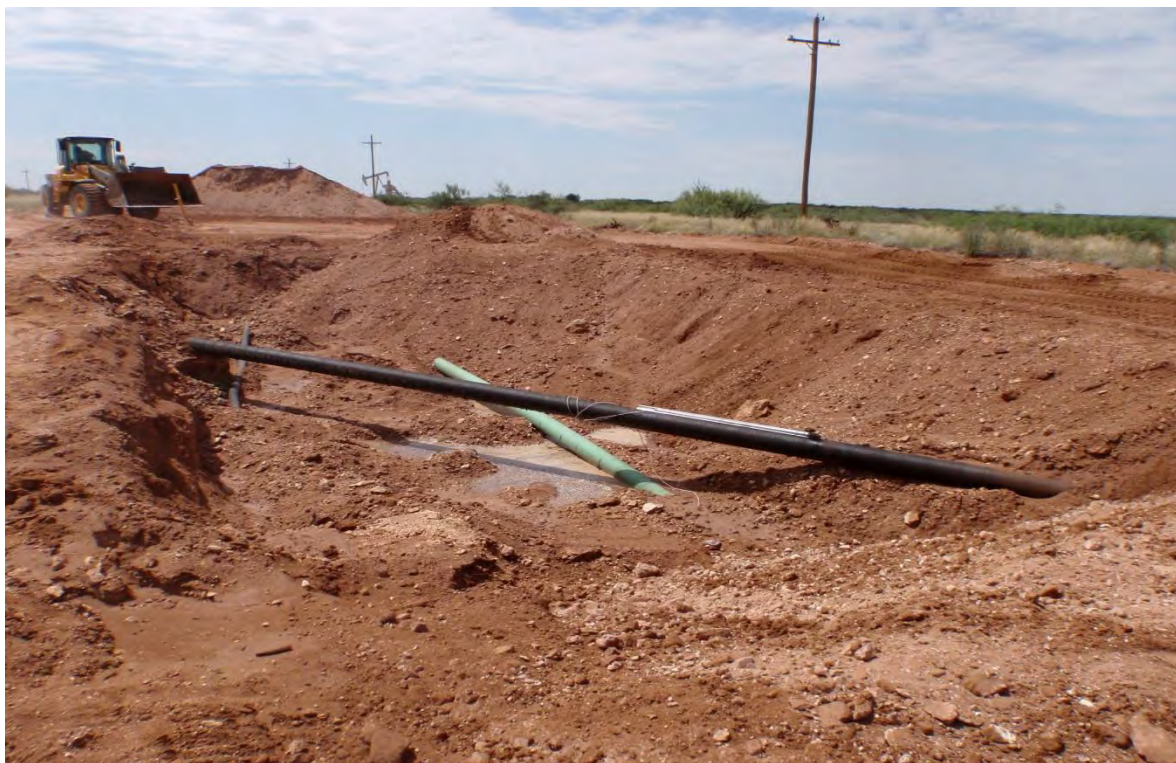
Taylor Poly Suction 4-Inch - Excavation (During Backfill; Looking Northeast)

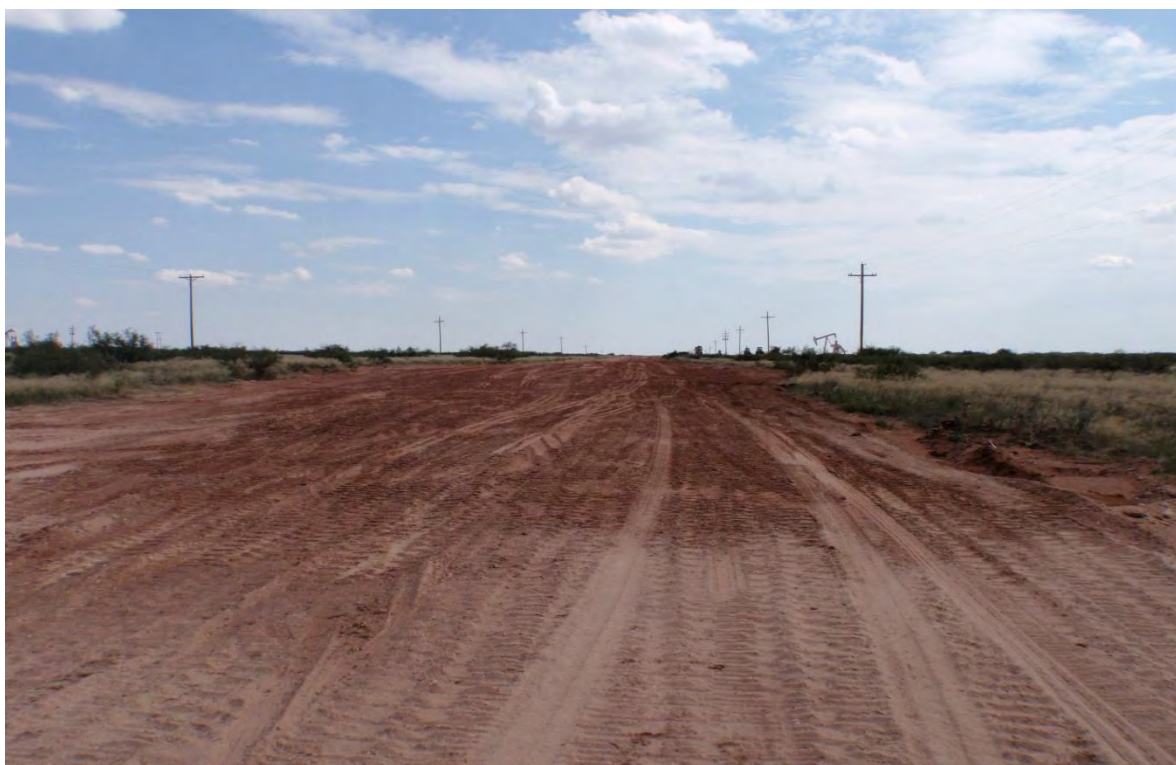
Taylor Poly Suction 4-Inch - Excavation (Following Backfill; Looking North)
