Re: Remediation Summary and Closure Report
Dump Yard 2 State #002H
API No. 30-015-42518
GPS: 32.502168, -104.060126
UL "N", Sec. 2, T21S, R28E
Eddy Co, NM
NMOCD Ref. No. 2RP-4424

TRC Environmental Corporation (TRC), on behalf of COG Operating, LLC (COG), has prepared this *Remediation Summary and Closure Report* for the Release Site known as the Dump Yard 2 State #002H. Details of the release are summarized below:

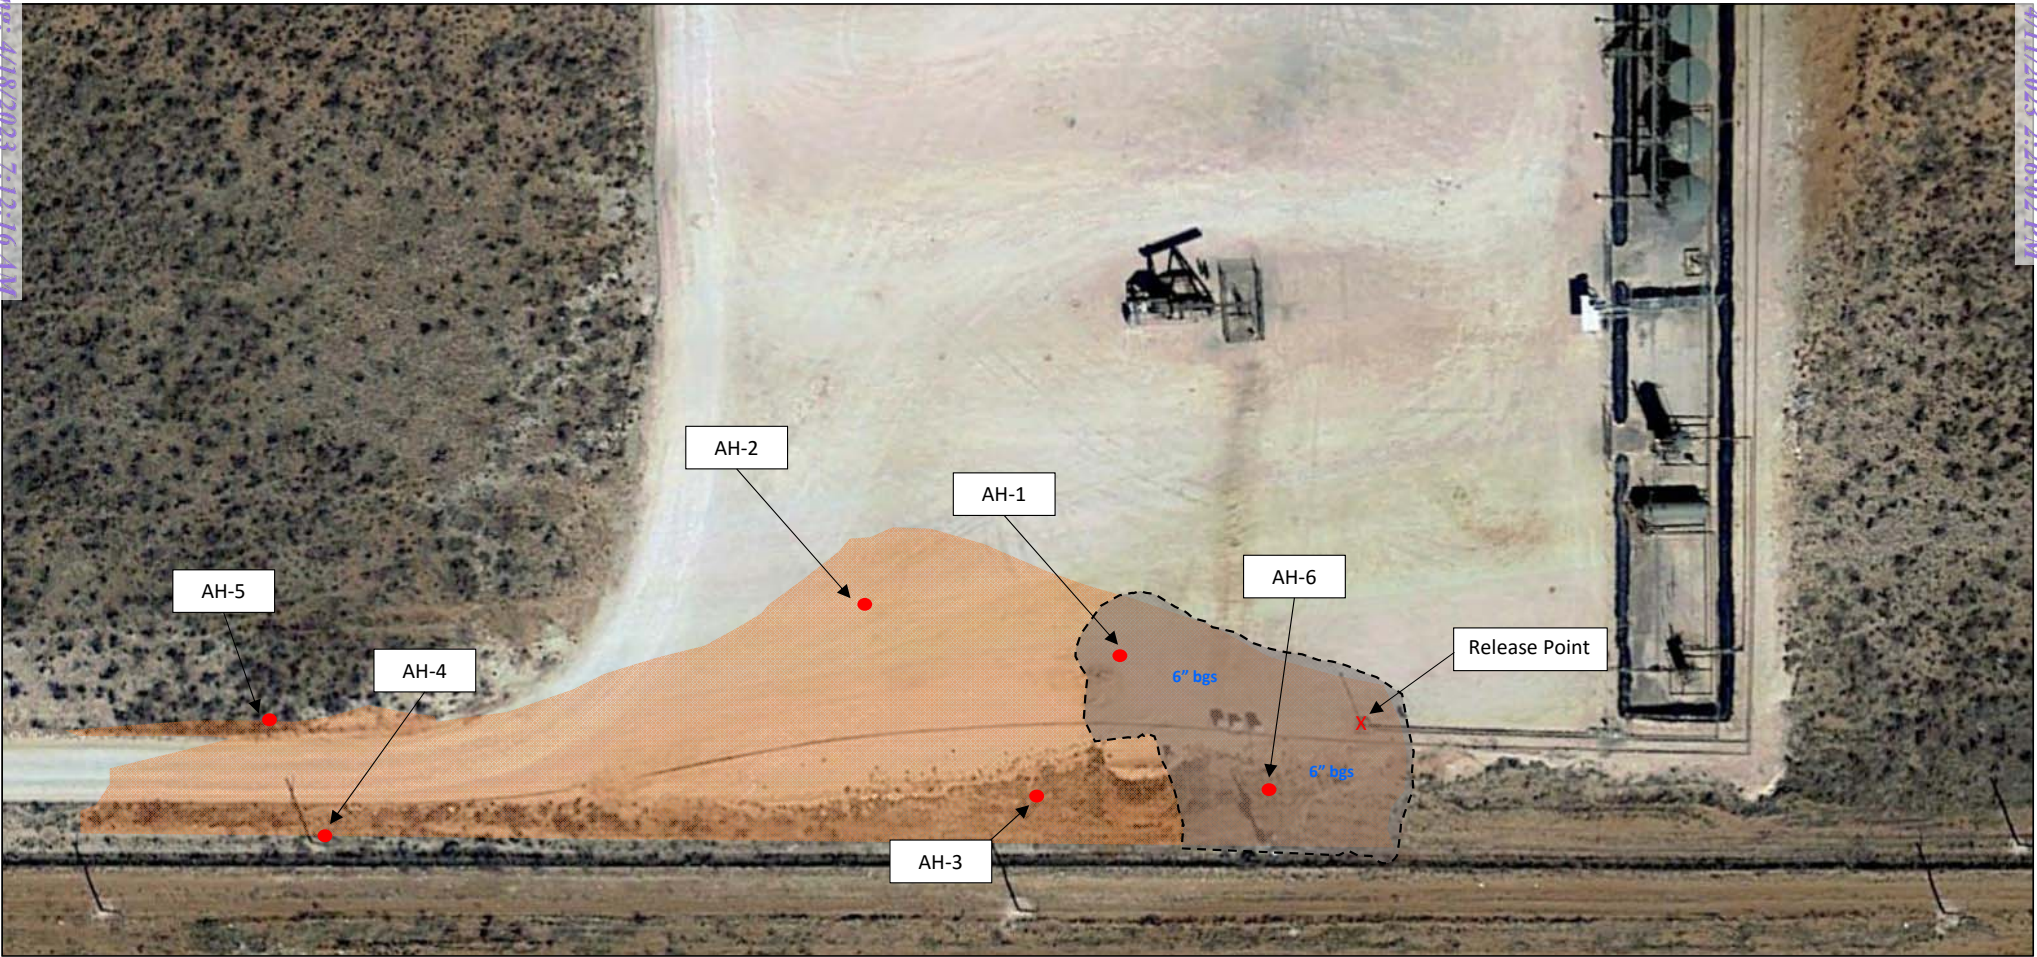
LEGEND: <div><div><div></div></div> Sample Locations</div> <div><div><div></div></div> Excavated Area</div>	Figure 2 Site & Sample Location Map COG Operating, LLC Dump Yard 2 State #002H Eddy Co, New Mexico	Scale 1" = ~10'	
		Drafted by: BC	Checked by: JL
		Draft: June 18, 2018	
		Lat. N 32.502168 Long. W 104.060126	
		UL "N", Sec. 2, T21S, R28E	
		TRC Proj. No.: 302166	
		<div><div><div></div><div>TRC</div></div><div>Results you can rely on</div></div> <div>2057 Commerce Drive Midland, Texas 79703 432.520.7720</div>

- Excavate the impacted area in the vicinity of sample locations AH-1 and AH-6 to a depth of one-half (0.5) ft. bgs.
- Transport excavated soil to and NMOCD-approved soil waste disposal facility.
- Upon completion of excavation activities, backfill the excavated area with locally sourced, non-impacted "like" material
- Prepare and submit a "Remediation Summary and Site Closure Request" to the NMOCD and NMSLO.

On May 30, 2018, remediation activities commenced at the release site. As per the approved *Workplan*, impacted soil in the areas characterize by sample points AH-1 and AH-6 was excavated to a depth of approximately one-half (0.5) ft bgs. Excavation sidewalls were advanced until field observations suggested hydrocarbon impacts had been mitigated. Excavated soil was temporarily stockpiled on-site, atop an impermeable liner, pending final disposition. A Photographic Log is provided as Attachment #5.

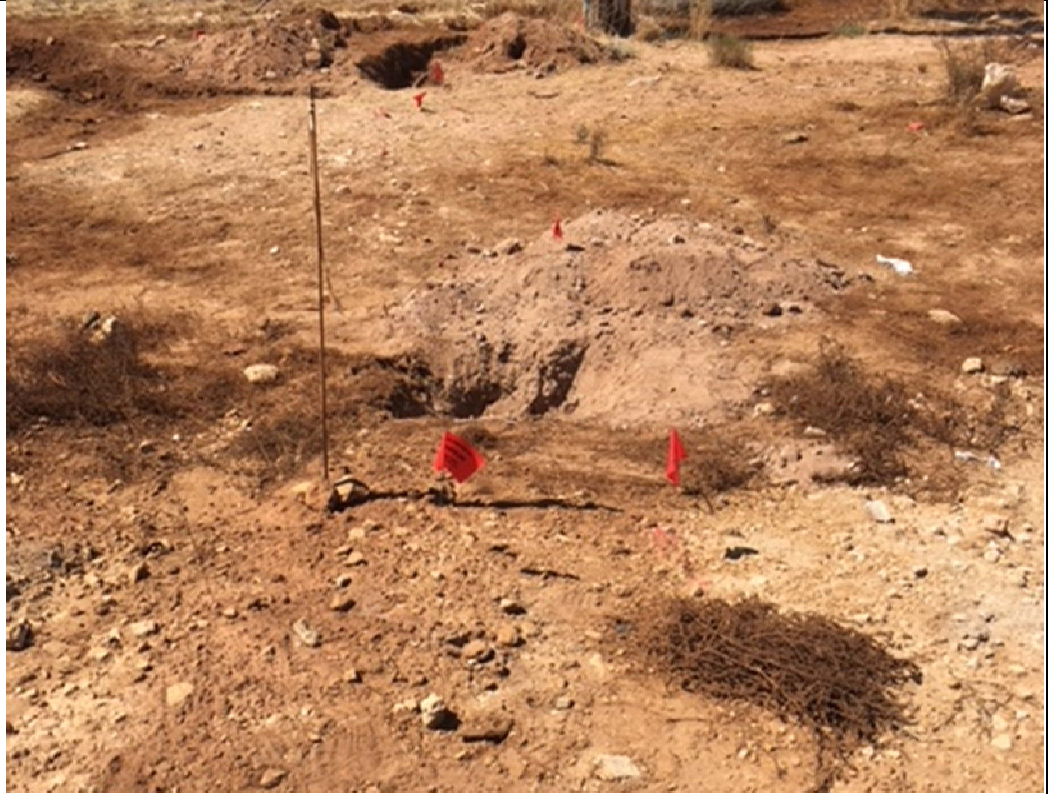
Description:
View of the
affected area.

Direction:
South

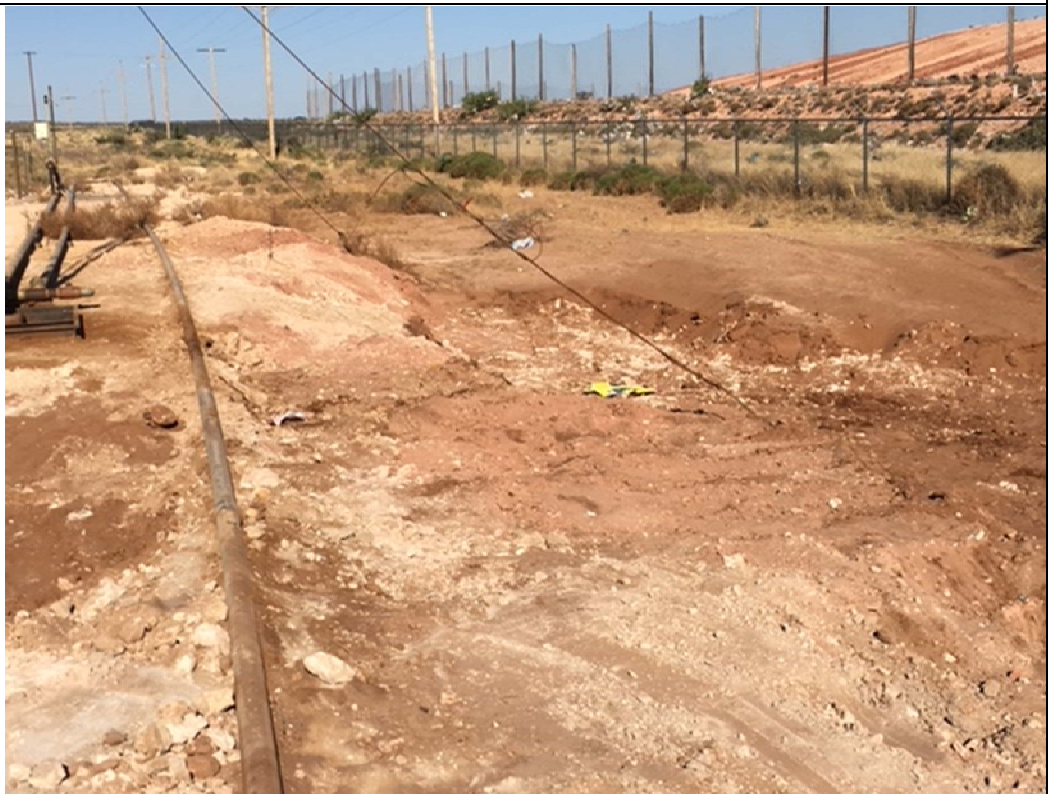
Photograph No. 2

Description:
View of portion of
the excavated
area.

Direction:
West

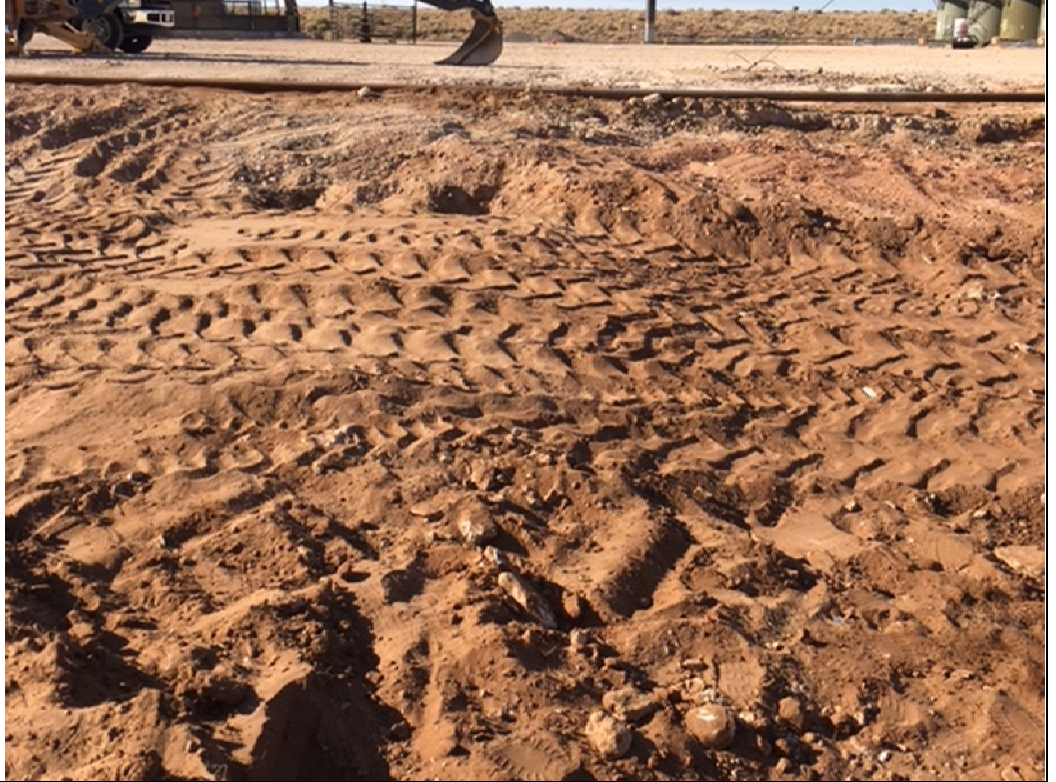
Description:
View of portion of
the excavated
area.

Direction:
North

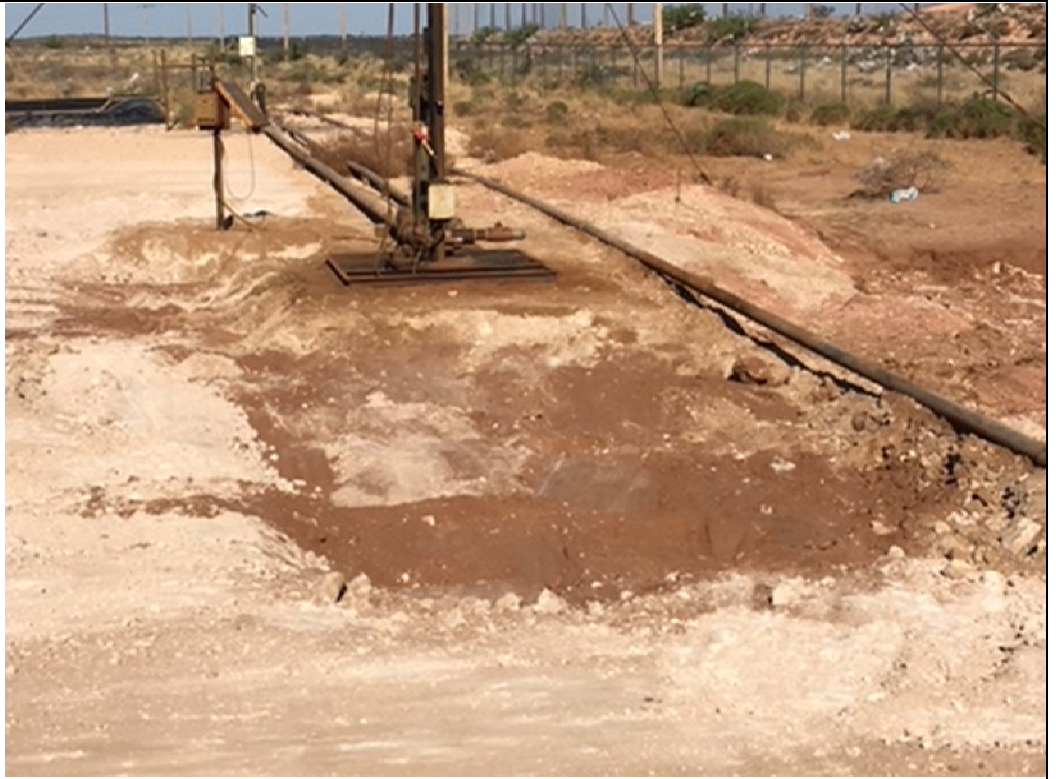
Photograph No. 4

Description:
View of portion of
the excavated
area.

Direction:
West

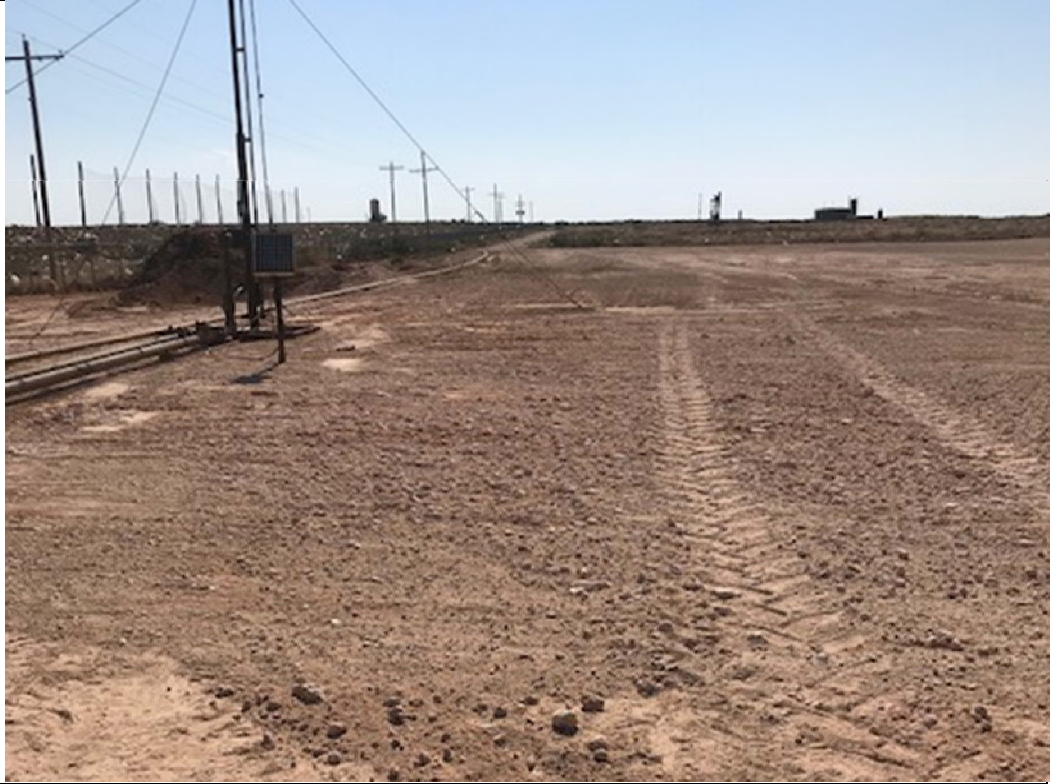
Description:
View of the
affected area after
remediation
activities.

Direction:
East

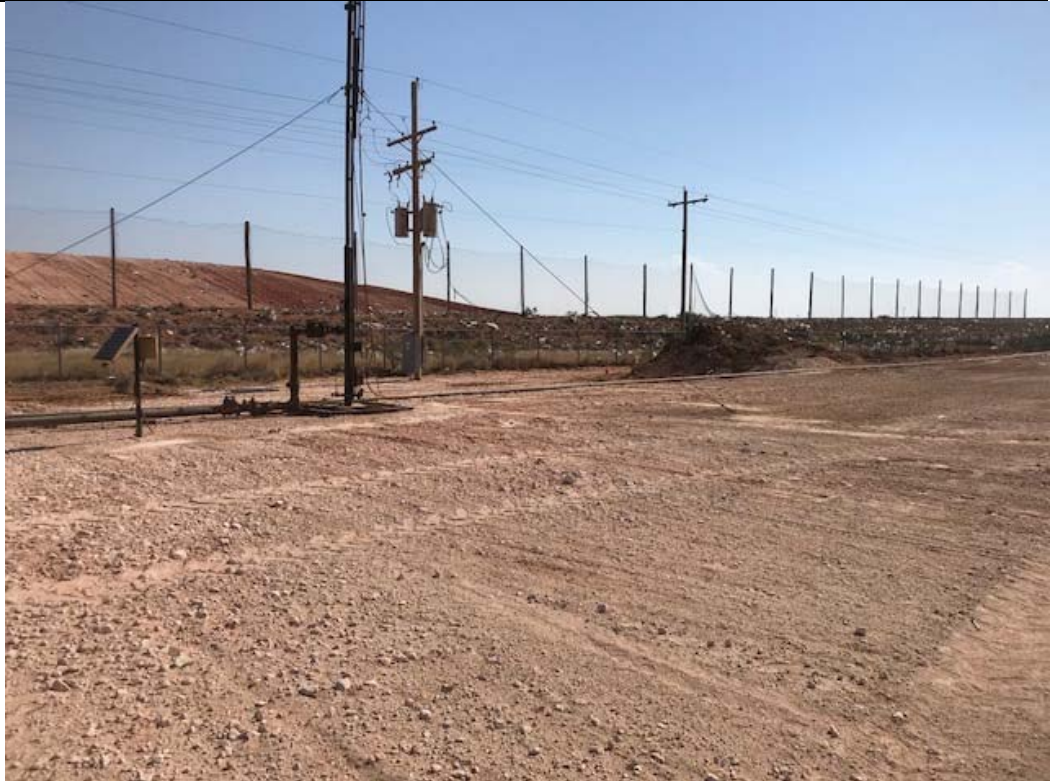
Photograph No. 6

Description:
View of the
affected area after
remediation
activities.

Direction:
Southwest
