Release Notification and Corrective Action

Name of Company	Enterprise Field Services LLC	Contact	Alena Miro
	PO Box 4324, Houston, TX 77210	Telephone No.	575-628-6802
Facility Name	Pipeline ROW, Line 1009	Facility Type:	Gas Gathering Pipeline
Surface Owner	State of New Mexico	Mineral Owner	NA - Pipeline
		Lease No.	NA

Enterprise Field Services LLC.
1009 Pipeline Release #2
 Lea County, New Mexico
 32.480269 N, 103.425138 W

SITE PHOTOS
1009 Pipeline Release #2

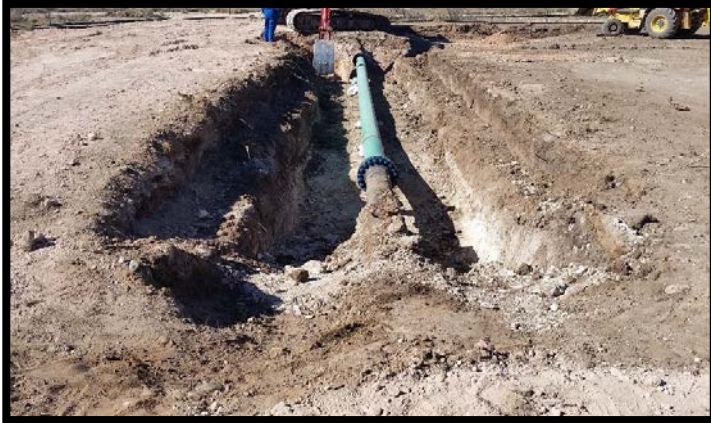
View of initial excavation activities, facing northeast.

The initial excavation activities to replace the leaking portion of the pipeline were carried out on February 11, 2016 by NMR Pipeline, LLC (NMR). Excavation activities resumed on February 24, 2016, to over-excavate and remove impacted material from the excavation sidewalls and floor. Apex was present during this time to provide excavation oversight and assist in soil removal utilizing field measurements collected with the PID and salinity meter. Impacted soil was removed from below and surrounding the release point on the 1009 pipeline. Based on Apex's field screening data generated during field activities, the excavation sidewalls and floor required further removal of affected soils.

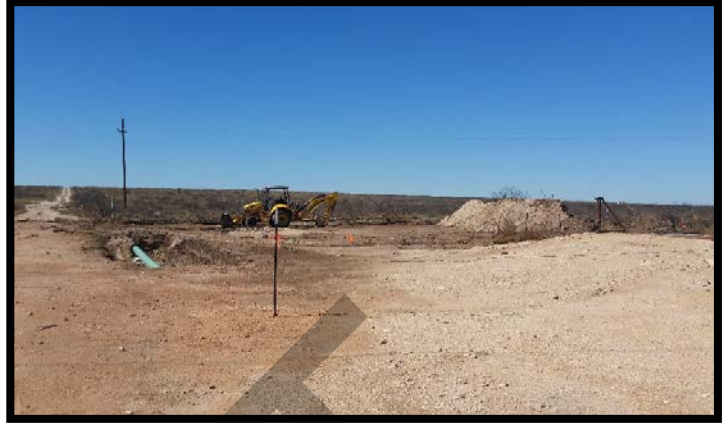
View of initial excavation and placement of stockpiled soils, facing southwest.

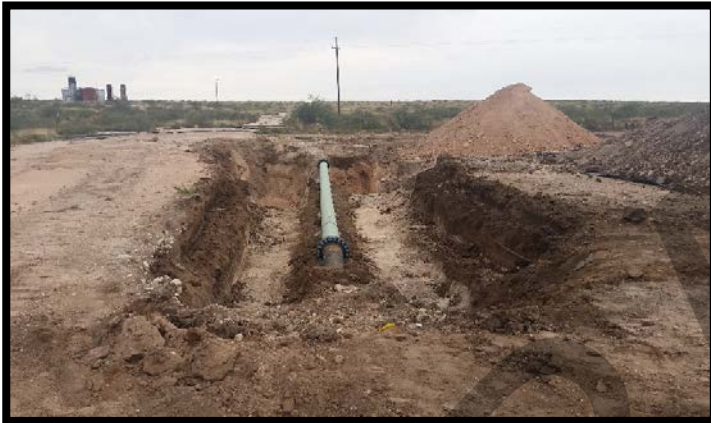
View of excavation area and stockpiles subsequent to over-excavation activities, facing northeast.

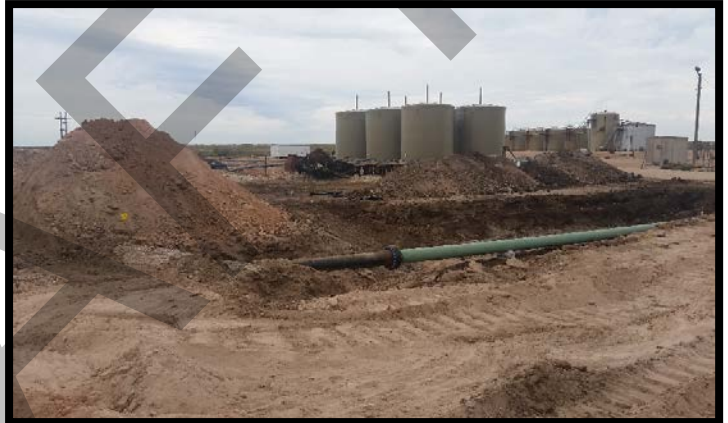
View of stockpiled soils generated during over-excavation activities, facing northeast.

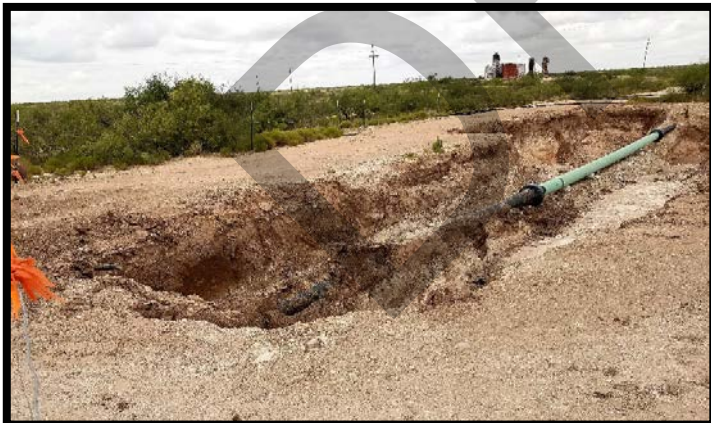
View of final excavation boundaries, facing north.
