**Re: Site Assessment, Remediation, and Closure Report**  
**Parseltongue 15 10 State Com 20H**  
**API No. 30-025-48503**  
**GPS: Latitude 32.298789 Longitude -103.564521**  
**UL -- M, 15, T23S, R33E**  
**Lea County, NM**  
**NMOCD Ref. No. NAPP2220652462**

Pima Environmental Services, LLC. (Pima) has been contracted by Devon Energy Production Company, LP (Devon) to perform a spill assessment, remediation activities, and submit this closure report for a drilling mud release that occurred at the Parseltongue 15 10 State Com 20H (Parseltongue). The initial C-141 was submitted on January 3, 2023 (Appendix C). This incident was assigned Incident ID NAPP2220652462 by the New Mexico Oil Conservation Division (NMOCD).

# Parseltongue 15-10 State Com 20H

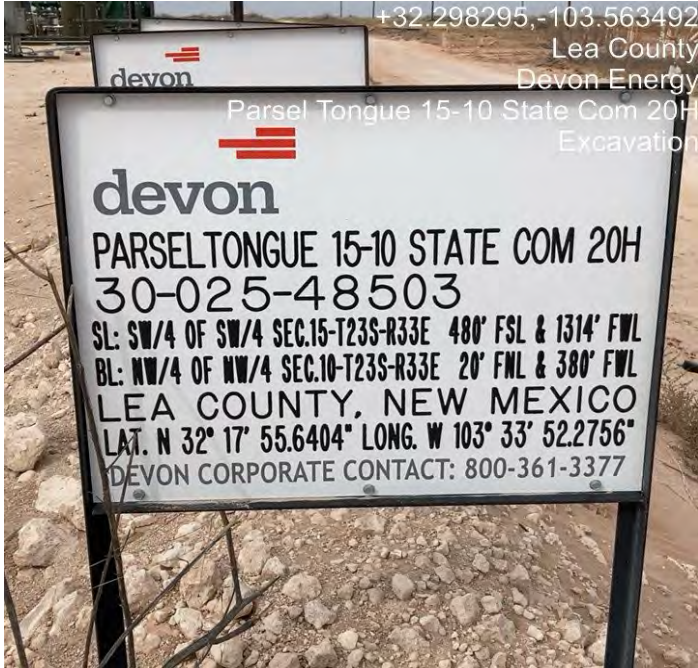
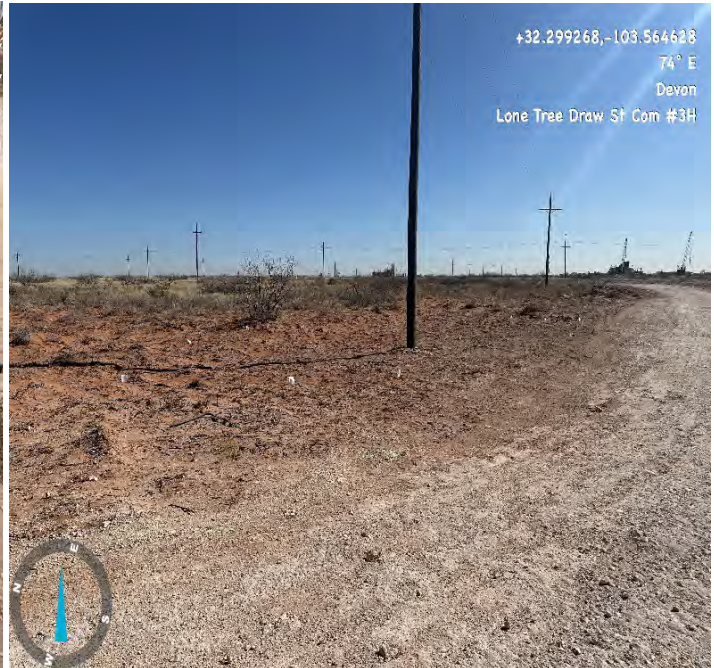
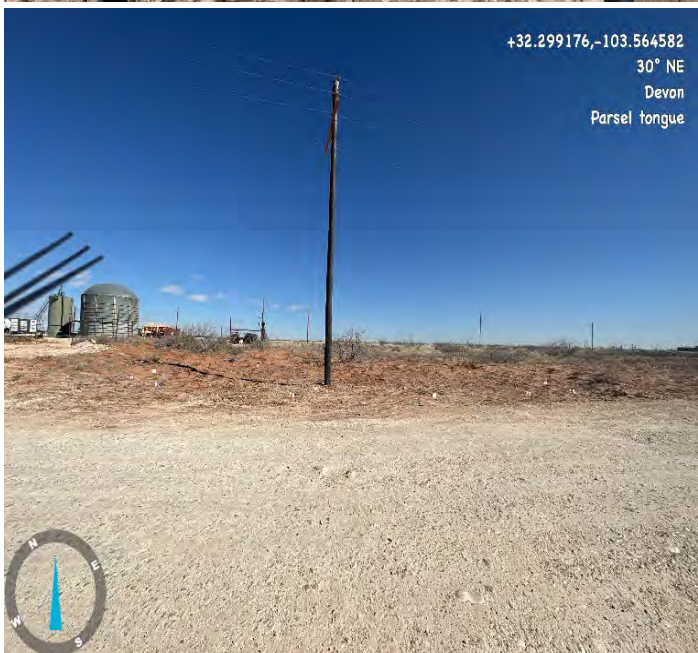
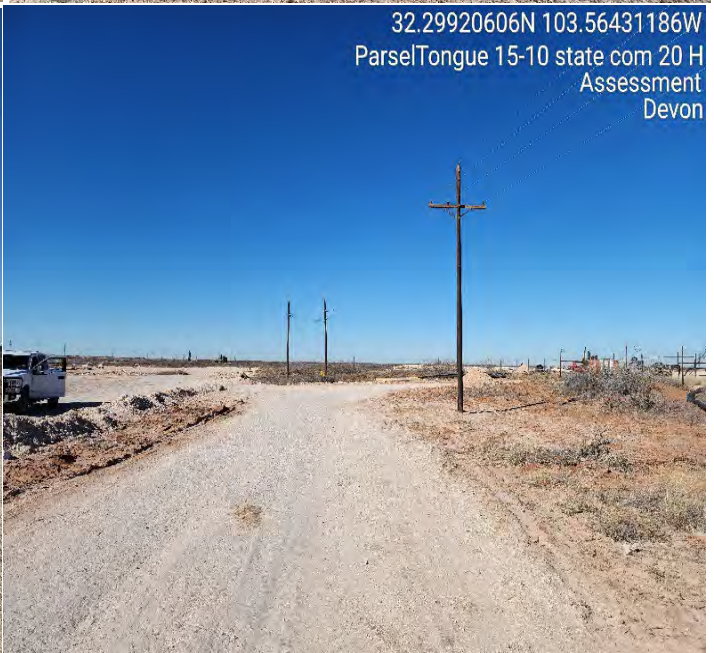
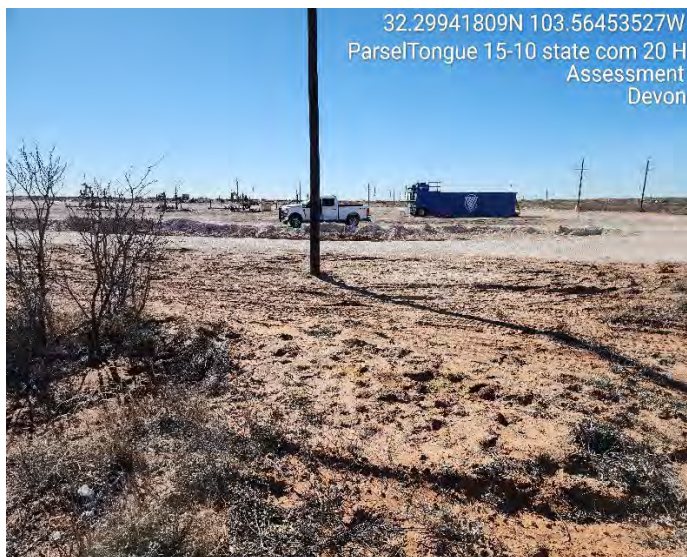
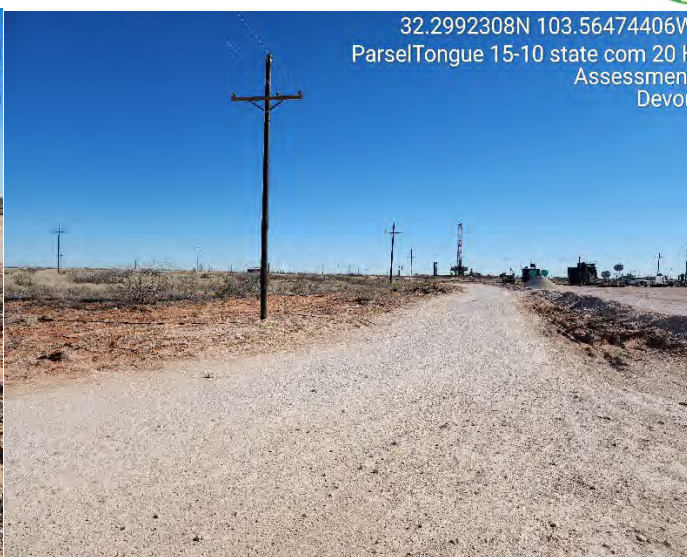
Site Assessment

**NAPP2220652462:** On July 25, 2022, while relogging and circulating bottoms up through 2 full open chokes, driller experienced an excessive loss although there were slight returns at shakers. All valves were in proper position. While building mud, solids control tech noticed mud had pooled up off edge of location which had come out of panic line. The released fluids were calculated to be approximately 49 barrels (bbls) of drilling mud. A vacuum truck was able to recover approximately 47 bbls of standing fluid.

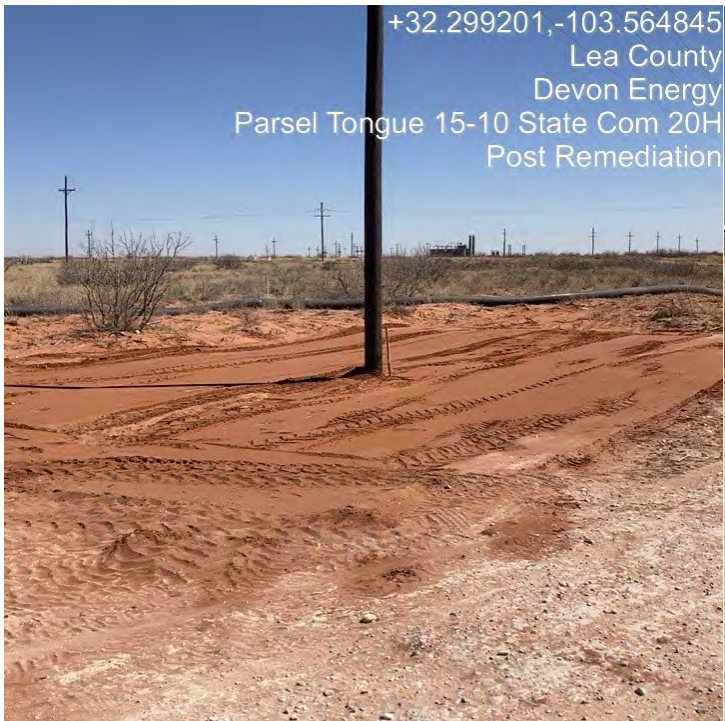
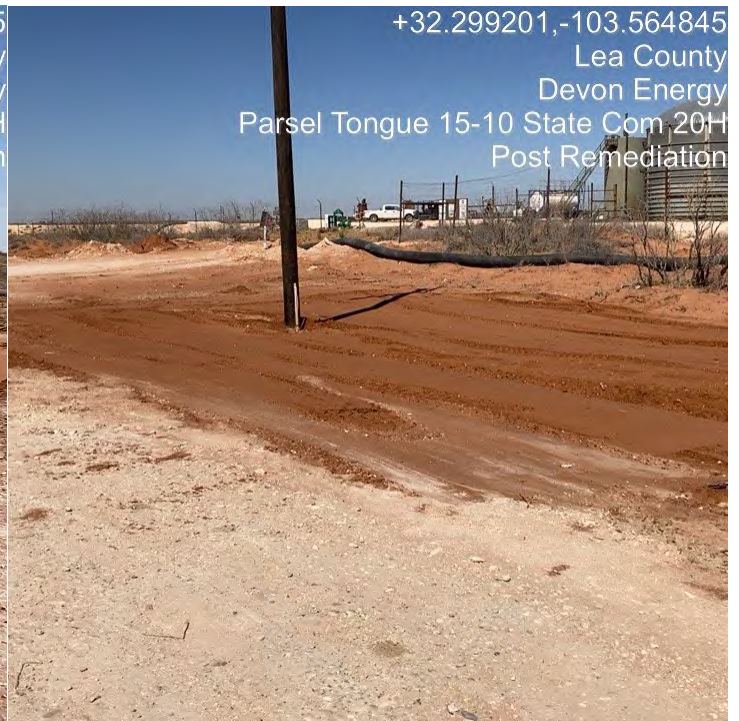
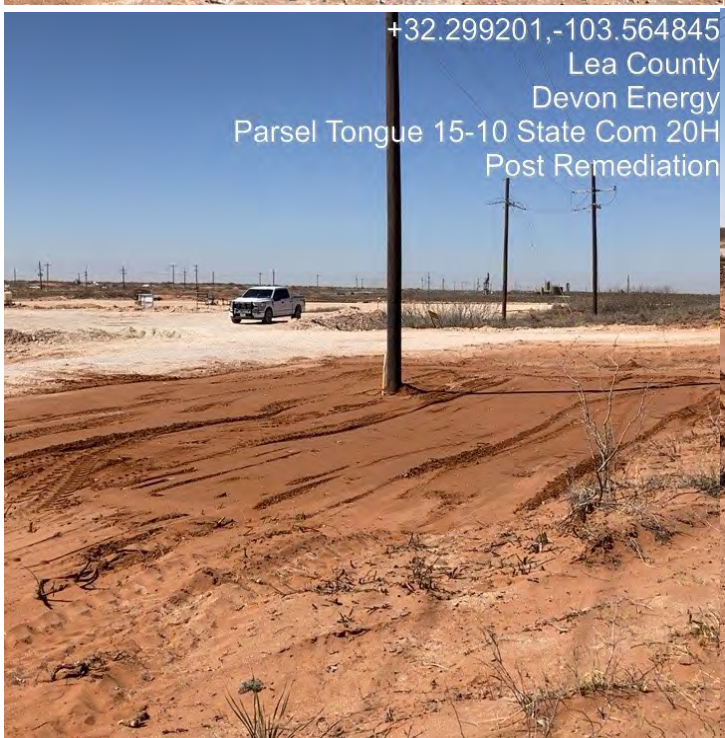
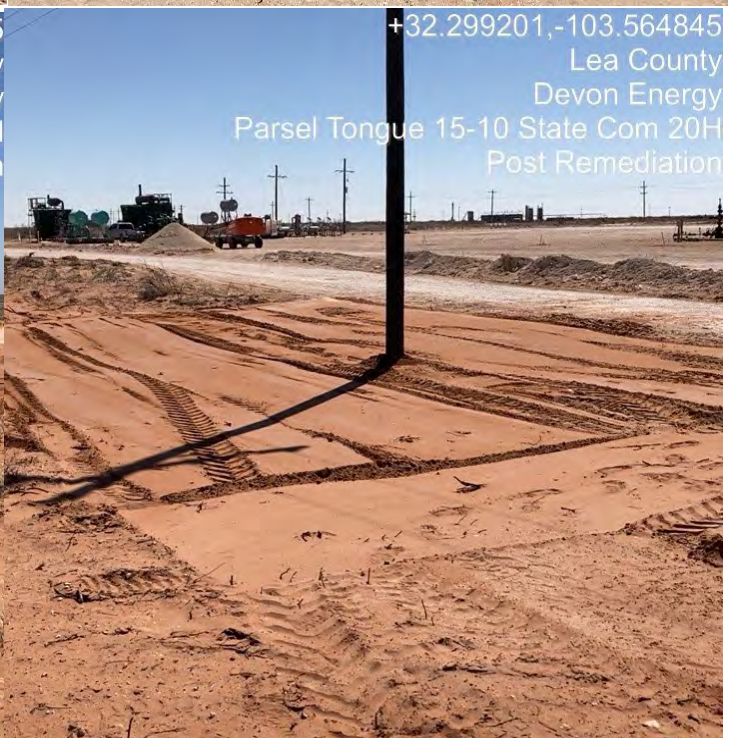
Post Excavation

Based on the sample results, the bottoms and sidewalls were below NMOCD Closure Criteria 19.15.29 NMAC. The contaminated material was removed then transported to an NMOCD approved disposal site. The excavation was then backfilled with clean like material, machine compacted and returned to its previous state. See Appendix D for Photographic Documentation.
