Closure Report

Emerald 32 Federal #001H
Eddy County, New Mexico
Incident #nAPP2229333053
F-32-24S-29E

Subject: **Closure Report**
Emerald 32 Federal #001H
Eddy County, NM
F-32-24S-29E

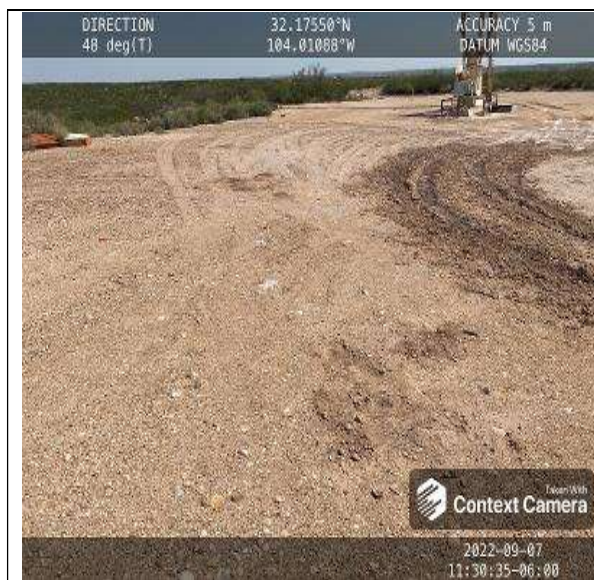
**Photograph No.1 Description:**

Impacted area, view north.

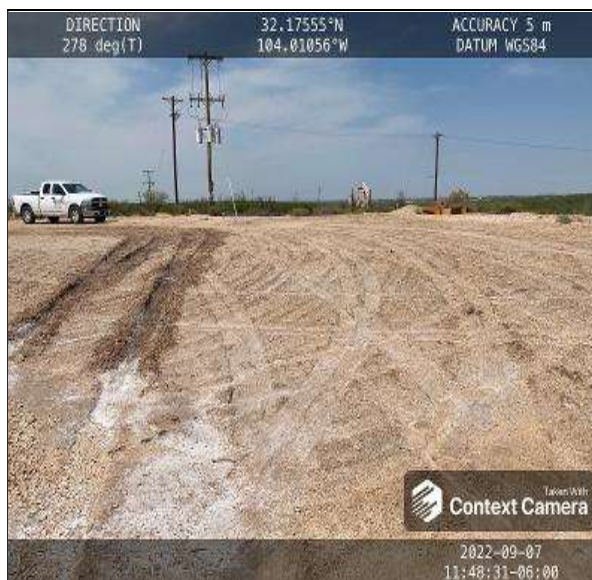
**Photograph No.2 Description:**

Impacted area, view south.

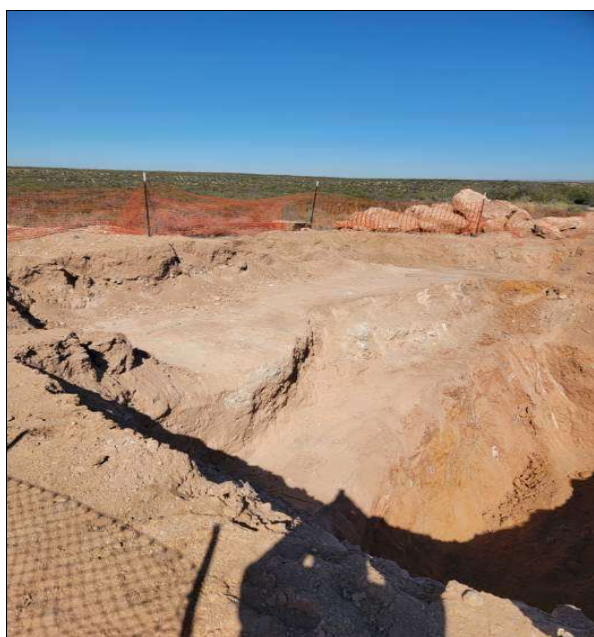
**Photograph No.3 Description:**

Excavation north side.

- The spill footprint of the impacted area was excavated to depths of 15 feet bgs (below ground surface), and the horizontal extent that all surface staining, TPH, and chlorides were removed.
- Sidewall samples were obtained in order to confirm horizontal delineation/remediation.
- The excavated area was backfilled with clean caliche, compacted, and restored to grade. Caliche was brought in from a private landowner, Onsurez.
- All contaminated soil was transported to R360 Environmental Solutions, an NMOCD approved disposal facility.

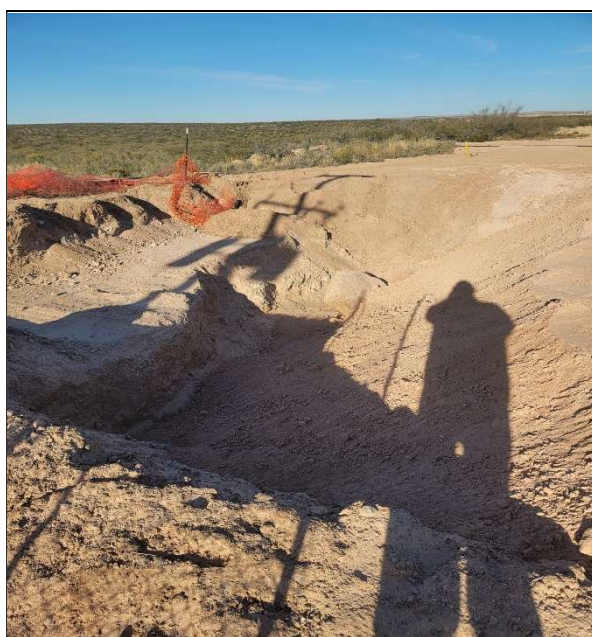
**Photograph No.4 Description:**

Excavation south side

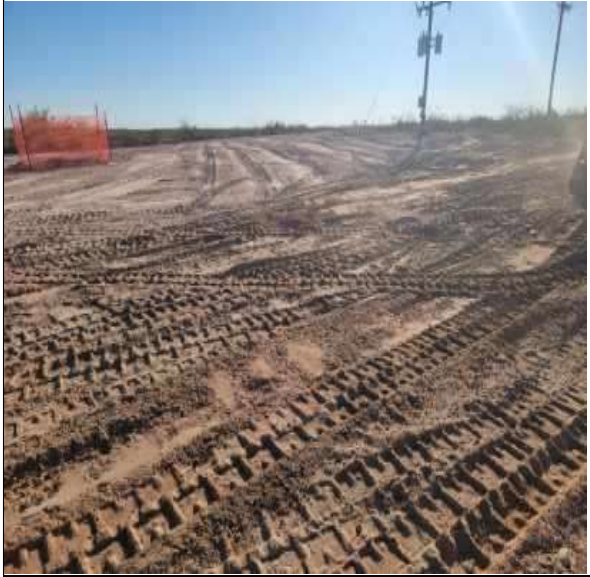
Photograph No.5 Description:

Backfill to grade.

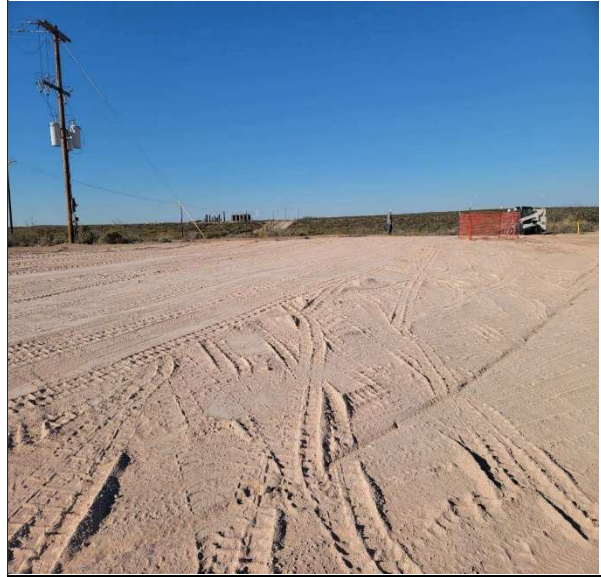
Photograph No.6 Description:

Backfill to grade.
