Site Assessment/Characterization

Closure

Re: Site Assessment, Liner Inspection, and Closure Report
Big Cat 16 CTB 9
API No. N/A
GPS: Latitude 32.30098 Longitude -103.6807
UL -- N, Sec. 16, T23S, R32E
Lea County, NM
NMOCD Ref. No. NRM2003146585

Pima Environmental Services, LLC. (Pima) has been contracted by Devon Energy Production Company, LP (Devon) to perform a spill assessment, remediation activities, and submit this closure report for a crude oil release that occurred at the Big Cat 16 CTB 9 (Big Cat). The initial C-141 was submitted on November 11, 2019 (Appendix C). This incident was assigned Incident ID NRM2003146585 by the New Mexico Oil Conservation Division (NMOCD).

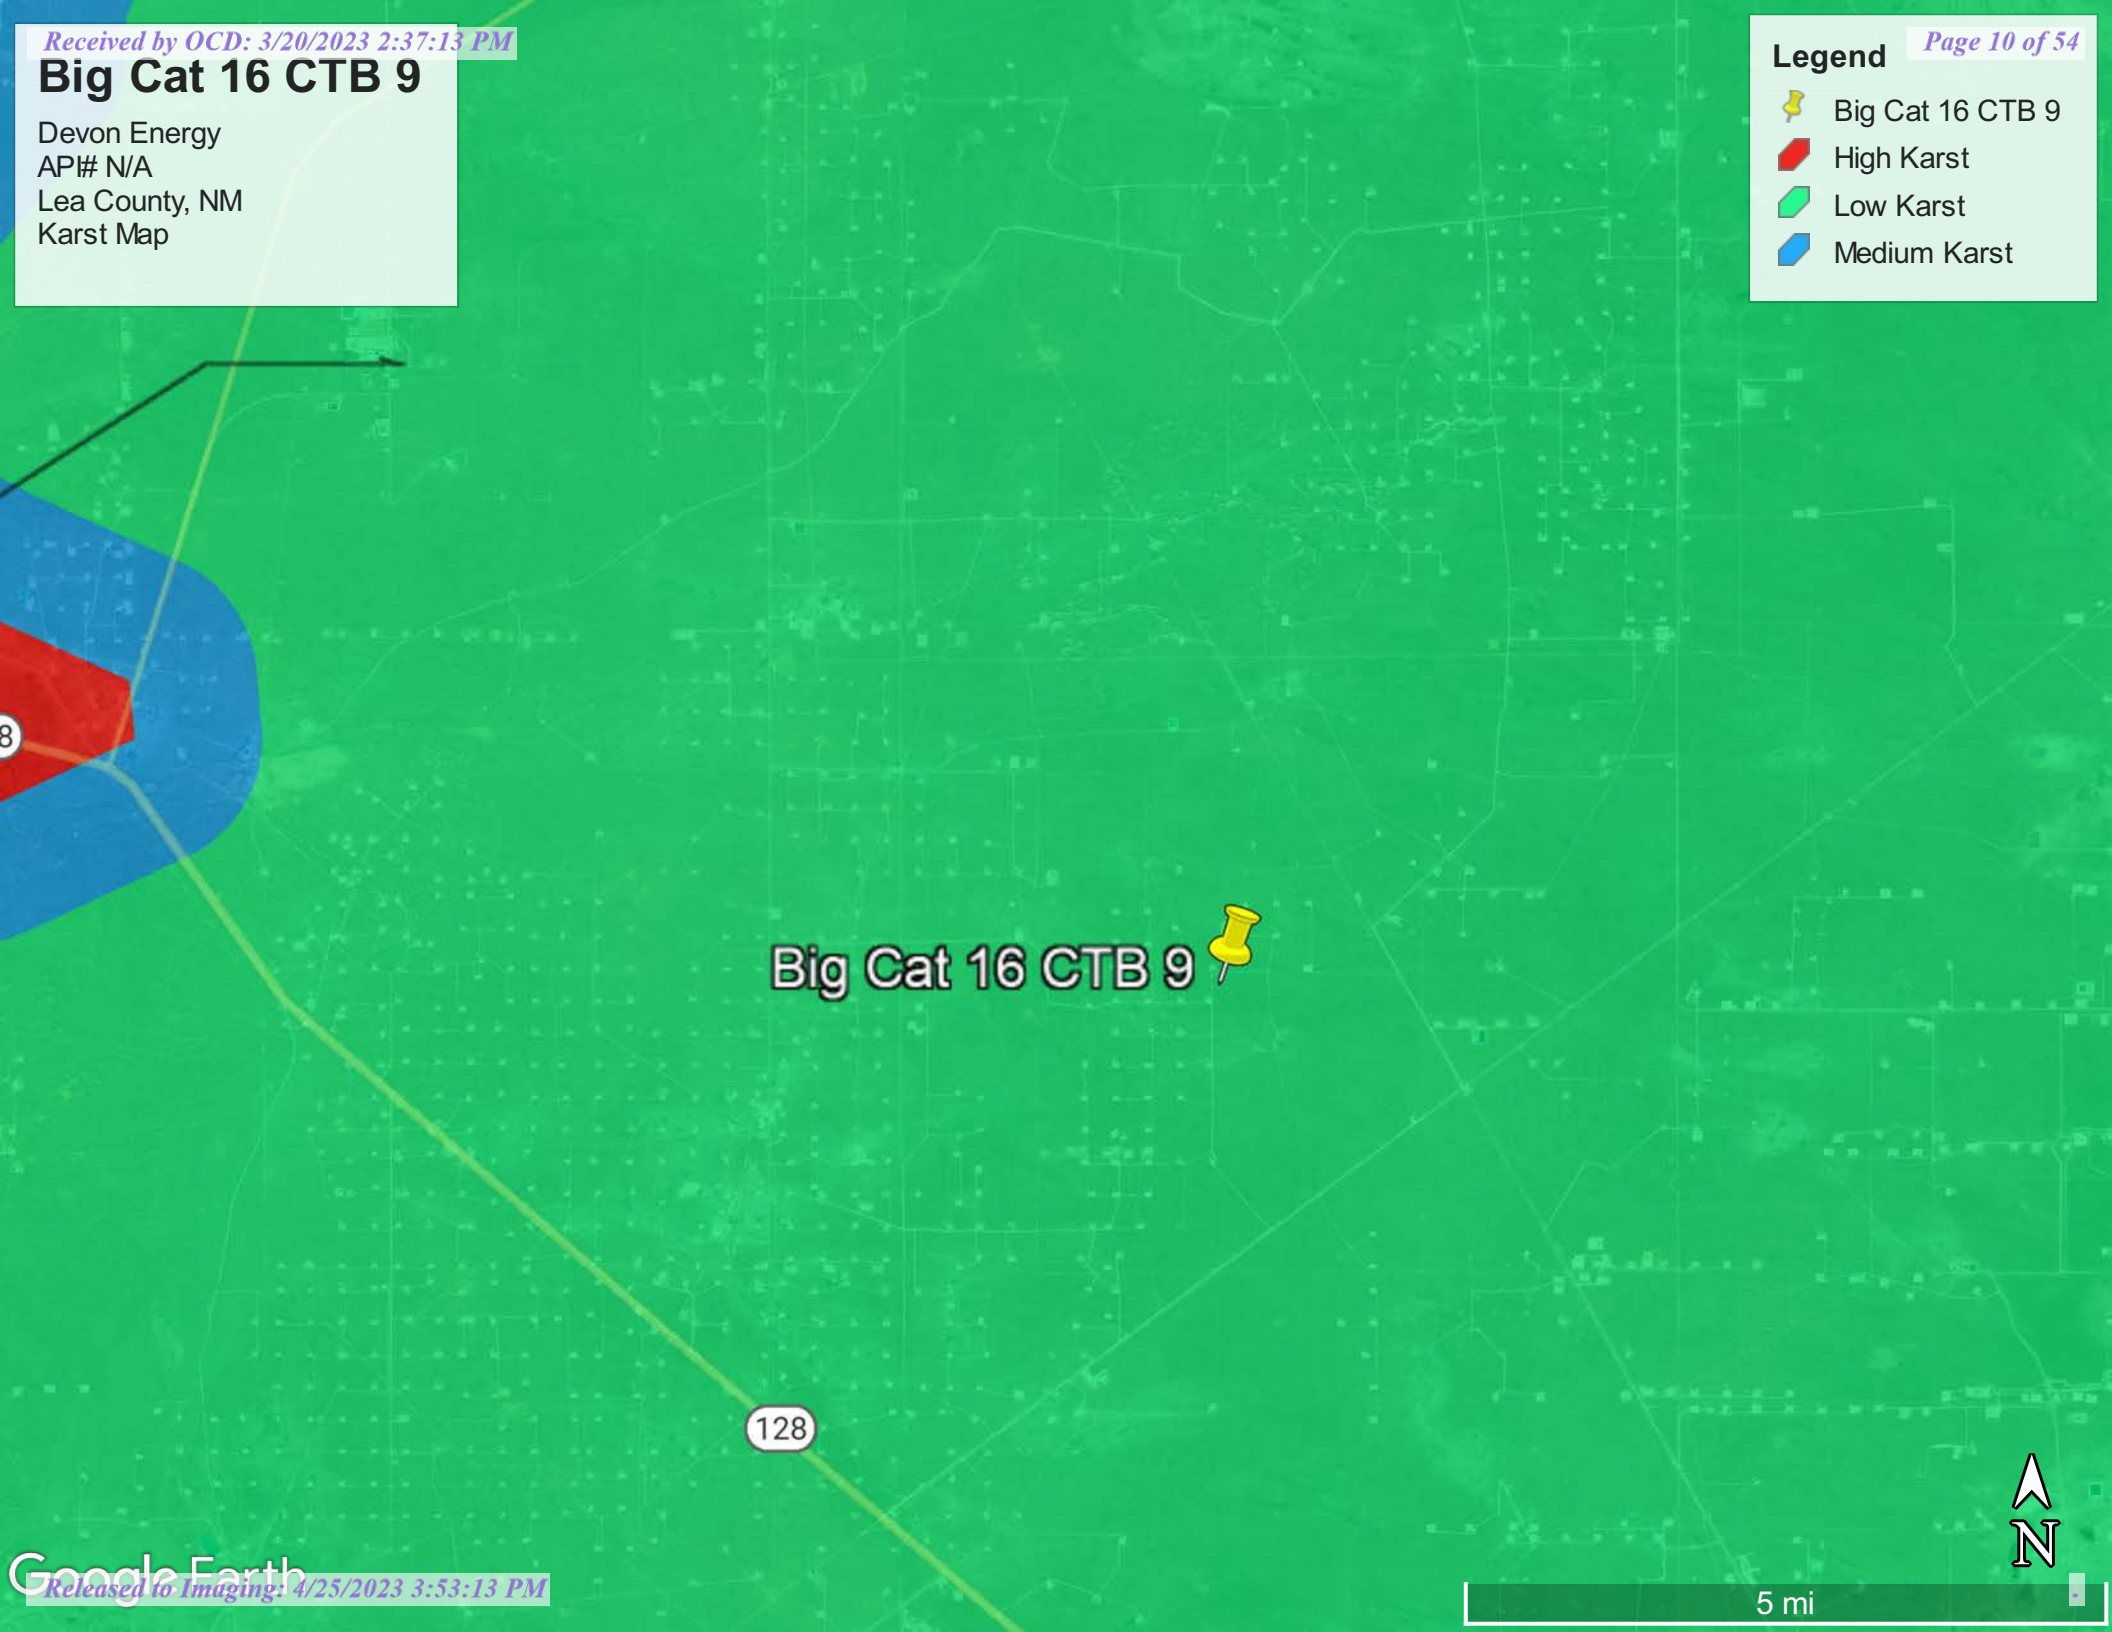
3-Karst Map

Per the New Mexico Bureau of Geology and Mineral Resources, the geology is made up of Interlayered eolian sands and piedmont-slope deposits along the eastern flank of the Pecos River valley, primarily between Roswell and Carlsbad. Typically capped by thin eolian deposits. The soil in this area is made up of Kermit-Palomas fine sands, 0 to 12 percent slopes according to the United States Department of Agriculture Natural Resources Conservation Service soil survey (Appendix B). The drainage class in this area is excessively drained. There is a high potential for karst geology to be present around the Big Cat (Figure 3).

Devon Energy
AP# N/A
Lea County, NM
Karst Map

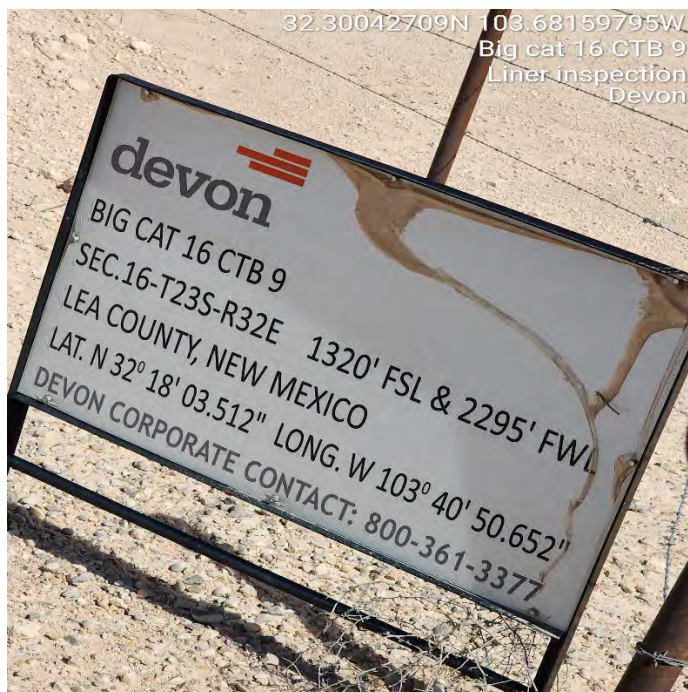
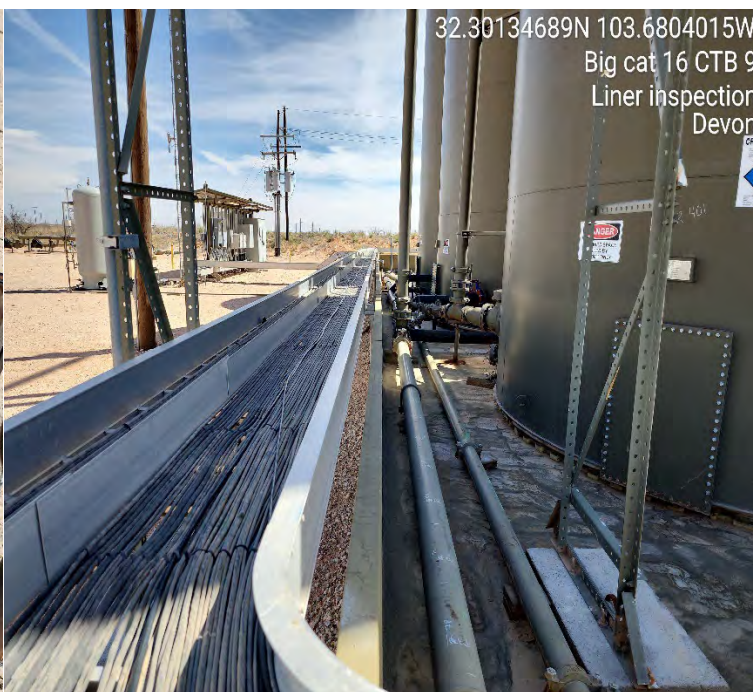
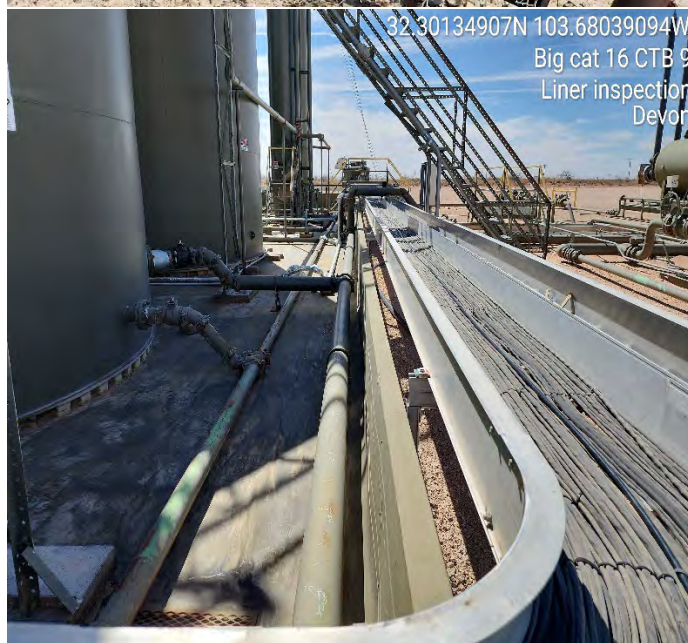
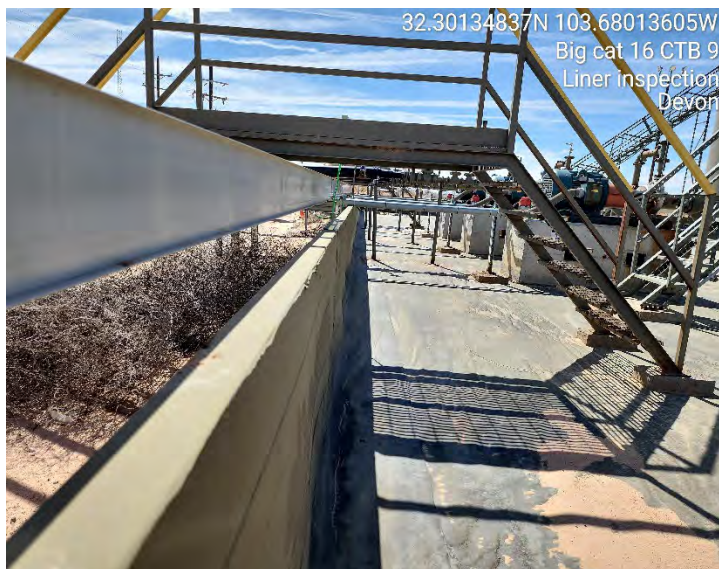
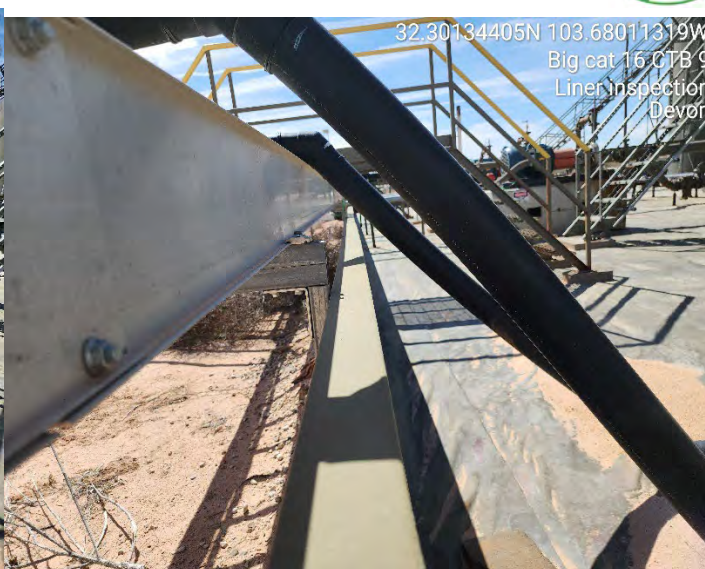
On March 10, 2023, after sending the 48-hour Notification (Appendix C) via email, Pima Environmental conducted a liner inspection at this location. We concluded that this liner and containment maintained its integrity and was able to retain the fluids. The Liner Inspection Form and photographic documentation can be found in Appendix D.

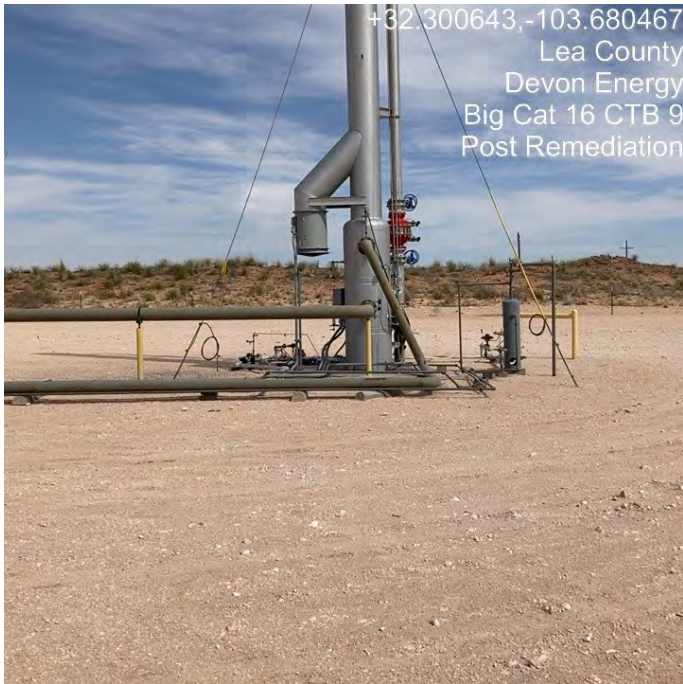
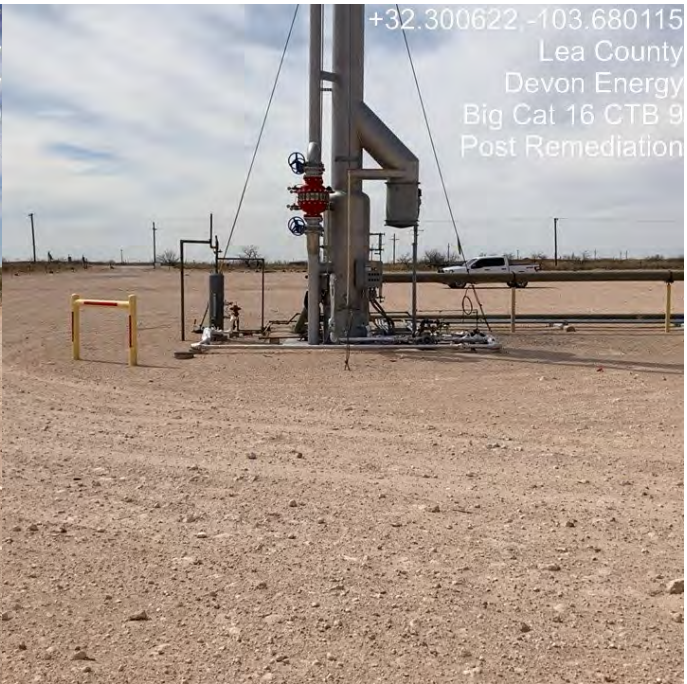
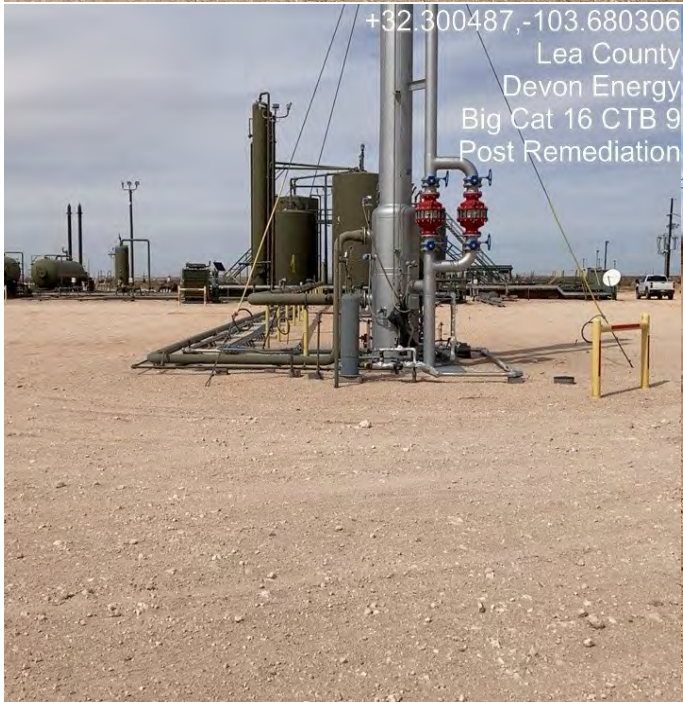
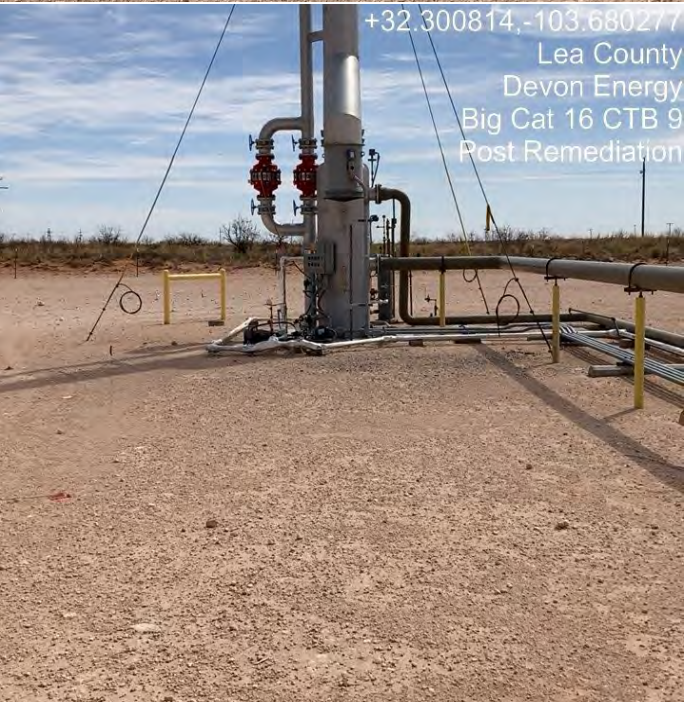
Flare photos

NRM2003146585: On October 27, 2019, a fire was caused by fluid being sent to the flare after the VRT swamped out, when the VRT swamped out it pressured up the tank and caused a release of liquid out of the thief hatch, the released fluids were calculated to be approximately 0.24 barrel (bbl) of produced crude oil from the tank and 2 bbls of crude oil from the flare. No fluid was able to be recovered, due to being on fire under the flare, and the .24 of a bbl was removed during the wash of the containment.
