Re: Site Assessment and Closure Report
Bell Lake 19 State #006H
API No. 30-025-42536
GPS: Latitude 32.19682317, Longitude -103.61895677
UL "M", Sec.19, T24S, R33E
Lea County, NM
NMOCD Ref. No. NAPP2115330967

Pima Environmental Services, LLC (Pima) has been contracted by Devon Energy Production Company (Devon) to perform a spill assessment and has prepared this closure report for a crude oil release that occurred at the Bell Lake 19 State #006H (Bell Lake). The initial C-141 was submitted on June 1, 2021 (Appendix C). This incident was assigned Incident ID NAPP2115330967, by the New Mexico Oil Conservation Division (NMOCD).

Bell Lake 19 State #006H

Devon Energy
API: 30-025-42536
Lea County, NM
Site Map

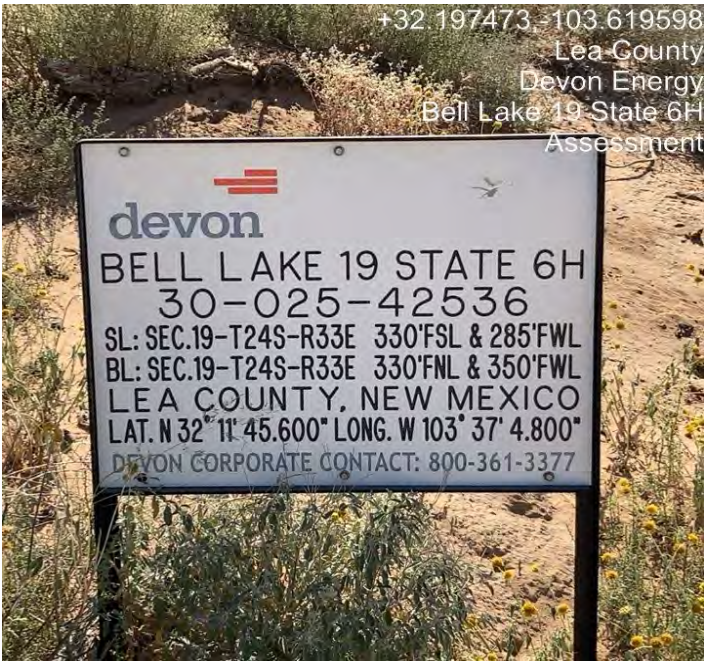
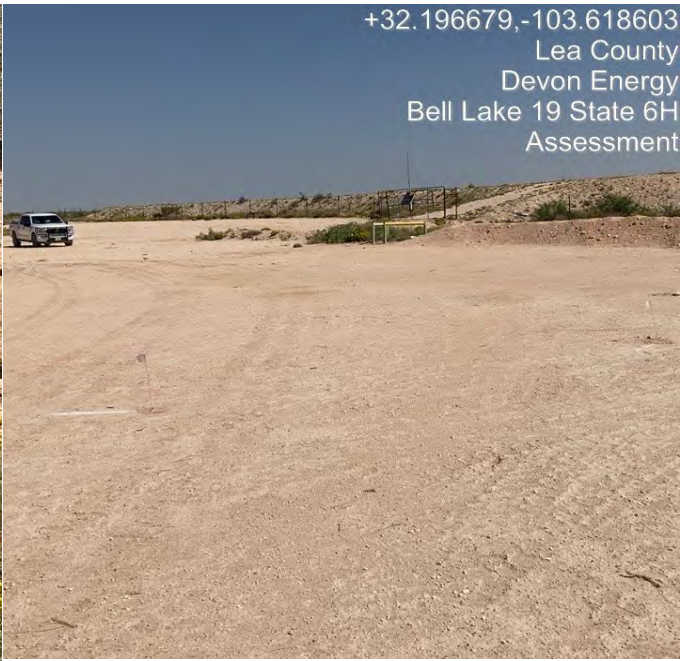
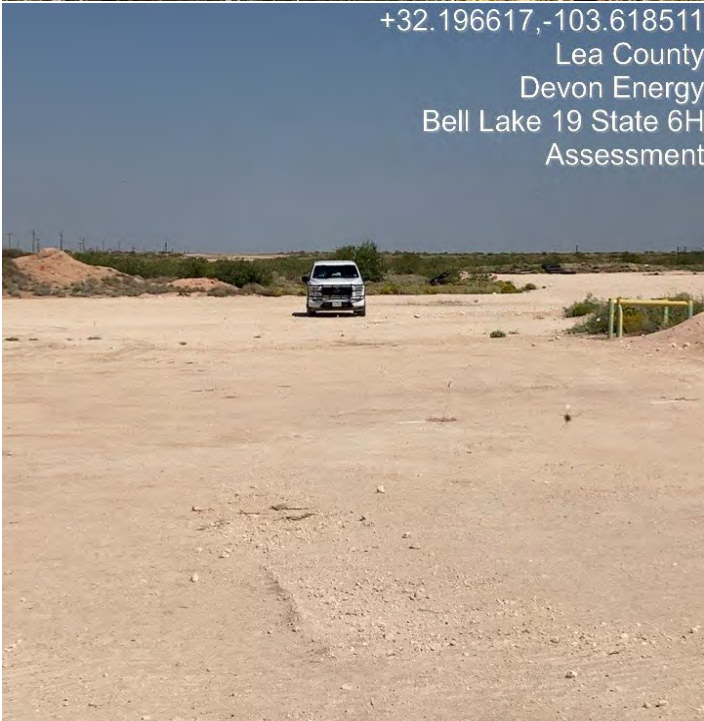
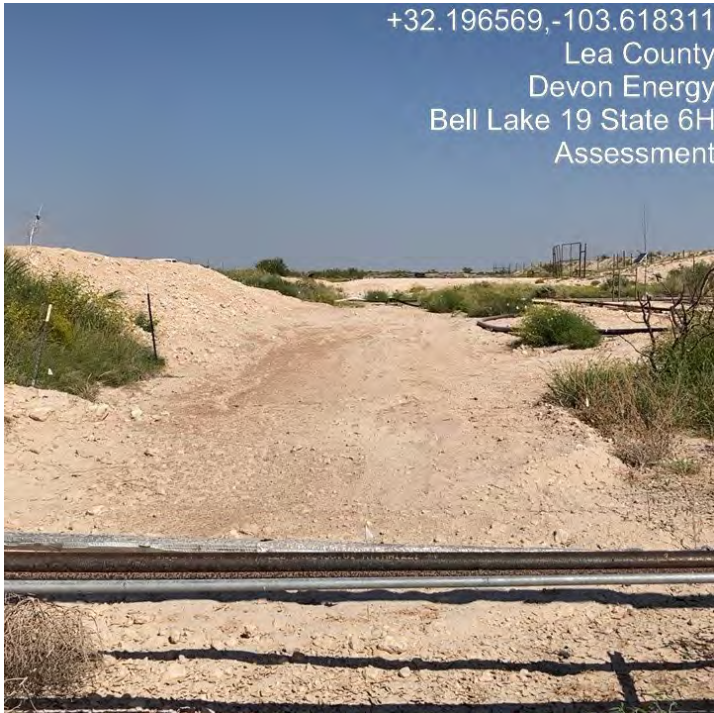
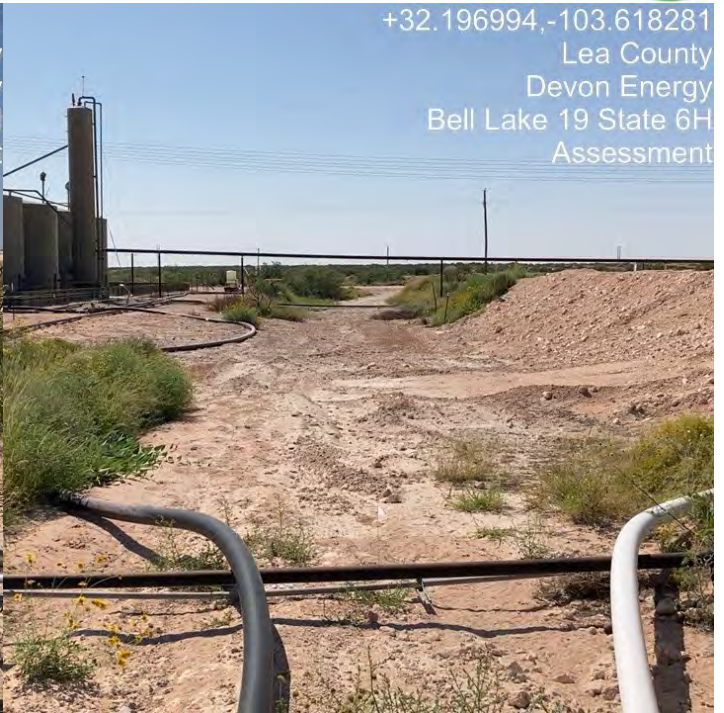
**SITE PHOTOGRAPHS
DEVON ENERGY
BELL LAKE 19 STATE 6H**

Site Assessment

The sample results were below NMOCD Closure Criteria 19.15.29 NMAC. Based on these findings, Devon Construction Department mobilized personnel and equipment to conduct a scrape to remove surface staining. No further remediation activities are required at this time. The contaminated surface soil was hauled to an approved, lined disposal facility.
