Site Assessment/Characterization

March 20, 2023

Tetra Tech, Inc. (Tetra Tech) was contacted by Devon Energy Production Company (Devon) to assess a release that occurred at the Red Bull 29 Central Tank Battery (CTB) 2 (Site) due to a leak developing on a line causing fluid release. The release footprint is entirely on pad and is located in Public Land Survey System (PLSS) Unit Letter O, Section 29, Township 23 South, Range 35 East, in Lea County, New Mexico (Site). The approximate release point occurred at coordinates 32.271062°, -103.385277°, as shown on Figures 1 and 2.

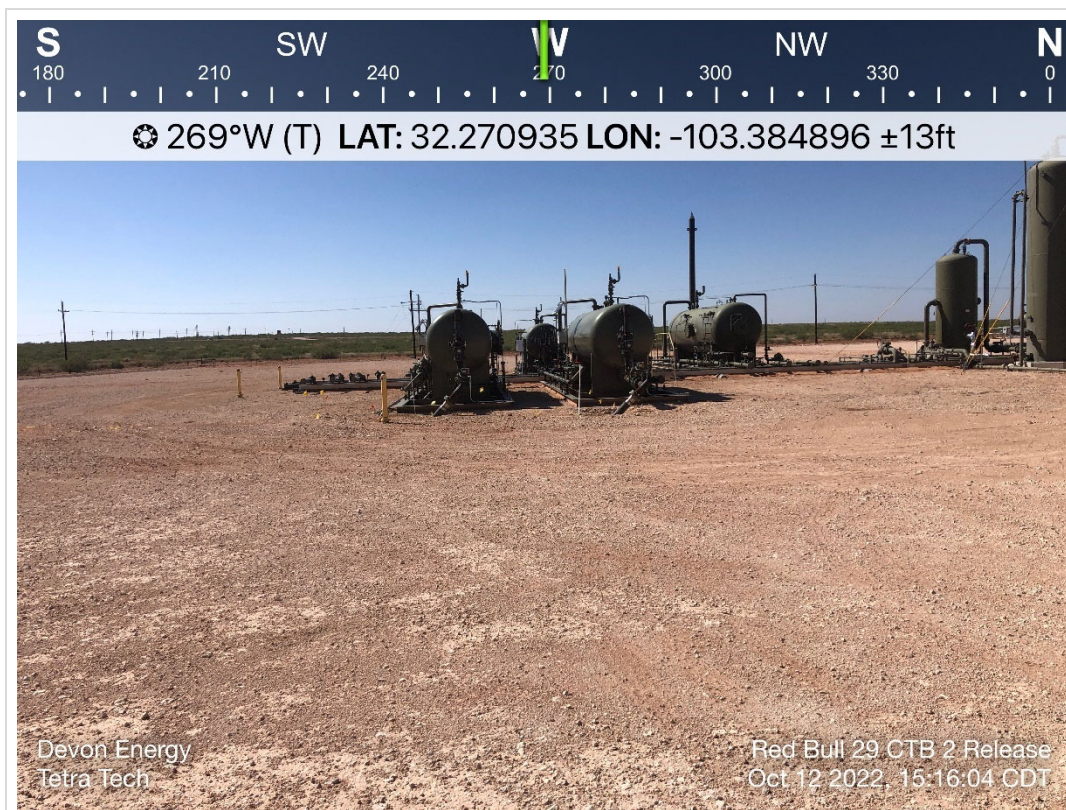
TETRA TECH, INC. PROJECT NO. 212C-MD-02865	DESCRIPTION	View West of the five separators nearest the release.	1
	SITE NAME	Devon Energy Corporation Red Bull 29 CTB 2 Release NAPP2226924595	10/12/2022

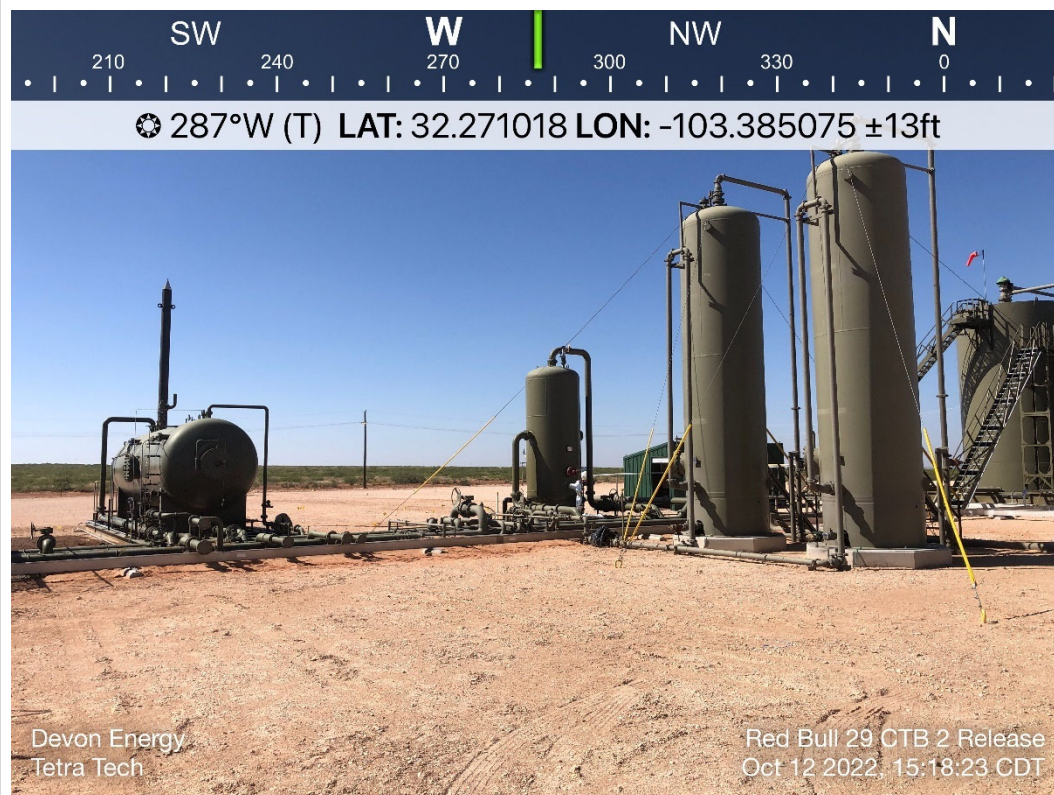
TETRA TECH, INC. PROJECT NO. 212C-MD-02865	DESCRIPTION	View towards the eastern side of the release extent.	2
	SITE NAME	Devon Energy Corporation Red Bull 29 CTB 2 Release NAPP2226924595	10/12/2022

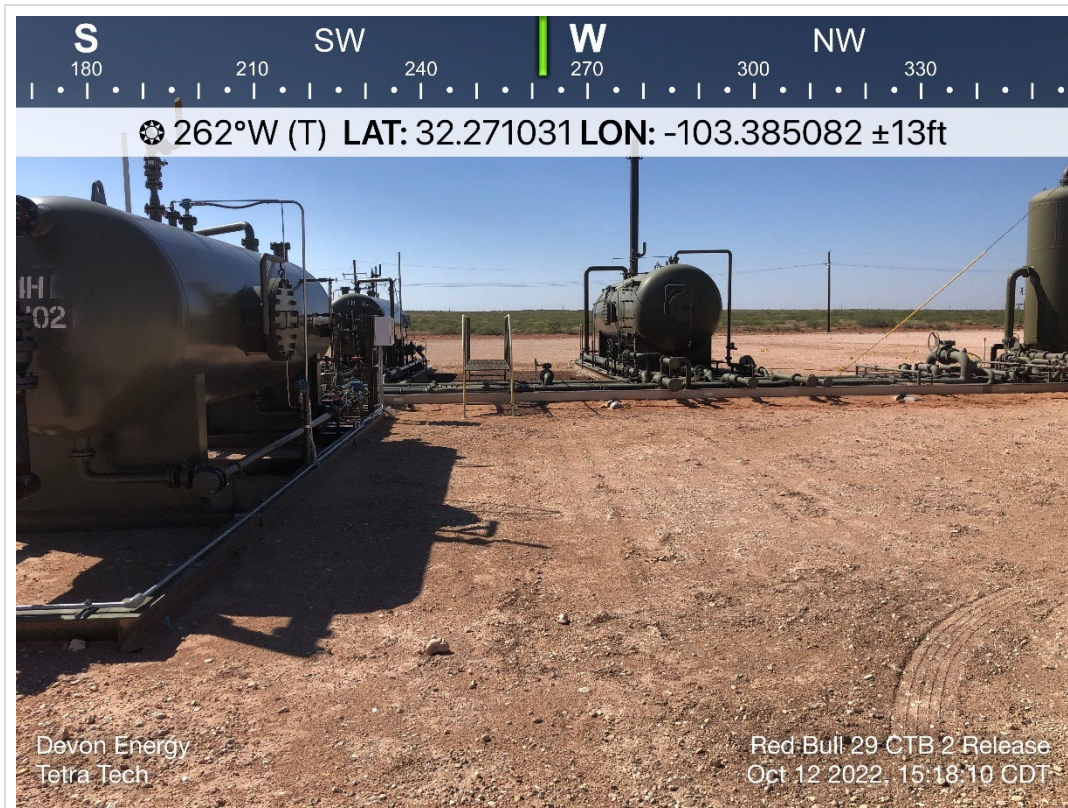
TETRA TECH, INC. PROJECT NO. 212C-MD-02865	DESCRIPTION	View towards the eastern side of the release extent.	3
	SITE NAME	Devon Energy Corporation Red Bull 29 CTB 2 Release NAPP2226924595	10/12/2022

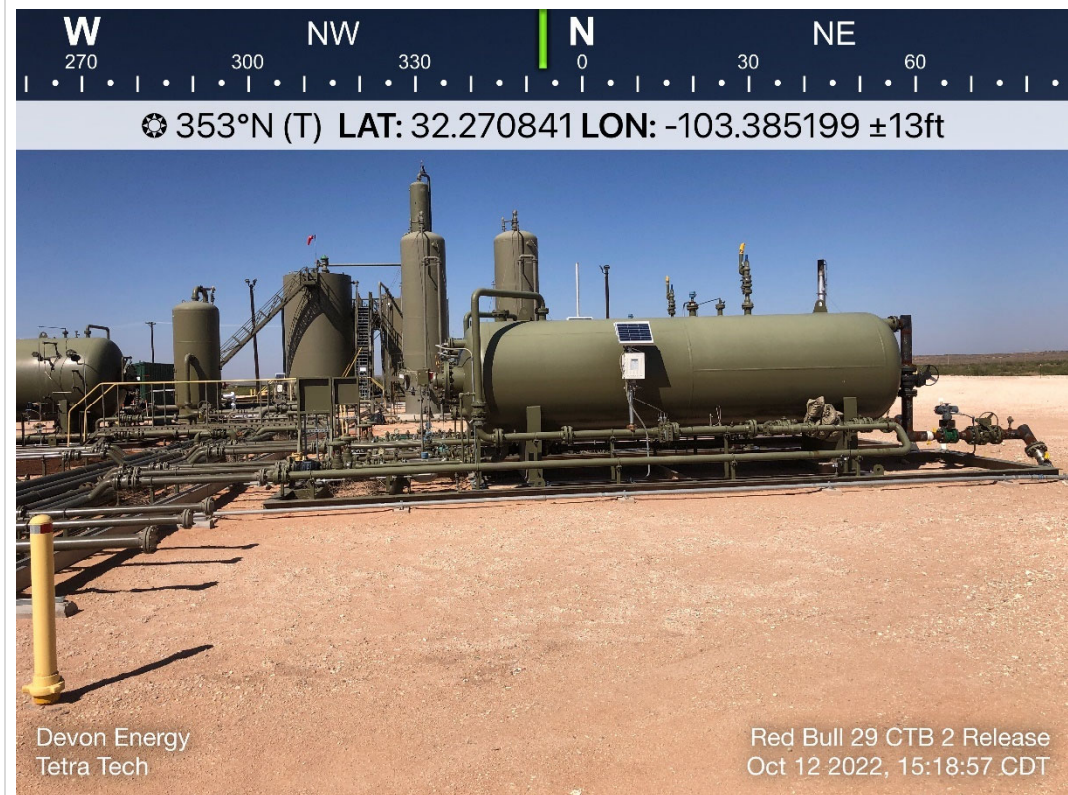
TETRA TECH, INC. PROJECT NO. 212C-MD-02865	DESCRIPTION	View north towards the release extent from the southern edge of the pad.	4
	SITE NAME	Devon Energy Corporation Red Bull 29 CTB 2 Release NAPP2226924595	10/12/2022

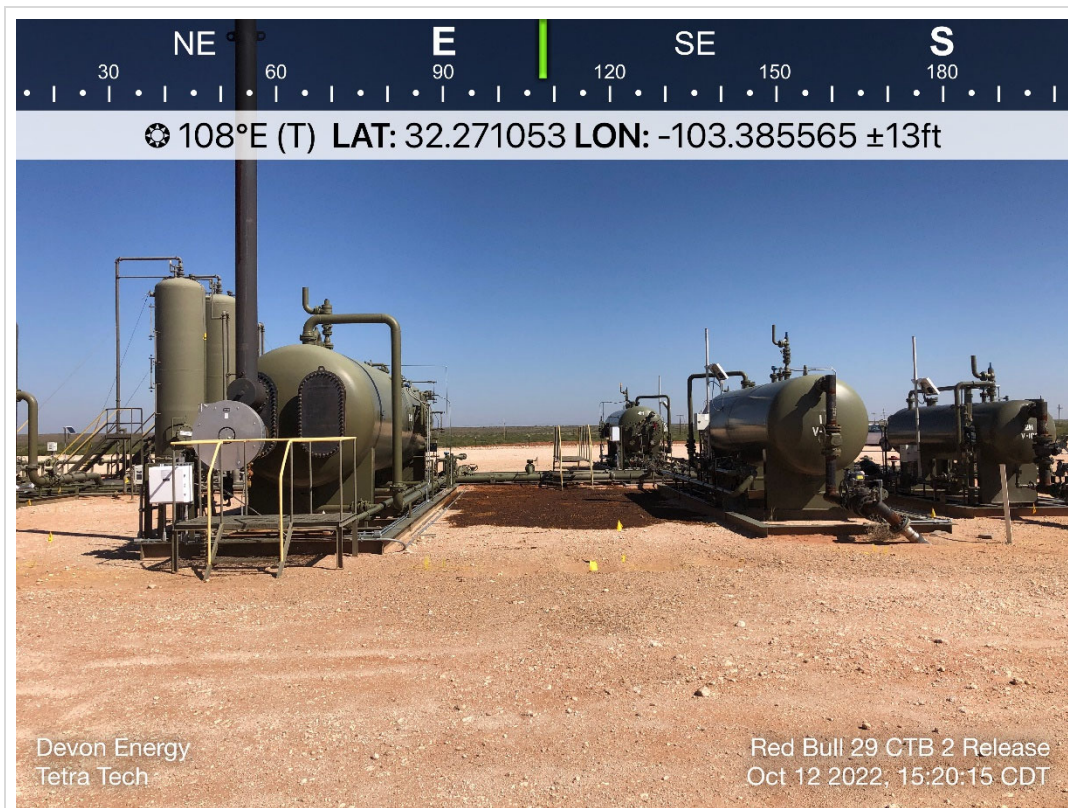
TETRA TECH, INC. PROJECT NO. 212C-MD-02865	DESCRIPTION	View east of the release extent.	7
	SITE NAME	Devon Energy Corporation Red Bull 29 CTB 2 Release NAPP2226924595	10/12/2022

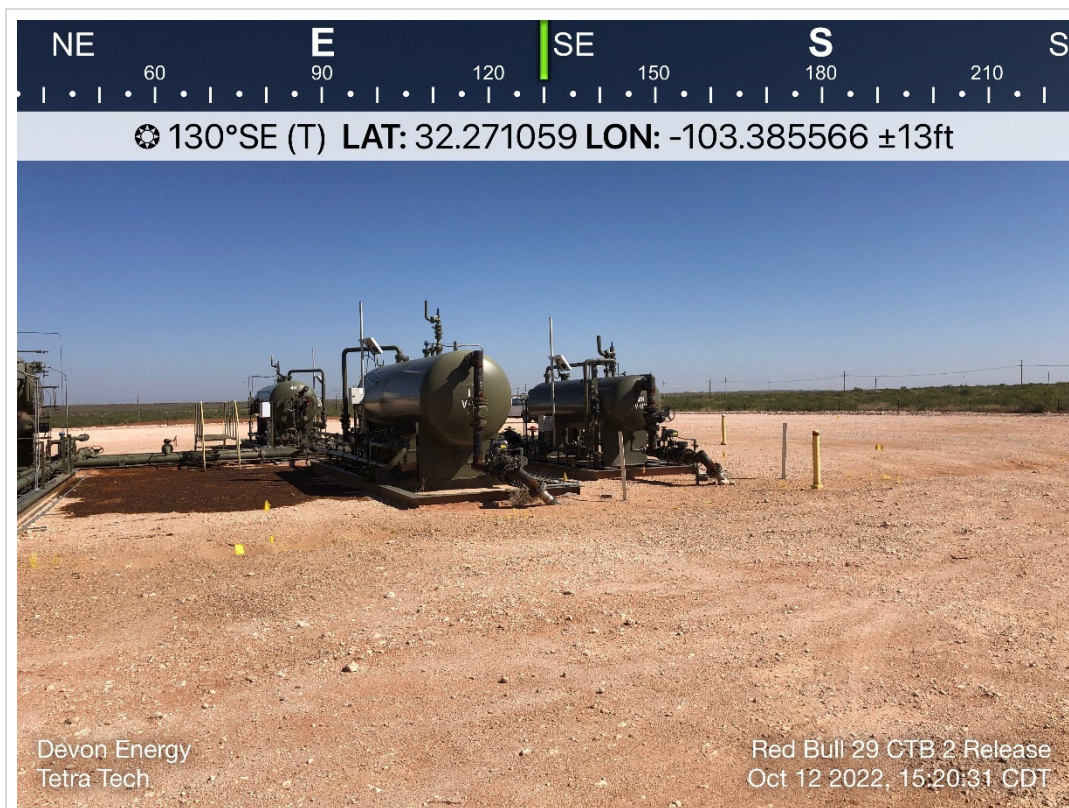
TETRA TECH, INC. PROJECT NO. 212C-MD-02865	DESCRIPTION	View of the area to the south of the release extent.	9
	SITE NAME	Devon Energy Corporation Red Bull 29 CTB 2 Release NAPP2226924595	10/12/2022

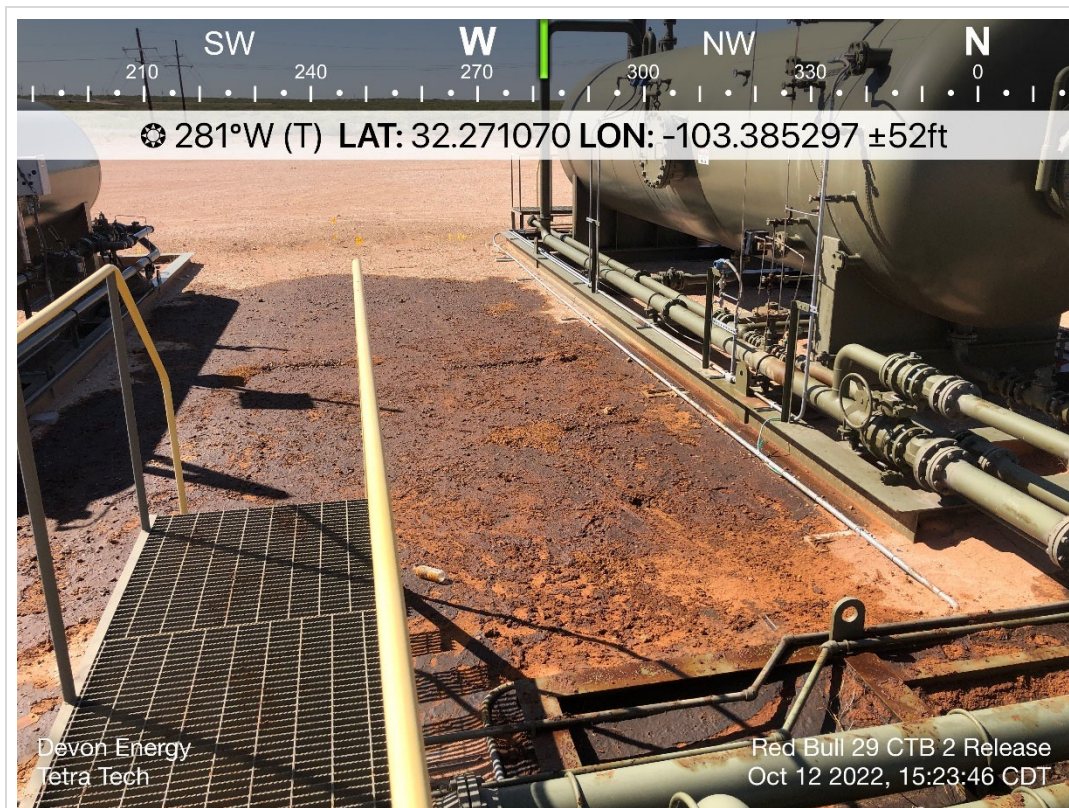
TETRA TECH, INC. PROJECT NO. 212C-MD-02865	DESCRIPTION	View to the west of the release extent from the bridge crossing the pipe racks.	11
	SITE NAME	Devon Energy Corporation Red Bull 29 CTB 2 Release NAPP2226924595	10/12/2022

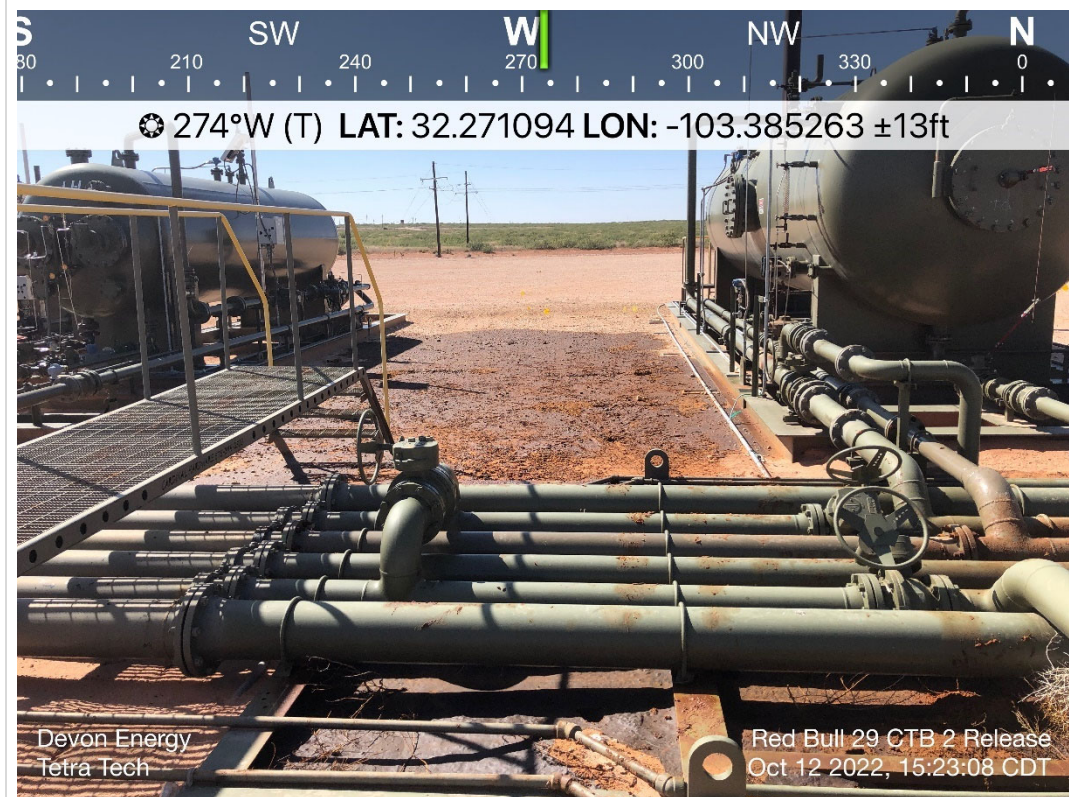
TETRA TECH, INC. PROJECT NO. 212C-MD-02865	DESCRIPTION	View to the west of the release extent and pipe racks.	12
	SITE NAME	Devon Energy Corporation Red Bull 29 CTB 2 Release NAPP2226924595	10/12/2022

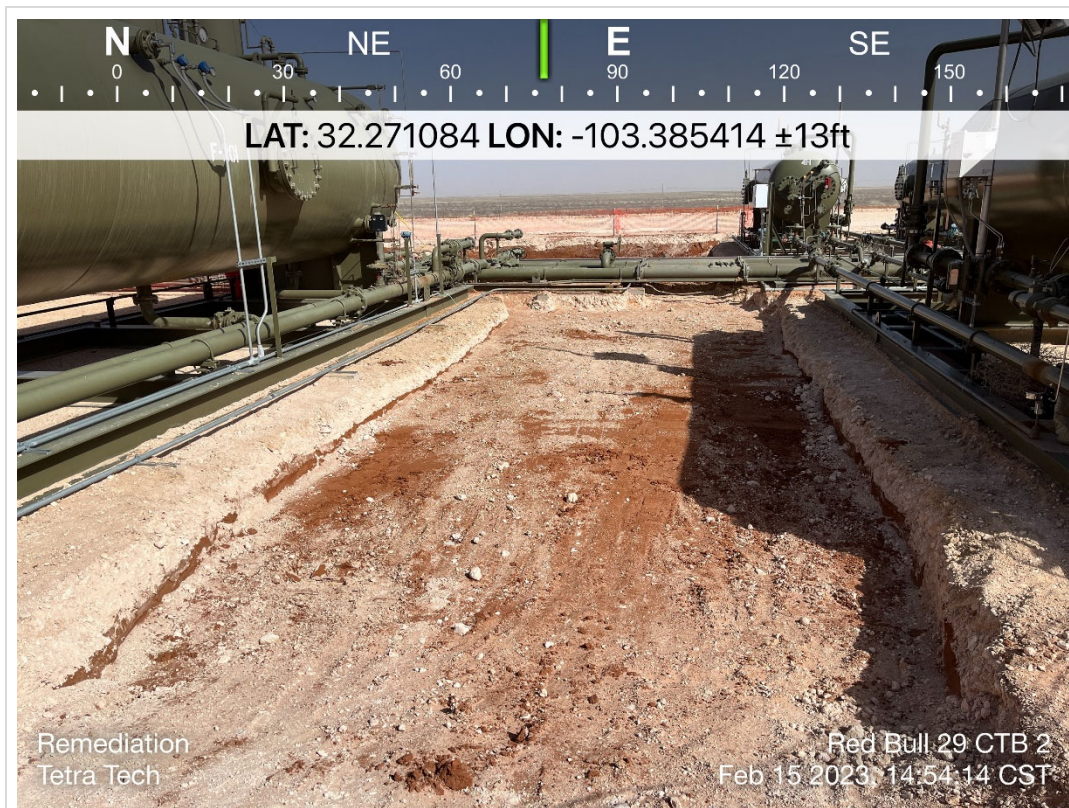
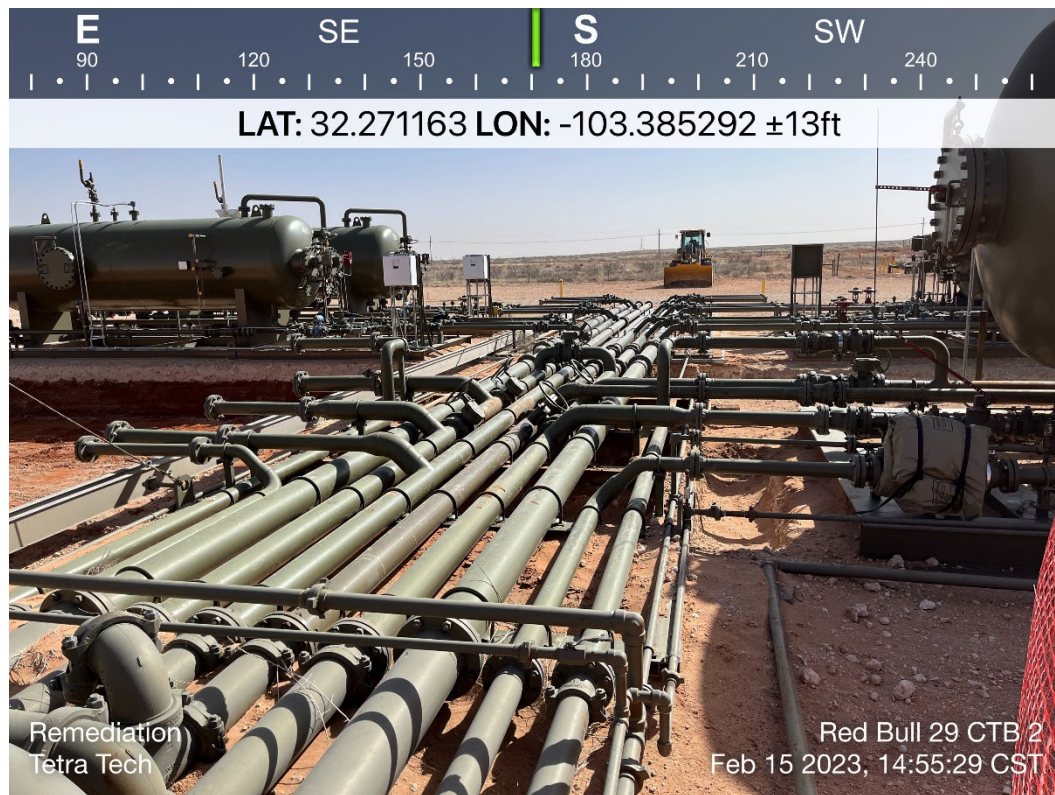
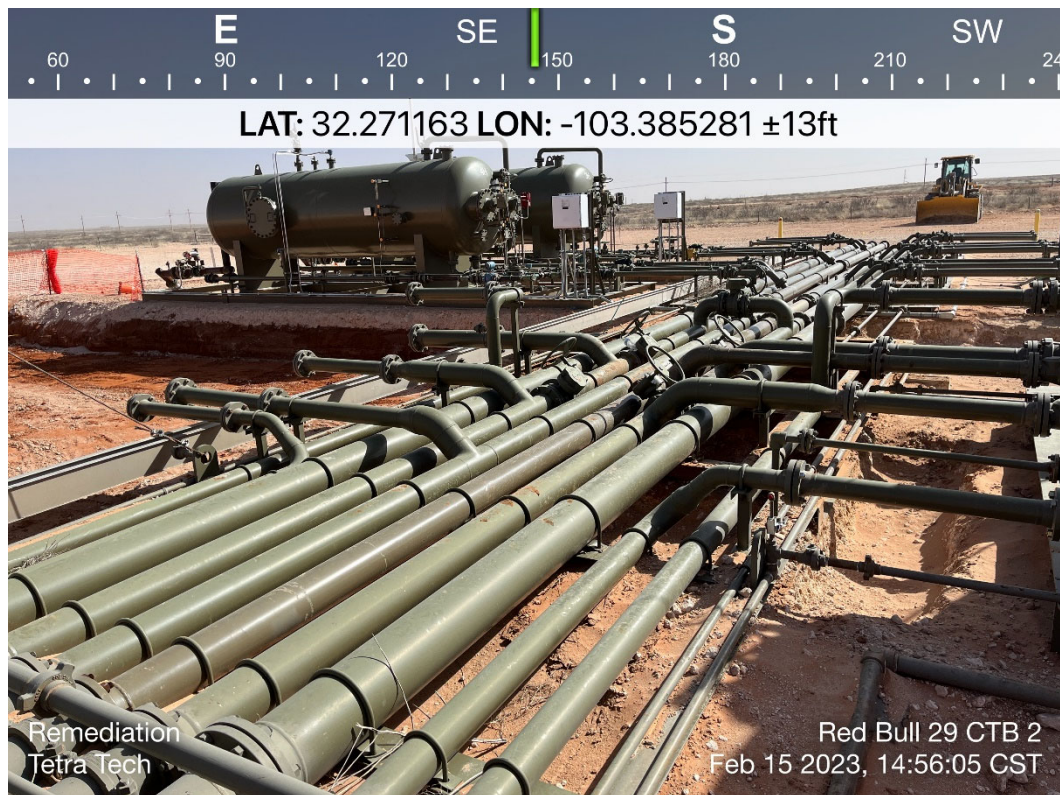
TETRA TECH, INC. PROJECT NO. 212C-MD-02865	DESCRIPTION	View of the excavation extent prior to backfilling.	17
	SITE NAME	Devon Energy Corporation Red Bull 29 CTB 2 Release NAPP2226924595	2/15/2023

TETRA TECH, INC. PROJECT NO. 212C-MD-02865	DESCRIPTION	View of the excavation extent prior to backfilling.	18
	SITE NAME	Devon Energy Corporation Red Bull 29 CTB 2 Release NAPP2226924595	2/15/2023

TETRA TECH, INC. PROJECT NO. 212C-MD-02865	DESCRIPTION	View of the excavation extent prior to backfilling.	19
	SITE NAME	Devon Energy Corporation Red Bull 29 CTB 2 Release NAPP2226924595	2/15/2023

TETRA TECH, INC. PROJECT NO. 212C-MD-02865	DESCRIPTION	View of the excavation extent prior to backfilling.	20
	SITE NAME	Devon Energy Corporation Red Bull 29 CTB 2 Release NAPP2226924595	2/15/2023

TETRA TECH, INC. PROJECT NO. 212C-MD-02865	DESCRIPTION	View of the excavation extent prior to backfilling.	21
	SITE NAME	Devon Energy Corporation Red Bull 29 CTB 2 Release NAPP2226924595	2/15/2023

TETRA TECH, INC. PROJECT NO. 212C-MD-02865	DESCRIPTION	View of the excavation extent prior to backfilling.	22
	SITE NAME	Devon Energy Corporation Red Bull 29 CTB 2 Release NAPP2226924595	2/15/2023

In accordance with 19.15.29.13 NMAC, Devon backfilled the area to resemble pre-release conditions. As the entirety of the proposed remediation area is on an active lease pad within an oil and gas production area, final reclamation will occur once the lease pad is no longer being used for oil and gas production. Therefore, seeding of the release area is deemed unnecessary until the end of the life of the lease pad.
