**MCA Well #357**  
(1RP-06-13-2927)

**CAP Report & Termination  
Request**

**RE: Corrective Action Plan Report & Termination Request  
ConocoPhillips – MCA Well #357 (1RP-06-13-2927)  
UL/M sec. 28 T17S R32E  
API No. 300252584900**

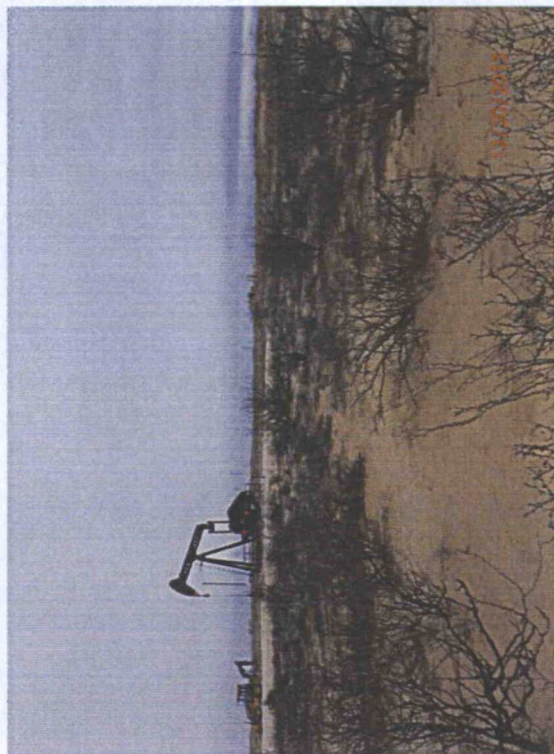
Site prior, facing southwest

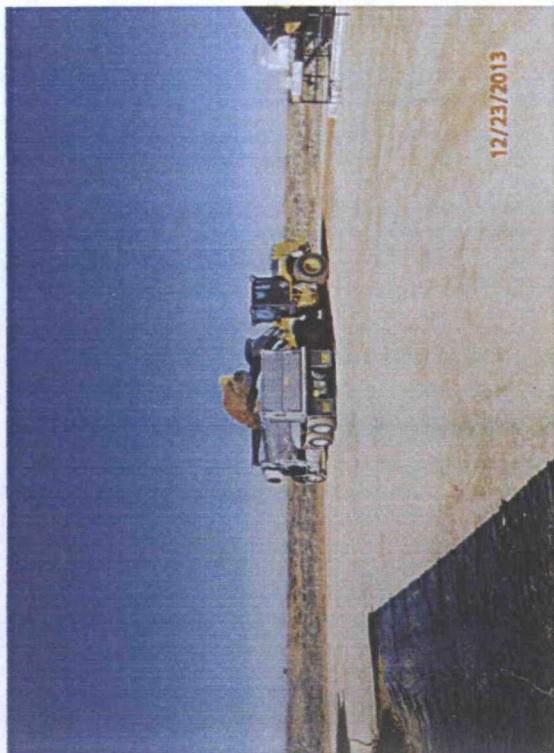
Exporting soil, facing northwest

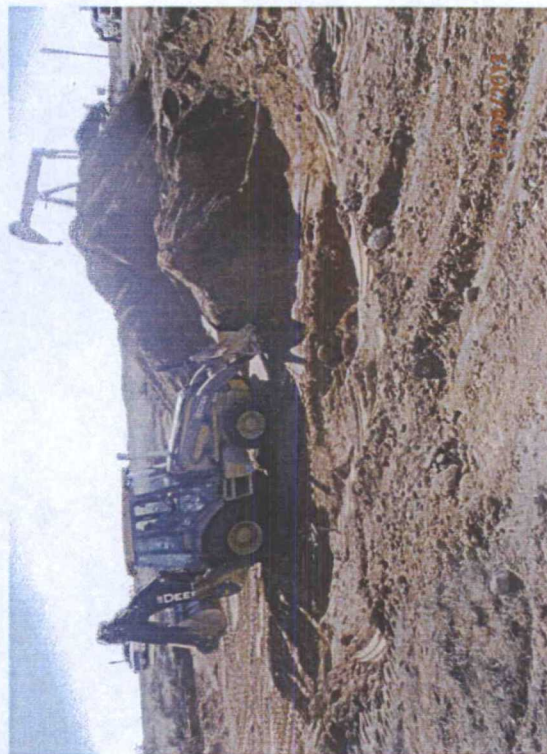
Excavating site, facing southeast

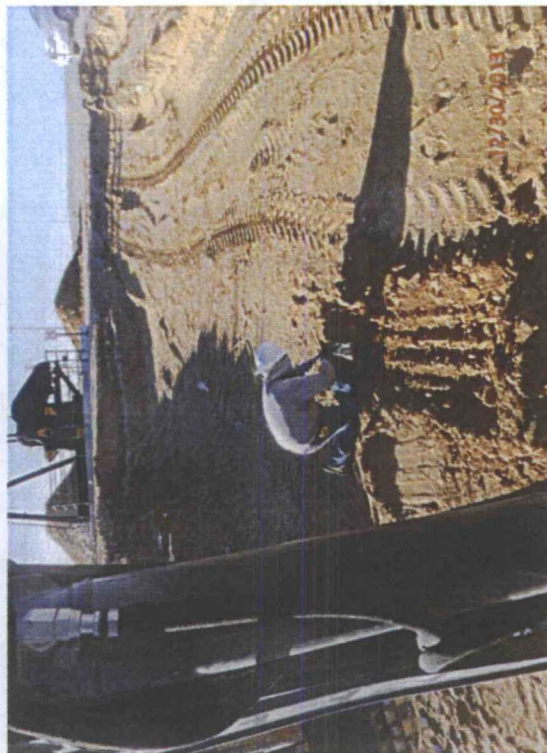
Collecting sample, facing south

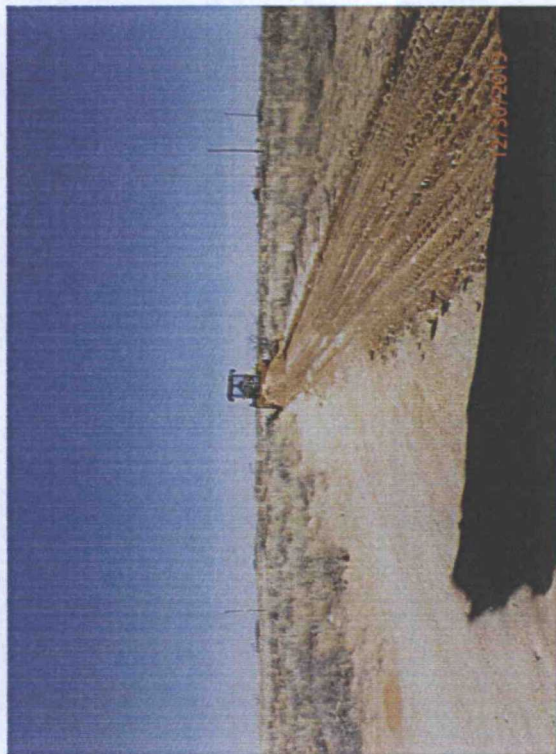
Scraping caliche road, facing northeast

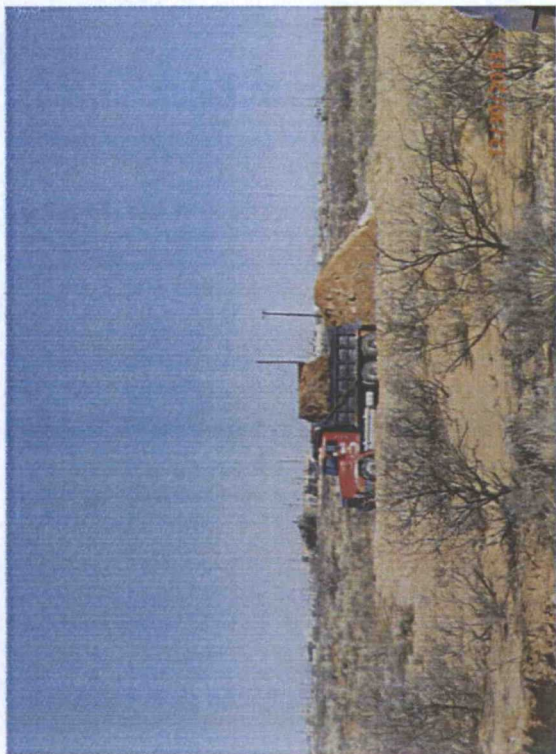
Importing caliche to site, facing north

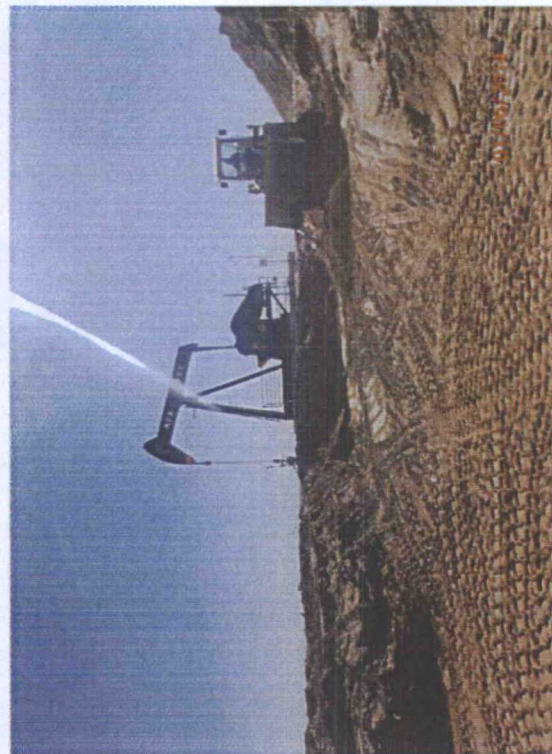
Backfilling base of excavation with caliche, facing south

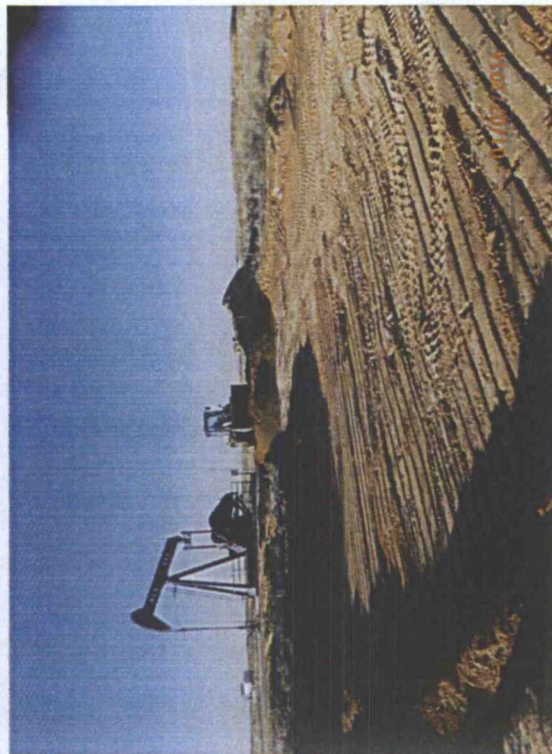
Excavation packed with caliche, facing southwest

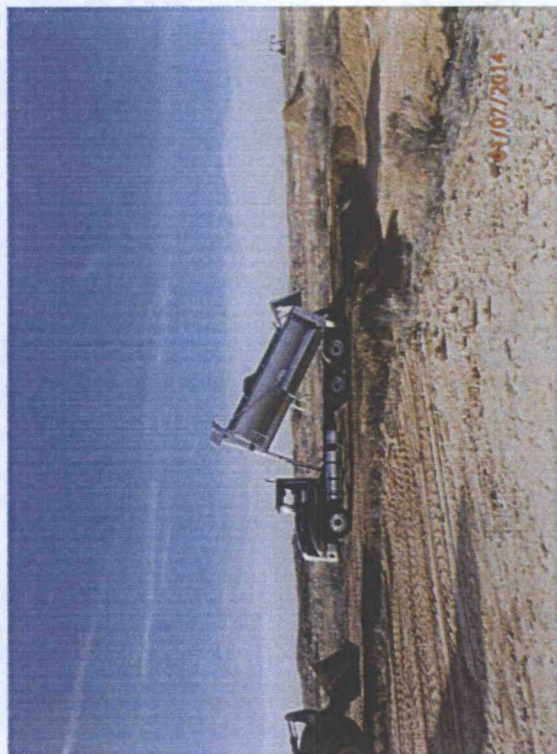
Importing top soil, facing northwest 1/7/2014

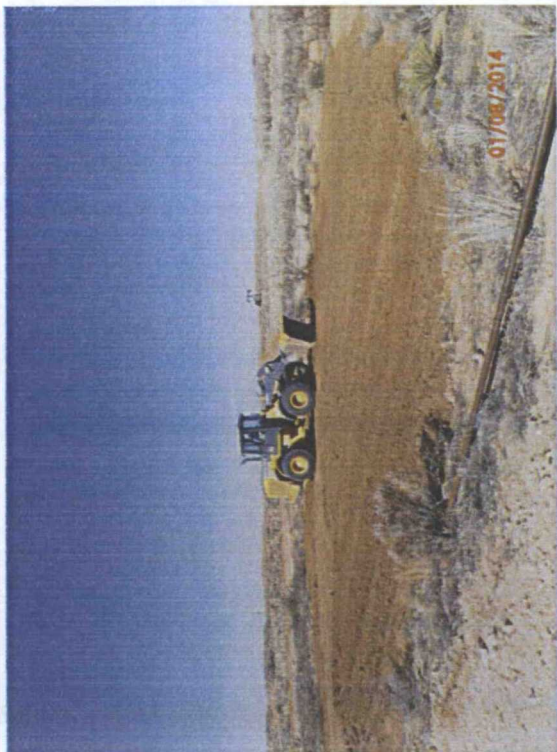
Backfilling excavation with top soil, facing northwest 1/8/2014

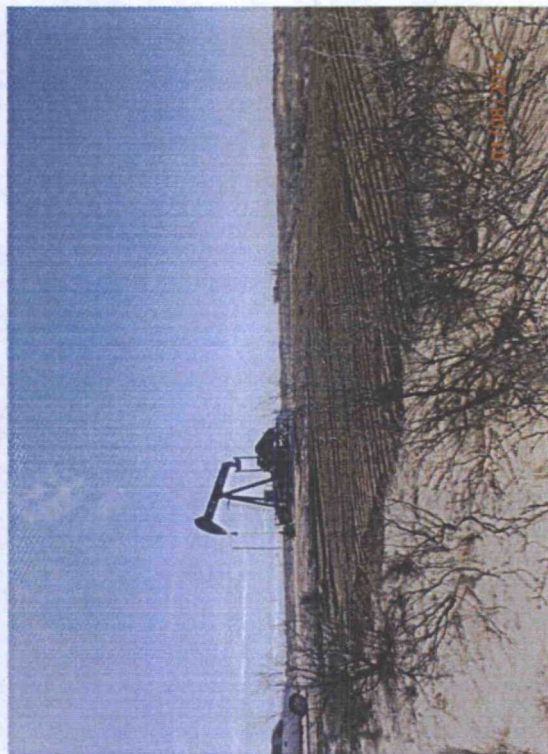
Backfilling completed, facing southwest 1/8/2014

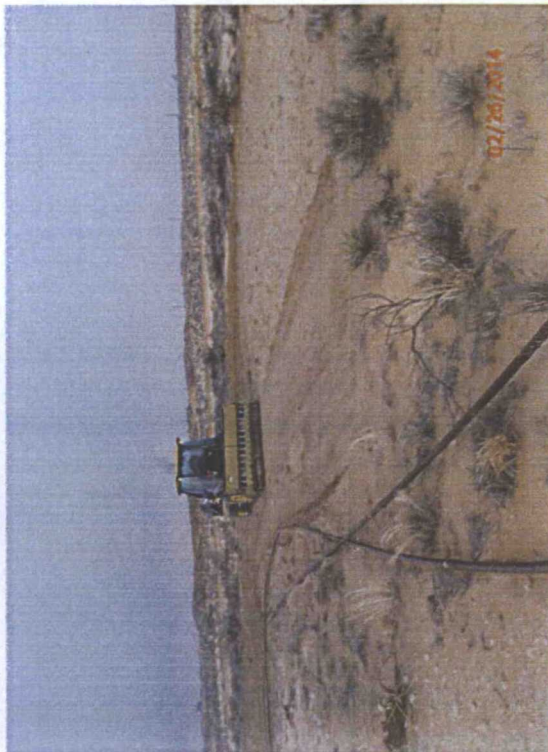
Seeding site, facing west 2/26/2014

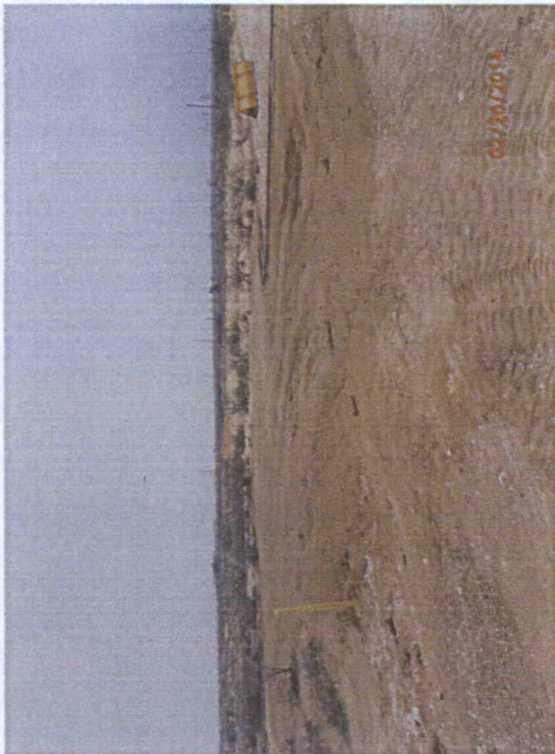
Site completed, facing northeast

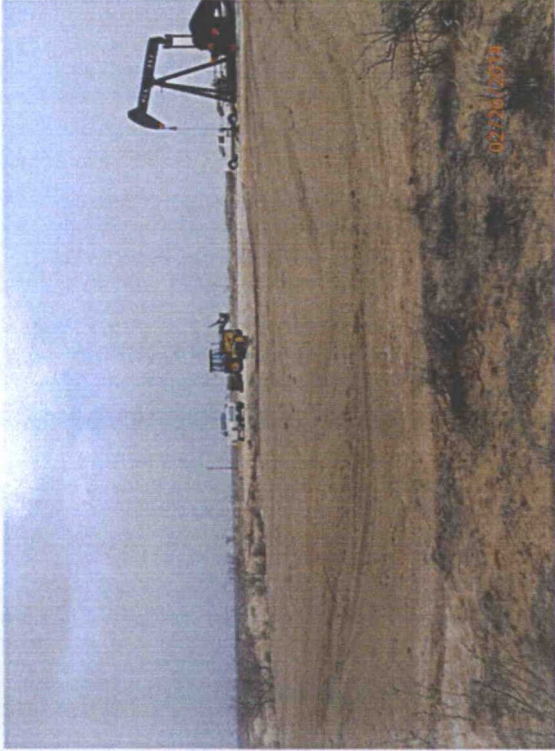
Site completed, facing southeast
