**Re: Release Characterization and Revised Deferral Request
ConocoPhillips
Heritage Concho
Corsair State #002H Tank Battery Release
Unit Letter A, Section 2, Township 19 South, Range 31 East
Eddy County, New Mexico
Incident ID# nAB1821442233**

Release Characterization and Closure Request
April 24, 2023

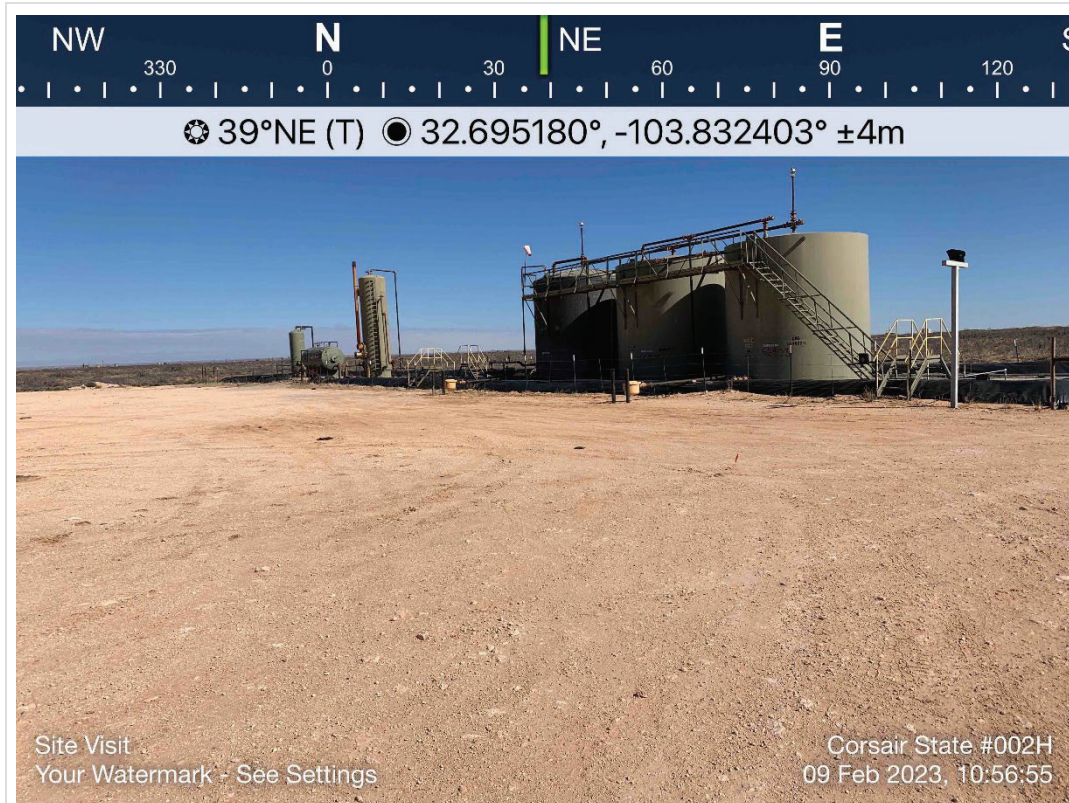
TETRA TECH, INC. PROJECT NO. 212C-MD-02990	DESCRIPTION	View northeast of stained Site pad area adjacent to tank batteries.	2
	SITE NAME	Corsair State #002H	2/9/2023

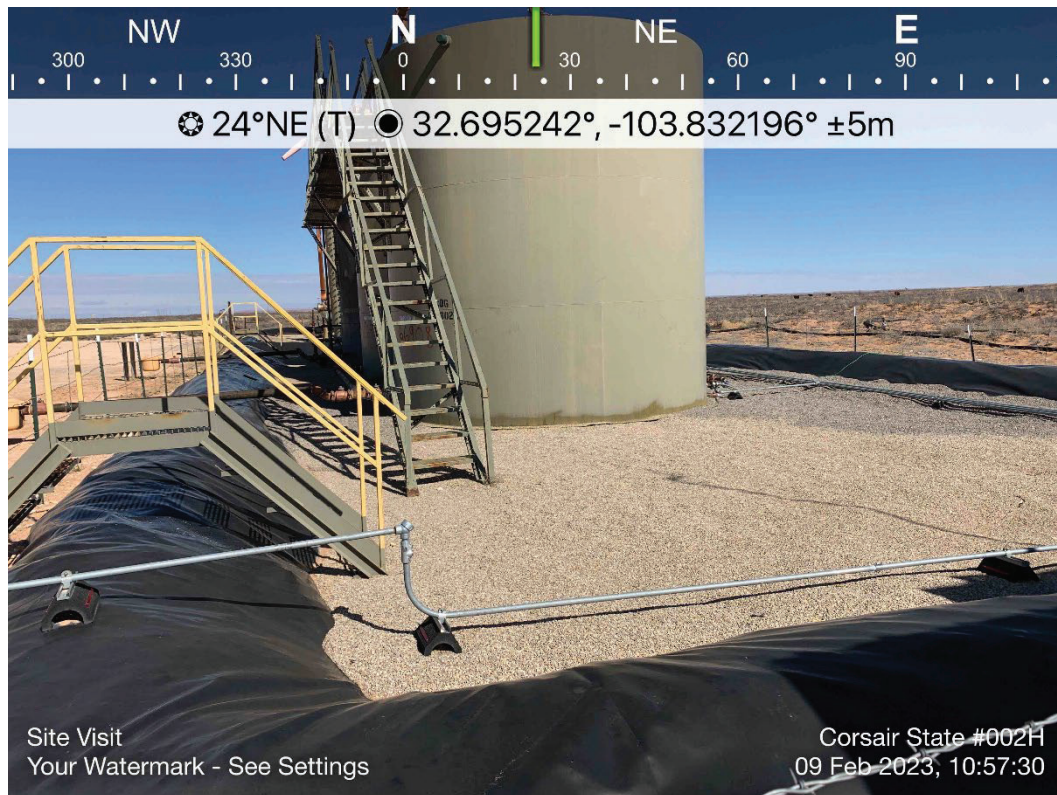
TETRA TECH, INC. PROJECT NO. 212C-MD-02990	DESCRIPTION	View north/northeast of tank battery. Staining visible in gravel within liner.	6
	SITE NAME	Corsair State #002H	2/9/2023

Based on the results of the additional release delineation and characterization, ConocoPhillips respectfully requests deferral of the remaining BTEX and TPH impacts present beneath the operating tank battery facility. Remediation and final reclamation of the well pad shall take place in accordance with 19.15.29.13 NMAC once the site is no longer being used for oil and gas operations. The final C-141 forms are enclosed in Appendix A.

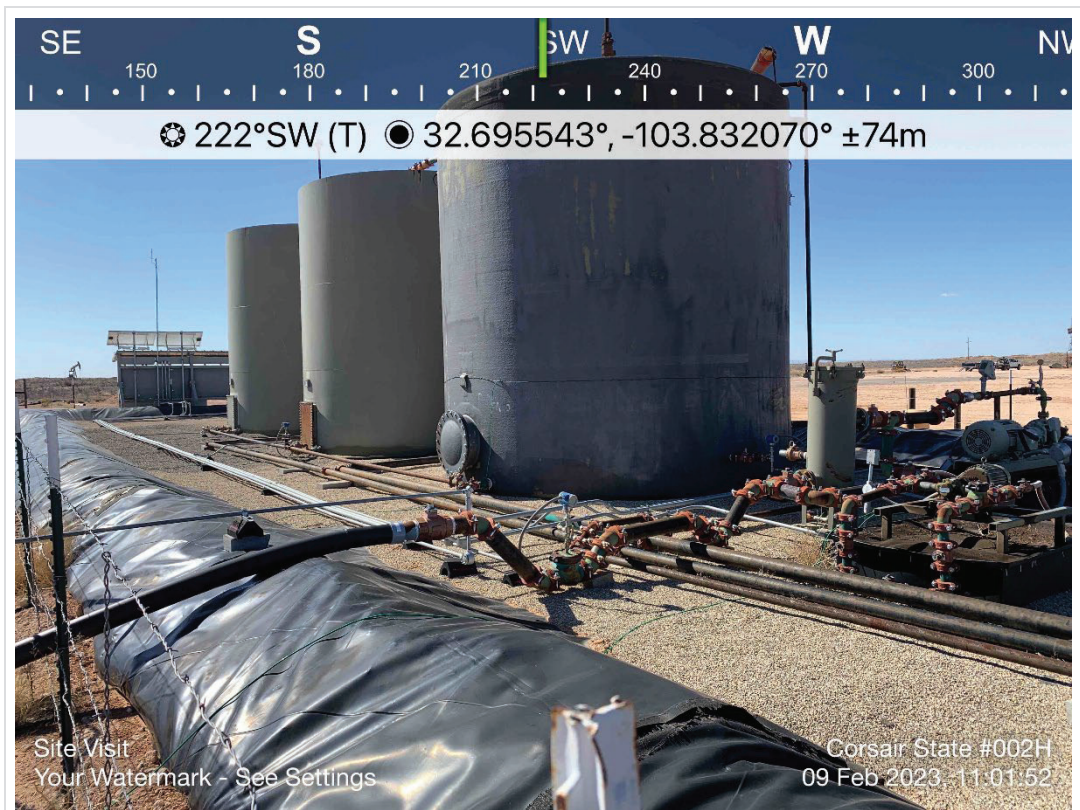
TETRA TECH, INC. PROJECT NO. 212C-MD-02990	DESCRIPTION	View southwest of tank battery. Staining visible in gravel within liner.	7
	SITE NAME	Corsair State #002H	2/9/2023

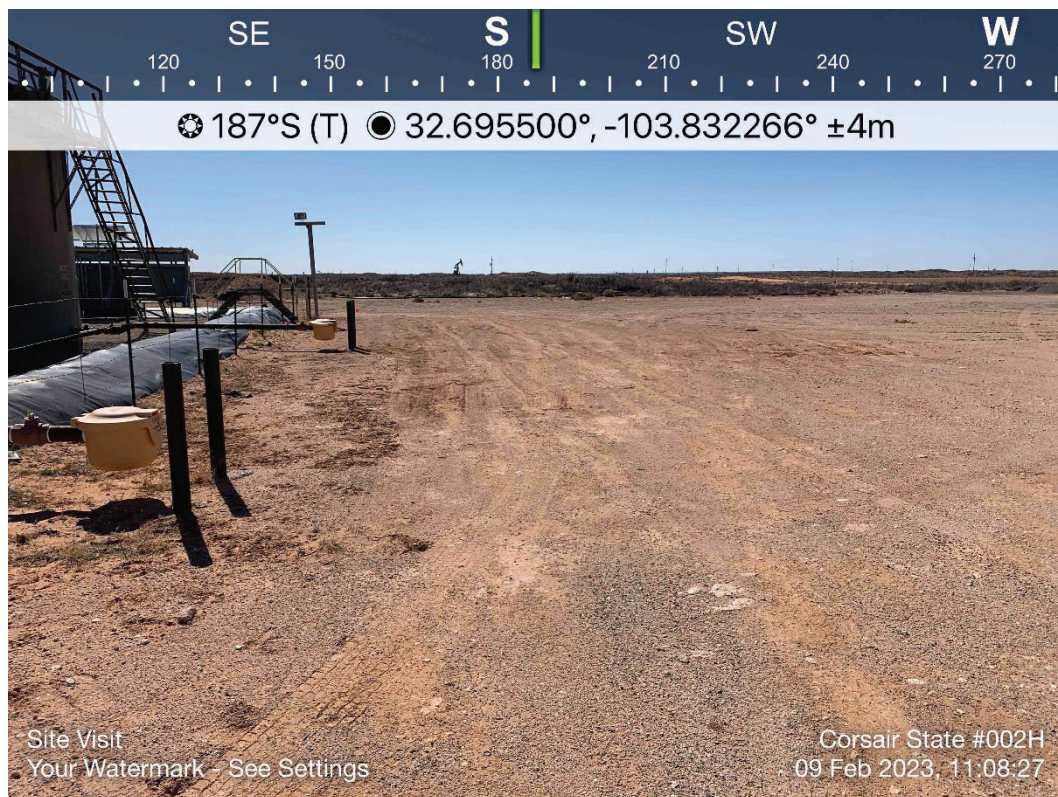
TETRA TECH, INC. PROJECT NO. 212C-MD-02990	DESCRIPTION	View south of lease pad east of tank battery.	8
	SITE NAME	Corsair State #002H	2/9/2023
