From: Price, Henryetta <hprice@blm.gov>
Sent: Thursday, June 7, 2018 6:18 PM
To: Sheldon Hitchcock
Cc: Bratcher, Mike, EMNRD; Weaver, Crystal, EMNRD; Robert McNeill; Rebecca Haskell; Dakota Neel; DeAnn Grant
Subject: Re: [EXTERNAL] (Closure Letter) Burch Keely Water Flood Satellite C (30-015-02971) 12-22-2016 (2RP-4052)

Please find the attached closure report for the Burch Keely Water Flood Satellite C release that occurred on December 22, 2016. If you have any questions or concerns please do not hesitate to contact me.

REMEDIATION WORK PLAN

COG - Burch Keely Unit Water Flood Satellite C

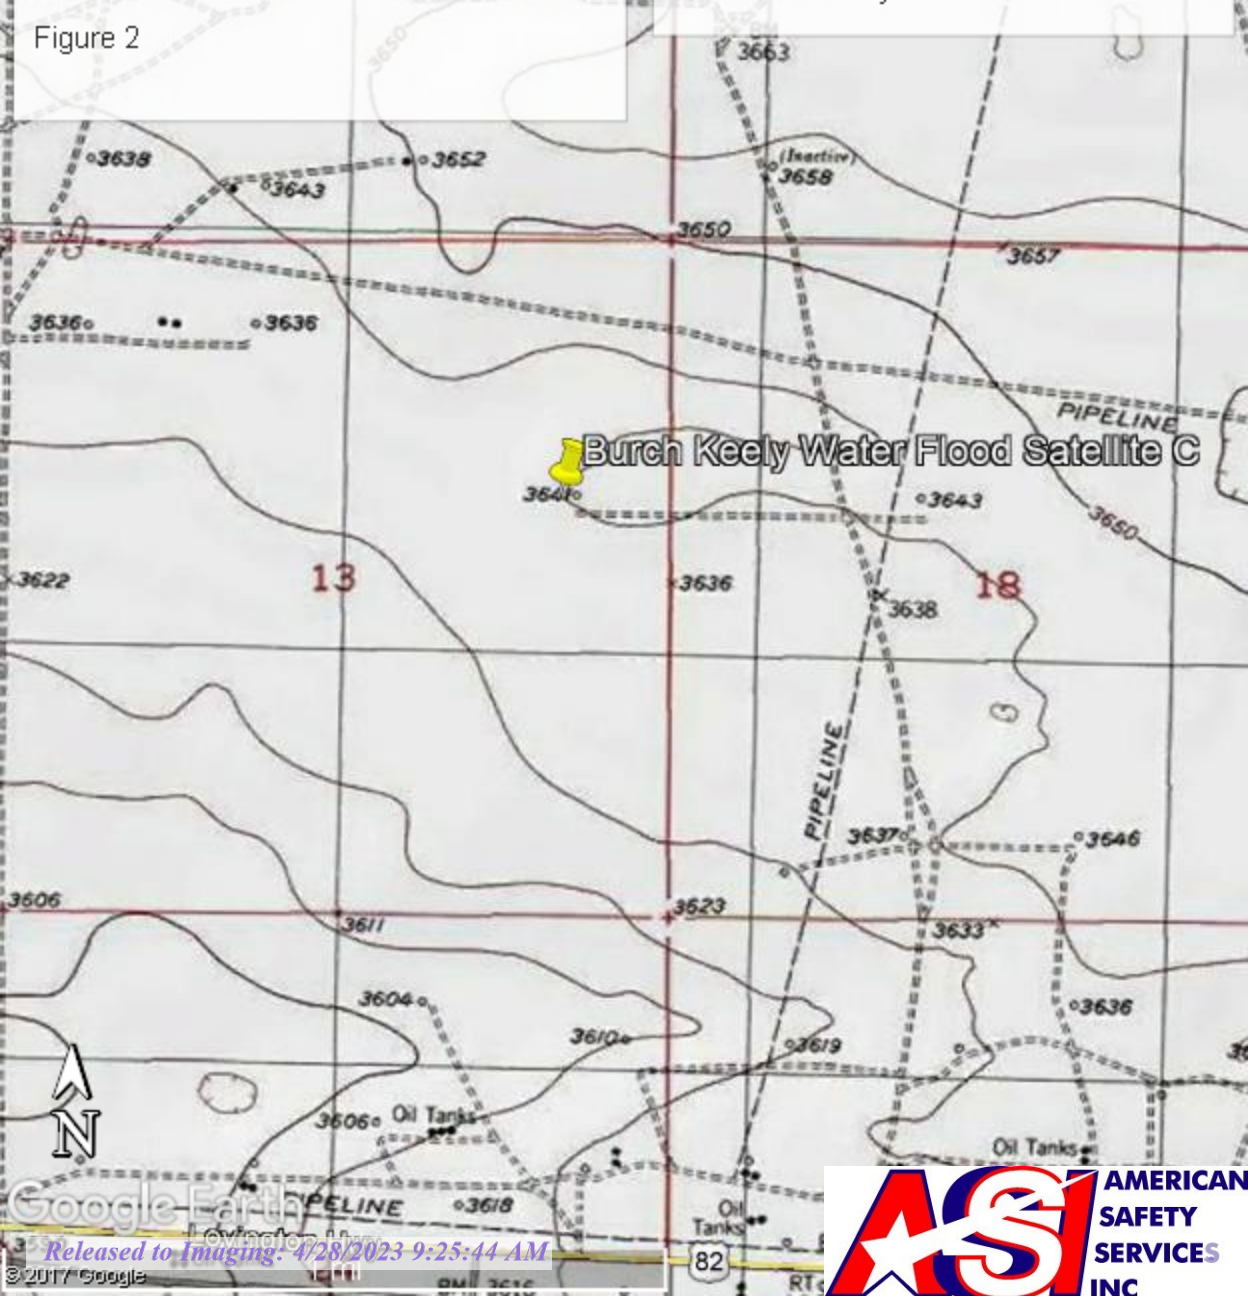
Figure 3

COG - Burch Keely Unit Water Flood Satellite C

On January 9, 2017, COG and GCI Construction personnel collected samples by means of trenching using mechanical means (i.e., backhoe tractor) in an effort to vertically delineate existing Total Petroleum Hydrocarbon (TPH) and Chloride in soil. Sampling activities were in response to a reportable release directly to the ground that occurred on December 22, 2016. Fifteen (15) barrels (bbls) of crude oil and twenty-five (25) bbls of produced water was released caused by a leak on a buried flowline. Ten (10) bbls of crude oil and twenty (20) bbls of produced water were recovered. The release impacted approximately seven thousand (7000) square feet of pasture area (Figure 3).
