Re: Release Characterization and Closure Report Devon Energy Production Company Red Bull 29 CTB 2 Release Unit Letter P, Section 29, Township 23 South, Range 35 East Lea County, New Mexico DOR: 3/12/2021 Incident ID: NAPP2111338900

Release Characterization and Closure Report March 24, 2023

Devon Energy Production Company

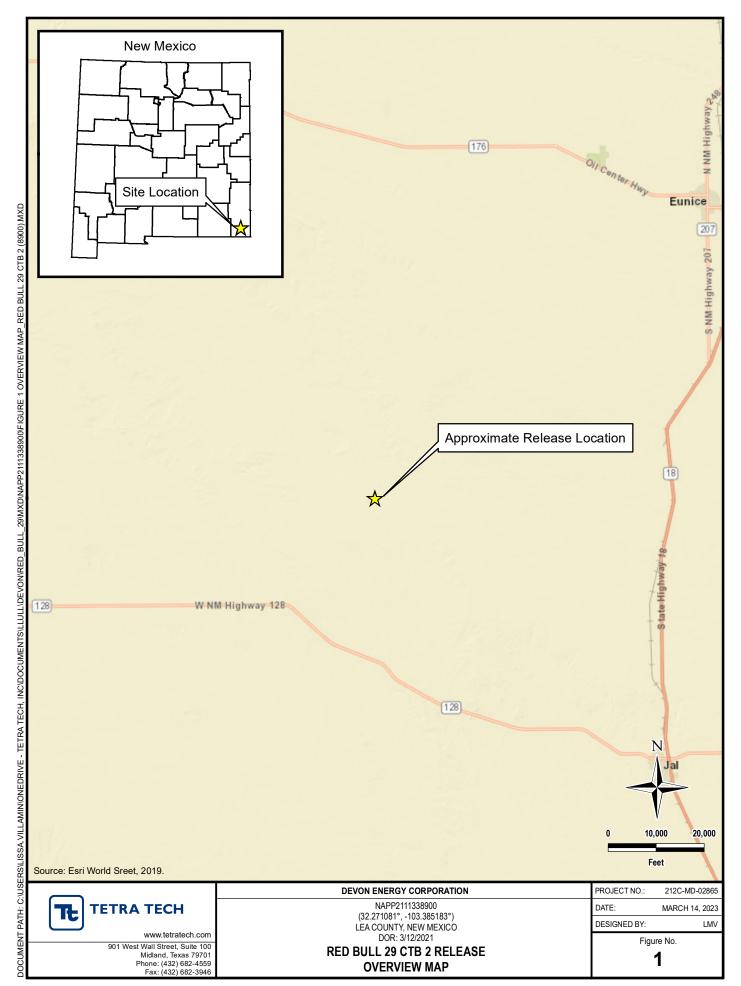
Figure 1 – Overview Map

Tetra Tech, Inc. (Tetra Tech) was contacted by Devon Energy Production Company (Devon) to assess a release that occurred at the Red Bull 29 Central Tank Battery (CTB) 2 (Site) due to a leak developing on a line causing fluid release. The release footprint is entirely on-pad and is located in Public Land Survey System (PLSS) Unit Letter P, Section 29, Township 23 South, Range 35 East, in Lea County, New Mexico (Site). The approximate release point occurred at coordinates 32.271081°, -103.385183°, as shown on Figures 1 and 2.

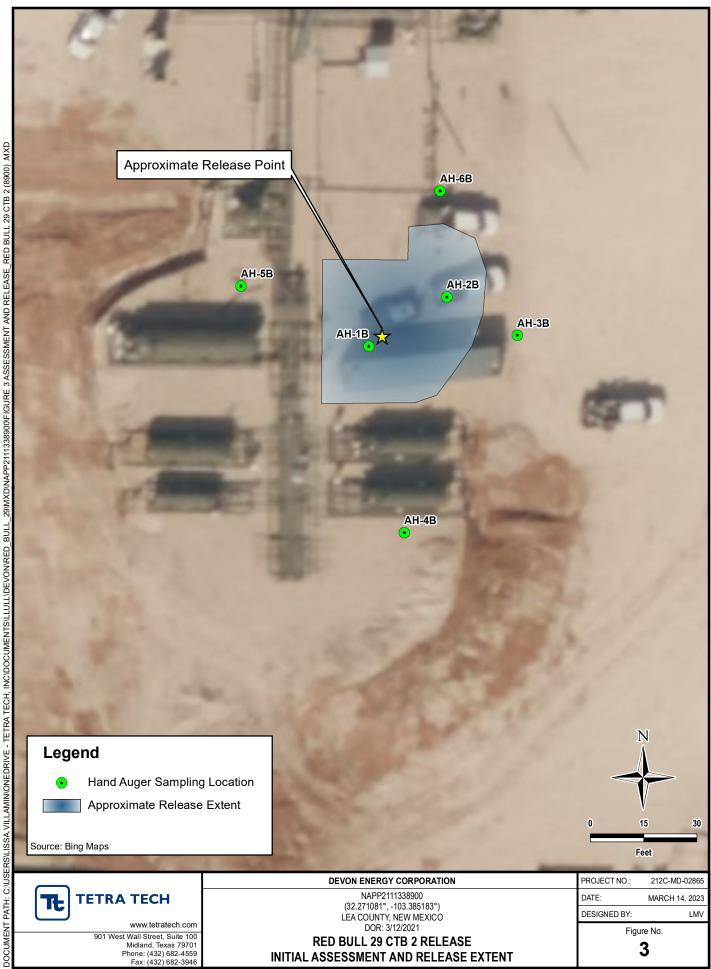
Figure 3 – Initial Assessment and Release Extent

On October 30, 2022, Tetra Tech conducted initial assessment activities to delineate the release extent and confirm the efficacy of the remedial activities conducted during the initial response. A total of six (6) hand auger borings (AH-1B through AH-6B) were installed in and around the release footprint to achieve vertical and horizontal delineation of the on-pad release. A total of four (4) hand auger borings (AH-3B through AH-6B) were installed around the perimeter of the release extent to a depth of 1-foot bgs to establish the lateral extent of impact. The remaining borings (AH-1B and AH-2B) were installed within the release footprint to determine the vertical extent of impact to 3 feet bgs. The approximate release extent and the locations of the 6 hand auger borings are indicated in Figure 3. Photographic documentation of the Site conditions at the time of the assessment is presented in Appendix D.

Results from the October 30, 2022 soil sampling event are summarized in Table 1. The analytical results associated with boring locations AH-1B and AH-2B exceeded the most stringent RRAL for chloride (600 mg/kg) to the boring depth of 2 feet bgs. No sample results exceeded the Site specific RRAL for chloride, TPH, or BTEX. Based on the analytical results from the October 12, 2022, sampling event, horizontal and vertical delineation of the release were achieved.

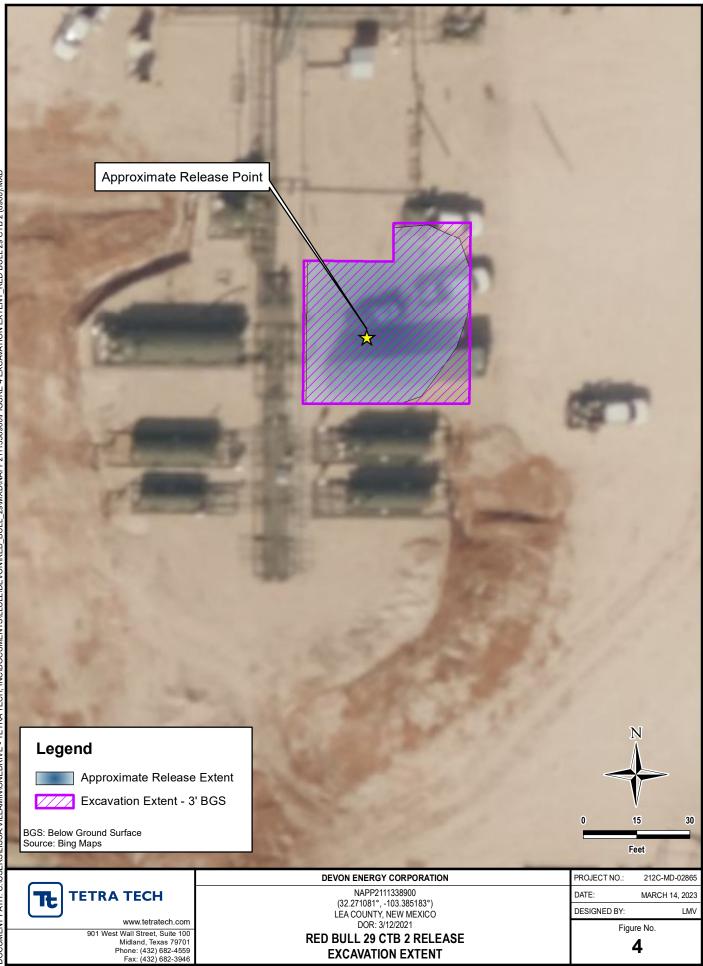
Figure 4 – Excavation Extent

On February 13, 2023, Devon contracted Tetra Tech to provide oversight and final confirmation sampling associated with the remedial activities to address Incident ID NAPP2111338900. Excavated extents and corresponding depths are indicated in Figure 4.

Impacted soils were excavated using heavy equipment (backhoes, hoe rams, and track hoes) to a depth of 3 feet bgs. The final square footage of the excavated extent was approximately 2,000 square feet, and approximately 225 cubic yards of material was hauled off for disposal. Excavated soils were transported offsite and disposed of at an NMOCD-approved or permitted facility.

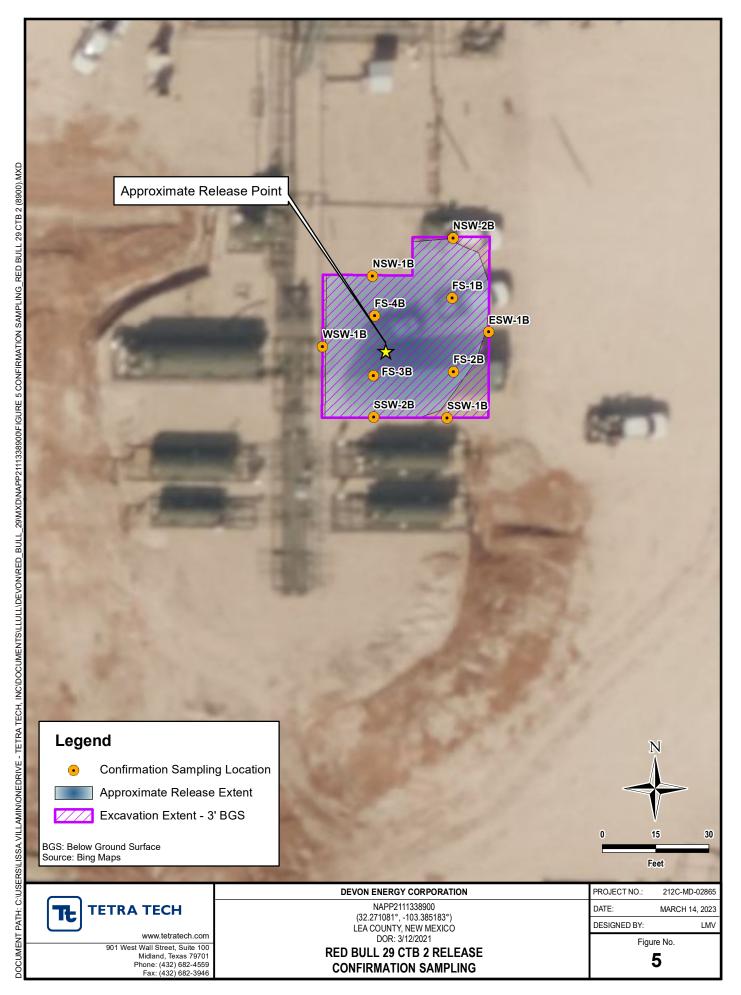
Figure 5 – Confirmation Sampling

During excavation Tetra Tech provided 48-hour notification of confirmation sampling to NMOCD, as required by Subparagraph (a) of Paragraph (1) of Subsection D 19.15.29.12 NMAC. The correspondence with NMOCD is included as Appendix E. On February 15, 2023, Tetra Tech personnel collected composite confirmation bottom and sidewall samples for verification of remedial activities with no sample being representative of more than 200 square feet in accordance with Subsection D,19.15.29.12 NMAC. The confirmation sampling locations are indicated in Figure 5.

Results from the February 15, 2023 sampling event are summarized in Table 2. The analytical results associated with the confirmation samples, floor, and sidewall, were all below the Site RRALs for chloride, TPH, and BTEX. Photographic documentation of the remediated area prior to backfilling is included in Appendix D.
