REMEDIATION SUMMARY AND RISK-BASED SITE CLOSURE REQUEST

**COG Operating, LLC
GJ West Coop Unit #108
Eddy County, New Mexico
Unit Letter "E", Section 28, Township 17 South, Range 29 East
Latitude 32.8073502° North, Longitude 104.0862198° West
NMOCD Reference No. 2RP-4351**

**COG Operating, LLC
GJ West Coop Unit #011
Eddy County, New Mexico
Unit Letter "E", Section 28, Township 17 South, Range 29 East
Latitude 32.8073502° North, Longitude 104.0862198° West
NMOCD Reference No. 2RP-4454**

April 2019

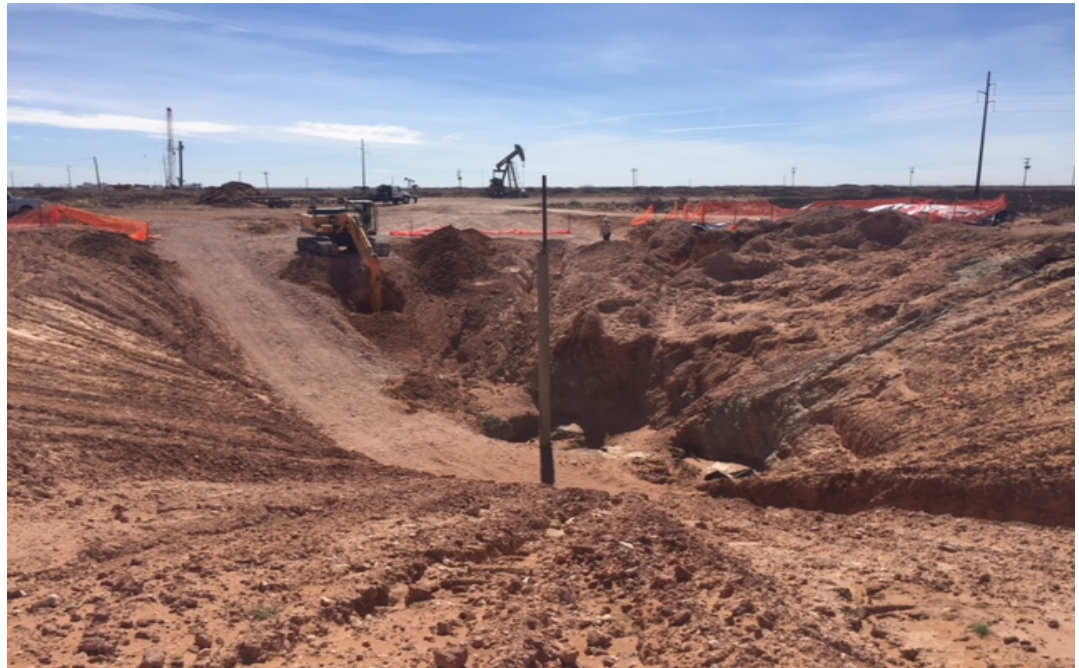
View of
excavated area.

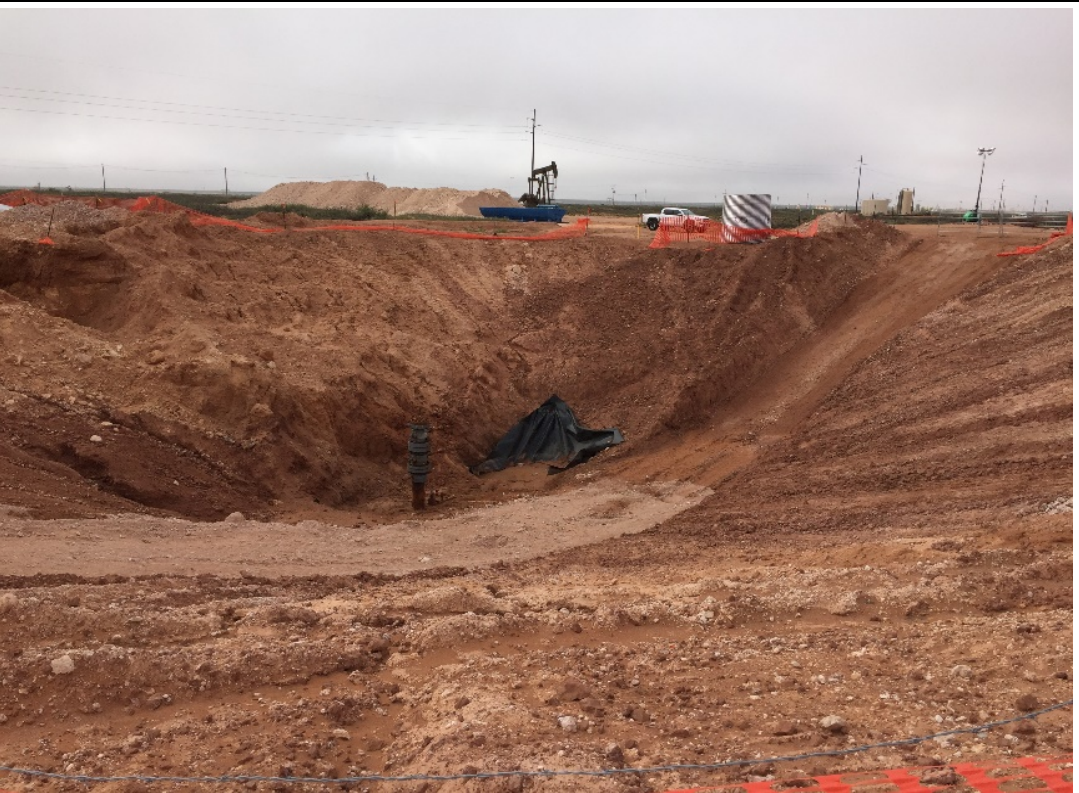
Photograph No. 2

Partially buried
liner.

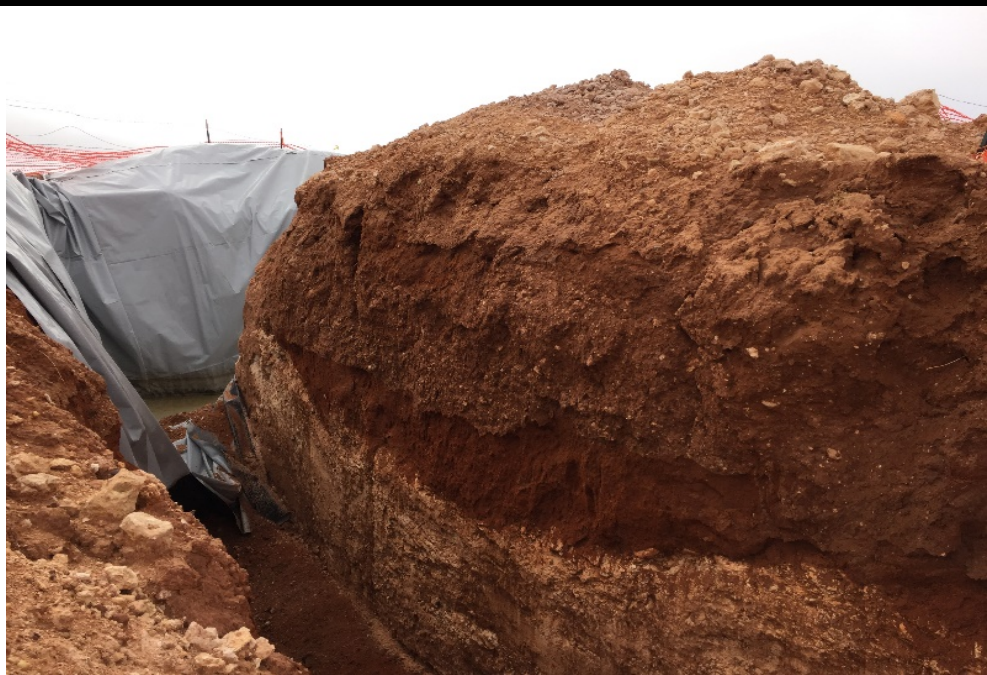
**Liner
installation.**

- After backfilling the excavated area to four (4) ft. bgs, install a second bentonite or polyurethane liner at four (4) ft. bgs atop impacted soil exhibiting chloride concentrations above the NMOCD regulatory guidelines. The liner will be extended vertically along the excavation sidewalls in the area of the inferred historical drilling reserve pit in an effort to limit the amount of moisture shed toward the north in the vicinity of the historical drilling reserve pit. This engineering control is designed to mitigate the vertical migration of contaminants left in-situ along with contaminants within portions of the proposed fill material. During the installation of the liner an approximate six (6)-inch layer of “pad sand” will be installed above and below the liner in an effort to maintain its integrity during backfilling activities.

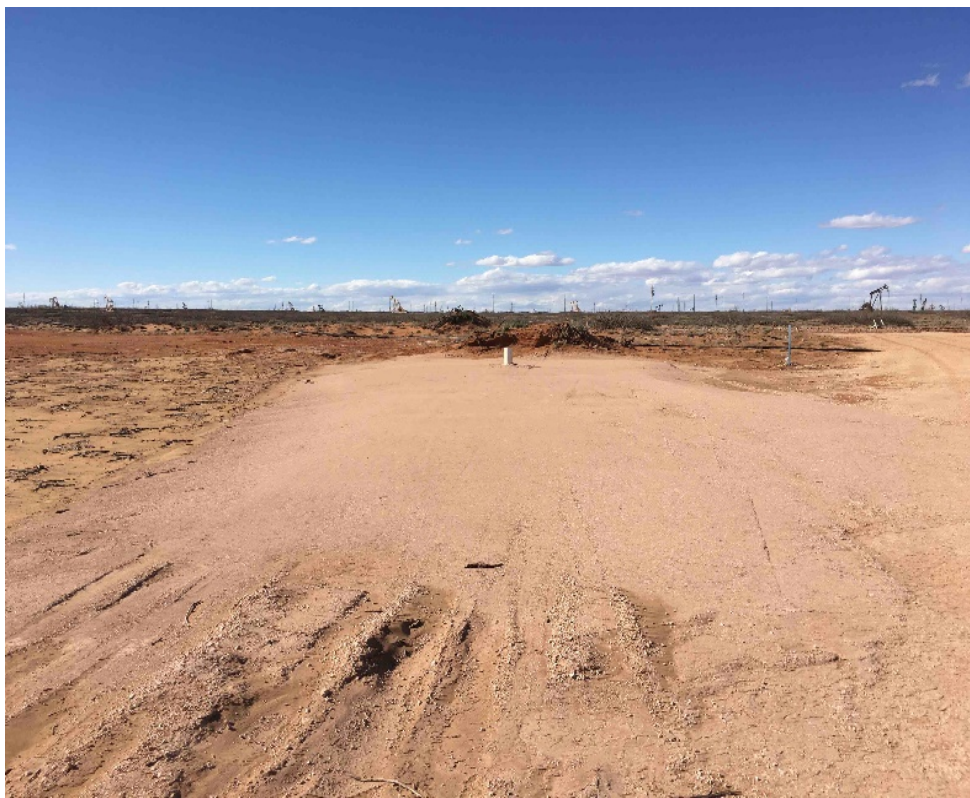
Photograph No.

**View of
backfilled area
with boring
conduit.**

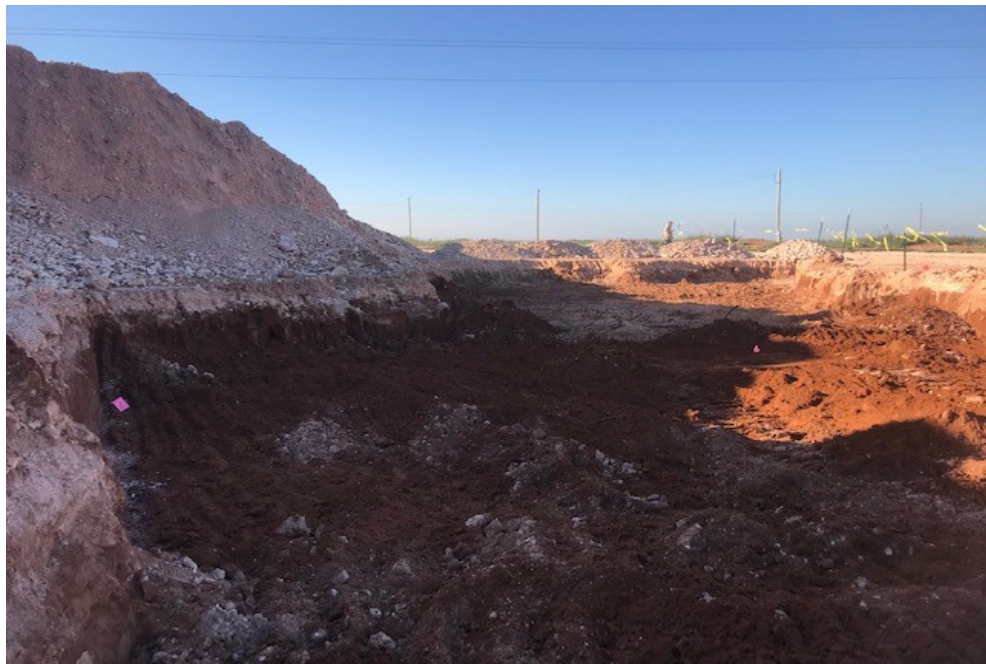
Description:
**View of
excavated area.**

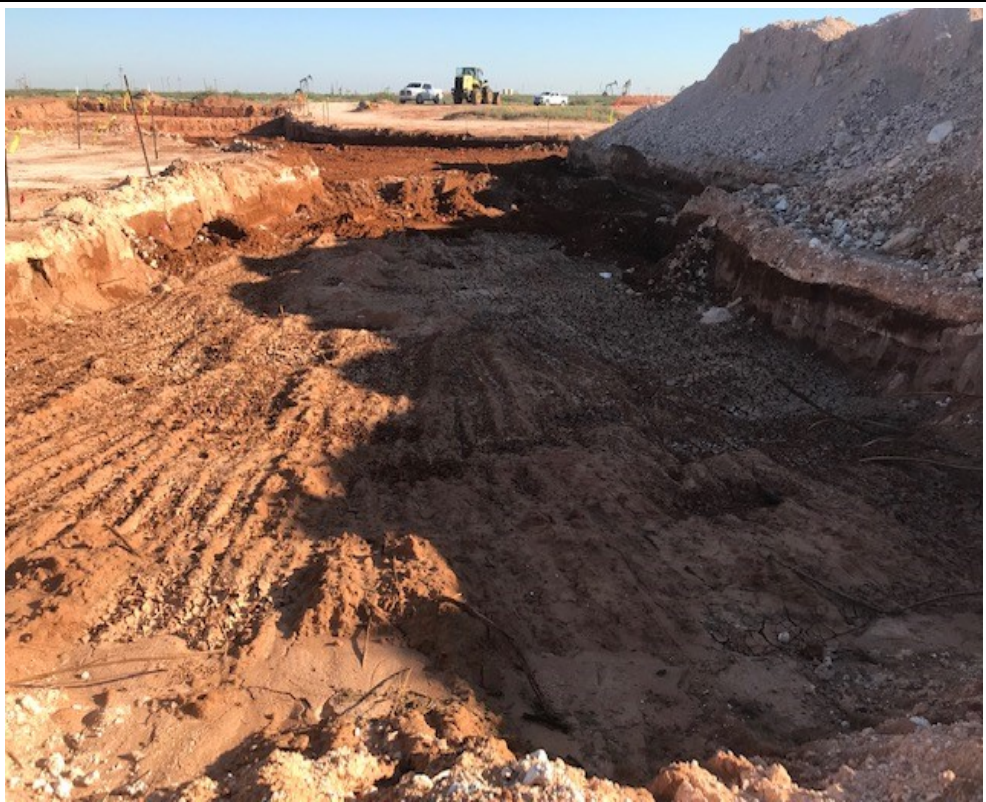
Photograph No.
6

Description:
**View of
excavated area.**

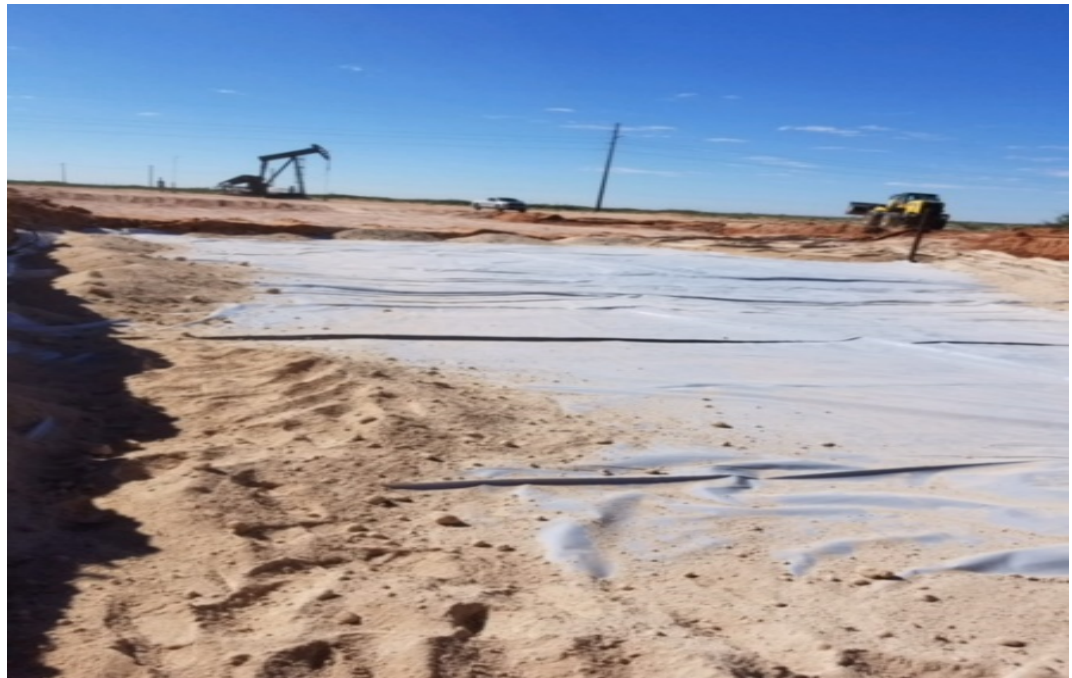
**View of liner
installation.**

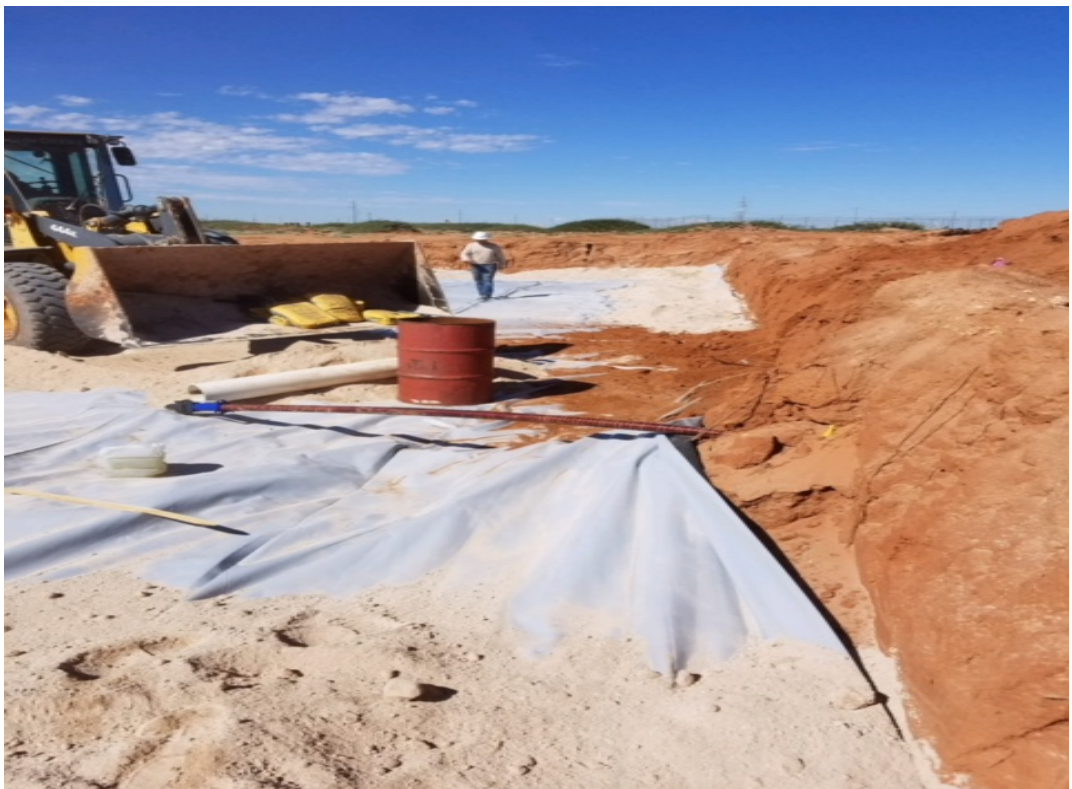
Photograph No. 8

**View of liner
installation.**

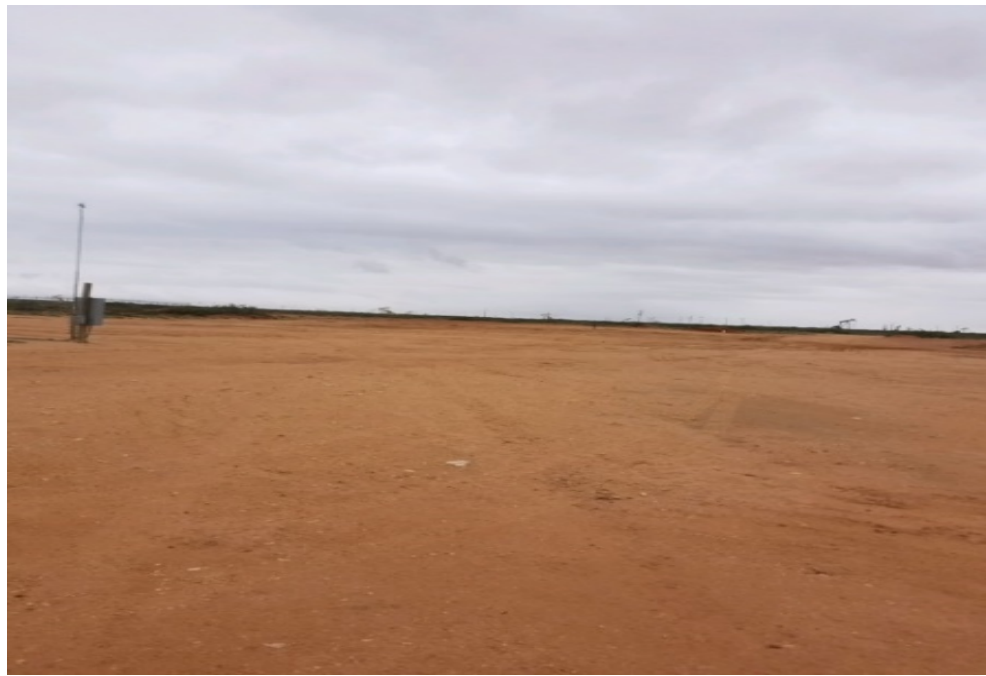
**View of
backfilled area.**

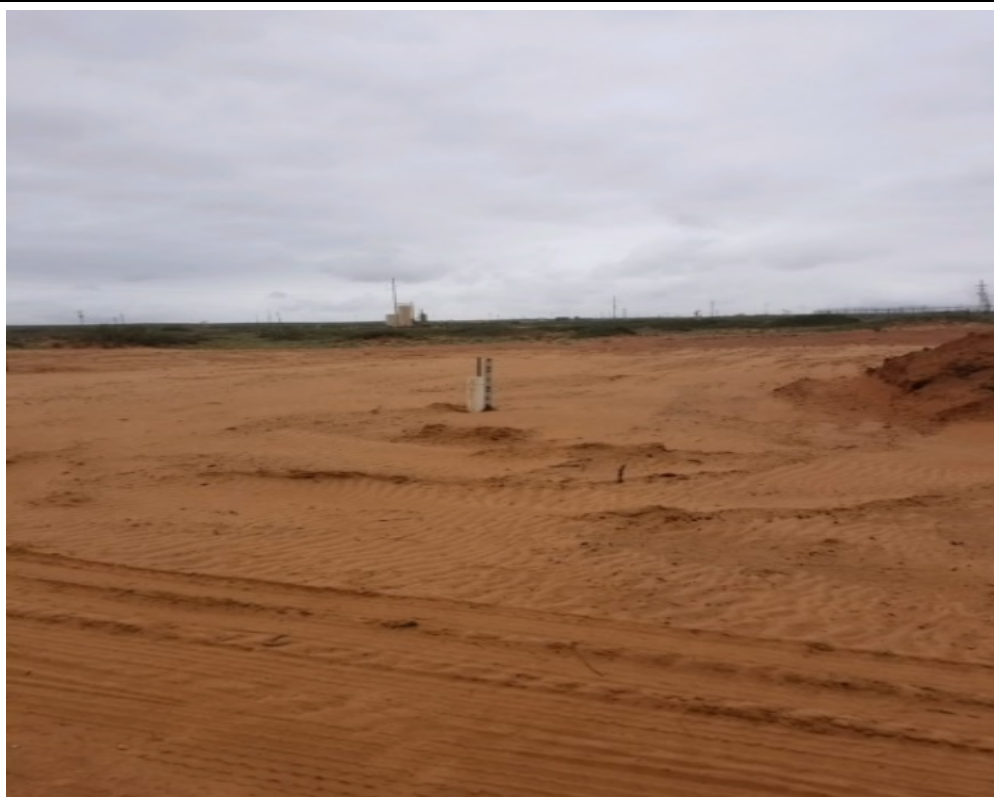
Photograph No.

**View of
backfilled area.**
