Site Assessment/Characterization

Blake Estep
Project Manager

Etech Environmental & Safety Solutions, Inc. (Etech), on behalf of Chevron Corporation, has prepared this *Remediation Summary and Soil Closure Request* for the release site known as Quail Queen Unit #002 henceforth, "Release Site". The legal description of the Release Site is Unit Letter "J", Section 11, Township 19 South, Range 34 East, in Lea County, New Mexico. The subject release is located on Bureau of Land Management property. The Release Site GPS coordinates are 32.669183° North and 103.529124° West. A "Topographic Map" is provided as Figure 1.

Site Location Topographic Map
Chevron Corporation
Quail Queen Unit #002
GPS: 32.66919, -103.52912
Lea County

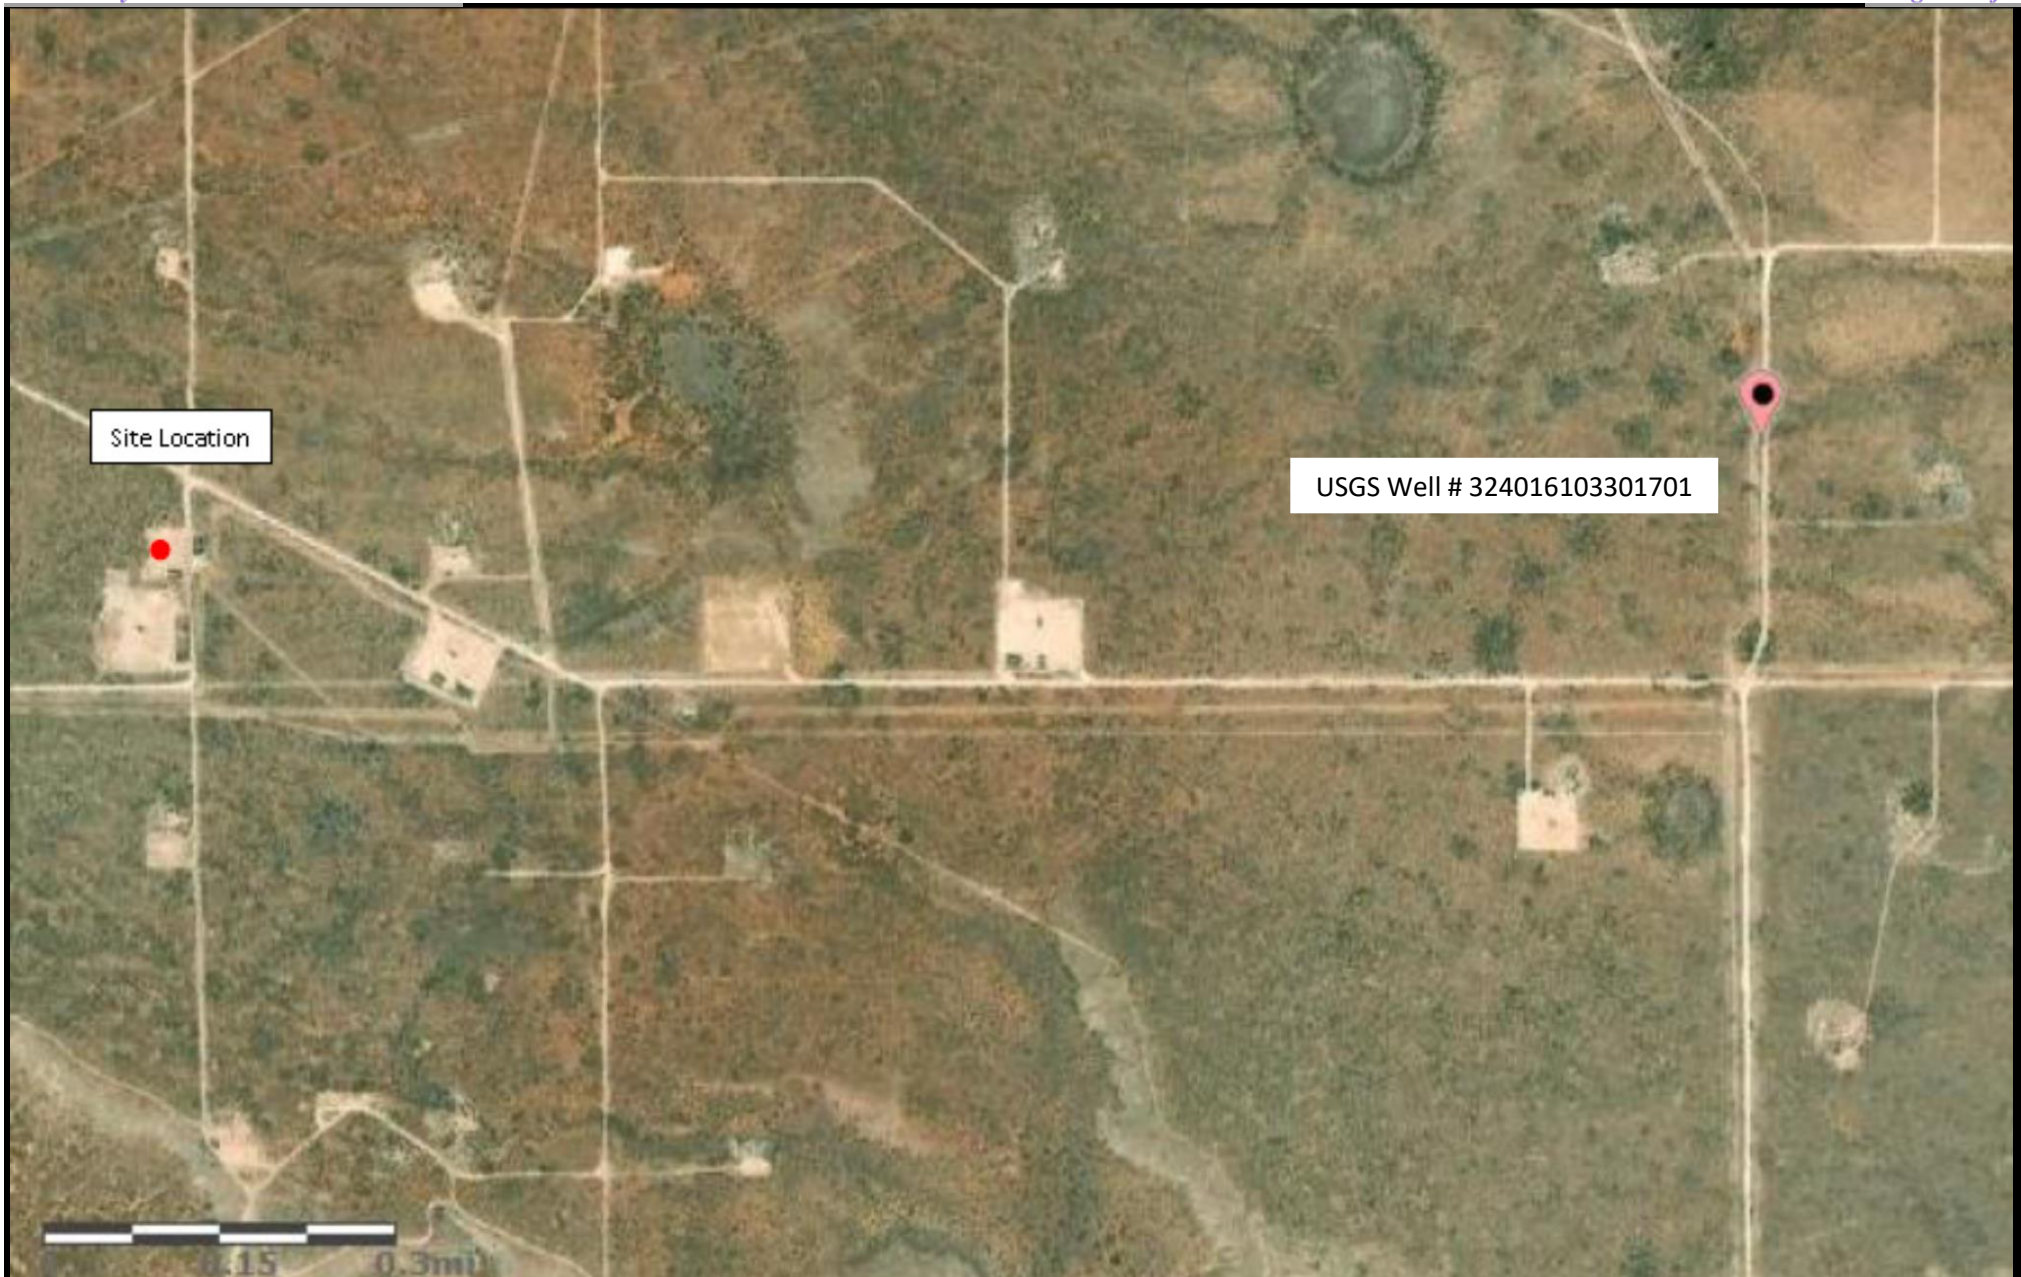
Figure 3

USGS Well Proximity Map
Chevron Corporation
Quail Queen Unit #002
GPS: 32.66919, -103.52912
Lea County

The Release Site is considered to be in an area of low potential for karst occurrence. An "Aerial Proximity Map and USGS Well Proximity Map" are provided as Figure 2 and Figure 3, respectively. Depth to groundwater information is provided in Appendix B.

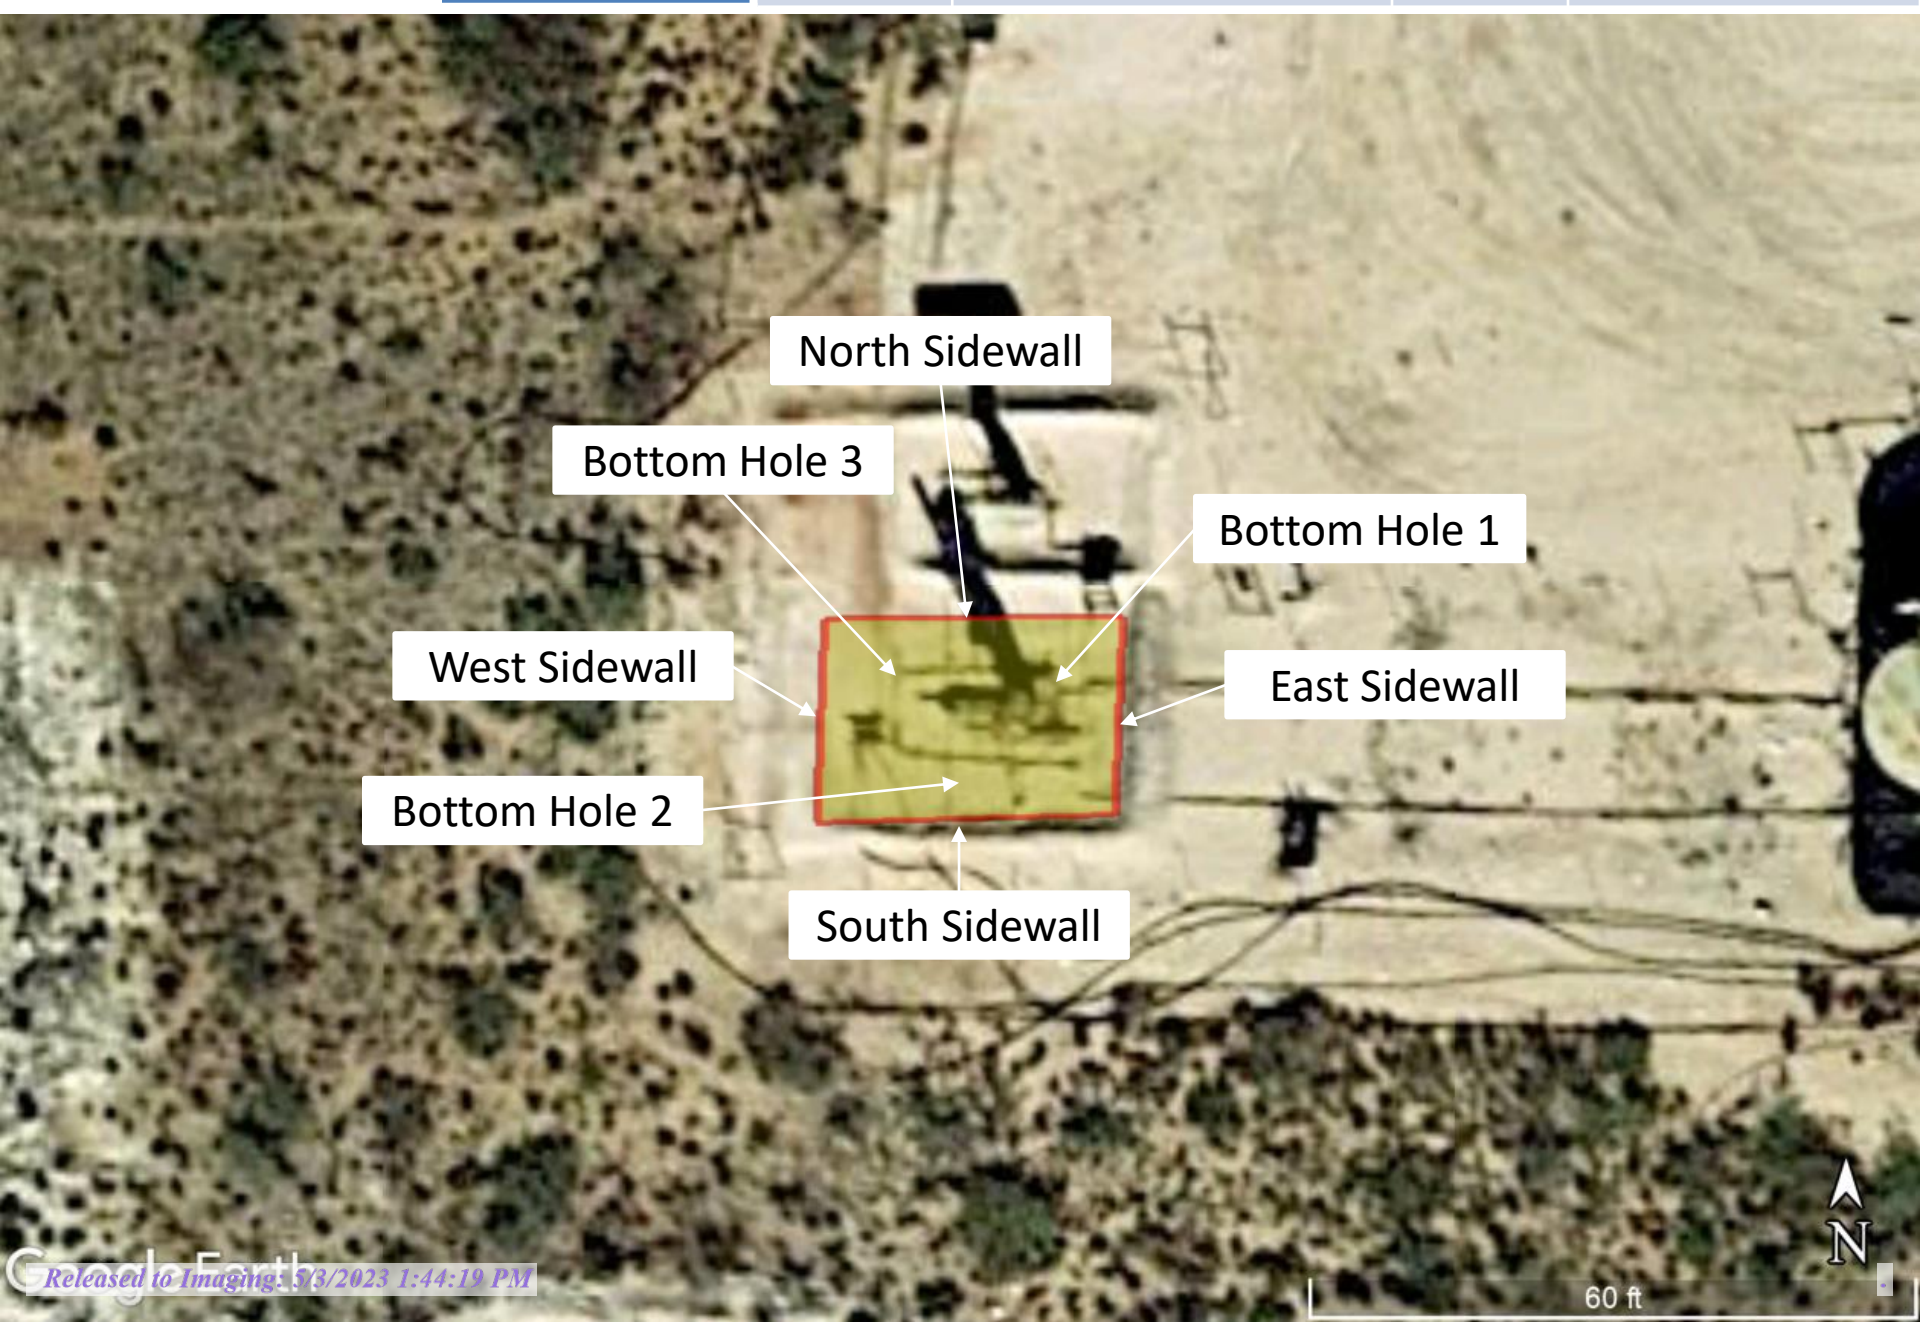
Project Name:	Quail Queen #002	Project No.:	15661	Page 14 of 92
Date Sampled:	December 1, 2022 & January 3, 2023	GPS:	32.669183, -103.529124

On December 1, 2022, three (3) composite bottom hole (Bottom Hole 1 through Bottom Hole 3) and four (4) composite wall (North Sidewall, East Sidewall, South Sidewall, and West Sidewall) samples were collected from the excavated area, representing no more than 200 square feet. Five-point composite confirmation soil samples were labeled, placed into a laboratory provided container, stored on ice, and transported under proper chain-of-custody documentation to Permian Basin Environmental Laboratory (PBELAB) in Midland, Texas.

On January 3, 2023, one (1) composite bottom hole (Bottom Hole 3A) and one (1) composite wall (East Sidewall A) samples were collected from the excavated area and submitted to PBELAB for confirmatory analysis of TPH, BTEX, and chloride utilizing the laboratory analytical methods previously described. Laboratory analytical results indicated TPH, BTEX, and chloride concentrations were below the NMOCD Closure Criteria and/or the NMOCD Reclamation Standards in each of the submitted soil samples.

See Figure 4 Site Sample Location Map for sample locations. See Appendix C for photos depicting remediation and backfill activities. See Table 1 Concentrations of Benzene, BTEX, TPH, and Chloride in Soil for sampling results and Appendix D for laboratory analytical reports.
