Site Assessment/Characterization

Closure

Re: Site Assessment, Liner Inspection and Closure Report
Bell Lake 19 State #001H
API No. 30-025-41024
GPS: Latitude 32.196472, Longitude -103.617622
UL "M", Sec.19, T24S, R33E
Lea County, NM
NMOCD Ref. No. NAPP2230656230

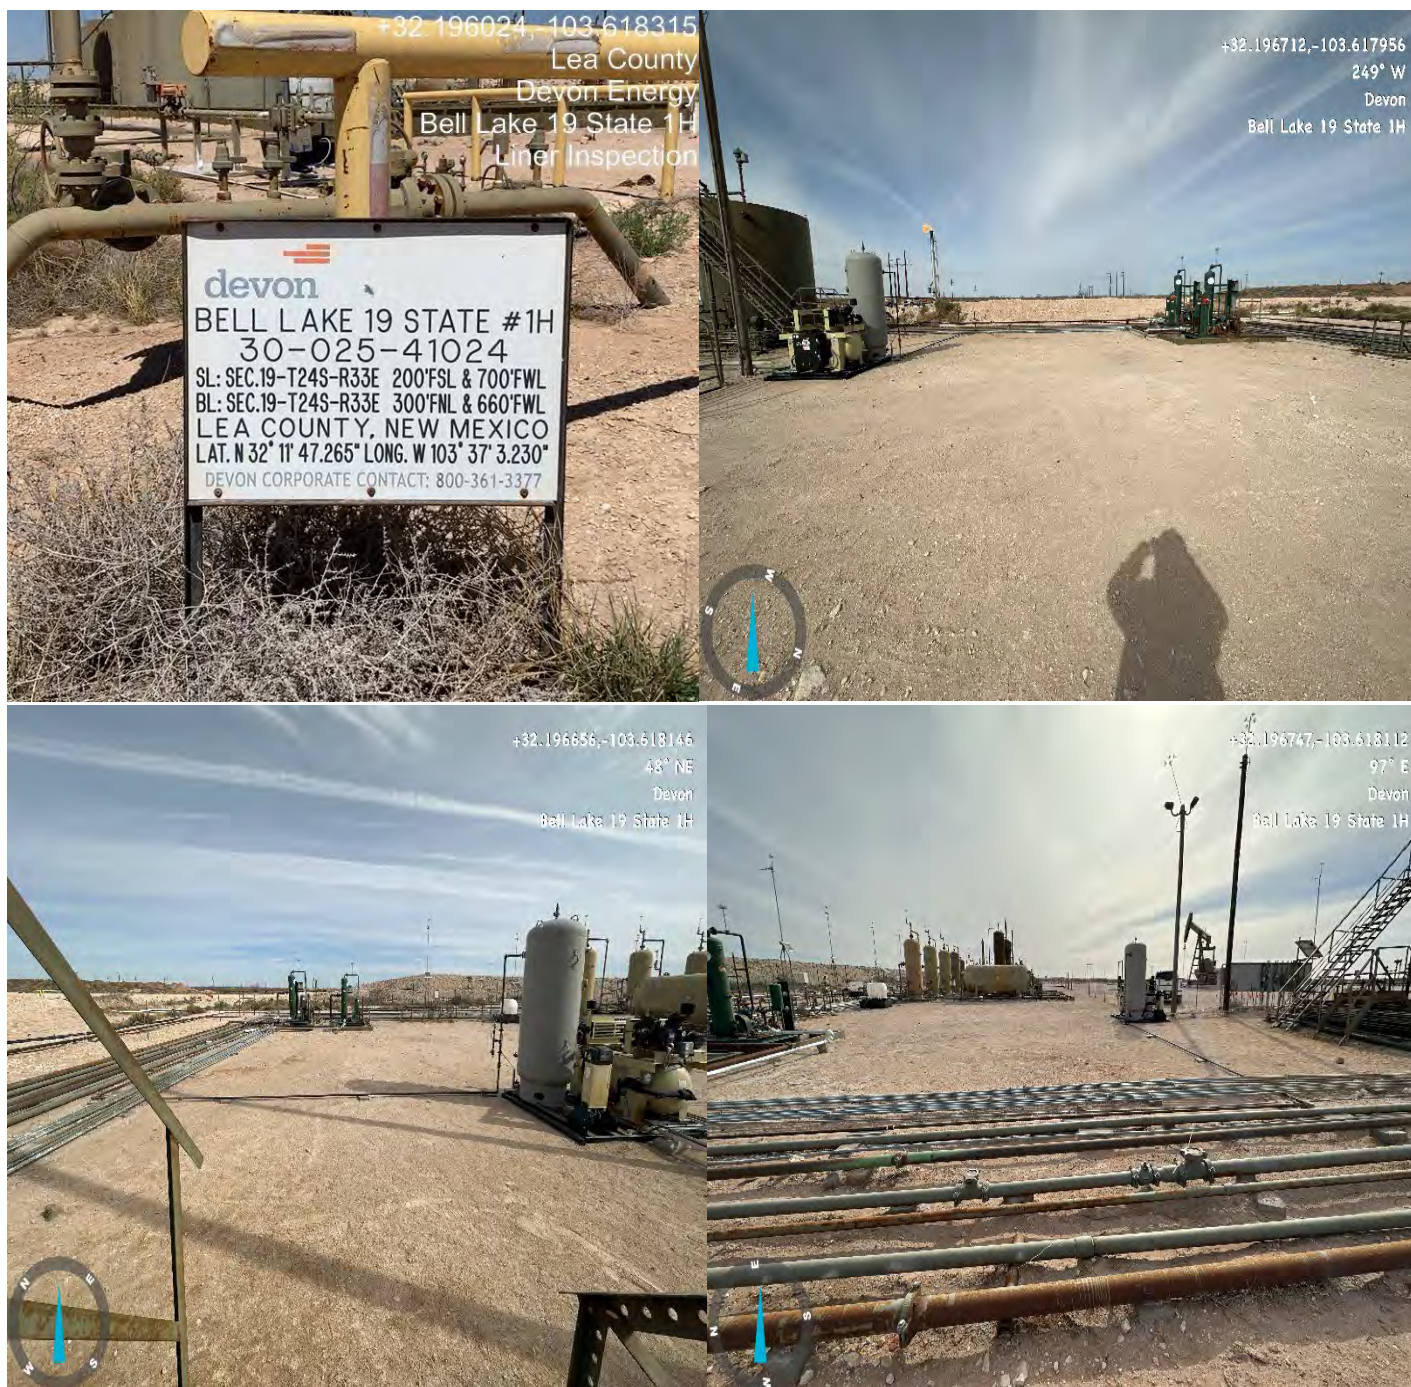
Site Assessment

NAPP2230656230 On November 2, 2022, a water tank ran over causing produced water to be released. The released fluids were calculated to be approximately 303.239 barrels (bbls) of produced water. Vacuum trucks were able to recover approximately 292 bbls of fluid from the lined SPCC containment ring, and 10 bbls of standing fluid from outside the containment. Once fluids were removed, the liner was visually inspected by Devon field staff for any pinholes or punctures.

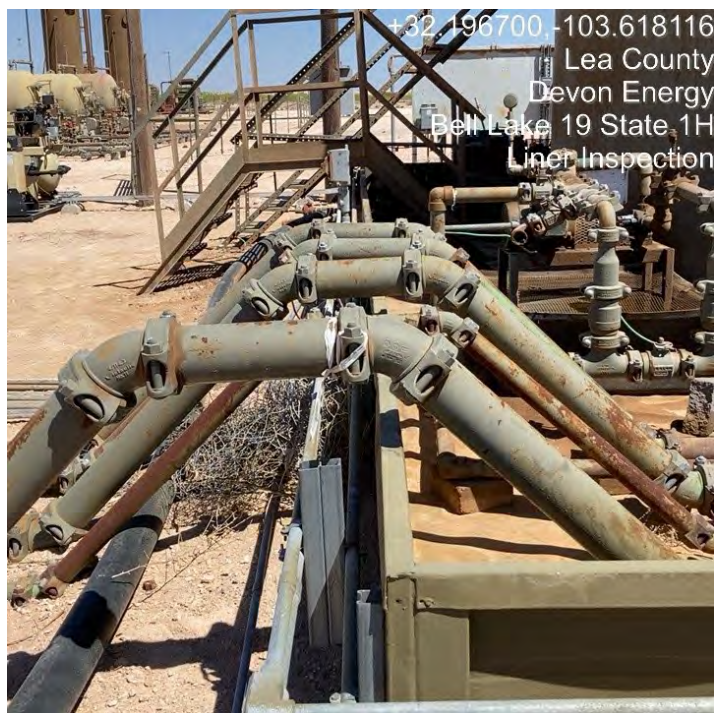
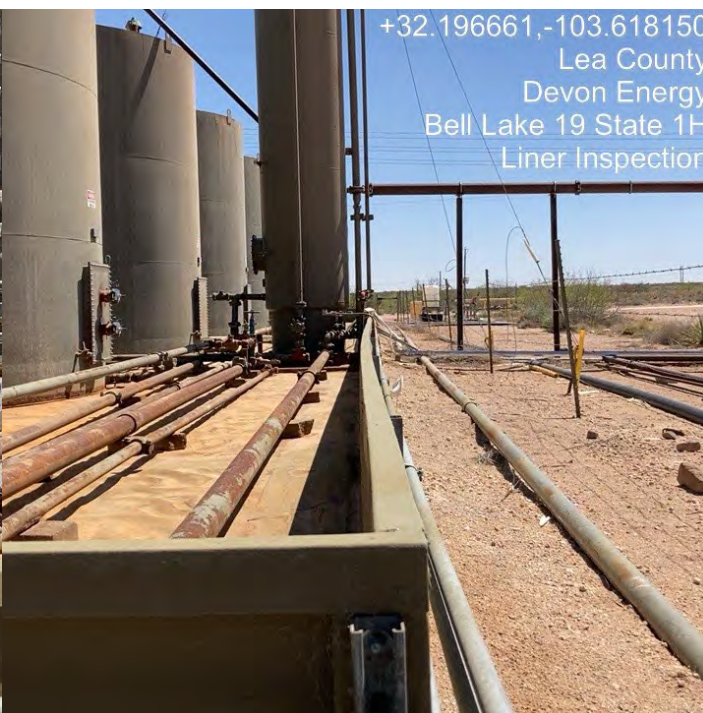
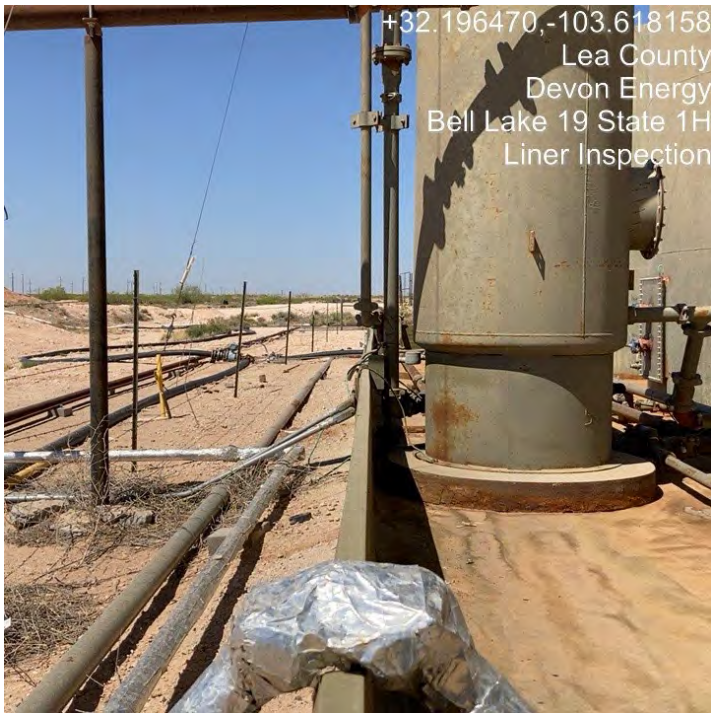
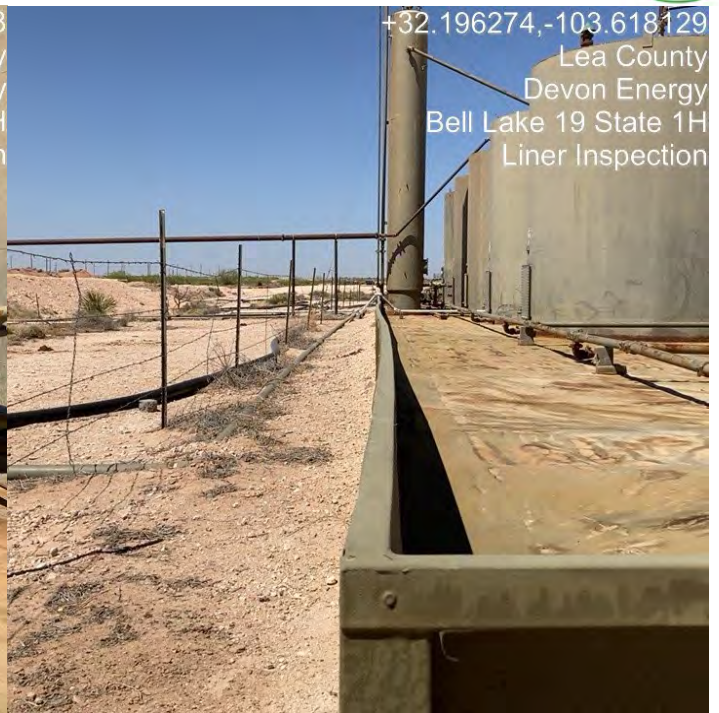
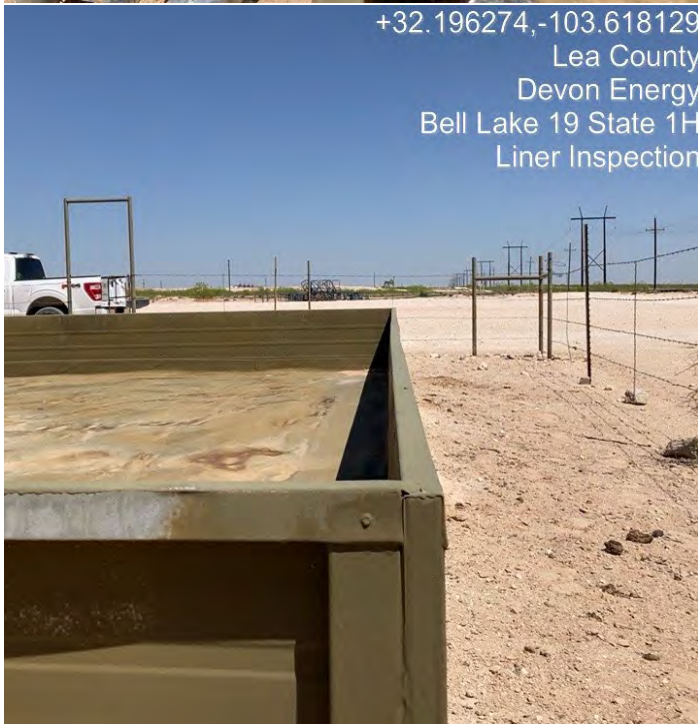
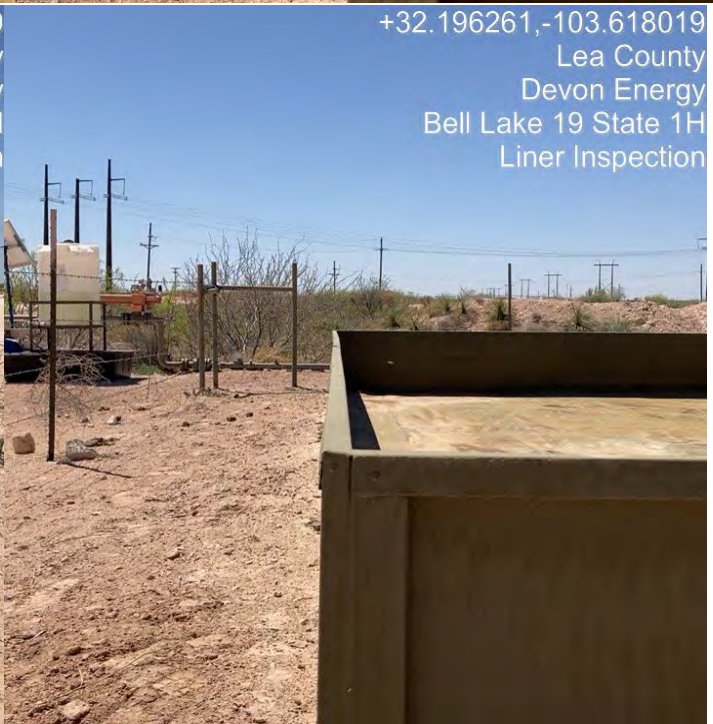
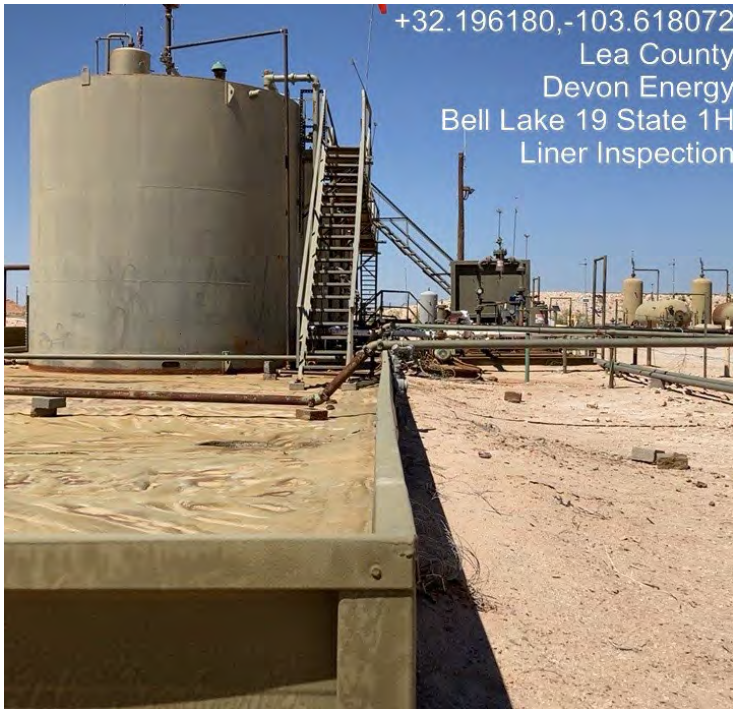
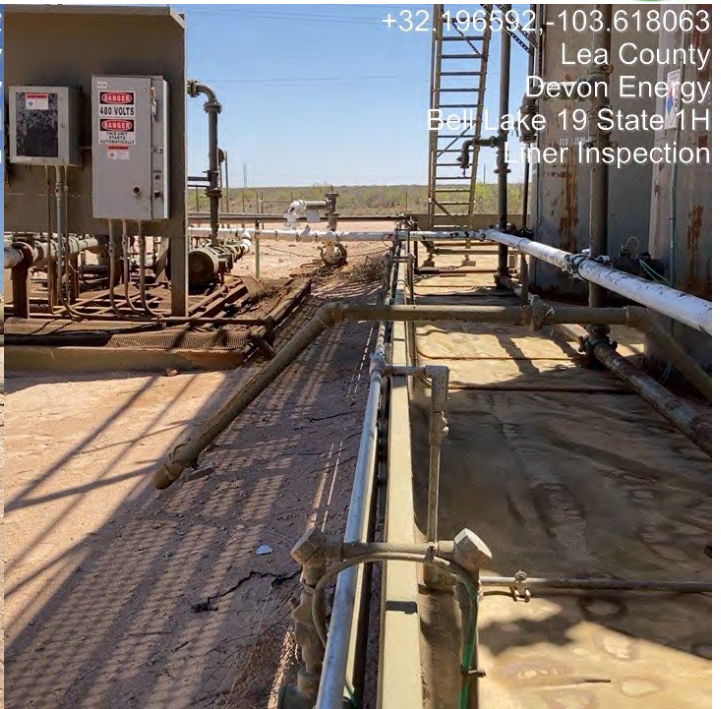
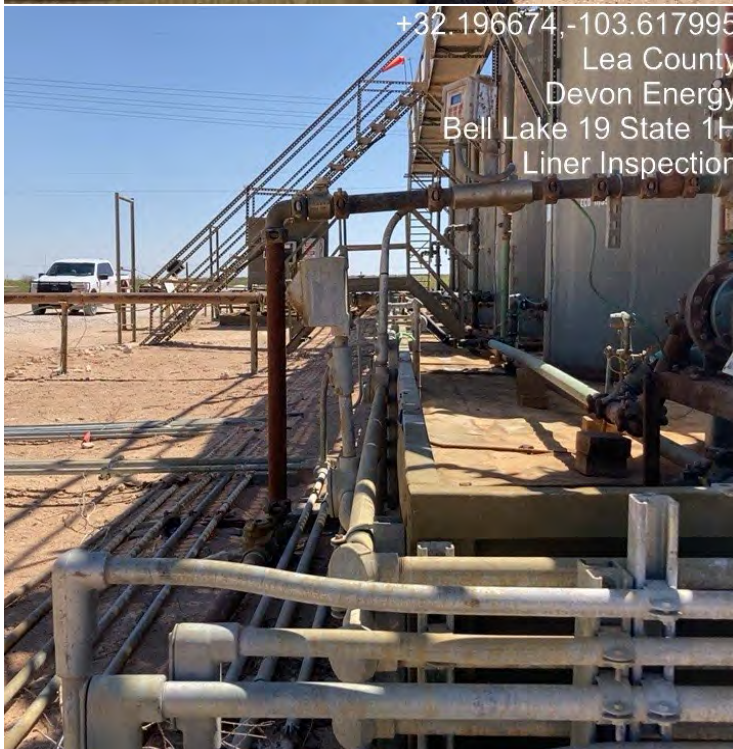
On April 9, 2023, after sending the 48-hour Notification (Appendix C) via email, Pima Environmental conducted a liner inspection at this location. We concluded that this liner and containment maintained its integrity and was able to retain the fluids. The Liner Inspection Form and photographic documentation can be found in Appendix D. Laboratory Reports can be found in Appendix E.

Visualization	Yes	No	Comments
Is there a tear in the liner?		X	
Are there holes in the liner?		X	
Is the liner retaining any fluids?		X	
Does the liner have integrity to contain a leak?	X
