Re: Third Quarter 2022 – SVE System Update

San Juan 28-6 #31
Rio Arriba County, New Mexico
Hilcorp Energy Company
NMOCD Incident Number: NVF1816655680

Ensolum, LLC (Ensolum), on behalf of Hilcorp Energy Company (Hilcorp), presents this *Third Quarter 2022 – SVE System Update* report summarizing the soil vapor extraction (SVE) system performance at the San Juan 28-6 #31 natural gas production well (Site) located in Unit M, Section 28, Township 28 North, Range 6 West in Rio Arriba County, New Mexico (Figure 1). Specifically, this report summarizes Site activities performed in July, August, and September of 2022 to the New Mexico Oil Conservation Division (NMOCD).

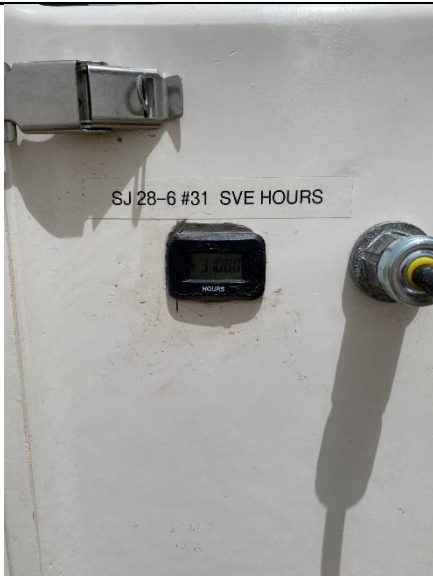
Photograph 1 Runtime meter taken on June 13, 2022 at 11:53 AM Hours = 3108.0

Between June 13 and September 19, 2022, the SVE system operated for 2,295 hours for a runtime efficiency of 97.6 percent (%). Table 1 presents the SVE system operational hours and percent runtime. Appendix B presents photographs of the runtime meter for calculating the third quarter runtime efficiency. During the third quarter 2022, all zones were operating with 15 of the 20 wells operational. SVE wells SVE-6, SVE-7S, SVE-7D, SVE-9, and SVE-15 have been turned off based on the low

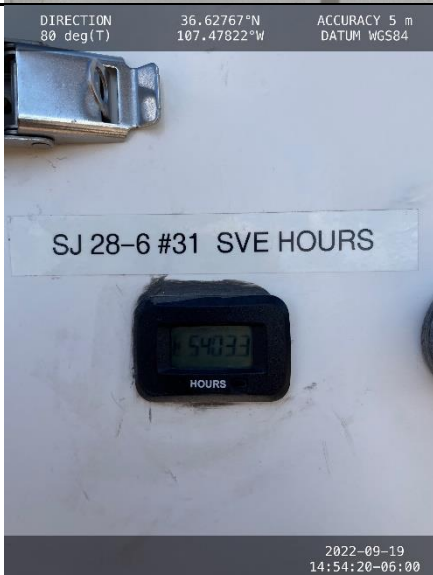
Photograph 2 Runtime meter taken on September 19, 2022 at 2:54 PM Hours = 5403.3
