**Re: Closure Letter**

**State S 19 #20**  
**API: 30-015-32060**  
**RP#: 2RP-3932**  
**Unit Letter M Section 19, Township**  
**17S, Range 29E Eddy County, NM**

**Report Type: Work Plan      2RP-3932**

**Re: Work Plan for the COG Operating LLC., State S19 #20, Unit M, Section 19, Township 17 South, Range 29 East, Eddy County, New Mexico. 2RP-3932.**

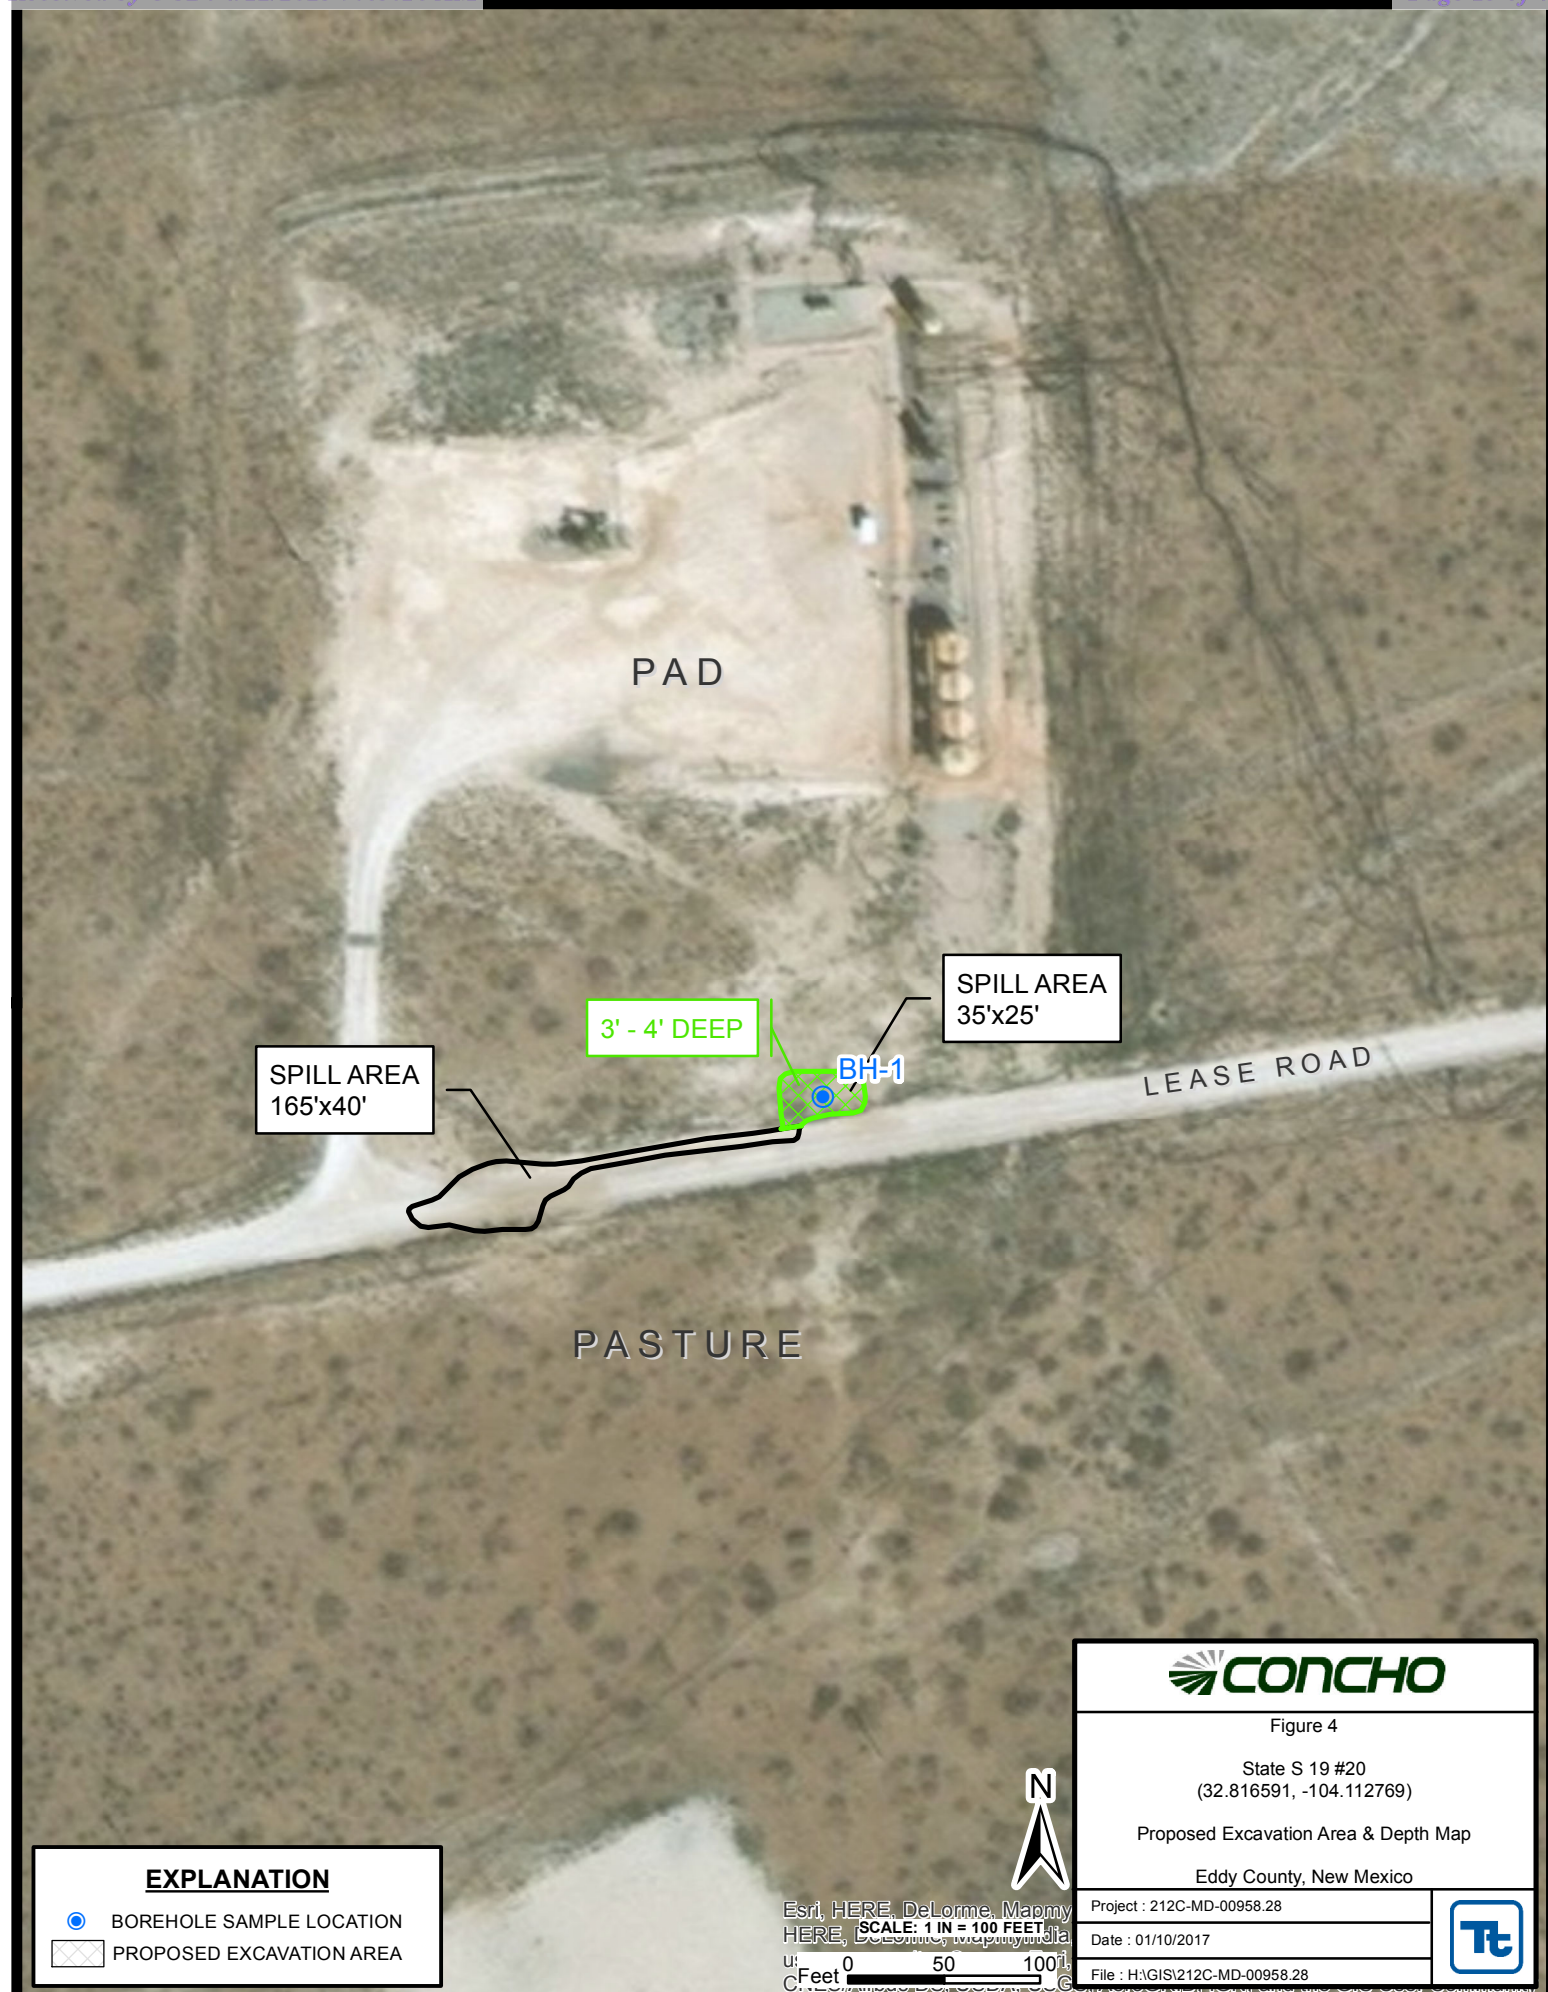
Based on the laboratory results, COG proposes to remove the chloride impacted soils as shown on Figure 4 and highlighted (green) on Table 1. The area of borehole (BH-1) will be excavated to approximately 3.0-4.0' below surface to remove the chloride impacted soils. Due to safety concerns and the heavy traffic, the area on the lease road will not be excavated. The excavated areas will be backfilled with clean material to surface grade. All of the excavated material will be transported offsite for proper disposal.

The proposed excavation depths may not be reached due to wall cave ins and safety concerns for onsite personnel. In addition, impacted soil around oil and gas equipment, structures or lines may not be feasible or practicable to be removed due to safety concerns for onsite personnel. As such, COG will excavate the impacted soils to the maximum extent practicable.

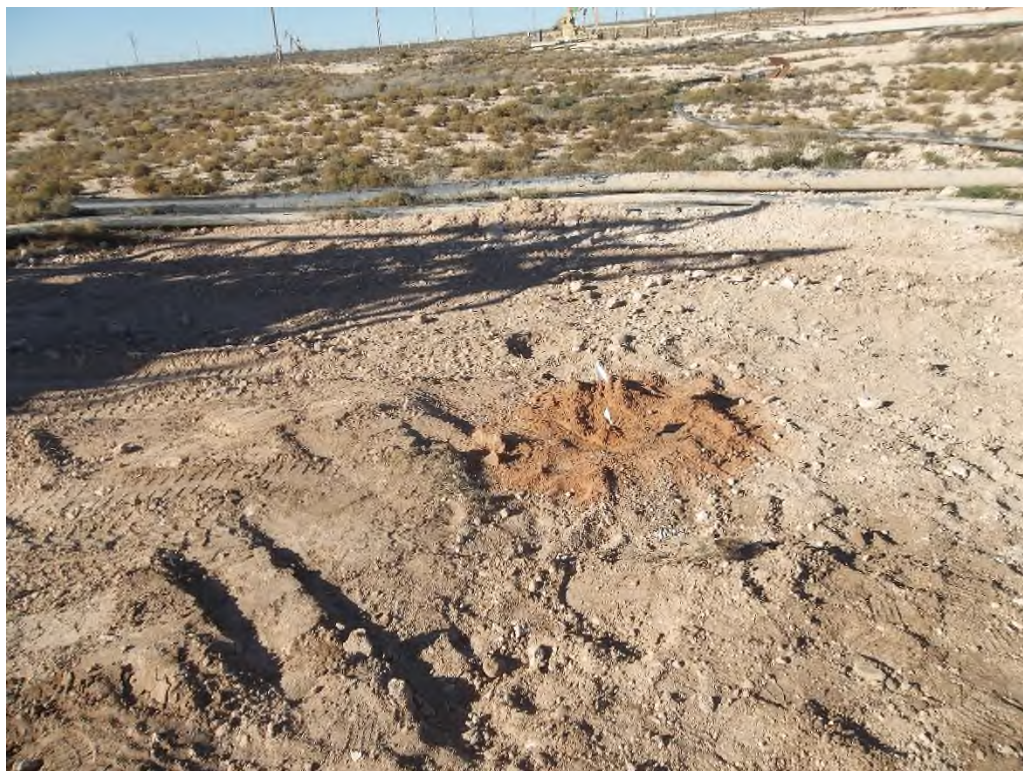
View North – Area of BH-1

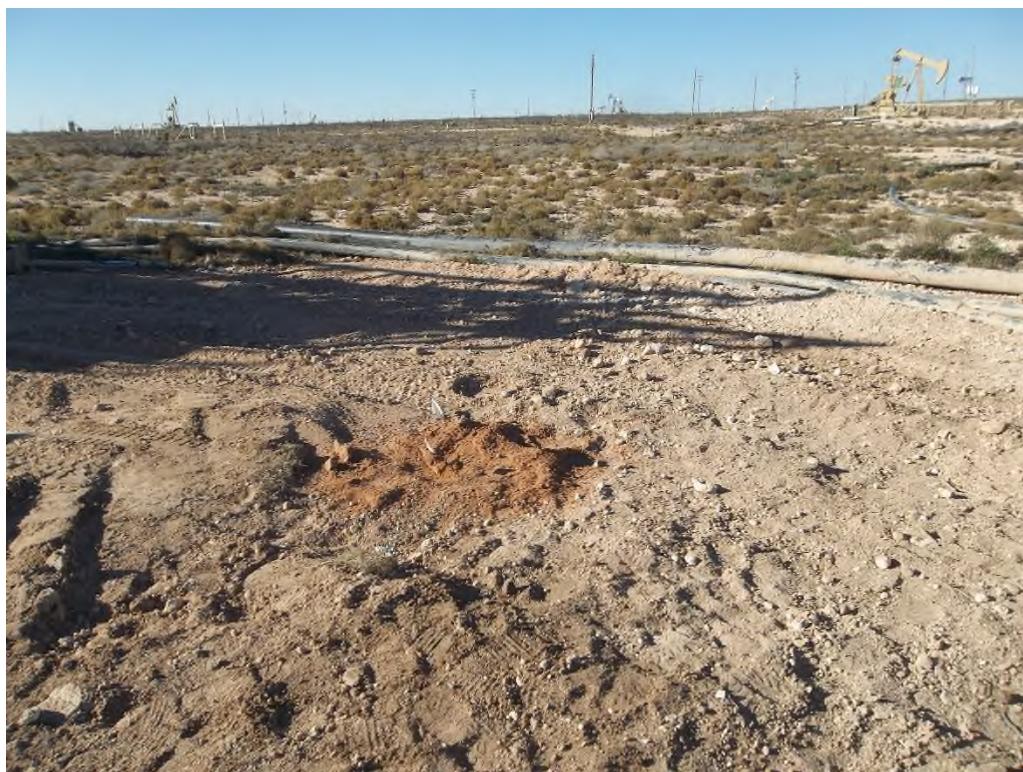
View North – Area of BH-1
