Amended Remediation Summary and Soil Closure Request

H.L. Brown Operating, LLC Fed Com 27 002

Roosevelt County, New Mexico
Unit Letter A, Section 5, Township 8 South, Range 37 East
Latitude 33.678874 North, Longitude 103.148393 West
NMOCD Reference No. nAPP2227230997

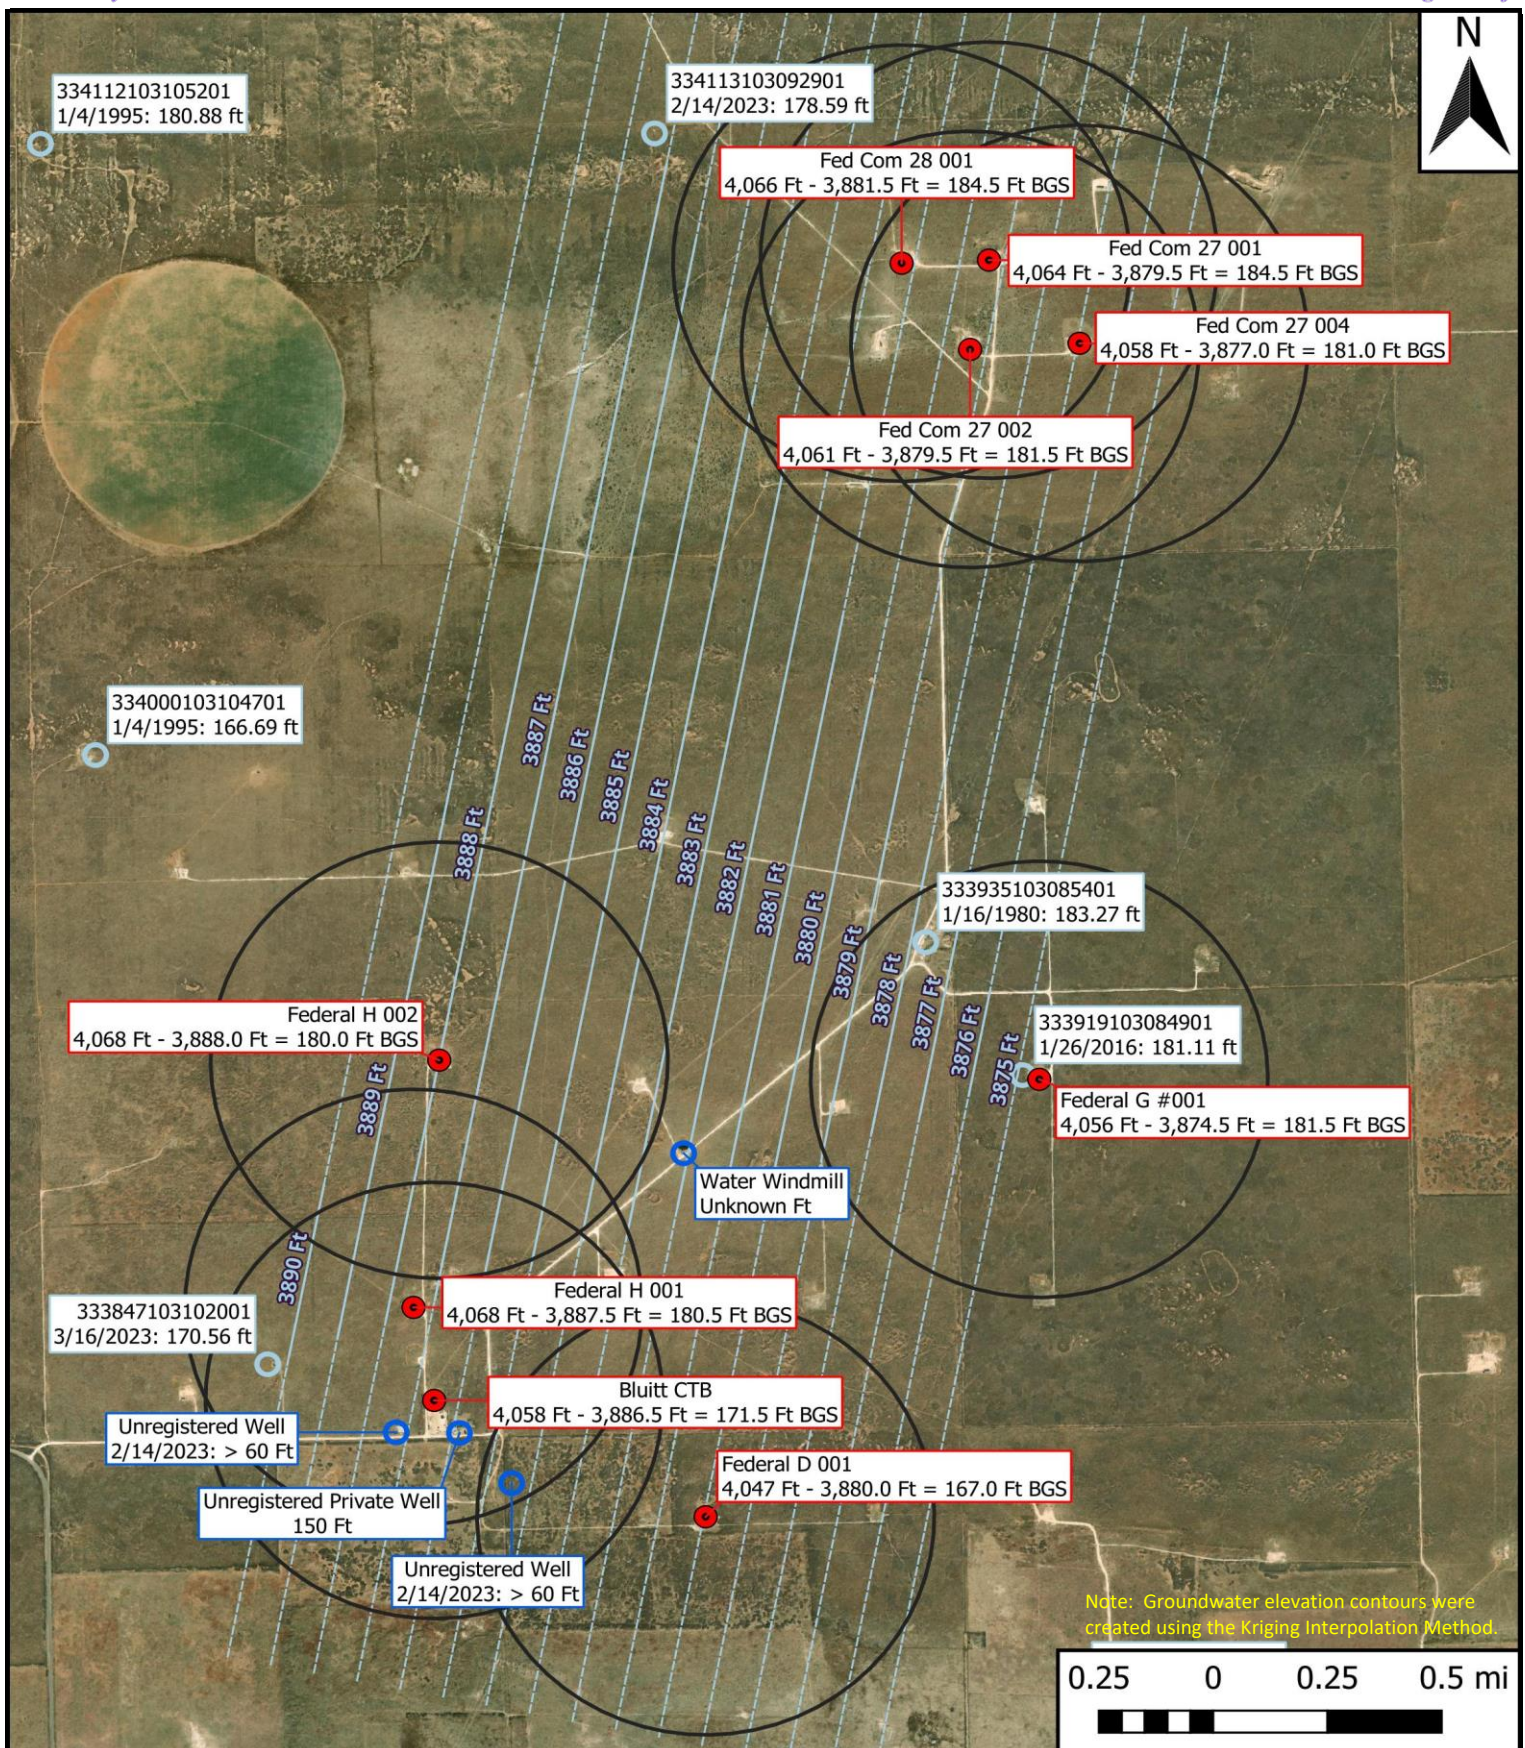
Depth to Groundwater Information

HL Brown Sites
 Inferred Depth to Groundwater Map
 H.L. Brown Operating, LLC
 Map GPS: 33.66350422, -103.15426221
 Roosevelt County, NM

A search of groundwater databases maintained by the New Mexico Office of the State Engineer (NMOSE) and United States Geological Survey (USGS) was conducted in an effort to determine the horizontal distance to known water sources within a half-mile radius of the Site. Probable groundwater depth was determined using data generated by numeric models based on available water well data and published information. Depth to groundwater information is provided as Appendix A.

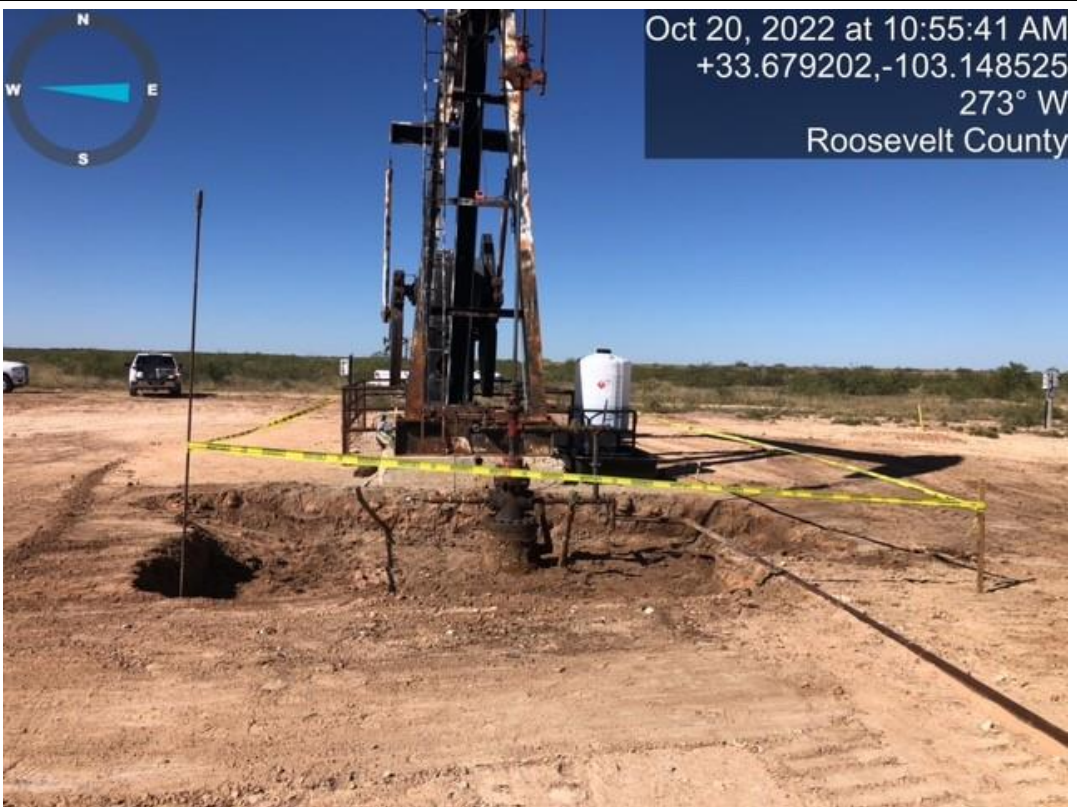
Photo Number: 6

Photo Direction: West	
Photo Description: View of excavated area adjacent to the well head.
