Release Notification

Site Name	NVA 260	Site Type	WELL FLOWLINE
Date Release Discovered	12/25/2022	API# (if applicable)	30-025-28821

Re: **Request for Approval of Work Plan**
NVA 260
Tracking #: NAPP2300550705

On 1/5/2023, Cross Timbers Energy, LLC reported a release at the NVA 260. The release was caused by 3" metal flowline froze and busted 3" coupling. Approximately 3,324 sqft. of the Pasture was found to be damp upon initial inspection.

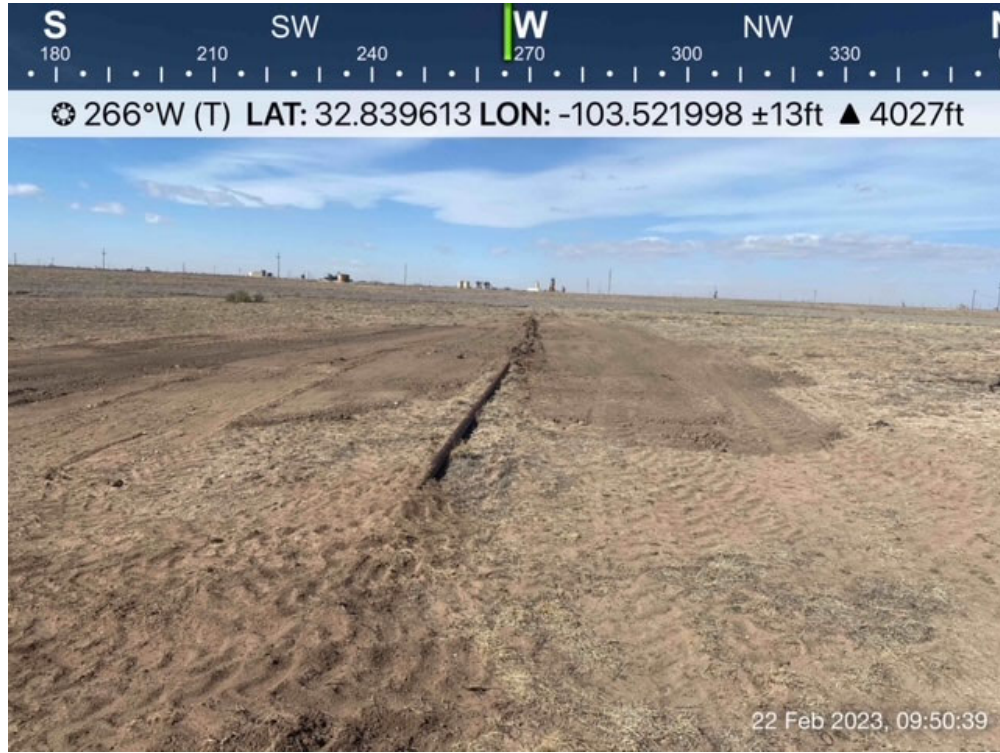
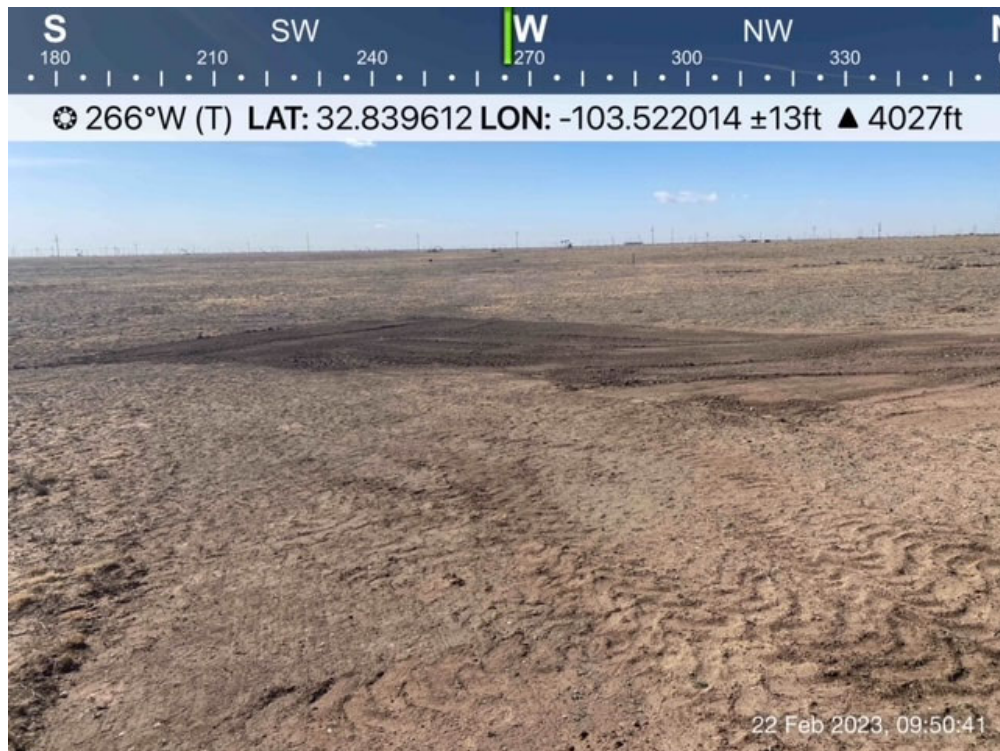
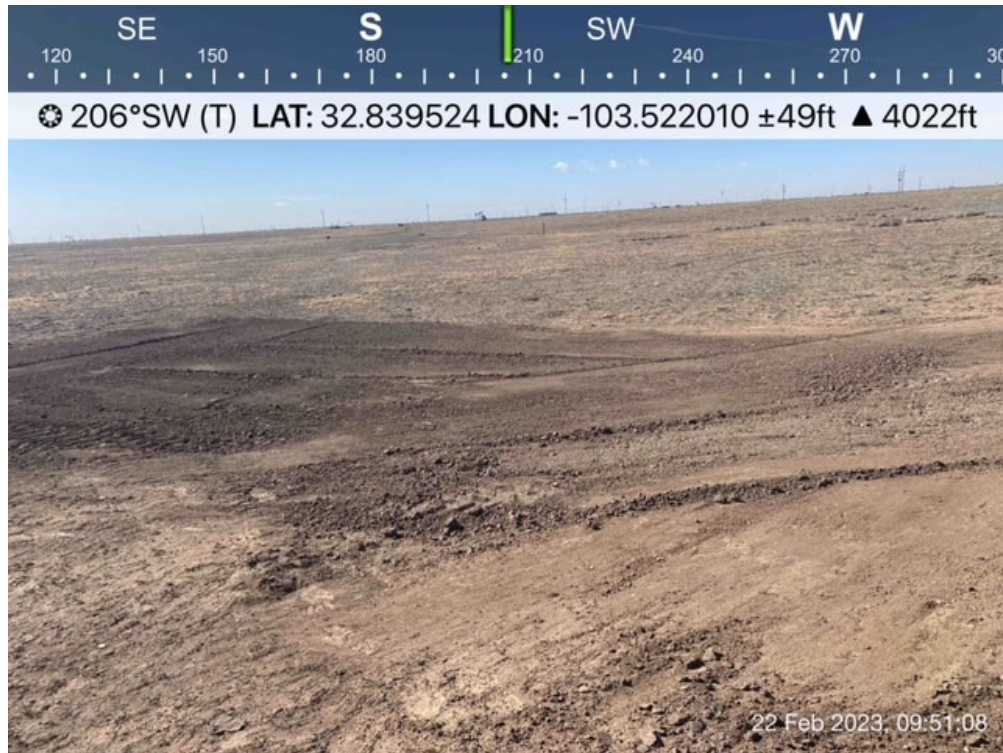
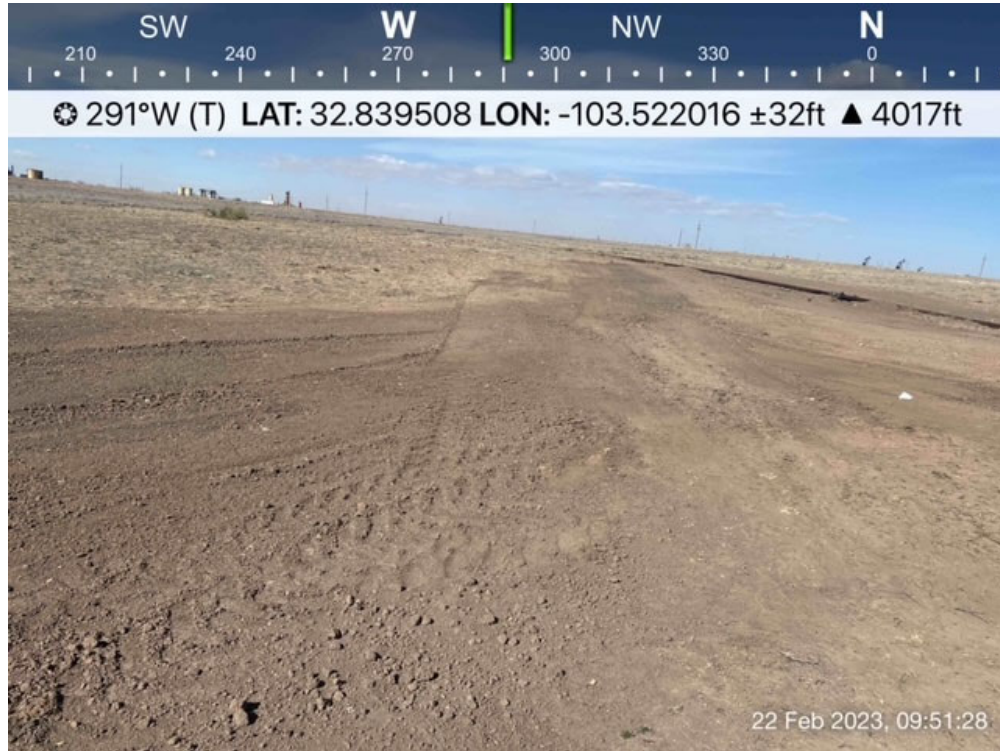
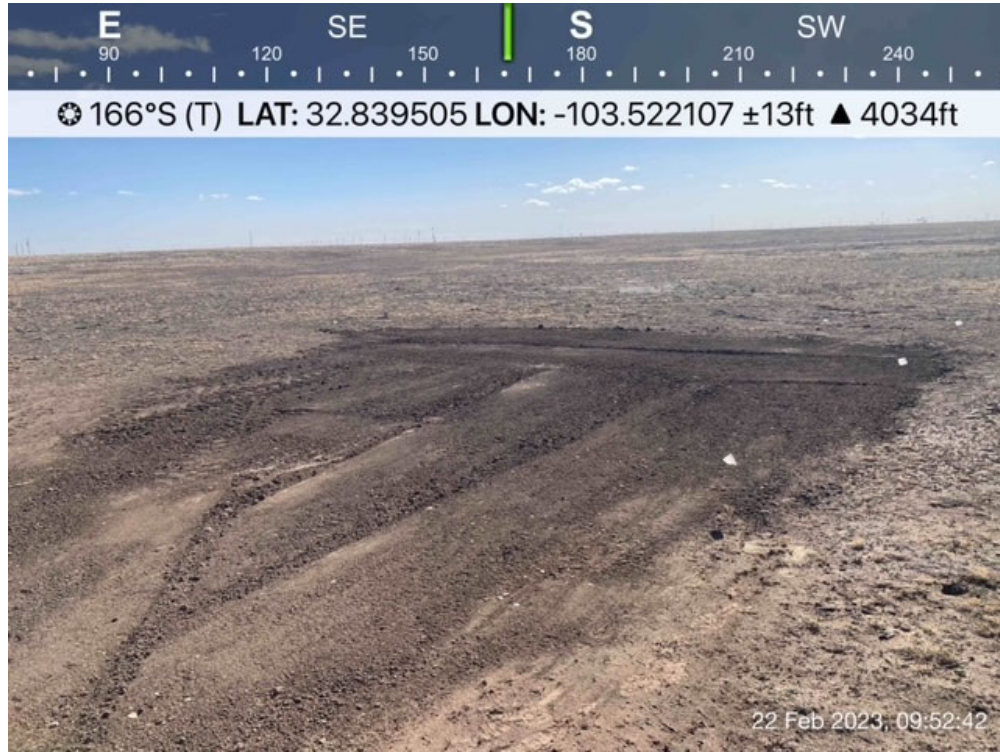
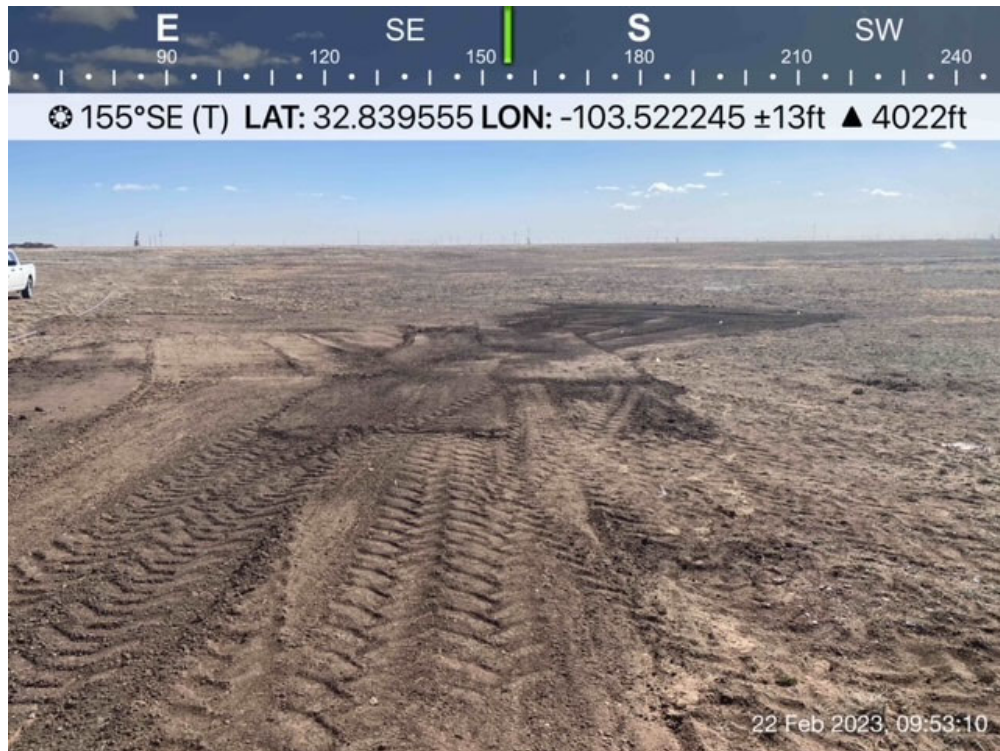
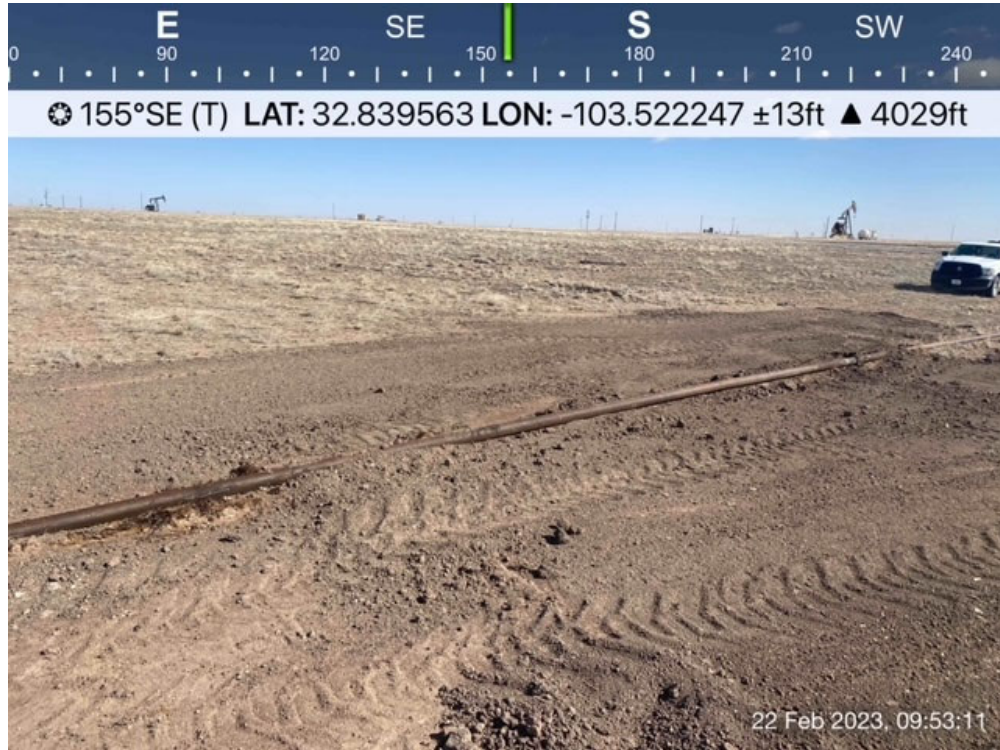
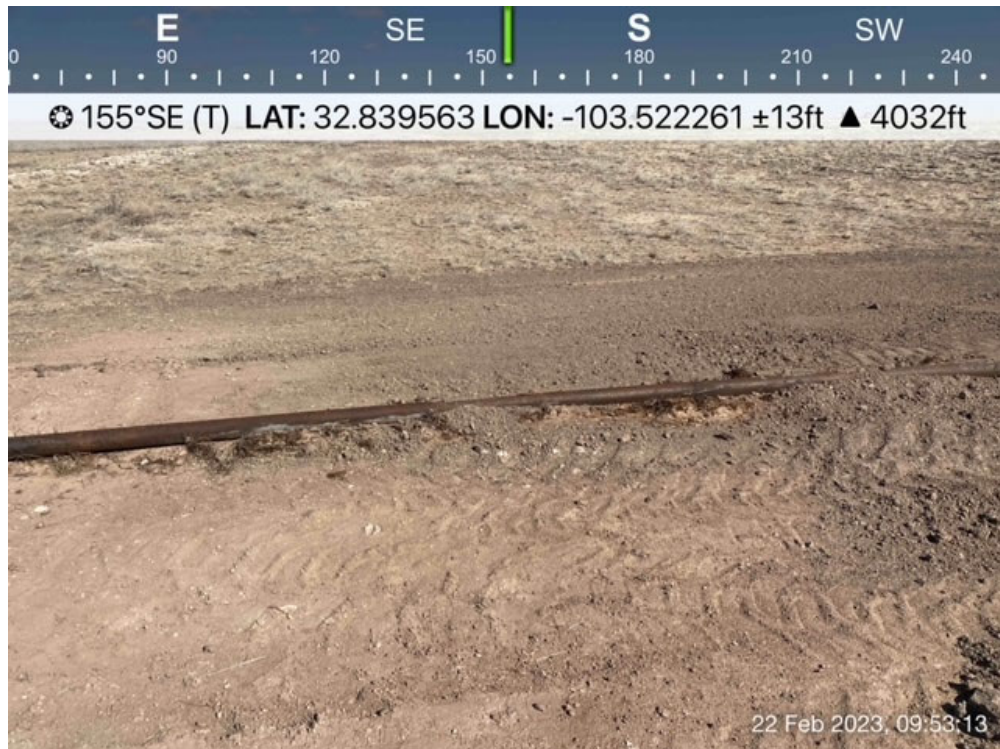
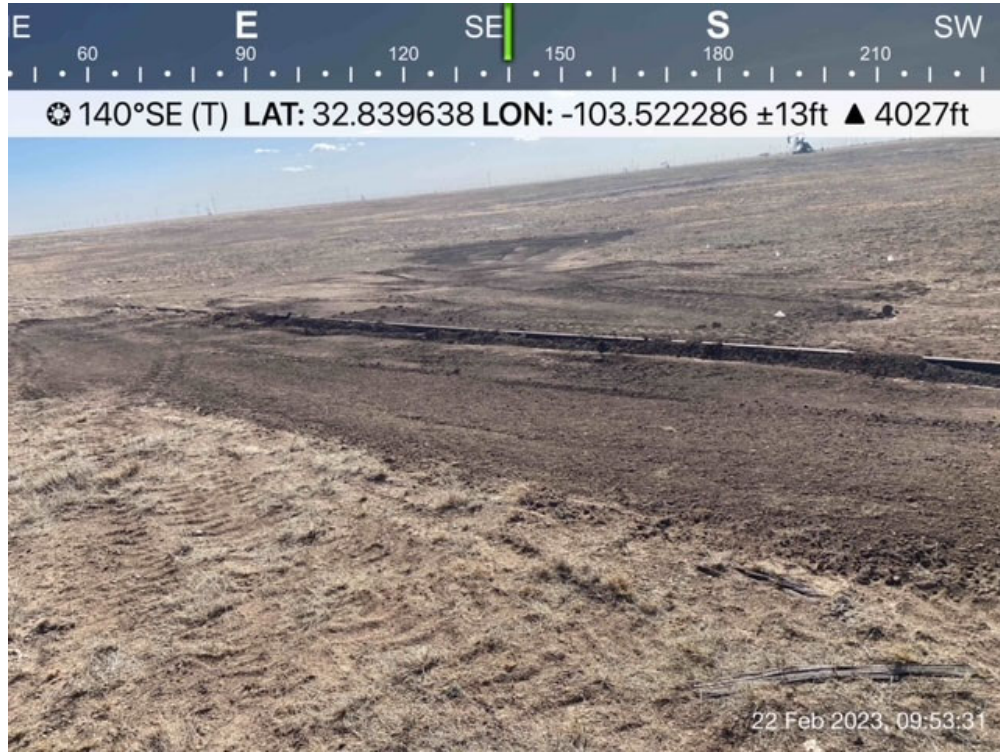
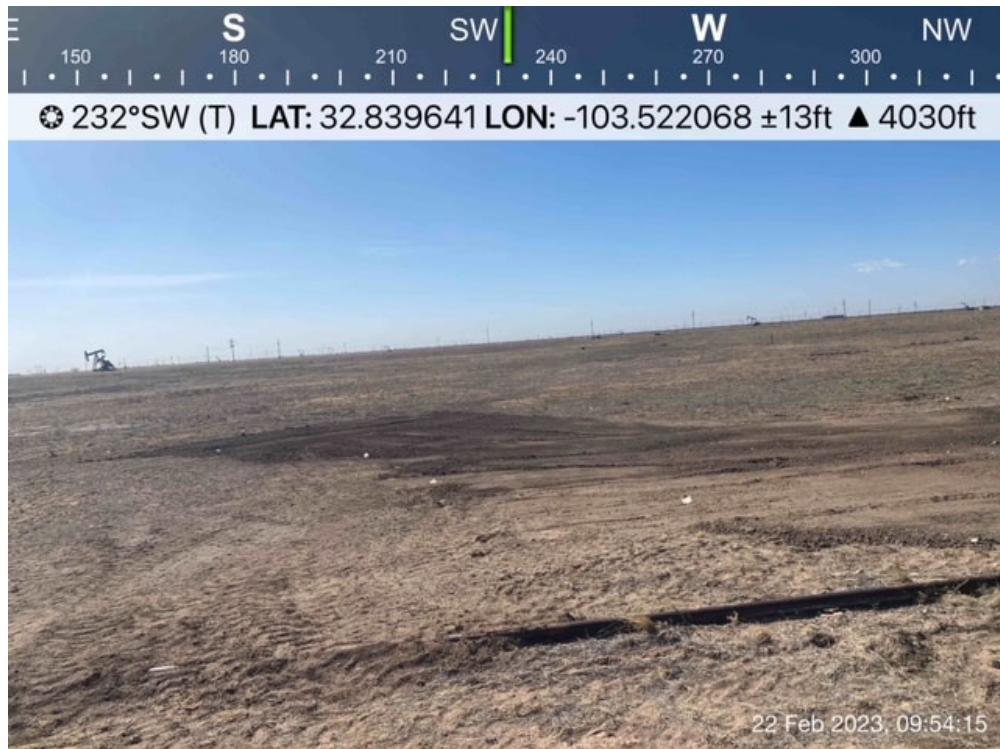
Initial Release

3" METAL FLOWLINE FROZE AND BUSTED 3" COUPLING

Areas affected by the release and the associated remediation activities will be restored to a condition which existed prior to the release to the extent practicable. The affected area will be contoured and/or compacted to provide erosion control, stability, and preservation of surface water flow. Affected areas not on production pads and/or lease roads will be reseeded with a prescribed US Bureau of Land Management seed mixture during the first favorable growing season following closure of the site in accordance with the applicable regulatory agency.
