Release Notification

Site Name: Libby Gas Plant	Site Type: Cryogenic gas separation facility
Date Release Discovered:	API# (if applicable)

Re: Libby Gas Plant Flare Fire Closure Report
Formerly Operated by 3Bear Field Services LLC
OGRID: 372603
Incident Number: Napp2232731776

As previously discussed, this summary report is being sent with relevant details to close your file subsequent to acquisition from 3Bear by Delek Logistics, LLC (Delek). The flare fire happened during a malfunction on November 23, 2022 at the 3Bear Libby Gas Plant. We estimated one barrel of liquid was ejected on fire from the flare and burned on the ground. Sampling results of the charred area indicate no surface environmental impact by hydrocarbons; therefore, there was no threat to subsurface soil or groundwater from this incident. We are hopeful that this brief report with attachments will justify closure.

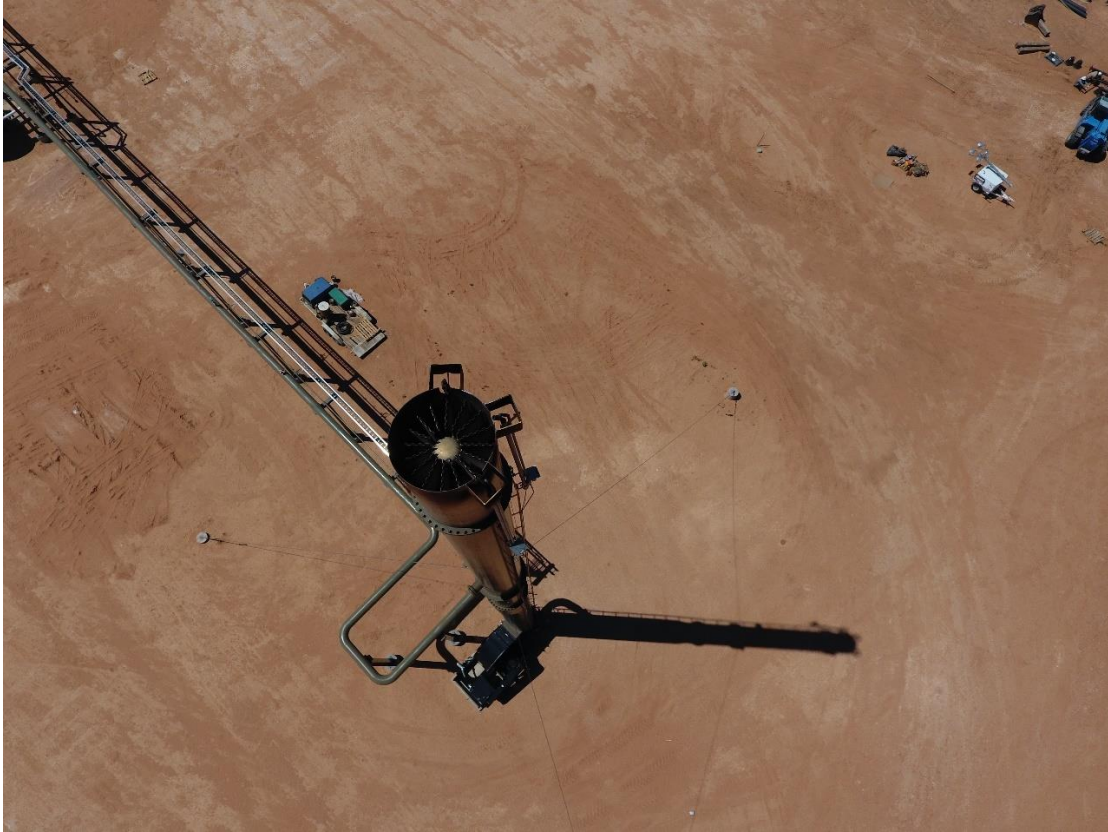
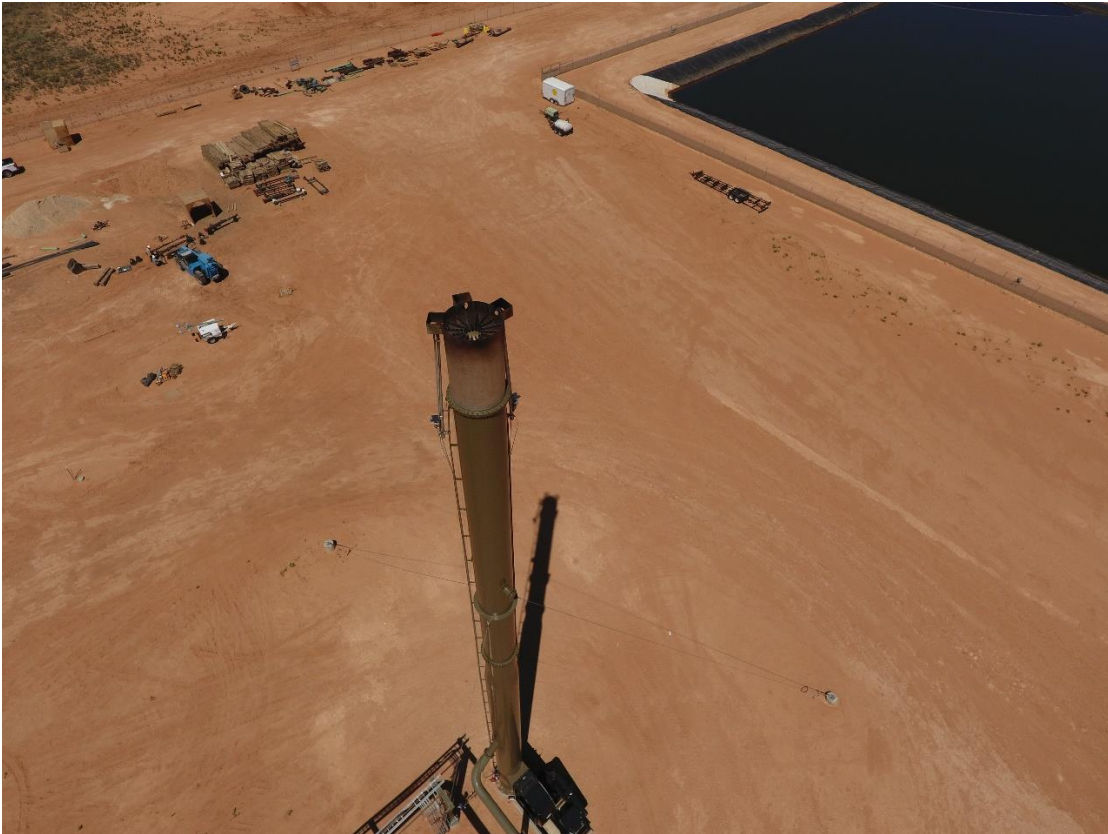
Photographs (Flare Fire Location 32.54236 -103.52573) Historical Aerials, November 22, 2022 Fire, and Sampled Charred Area

Photos of the Charred/Sampled Area and Flare Fire in Progress

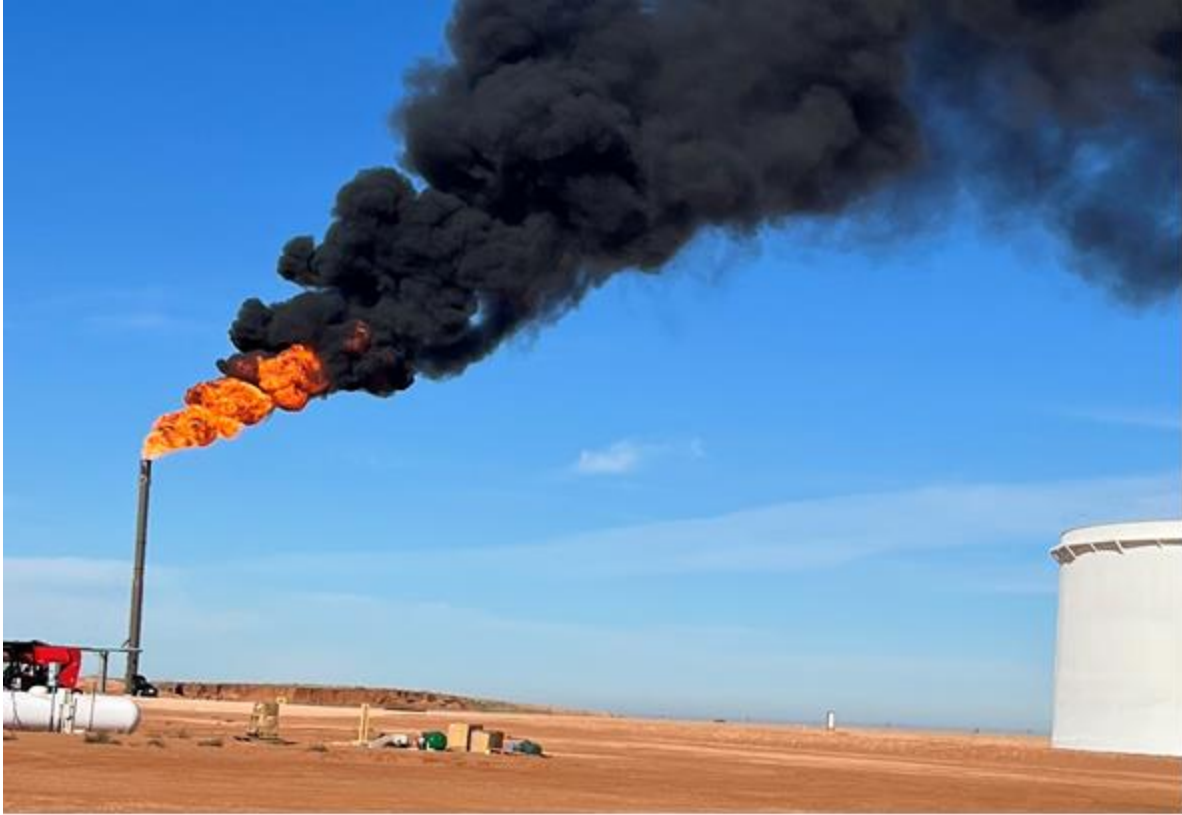
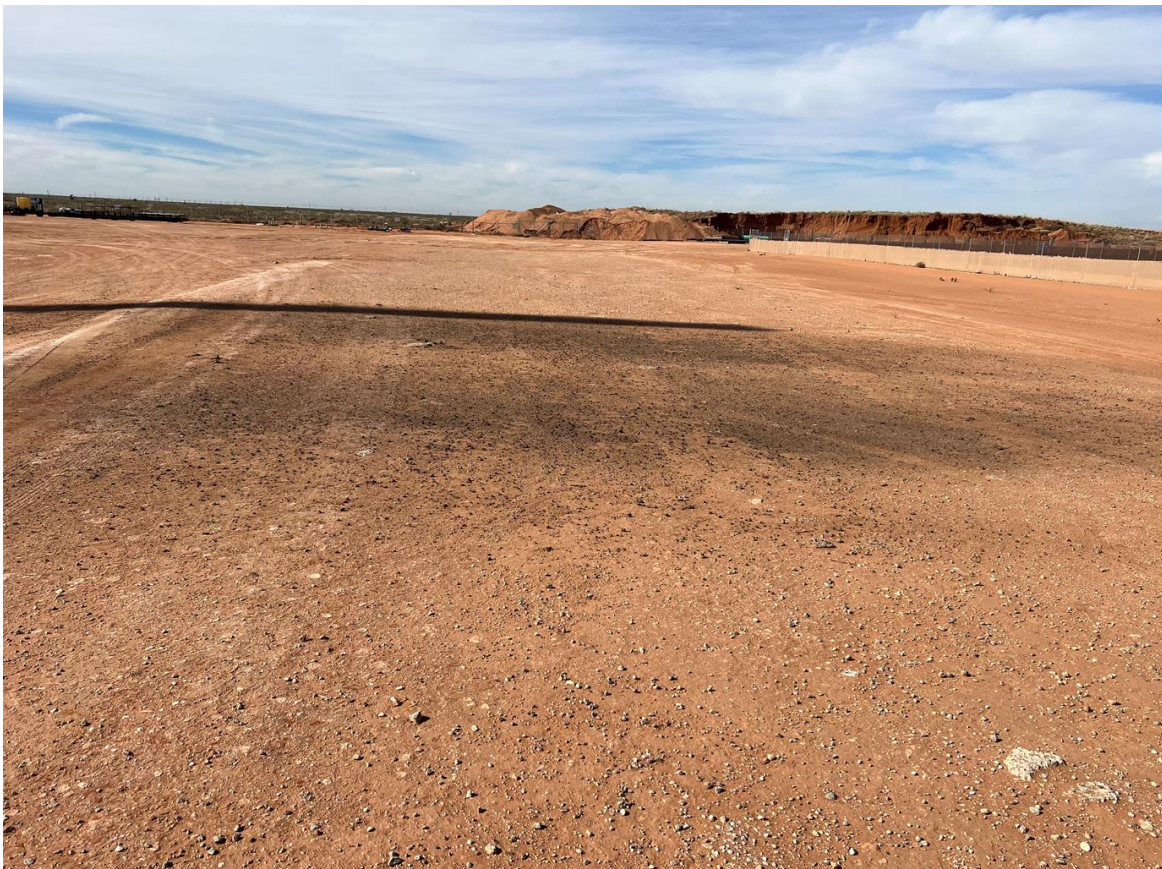
Photographs (Flare Fire Location 32.54236 -103.52573) Historical Aerials, November 22, 2022 Fire, and Sampled Charred Area
