FAB1514 737885 **Release Notification and Corrective Action** **AMENDED**

Name of Company	Plains Pipeline, LP <i>240911</i>	Contact	Camille Bryant
Address	2530 State Hwy. 214, Denver City, TX 79323	Telephone No.	(575) 441-1099
Facility Name	Palladium 7-1 4-Inch Poly	Facility Type	4-Inch Poly Pipeline

Attachment #2
Site Location Map
Plains Pipeline, LP
Palladium 7-1 4-Inch Poly
Eddy County, New Mexico
Plains SRS #: 2013-044

Attachment #3
Site & Sample Location Map
Plains Pipeline, LP
Palladium 7-1 4-Inch Poly
Eddy County, New Mexico
Plains SRS #: 2013-044

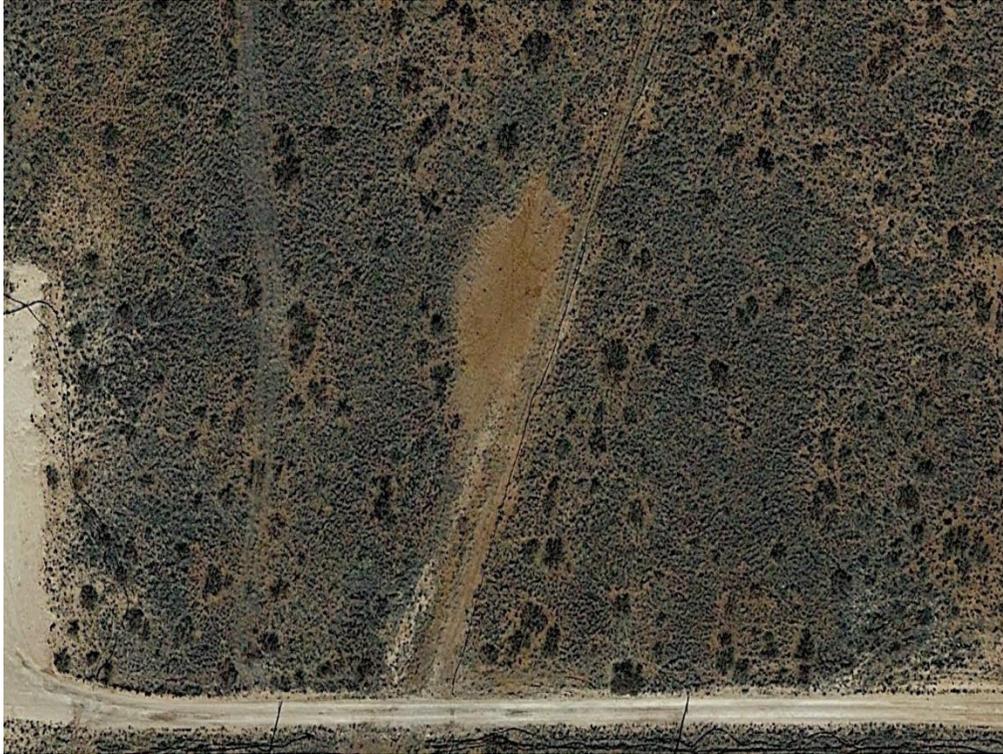
Palladium 7-1 4-Inch Poly - Release Site Aerial

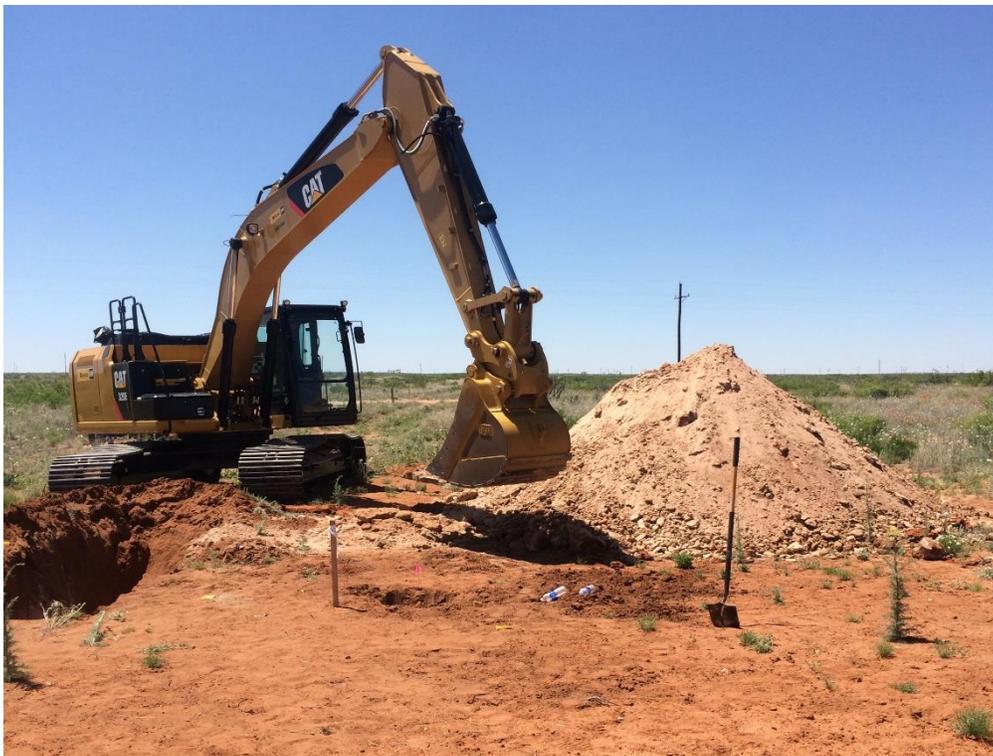
Palladium 7-1 4-Inch Poly – Advancement of Delineation Trench TT-1

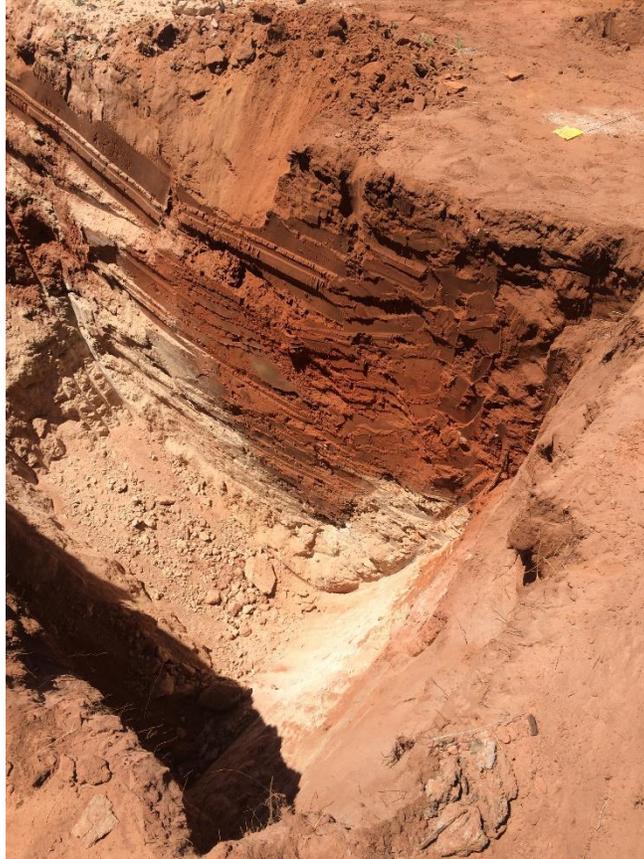
Palladium 7-1 4-Inch Poly – Delineation Trench TT-1
(Staining Visible on Wall of Trench)

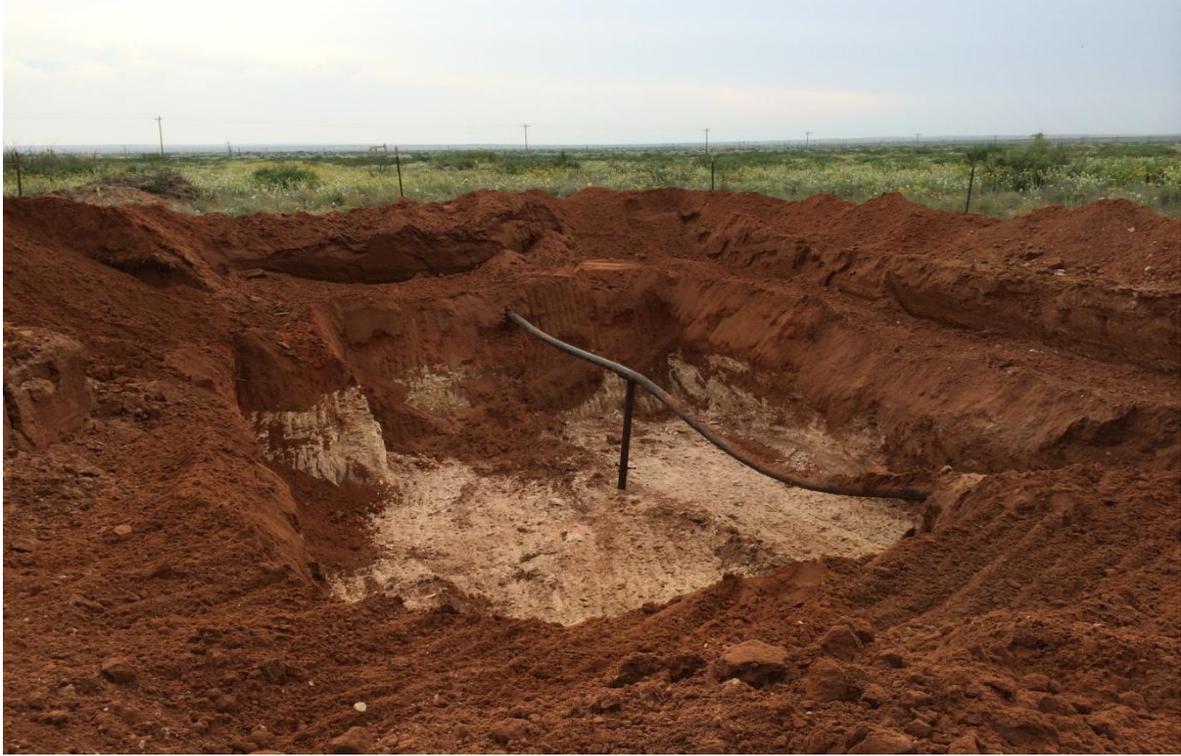
Palladium 7-1 4-Inch Poly – Point of Release (Looking Northeast)

Describe Cause of Problem and Remedial Action Taken.* Pinhole developed in 4-inch poly pipeline. The pipeline was de-oiled and the damaged portion of the pipeline was replaced.

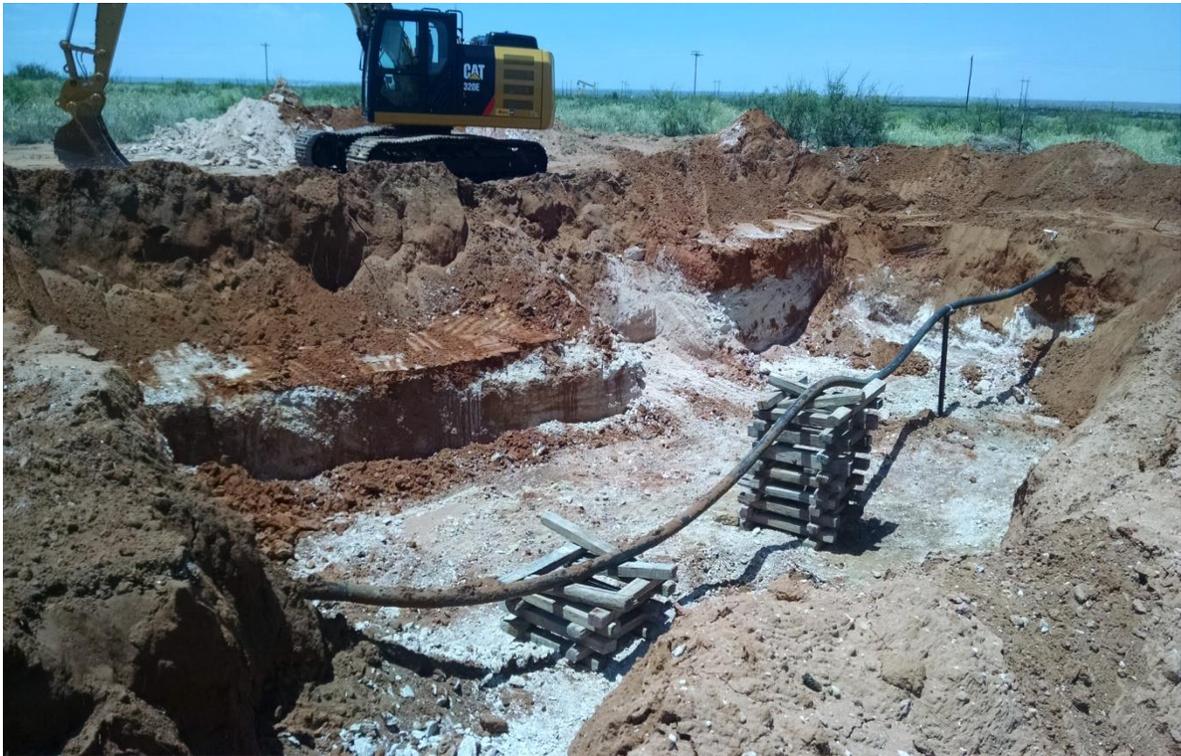
Palladium 7-1 4-Inch Poly – Excavation (Looking North)

On June 10, 2015, the area represented by soil sample #1 was advanced horizontally to the north and vertically to approximately ten feet (10') bgs. Due to the appearance of staining in the excavation sidewall attributed to leaching, the area represented by soil sample #3 was advanced horizontally to the west and vertically to approximately ten feet (10') bgs. Two (2) soil samples (#1b @ 9' and #3b @ 9') were collected from the sidewall of the excavation and submitted to the laboratory for analysis of TPH and BTEX concentrations. Laboratory analytical results indicated TPH and BTEX constituent concentrations were less than the appropriate laboratory MDL.

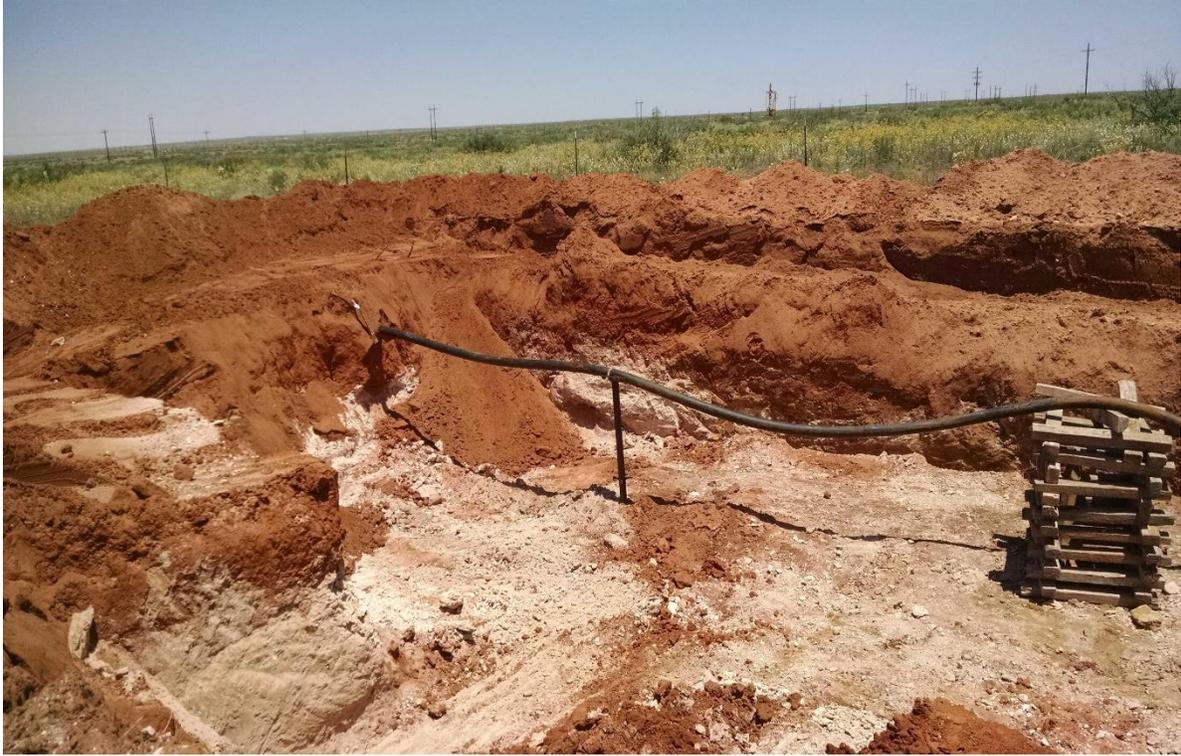
Palladium 7-1 4-Inch Poly - Excavation (Looking East-Northeast)

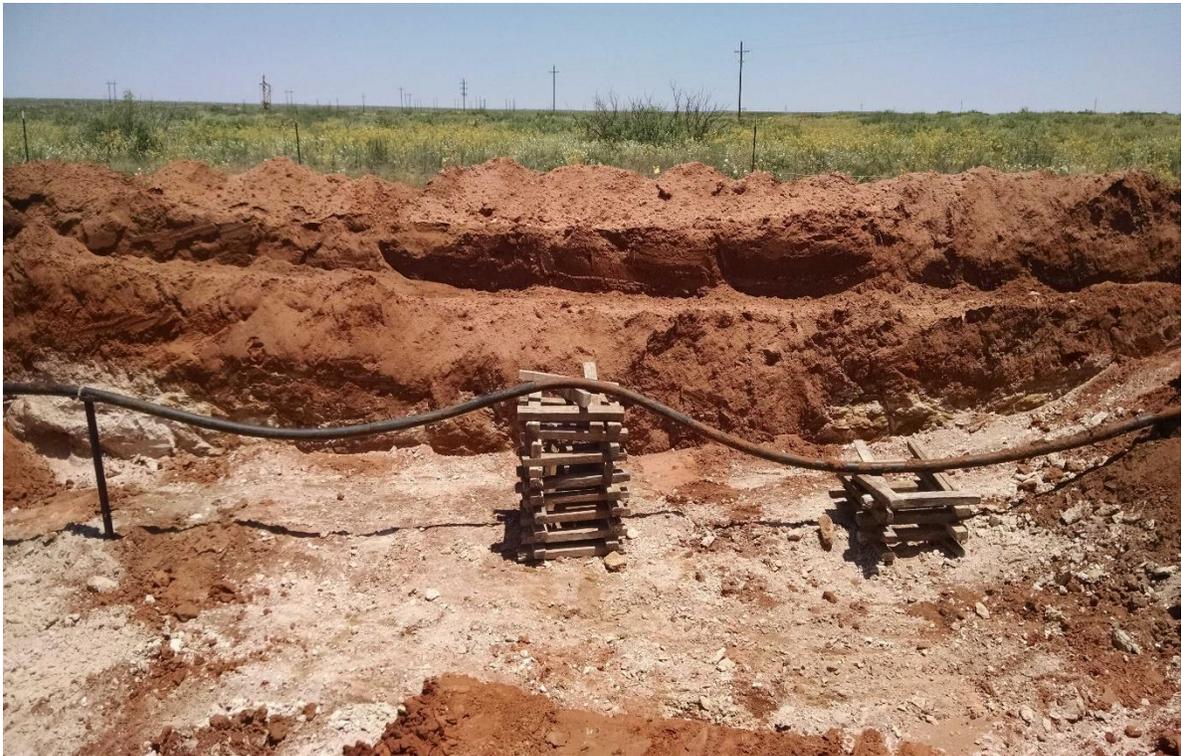
Palladium 7-1 4-Inch Poly - Excavation (Looking Southeast)

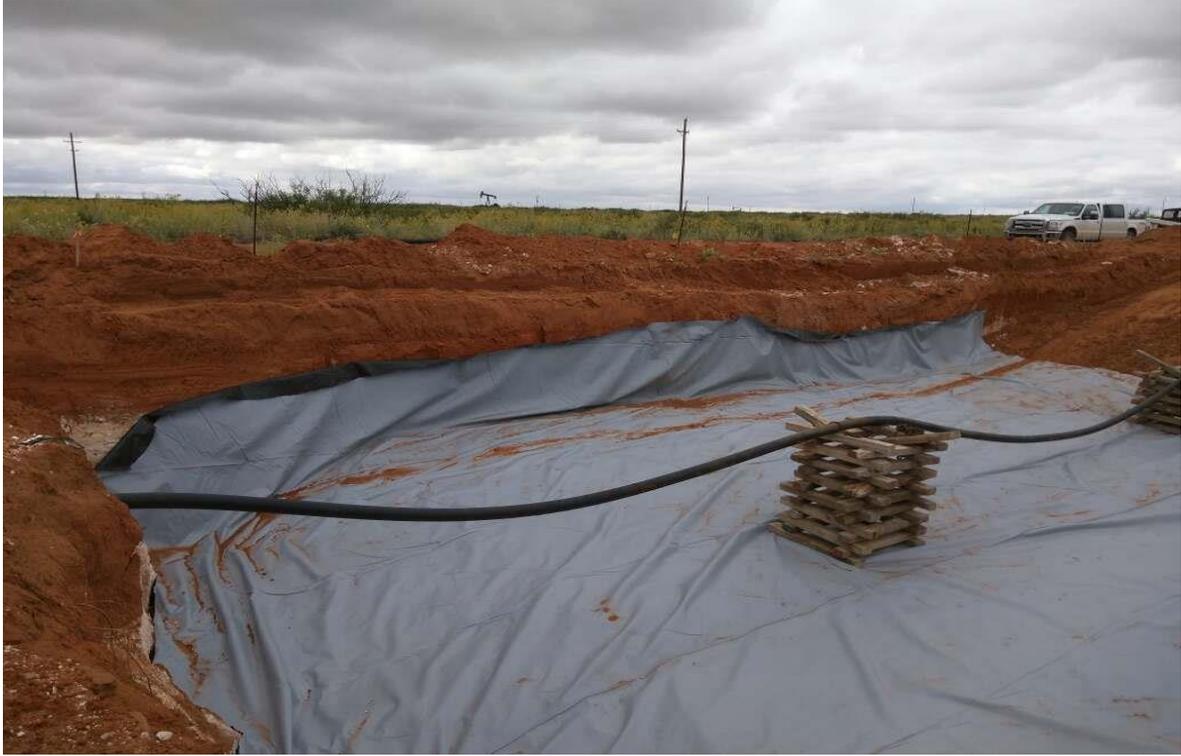
Palladium 7-1 4-Inch Poly – Liner Installation (Looking South-Southeast)

On July 7, 2015, a twenty (20) mil, impermeable, polyethylene liner was installed on the floor excavation at approximately ten feet (10') bgs. A cushion of sand was installed both above and below the liner to protect the liner from damage during installation and backfilling activities. Pursuant to BLM request, the liner was extended horizontally into the four-foot (4') buffer zone around the excavation and sloped to facilitate shedding of moisture outside the footprint of the excavation and the maximum horizontal extent of in-situ impacted soil. The liner was also extended vertically approximately four feet (4') along the eastern extent of the excavation. This

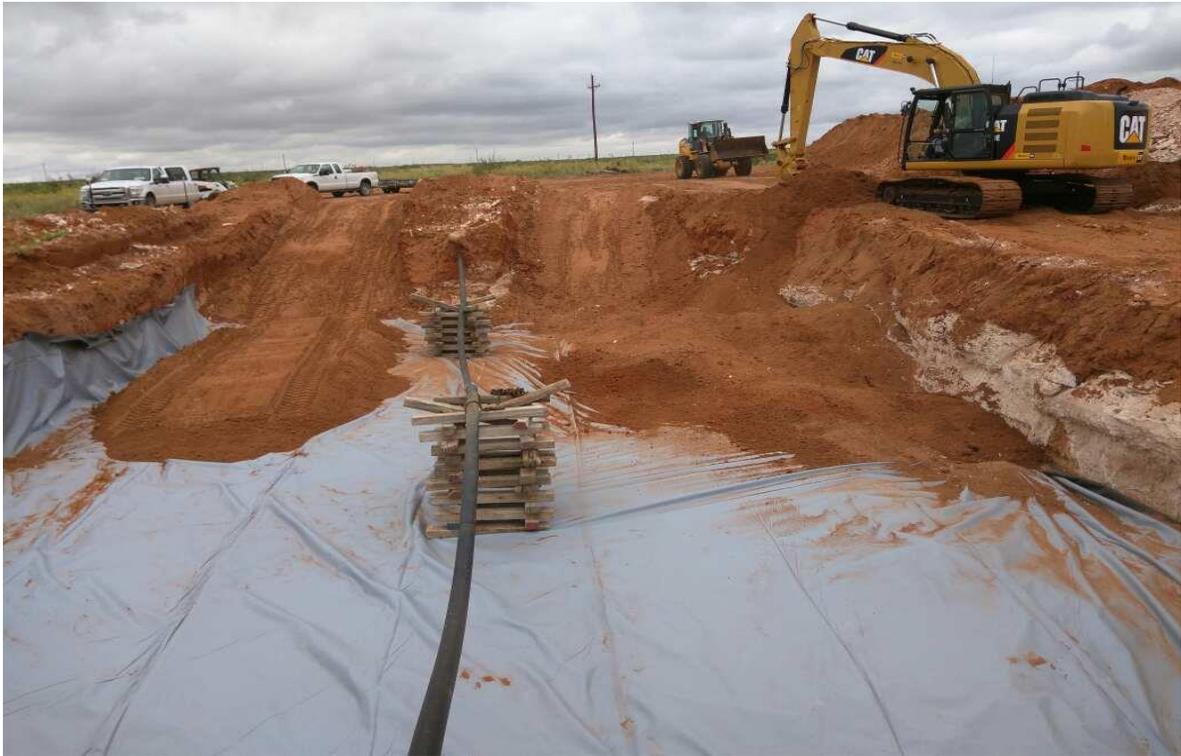
Palladium 7-1 4-Inch Poly – Liner Installation (Looking Southwest)

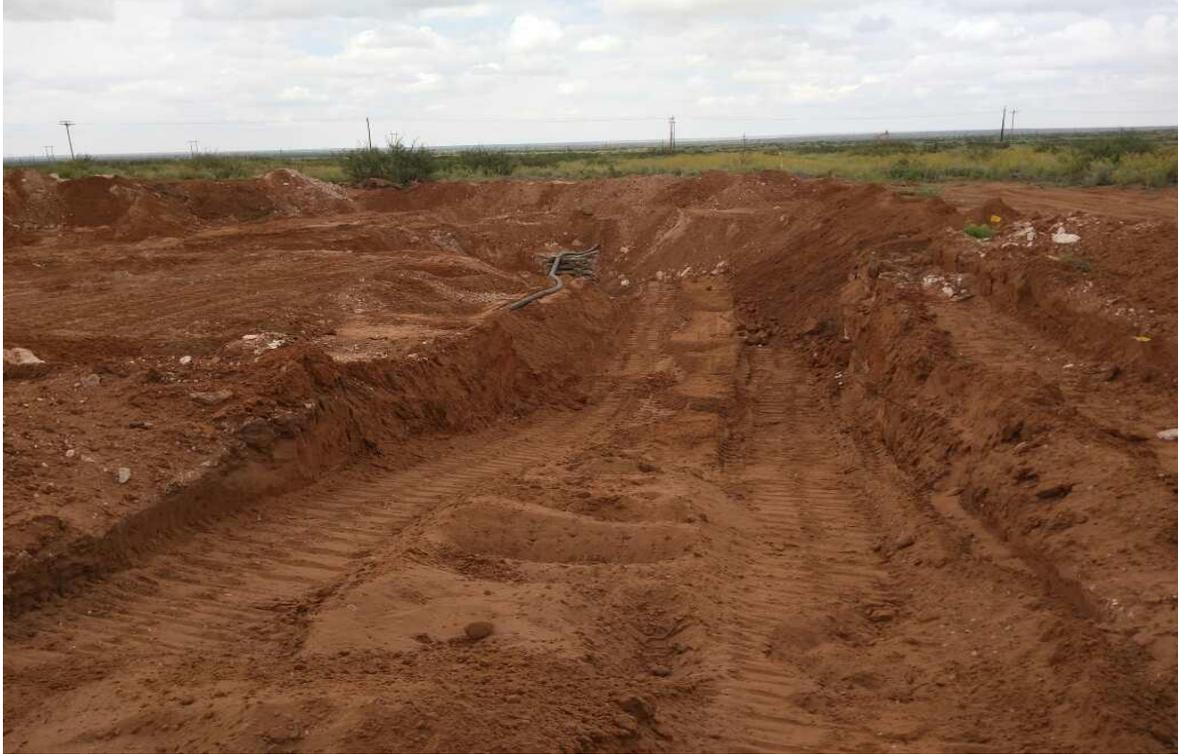
Palladium 7-1 4-Inch Poly – Backfilling (Looking Northeast)

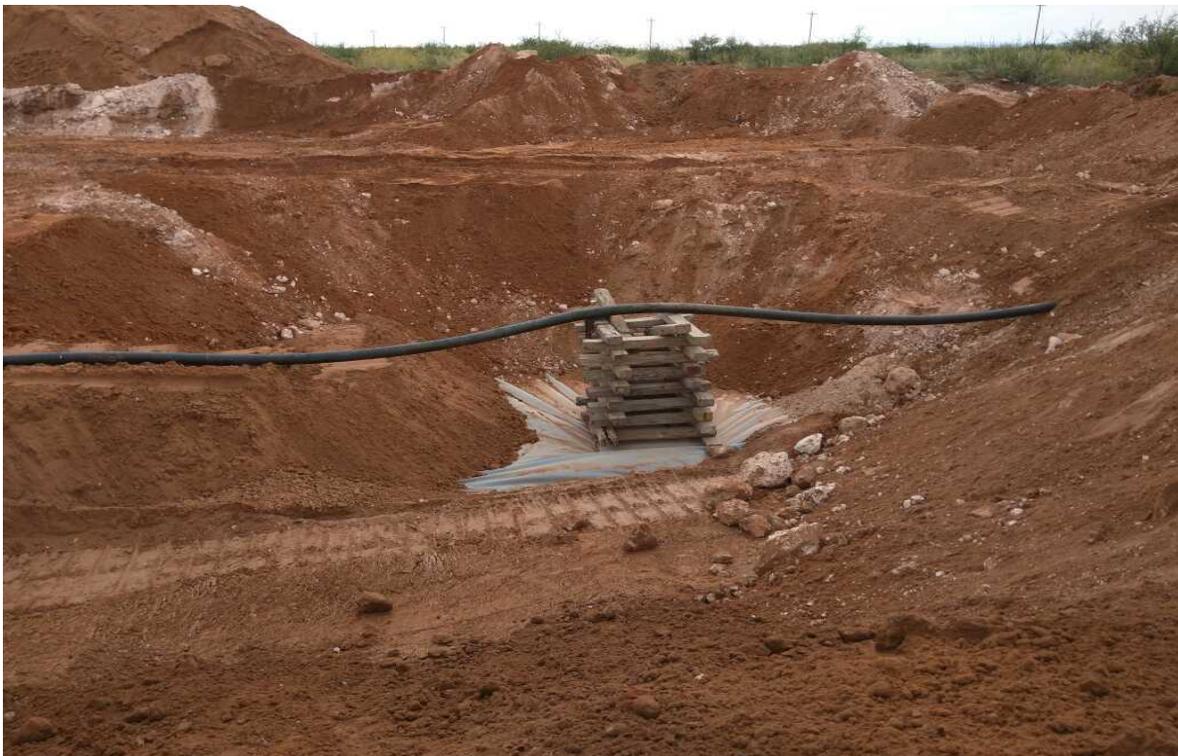
Palladium 7-1 4-Inch Poly - Backfilling (Looking West)

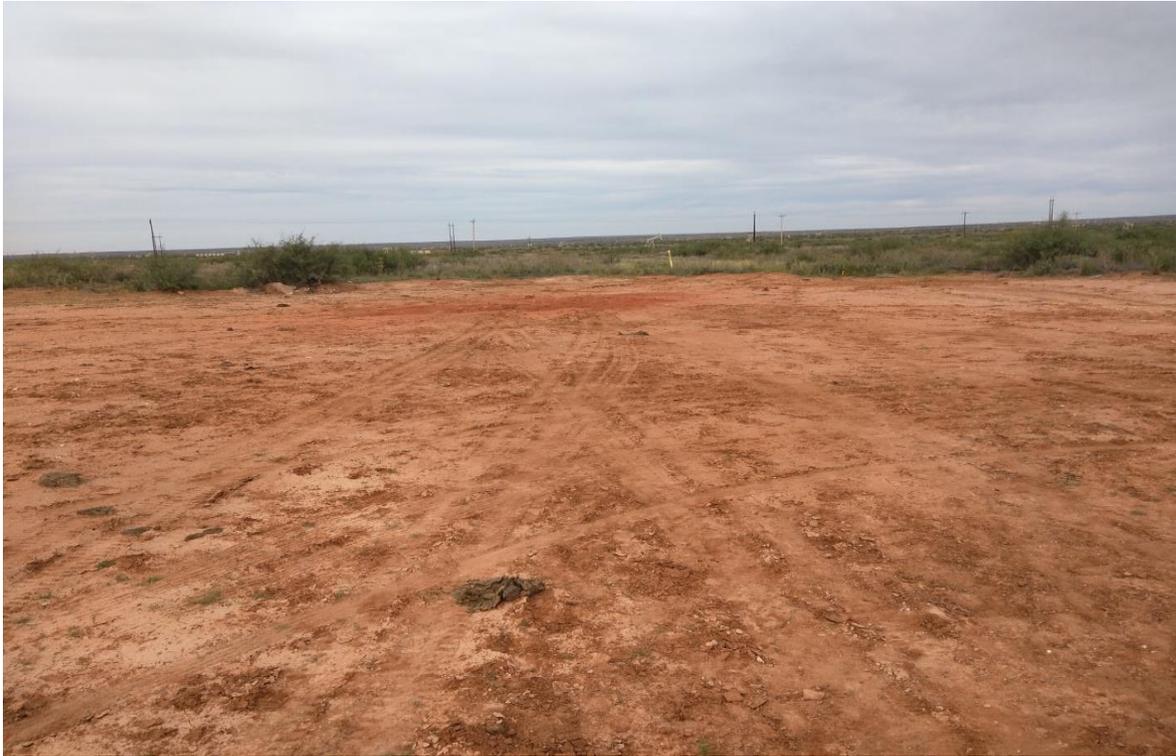
Palladium 7-1 4-Inch Poly – Backfilled Excavation

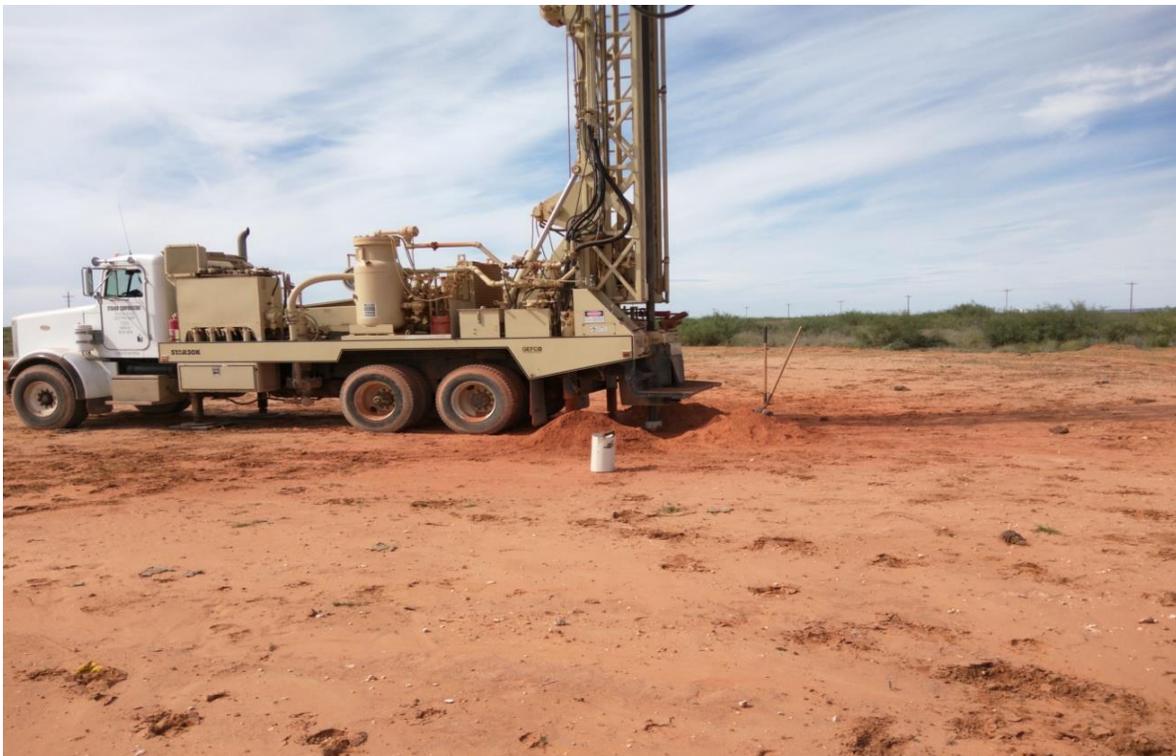
Palladium 7-1 4-Inch Poly – Advancement of Soil Boring SB-1

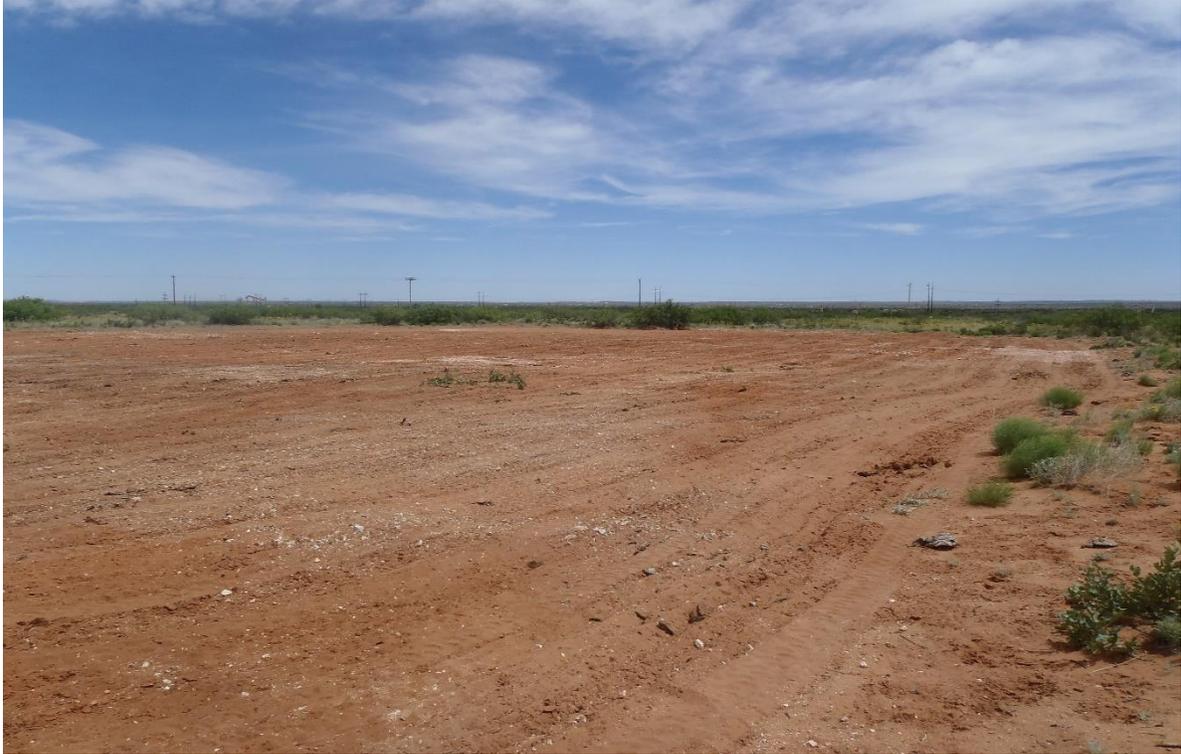
Palladium 7-1 4-Inch Poly – Post-Seeding (Looking North)

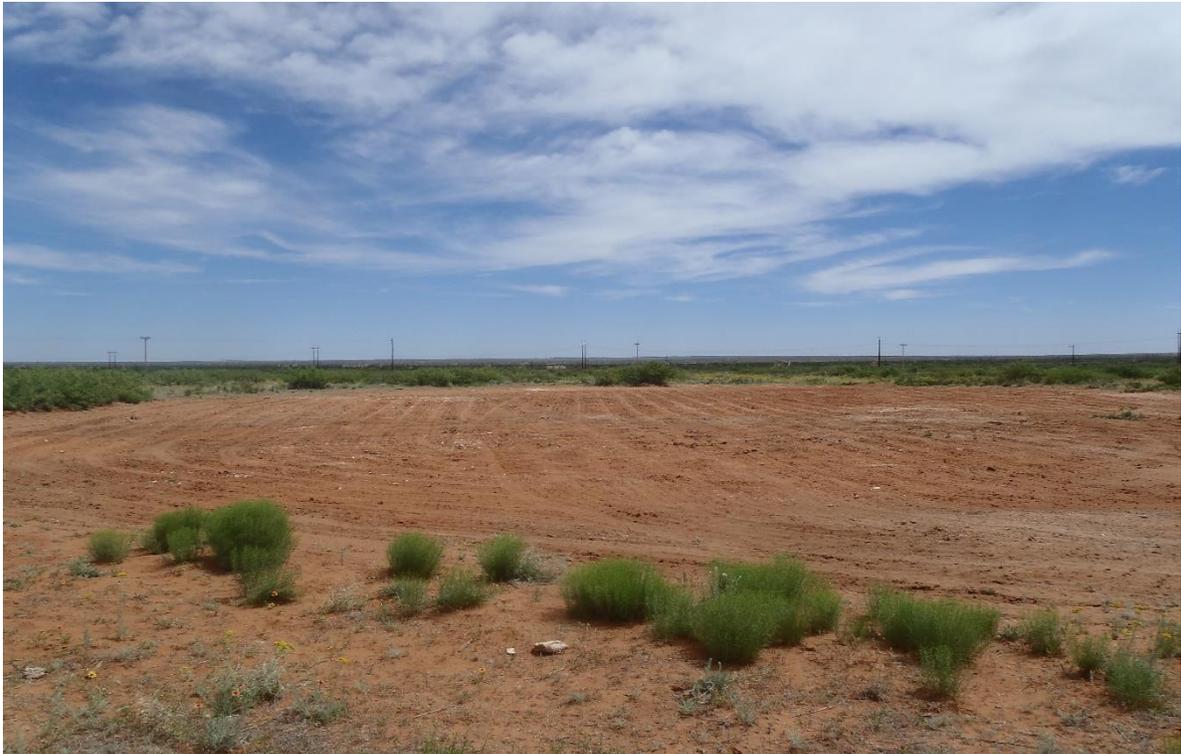
Palladium 7-1 4-Inch Poly –Post-Seeding (Looking Northeast)
