Re: First Quarter 2023 – SVE System Update

Scott 4M
San Juan County, New Mexico
Hilcorp Energy Company
NMOCD Incident Number: NCE2003650476

Ensolum, LLC (Ensolum), on behalf of Hilcorp Energy Company (Hilcorp), presents this *First Quarter 2023 – SVE System Update* report summarizing the soil vapor extraction (SVE) system performance at the Scott 4M natural gas production well (Site), located in Section 17, Township 31 North, and Range 10 West in San Juan County (Figure 1). The SVE system has operated since January 2021 to remediate subsurface soil impacts resulting from approximately 42 barrels (bbls) of natural gas condensate released from an aboveground storage tank. This report summarizes Site activities performed in January, February, and March of 2023.

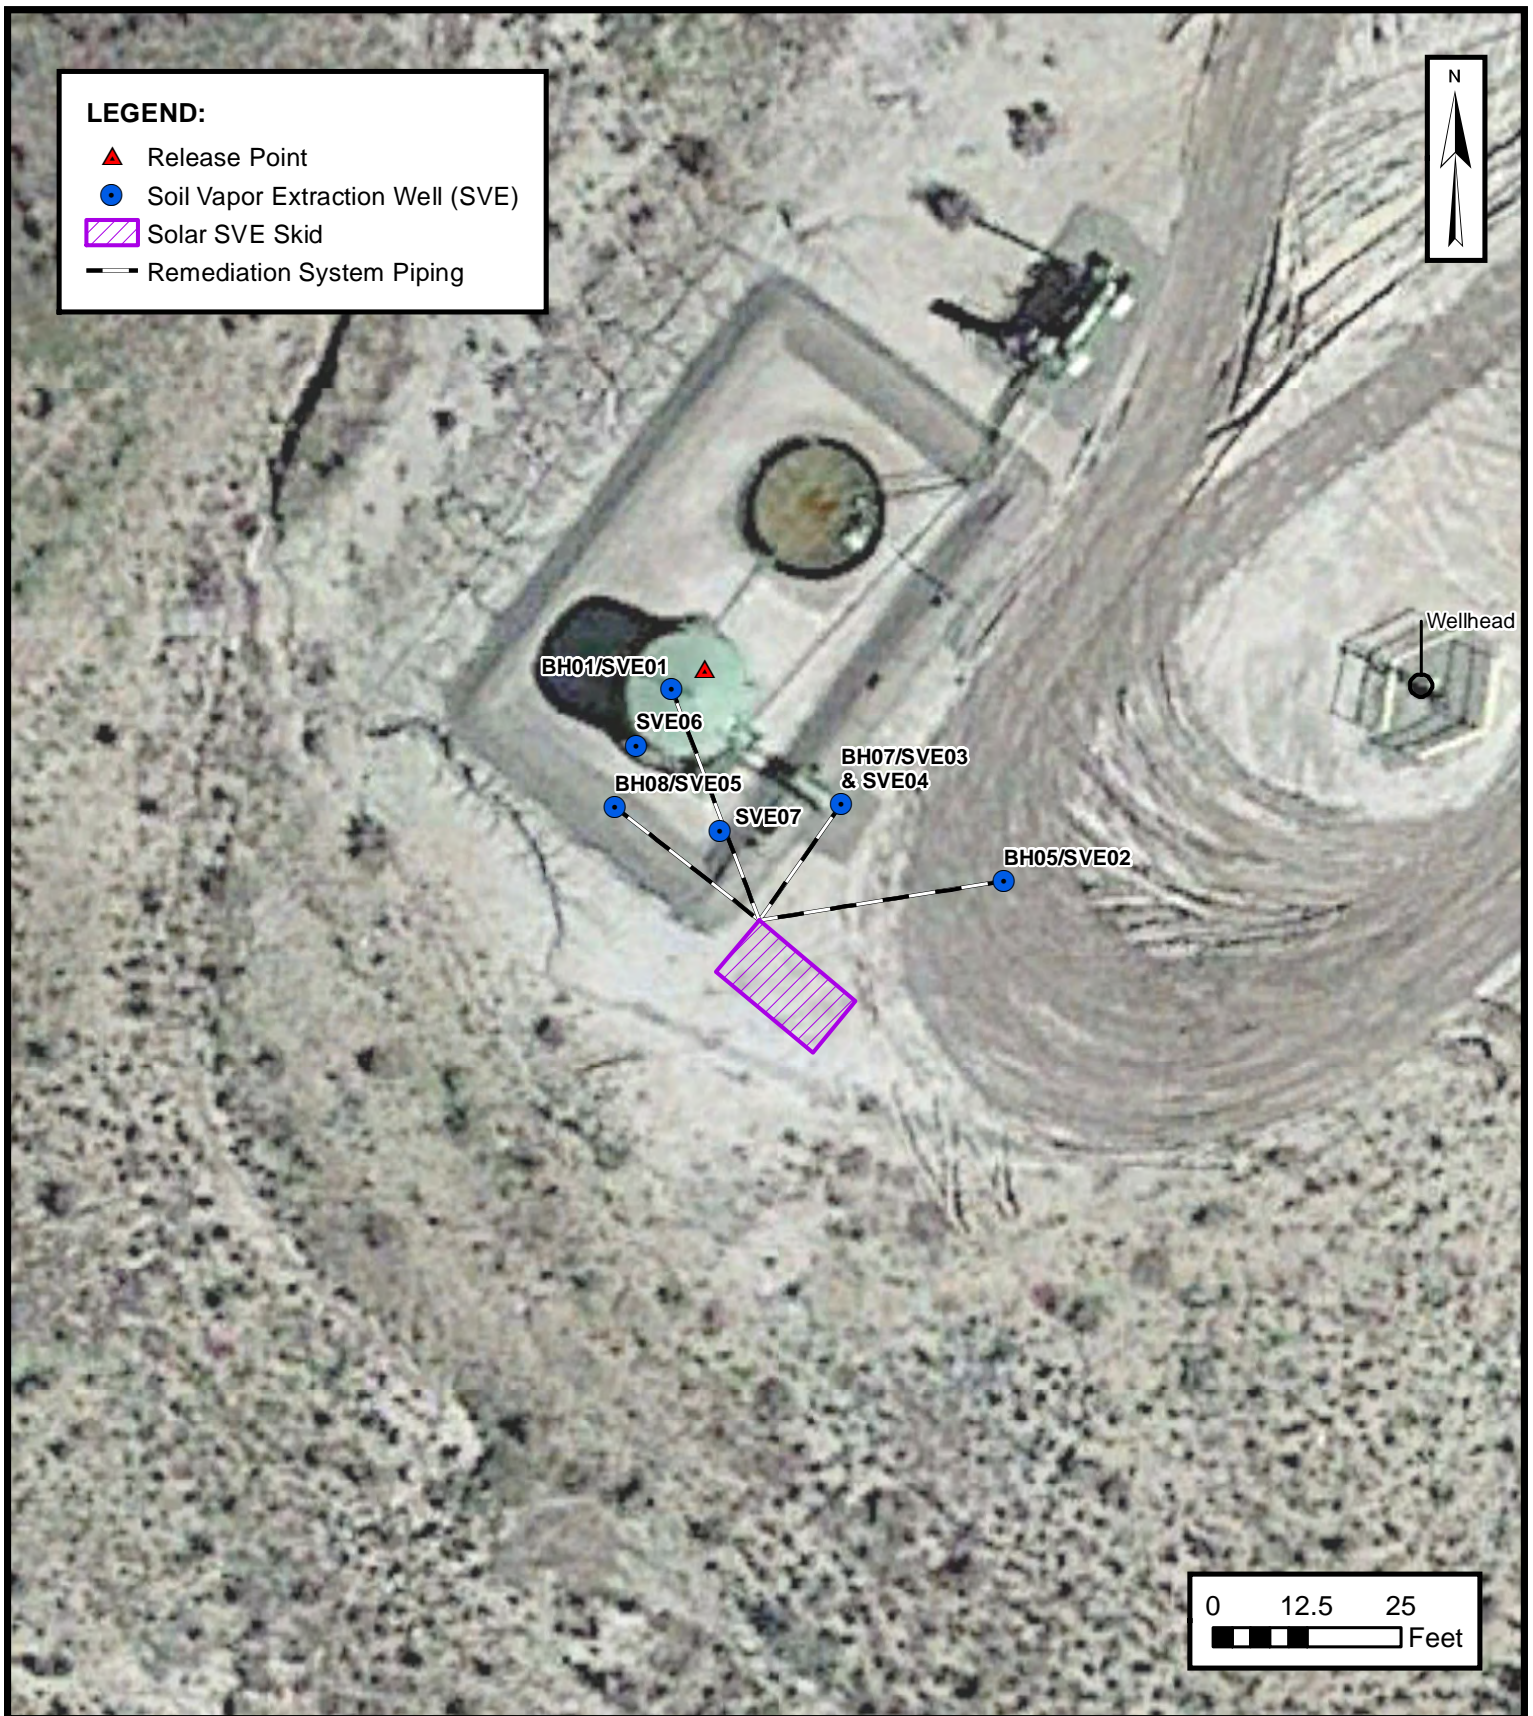
2

SVE SYSTEM CONFIGURATION

An upgraded SVE system was installed at the Site at the end of September 2022 and consists of 3-phase, 3.4 horsepower Republic Model KVHRC500 blower capable of producing a flow of 221 standard cubic feet per minute (scfm) and a vacuum of 76 inches of water column (IWC). The system is powered by a permanent power drop and is intended to run 24 hours per day. Seven SVE wells are currently present at the Site (SVE01 through SVE07, shown on Figure 2). SVE wells SVE01 through SVE03 are screened at depth intervals ranging from 25 feet to 45 feet below ground surface (bgs) in order to remediate deep soil impacts located at the Site. SVE wells SVE04 and SVE05 are screened at depth intervals ranging from 5 feet to 25 feet bgs in order to remediate shallow soil impacts at the Site. SVE wells SVE06 and SVE07 were installed at the Site in order to complete the pilot test conducted in 2021; however, these wells are not located in impacted areas and are used as observation wells only.

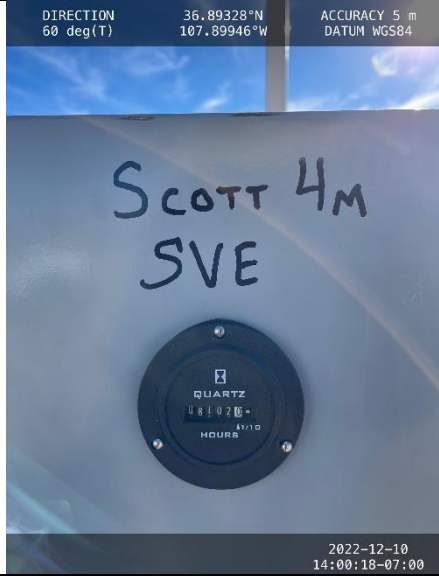
Photograph 1 Runtime meter taken on December 10, 2022 at 2:00 PM Hours = 8,102.0

system operated for 2,100.7 hours for a runtime efficiency of 98.3 percent (%). Appendix B presents photographs of the runtime meter for calculating the first quarter runtime efficiency. Table 1 presents the SVE system operational hours and calculated percent runtime.
