Re: First Quarter 2023 – SVE System Update

OH Randel #5
San Juan County, New Mexico
Hilcorp Energy Company
NMOCD Incident Number: NVF1602039091
Ensolum Project No. 07A1988025

Hilcorp Energy Company
First Quarter 2023 – SVE System Update
OH Randel #5

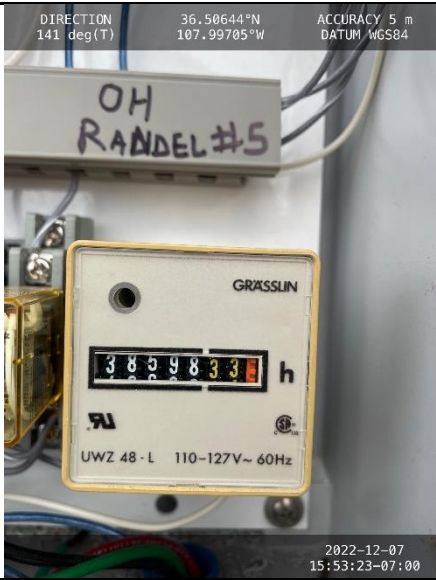
<p>Photograph 1</p> <p>Runtime meter taken on December 7, 2022 from SVE Skid 1 (original SVE system) at 3:53 PM Hours = 38,598.33</p>

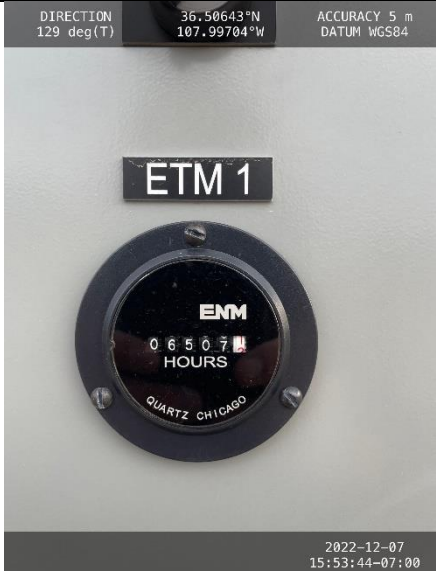
<p>DIRECTION 141 deg(T) 36.50644°N 107.99705°W ACCURACY 5 m DATUM WGS84</p> <p>2022-12-07 15:53:23-07:00</p>
<p>Photograph 2</p> <p>Runtime meter taken on December 7, 2022 from SVE Skid 2 (new SVE system) at 3:53 PM Hours = 6,507.2</p>
