Incident ID	nAPP2222749455
District RP	
Facility ID	
Application ID

Closure

APPENDIX A – EXHIBITS

6" Vandiver Pipeline #2 Release ■ Eddy County, New Mexico
December 20, 2022 ■ Terracon Project No. KH227013

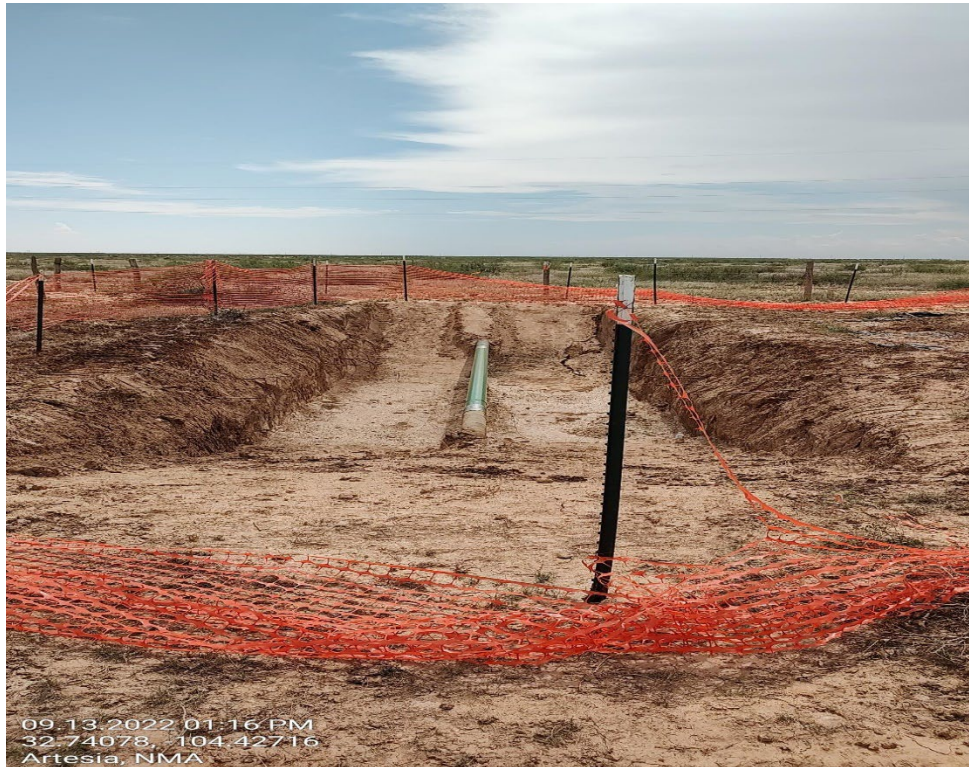
PHOTO 1: View of area prior to Excavation from the North looking South

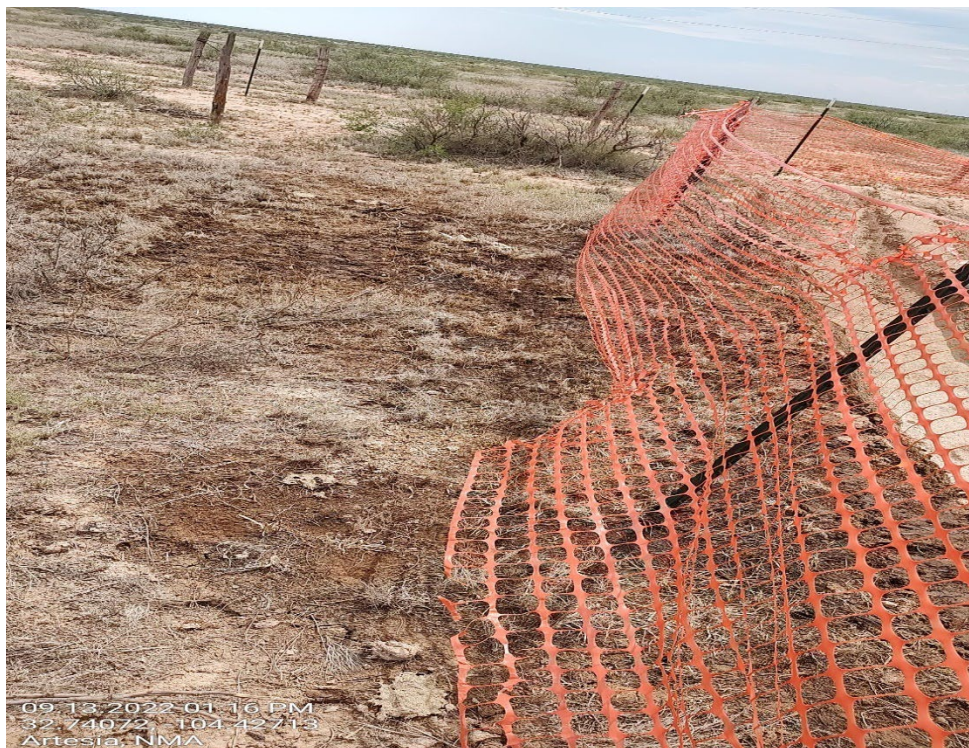
PHOTO 2: View of area prior Excavation Visible Staining to the East

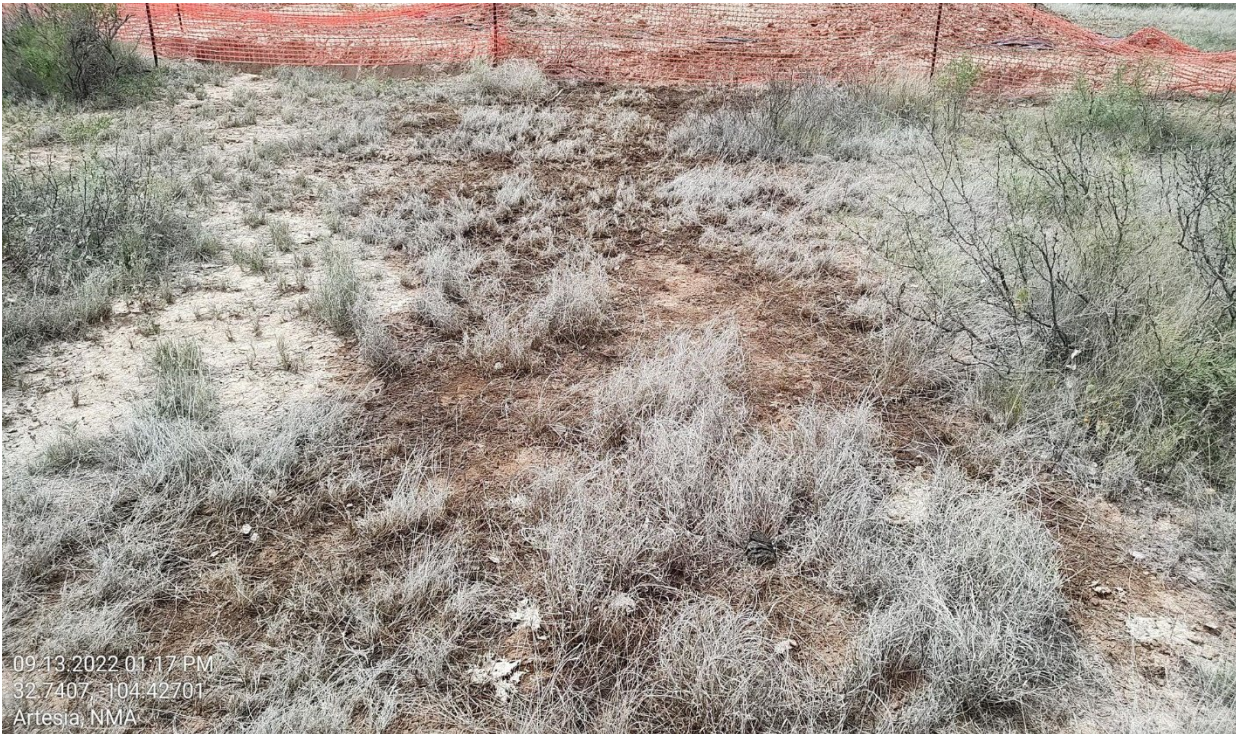
PHOTO 3: View of area prior Excavation Visible Staining facing Pipeline

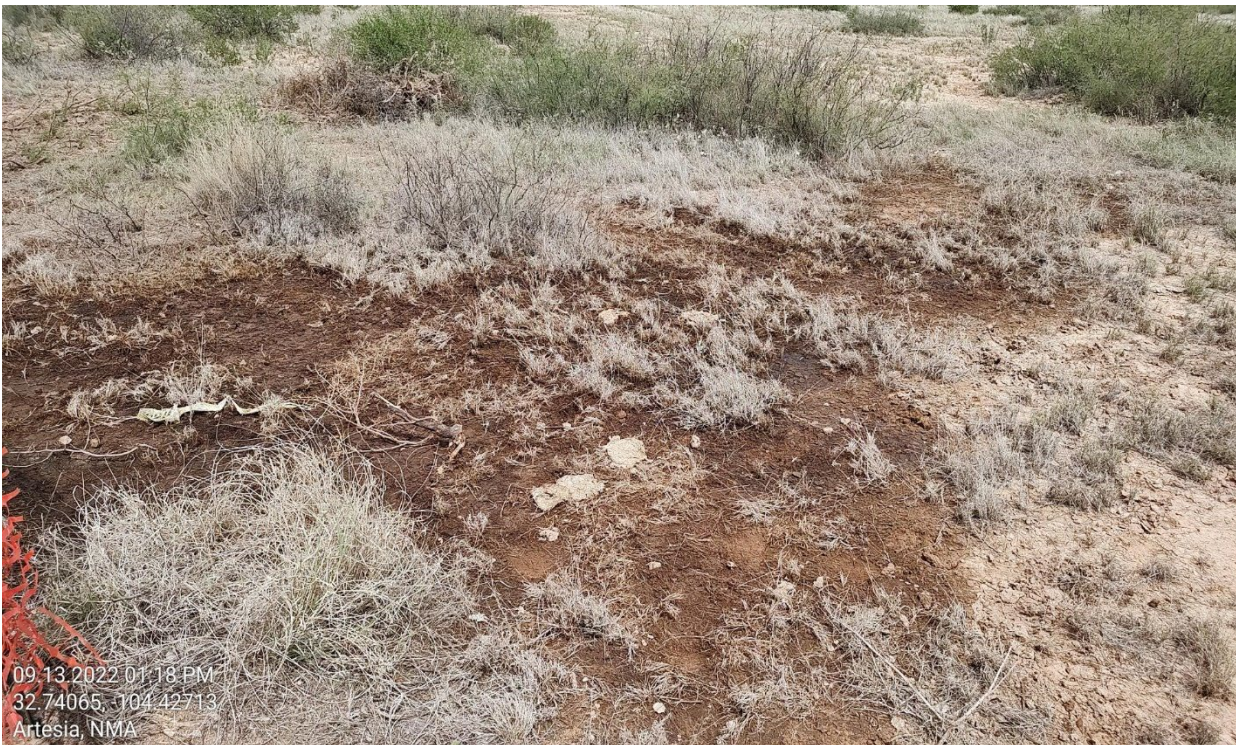
PHOTO 4: View of area prior Excavation Visible Staining facing North

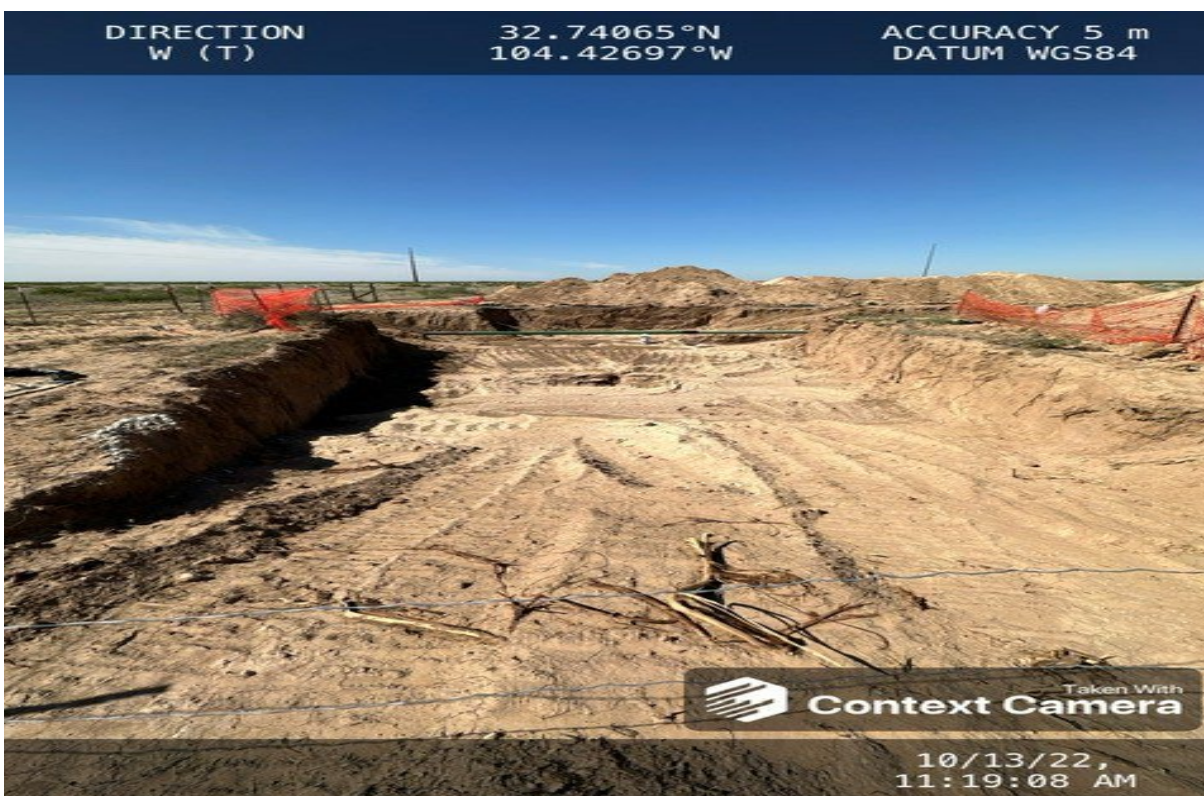
PHOTO 5: Excavation at 5' facing West

Soil Management Plan	
Soil Objectives	Approach Actions
General Soil Plan	Alternative analysis indicated the most effective remedial action was excavation of all impacted materials and disposal of impacted materials at an approved oil and gas waste facility.
Reclamation Response Objectives	Removal of impacted materials from surface to 4 ft. below grade surface (bgs) that had chloride concentrations exceeding 600 mg/kg and replacement with clean fill.
Remediation Response Objectives	Ensure that all soils at depths below 4 ft. bgs. were at a chloride concentration below 600mg/kg.
Soil Management	Excavated soil was placed on a 20-mil poly liner bermed around the edges to avoid impacts to native soils.
Depth of Remediation Confirmation Soil Map – (Figure 3 in Appendix A)	The depths of remedial activities at the site were determined by titrating confirmation samples during excavation activities. The sections of the excavation from FS01 through FS03 were completed at 7ft. bgs., while sections N-SW, E-SW, S-SW, and W-SW were terminated at 0 - 7ft. bgs.

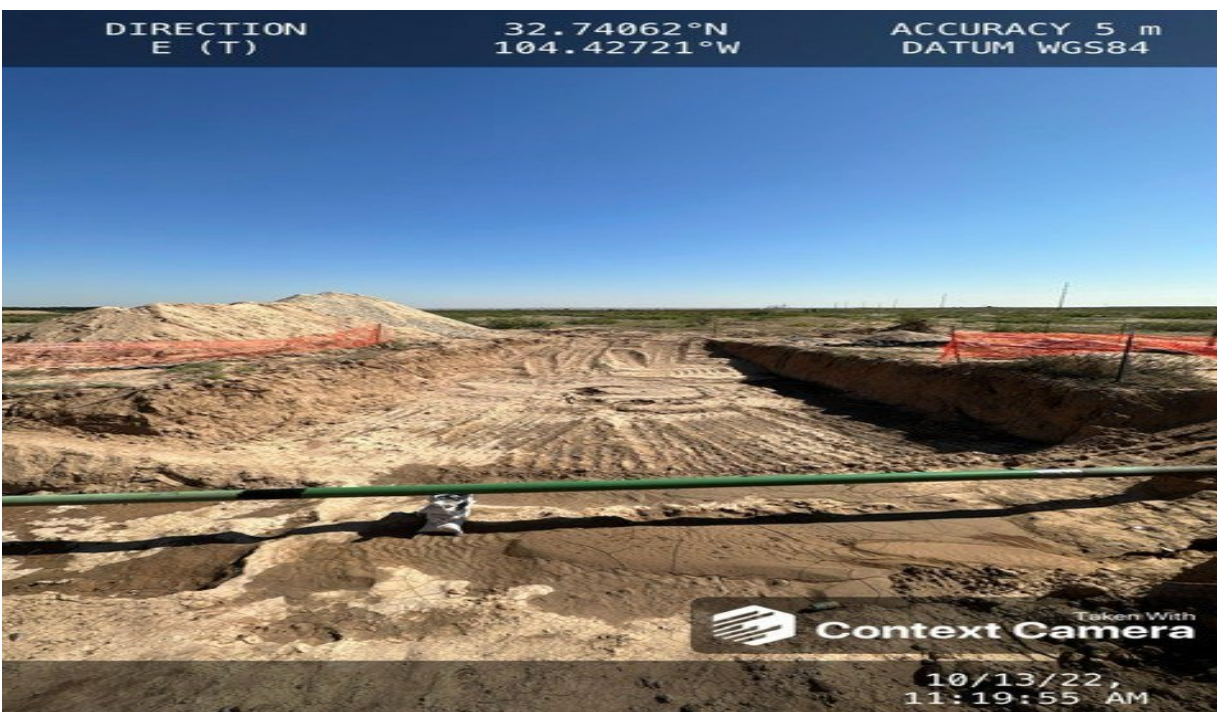
PHOTO 6: Excavation at 5' facing East
