CLOSURE REQUEST REPORT

**Saragossa 16 State 2
Eddy County, New Mexico
Incident Number
nAB1625254125**

January 17, 2023
Ensolum Project No. 03A1987017

Ensolum, LLC (Ensolum) has prepared this Closure Request Report (CRR) to document corrective actions and follow up soil sampling activities performed by WPX Energy Permian, LLC (WPX) at the Saragossa 16 State 2 (hereinafter referred to as the "Site") in Unit A, Section 16, Township 23 South, Range 23 East, in Eddy County, New Mexico (**Figure 1** in **Appendix A**). The corrective actions have been completed in accordance with New Mexico Oil and Conservation Division (NMOCD) regulatory requirements and guidelines.

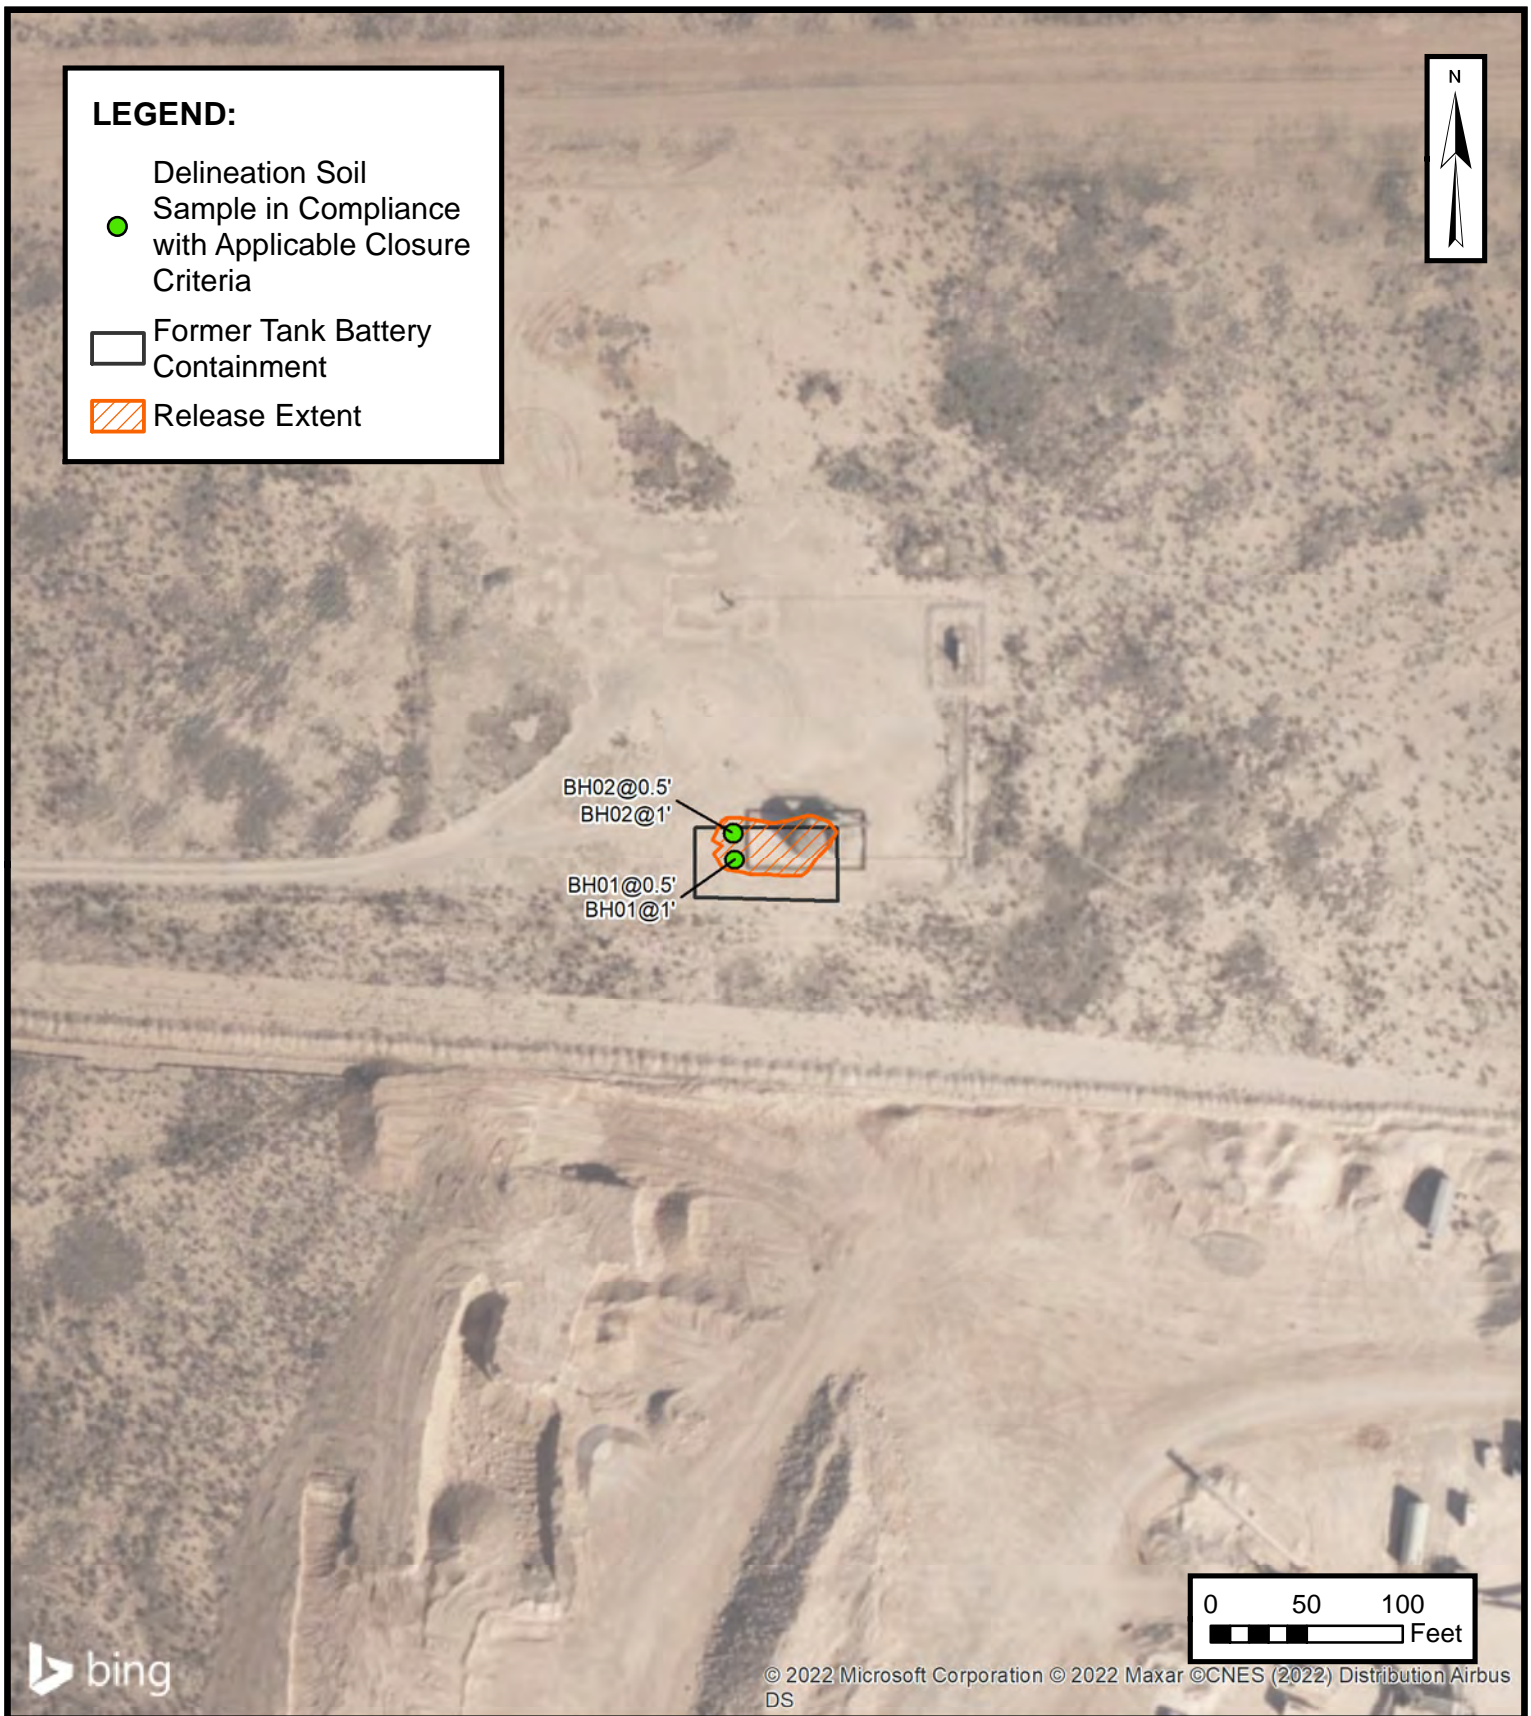
FIGURE
2

DELINEATION SOIL SAMPLE LOCATIONS

WPX ENERGY PERMIAN, LLC
SARAGOSSA 16 STATE 2
Unit A Sec 21 T26S R30E
Eddy County, New Mexico

Laboratory analytical results for delineation soil samples BH01 and BH02 indicated COCs were below the applicable Closure Criteria for the Site and delineated to the most stringent Table 1 Closure Criteria. Laboratory analytical results are summarized on **Table 1** in **Appendix E**. The executed chain-of-custody forms and laboratory analytical reports are provided in **Appendix F**.

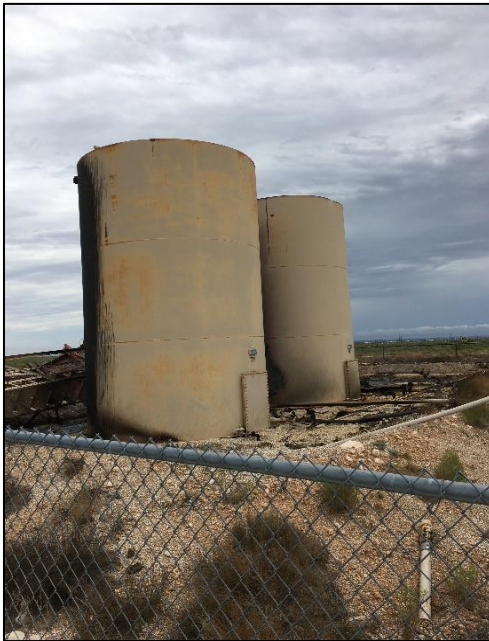
Photograph: 1 Date: 8/24/2016
Description: Release point.
View: Northeast

On August 23, 2016, lightning struck the facility tank battery, causing a fire and resulting in the release of approximately 20 barrels (bbls) of produced water and 61 bbls condensate within the earthen tank battery containment. The condensate burned off, and no fluids were recovered. The release was mapped via Global Positioning System (GPS) by WPX and is shown on (**Figure 2** in **Appendix A**). Currently, the tank battery has been rebuilt and relocated northeast of its original location. Ensolum was retained to confirm impacted soil was removed during response and relocation activities.

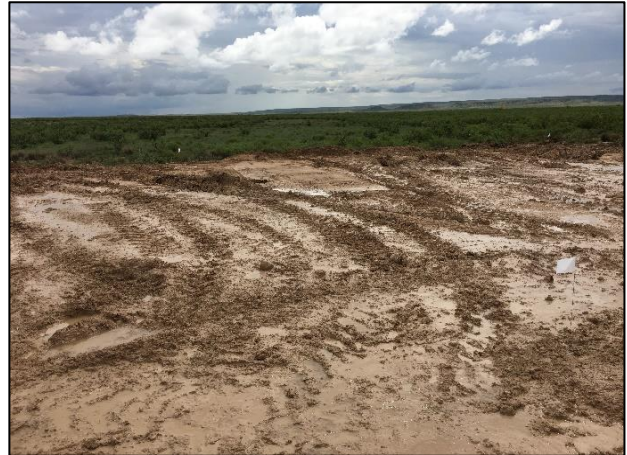
Photograph: 2 Date: 9/14/2016
Description: Release area following tank battery relocation.
View: South

- Initial efforts performed by WPX included rebuilding and relocating the tank battery northeast of its original location. Ensolum was retained to confirm residual soils accessible from the release event were removed during response and relocation activities. Laboratory analytical results for delineation soil samples collected from the former tank battery earthen containment indicated COCs were within the applicable Closure Criteria for the Site based on a confirmed depth to groundwater greater than 100 feet bgs and that impacted soil associated with the release event was successfully addressed; and
- The delineation samples also meet the reclamation requirement for chloride and TPH concentrations in the top four feet of the subsurface.

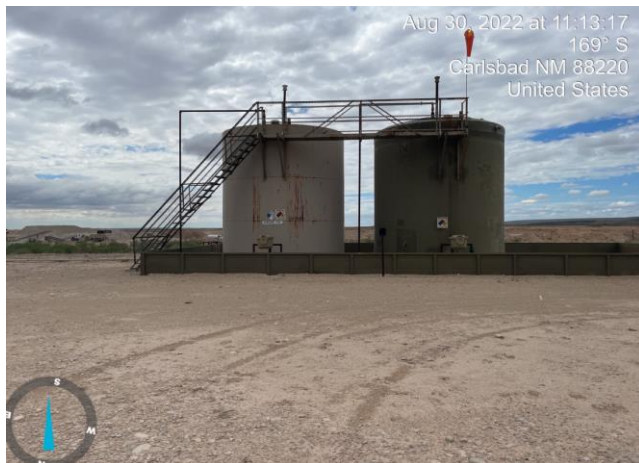
Photograph: 3 Date: 8/30/2022
Description: Site Assessment
View: South

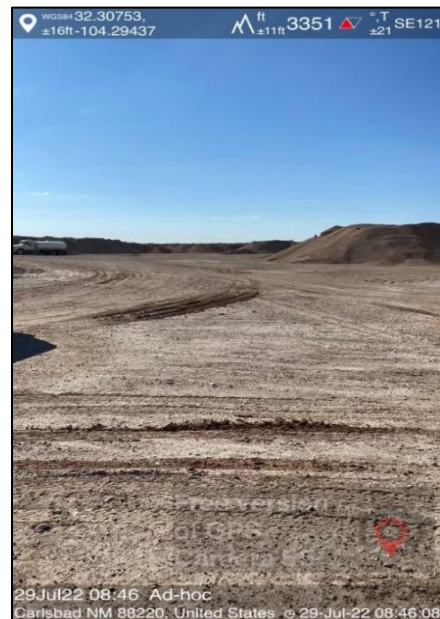
Photograph: 4 Date: 7/29/2022
Description: USGS water well verification.
View: Southeast

Based on the initial desktop review, it appeared that the closest water well with groundwater data was USGS water well 321826104173801, located 0.17 miles southwest of the Site. The USGS well was presumed to be located on private mining land operated by United Materials, LLP. (United). Ensolum coordinated a field verification visit with United to verify the location of the well. No well was identified during the investigation, which included a visual survey of a 500-foot radius of the documented latitude and longitude. United was unaware of the presence of a well in the area. Therefore, the next closest water well was used to estimate groundwater depth at the Site.

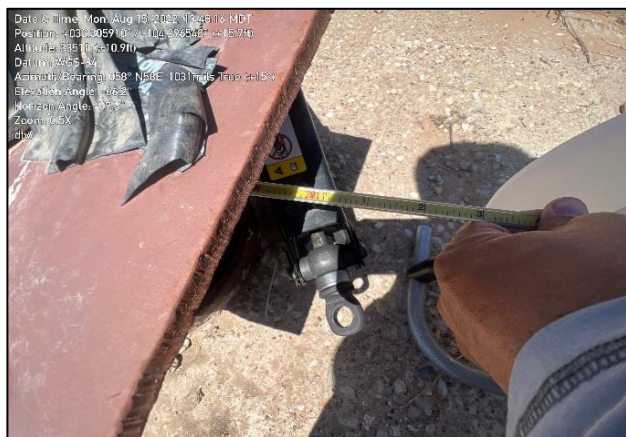
Photograph: 5	Date: 8/15/2022
Description: Depth to water measurement.	
View: Northeast

ultimately reached the maximum length of 200 feet without detecting water. Groundwater at the Site was confirmed to be greater than 100 feet below ground surface (bgs). The well record and the current Groundwater Measurement Form is provided in **Appendix B**. Photographic documentation during the water well verification and measurement activities is included in **Appendix C**.

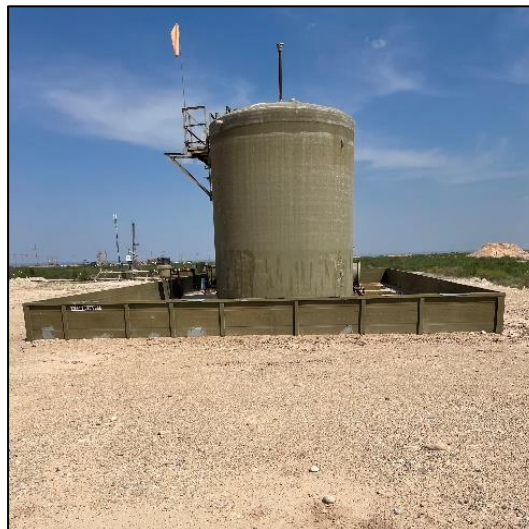
Photograph: 6	Date: 9/7/2022
Description: Site during delineation activities	
View: East

Between August 30, 2022 and September 7, 2022, site assessment and delineation activities were conducted by Ensolum to characterize the subject release by verifying the presence or absence of impacted soil. Delineation soil samples were collected in boreholes advanced via hand auger (samples designated BH) within the accessible portions of the release footprint. Delineation activities were directed by field screening soil for volatile organic compounds (VOCs) utilizing a calibrated photoionization detector (PID) and chloride using Hach® chloride QuanTab® test strips. A total of two soil samples were collected from each delineation soil sample location (BH01 and BH02): the sample with the highest observed field screening (0.5-foot bgs) and the greatest depth (1-foot bgs). The location of the delineation soil samples are shown in **Figure 2** in **Appendix A**. Field screening results and observations for each delineation soil sample were recorded on lithologic soil sampling logs (**Appendix D**). Photographic documentation during delineation activities is included in **Appendix C**.
