Closure

January 18, 2023

**Re: Closure Report
ConocoPhillips
Heritage Concho
JR Horz Federal #001 Release
Unit Letter D, Section 10, Township 26 South, Range 29 East
Eddy County, New Mexico
Incident ID# NAB1531639135
2RP-3386**

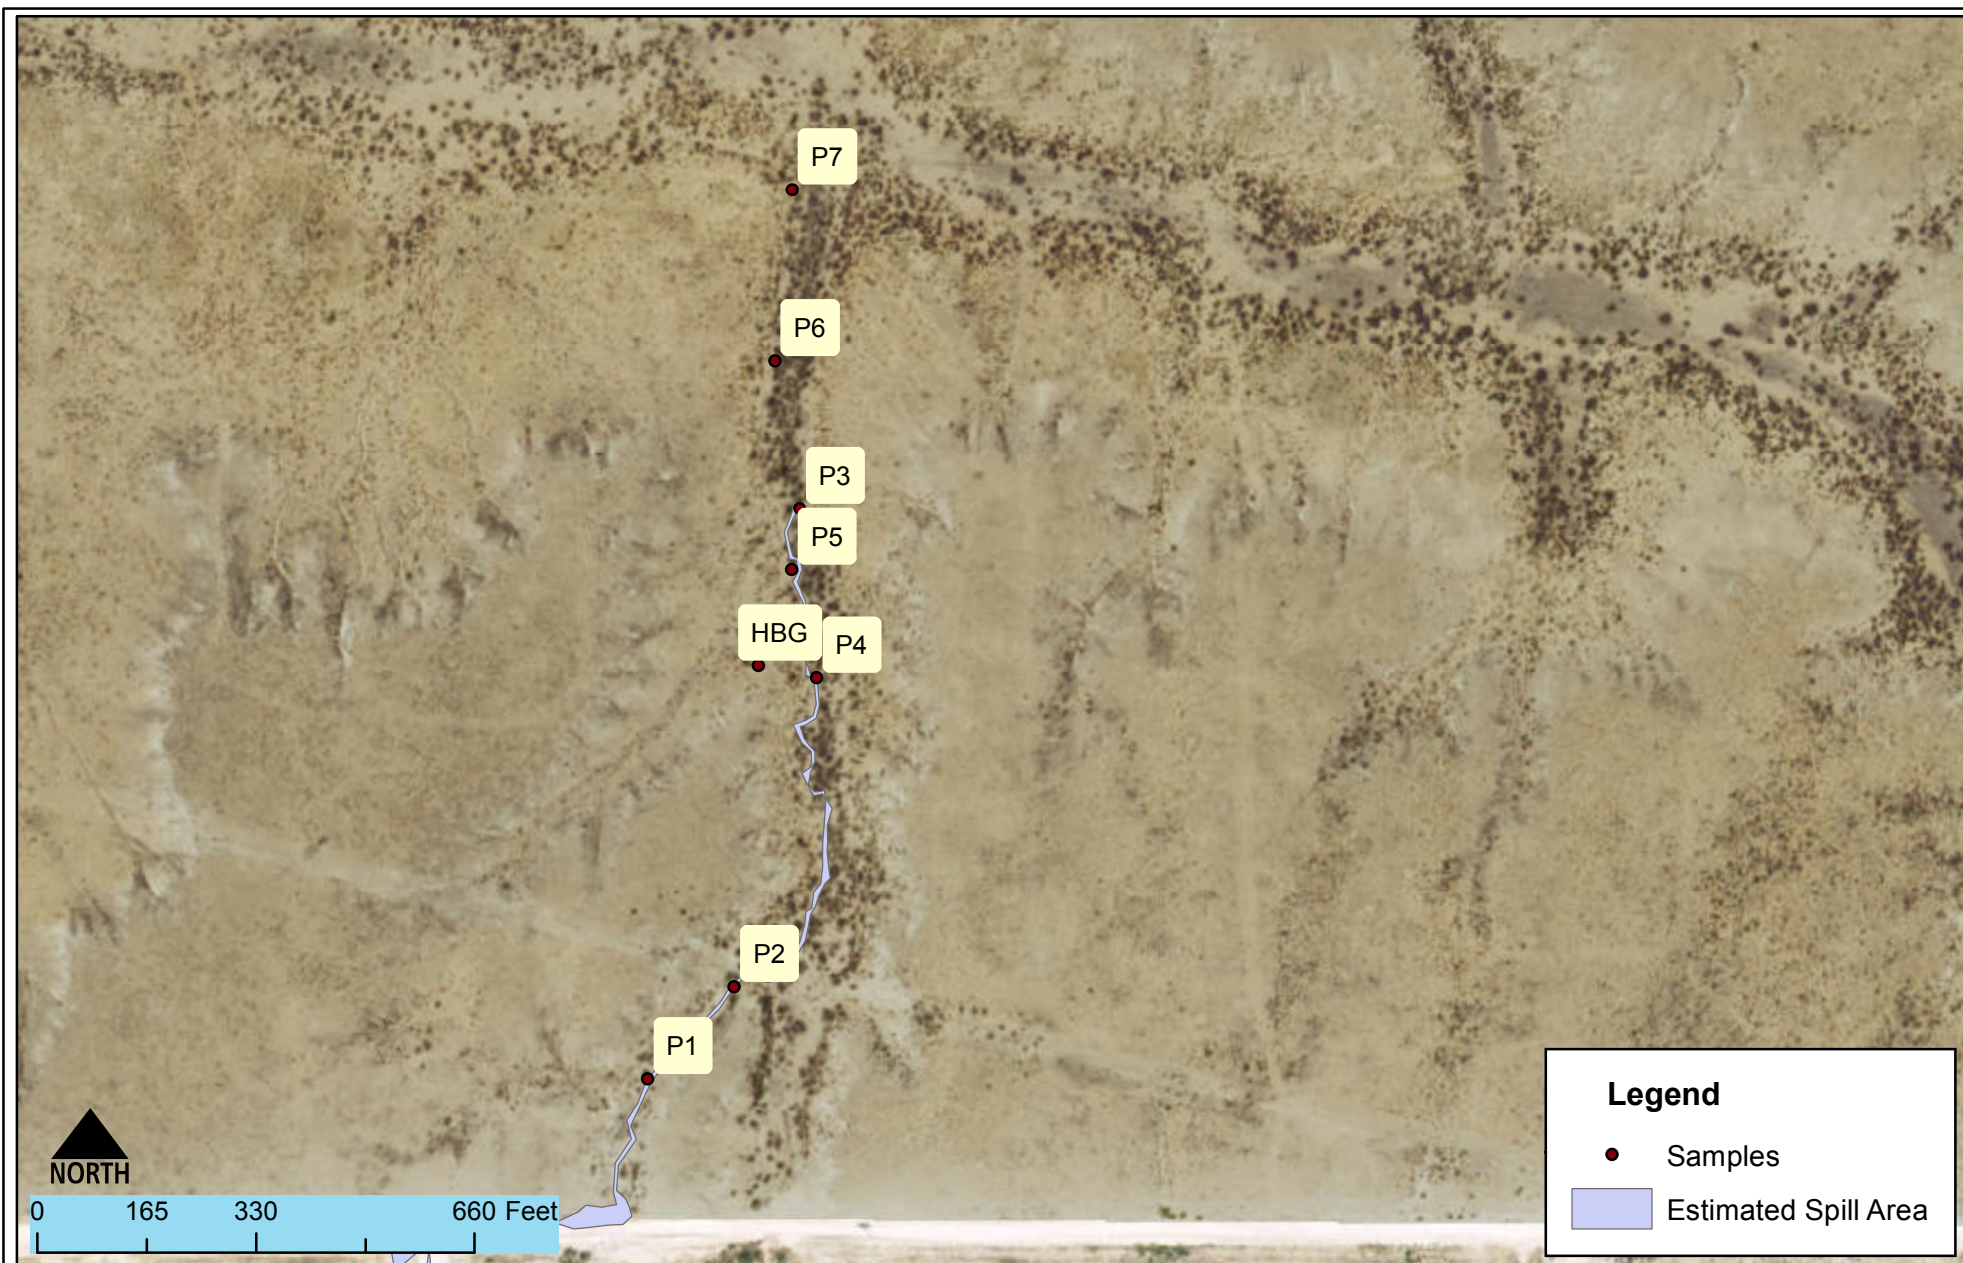
Sample locations are noted on Figure 2 Site Details and Sample Location Map. All samples were collected and processed according to NMOCD soil sampling procedures. The samples were sent under chain-of-custody protocols to Hall Environmental Analysis Laboratory for analysis for Benzene and Total BTEX using EPA Method 8021B, DRO and GRO by EPA Method 8015D, and total Chlorides using EPA Method 300.0.

Soil contaminant concentrations found during the initial delineation are illustrated in Figure 2. A summary of the laboratory analyses is included in Table 2. Laboratory reports are included in Appendix A.

Site Detail and Sample Locations
 COG- JRS HORZ Federal #1
 Malaga, New Mexico
