**Re: Site Assessment, Remediation, and Closure Report**  
**Rattlesnake 16 SWD #001**  
**API No. 30-025-42355**  
**GPS: Latitude 32.0441688 Longitude -103.4826937**  
**UL -- E, Sec. 16, T26S, R34E**  
**Lea County, NM**  
**NMOCD Ref. No. NDHR1913358110**

# Rattlesnake 16 SWD #001

Devon Energy  
NDHR1913358110  
Lea County, NM  
32.0441688,-103.4826937  
Site Map

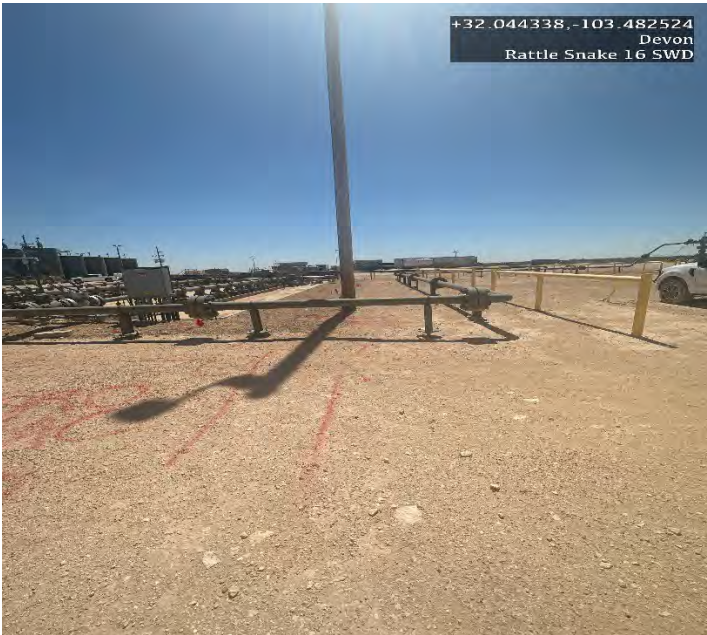
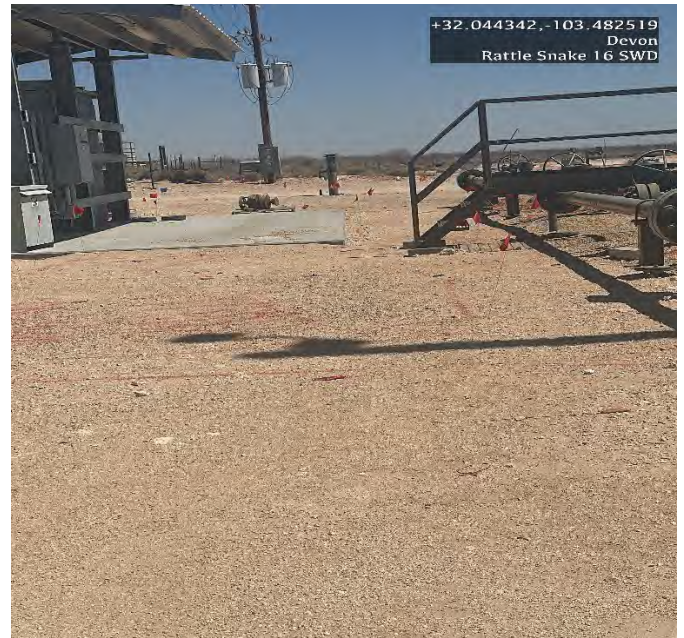
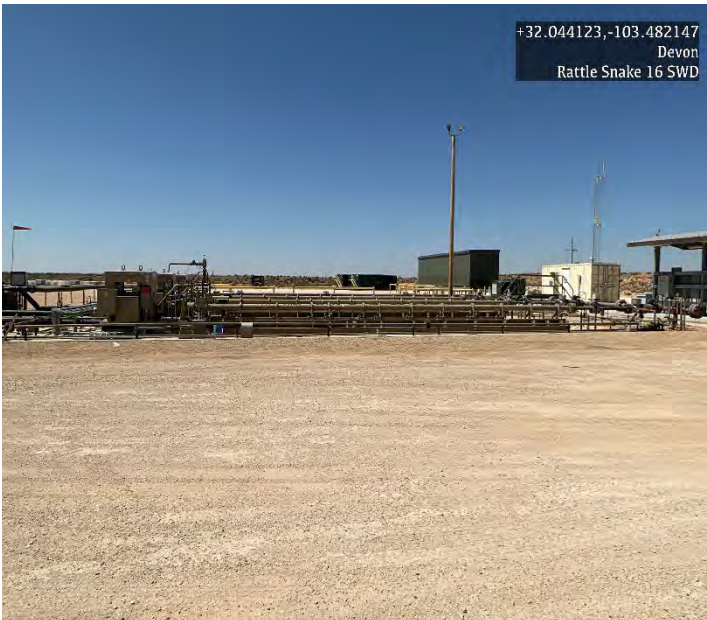
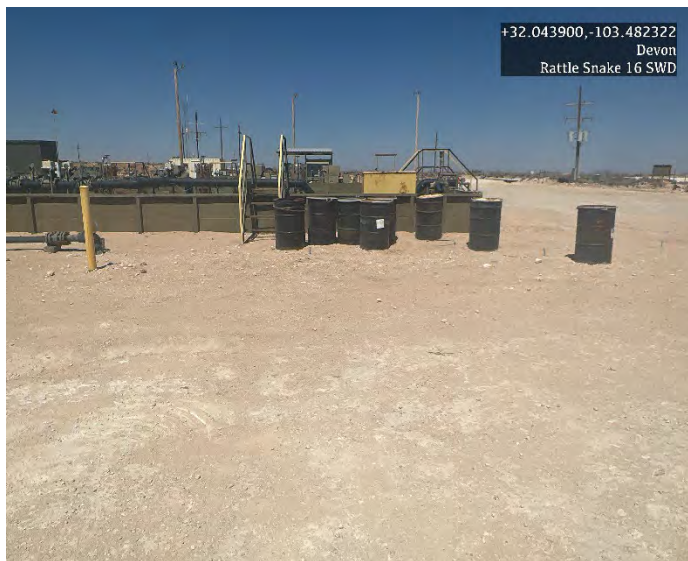
**SITE PHOTOGRAPHS  
DEVON ENERGY  
RATTLESNAKE 16 SWD 1**

Based on the sample results, the bottoms and sidewalls are below NMOCD Closure Criteria 19.15.29 NMAC. See Appendix D for Photographic Documentation.

**Site Assessment**
