Site Assessment/Characterization

Closure

Re: Site Assessment, Remediation, and Closure Report
Rattlesnake 16 SWD #001
API No. 30-025-42355
GPS: Latitude 32.0441688 Longitude -103.4826937
UL -- E, Sec. 16, T26S, R34E
Lea County, NM
NMOCD Ref. No. NRM2003157418

Rattlesnake 16 SWD

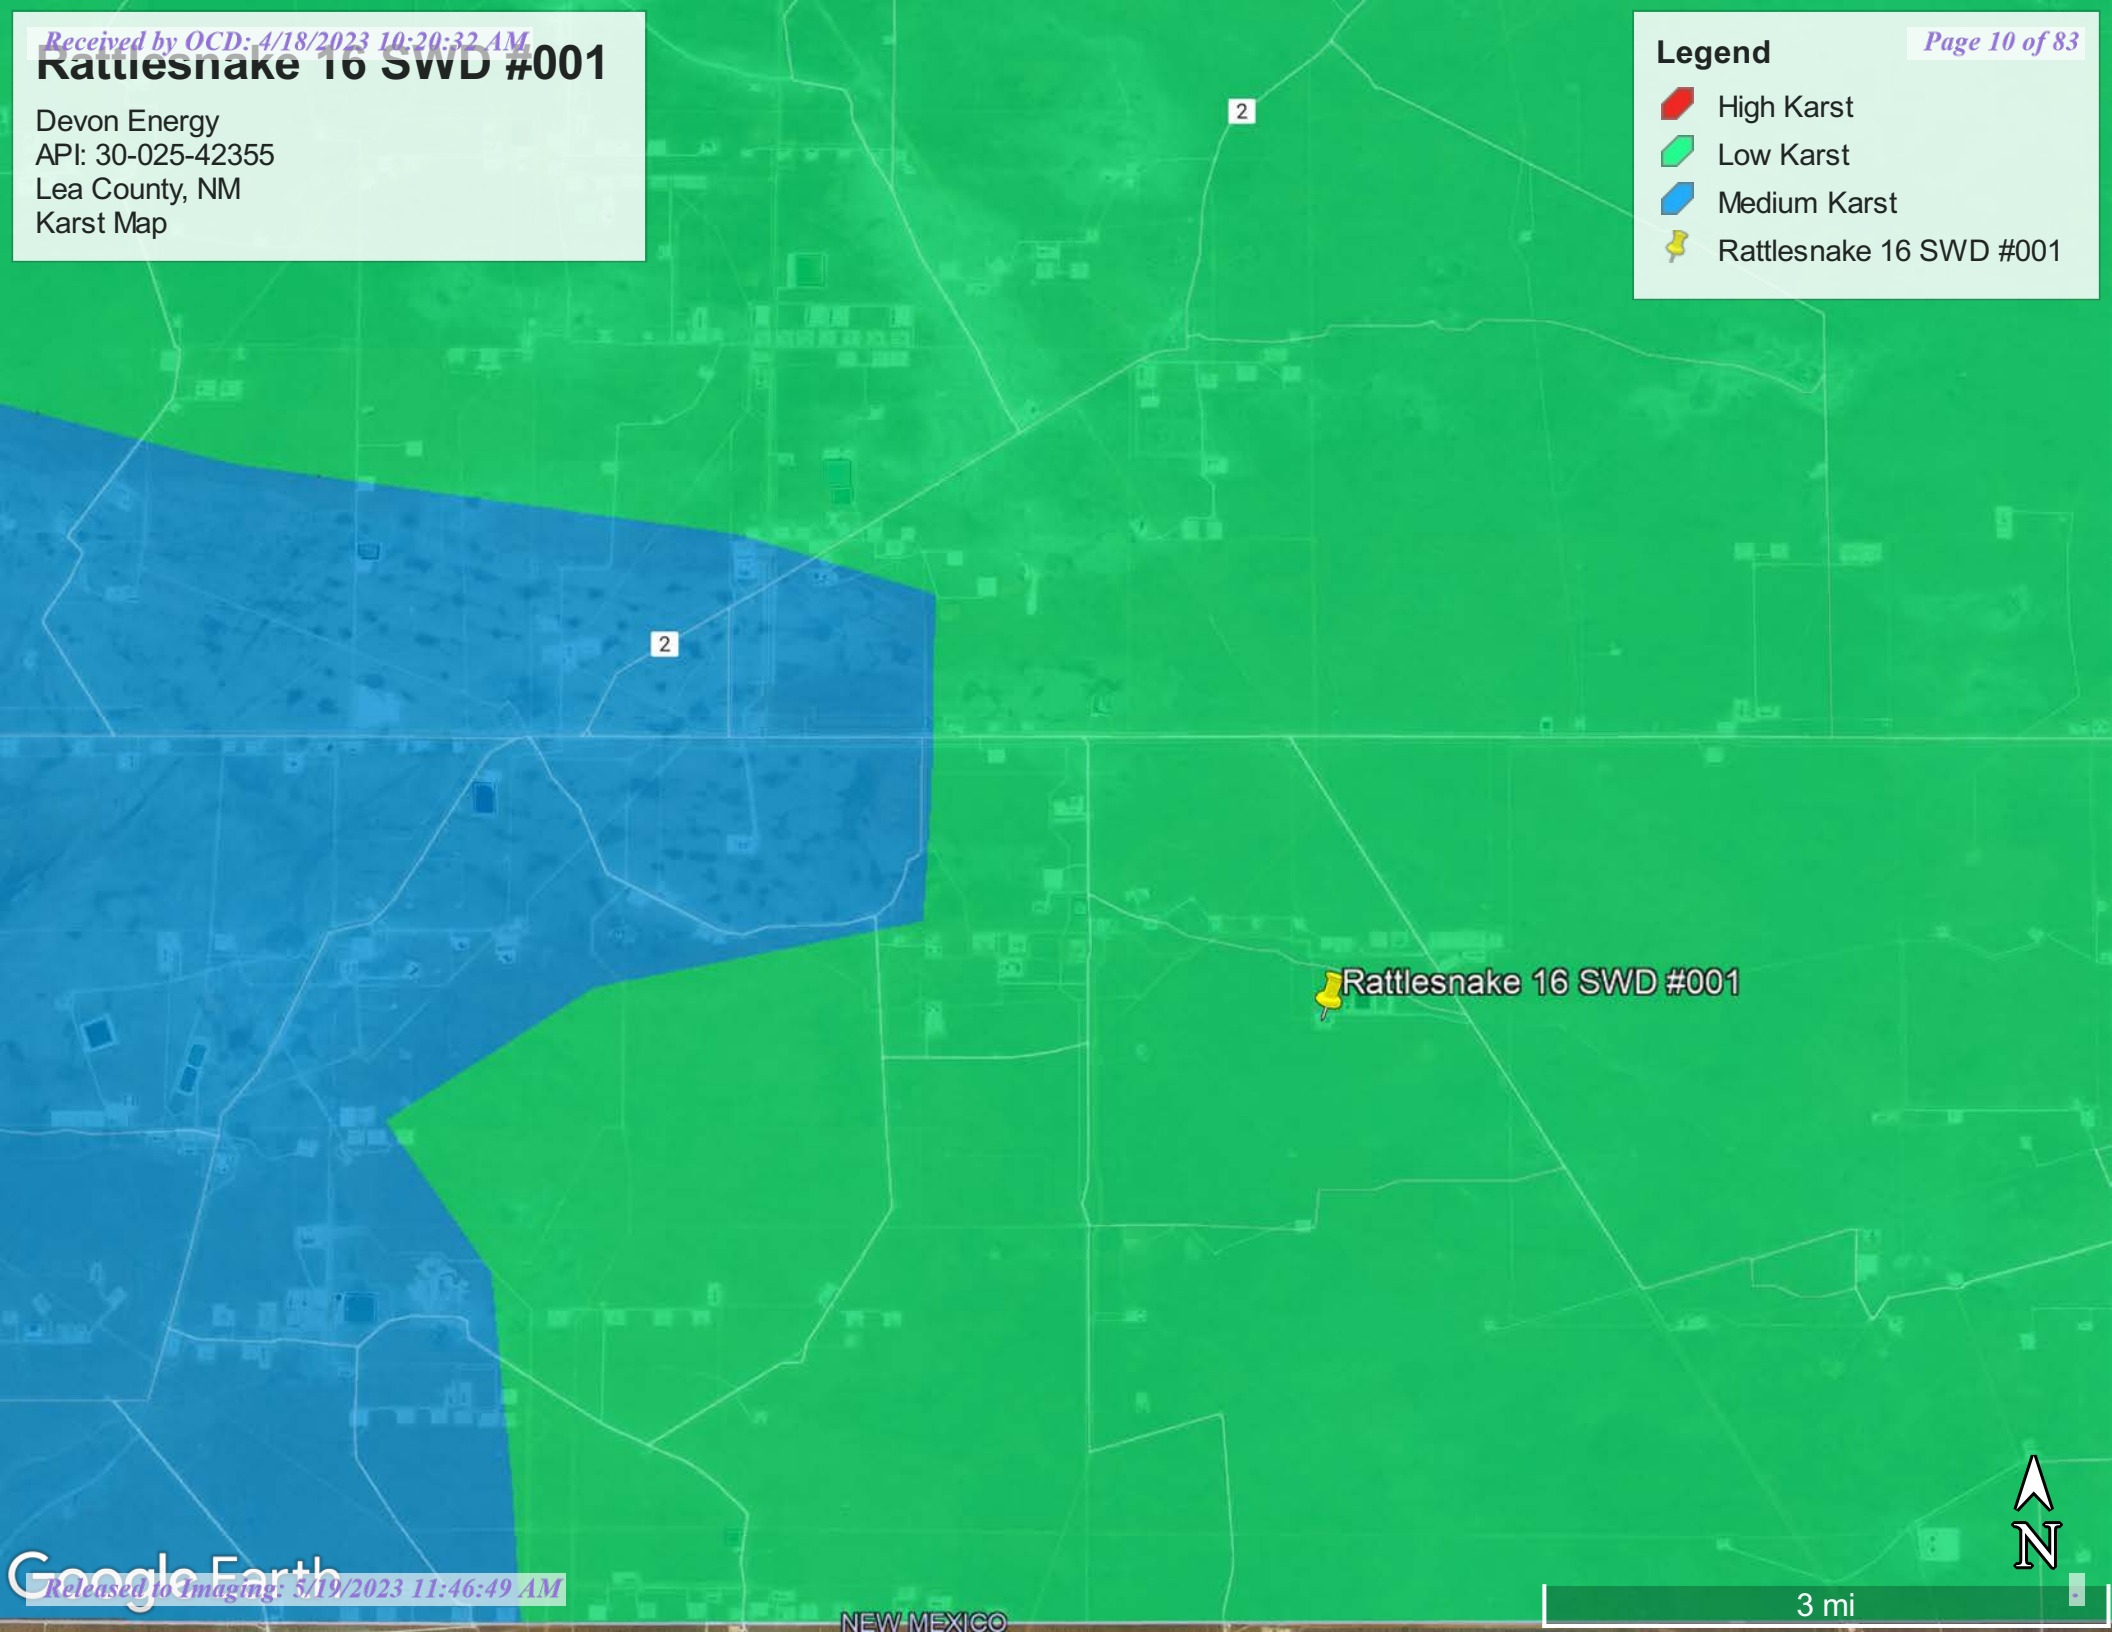
3-Karst Map

Devon Energy
API: 30-025-42355
Lea County, NM
Karst Map

High Karst
-

Low Karst
-

Medium Karst
-

Per the New Mexico Bureau of Geology and Mineral Resources, the geology is in the eolian and piedmont deposits (Holocene to middle Pleistocene). The soil in this area is made up of Pyote and Maljamar fine sands, 0 to 3 percent slopes, eroded according to the United States Department of Agriculture Natural Resources Conservation Service soil survey (Appendix B). The drainage courses in this area are well-drained. There is a low potential for karst geology to be present in the area of the Rattlesnake (Figure 3).

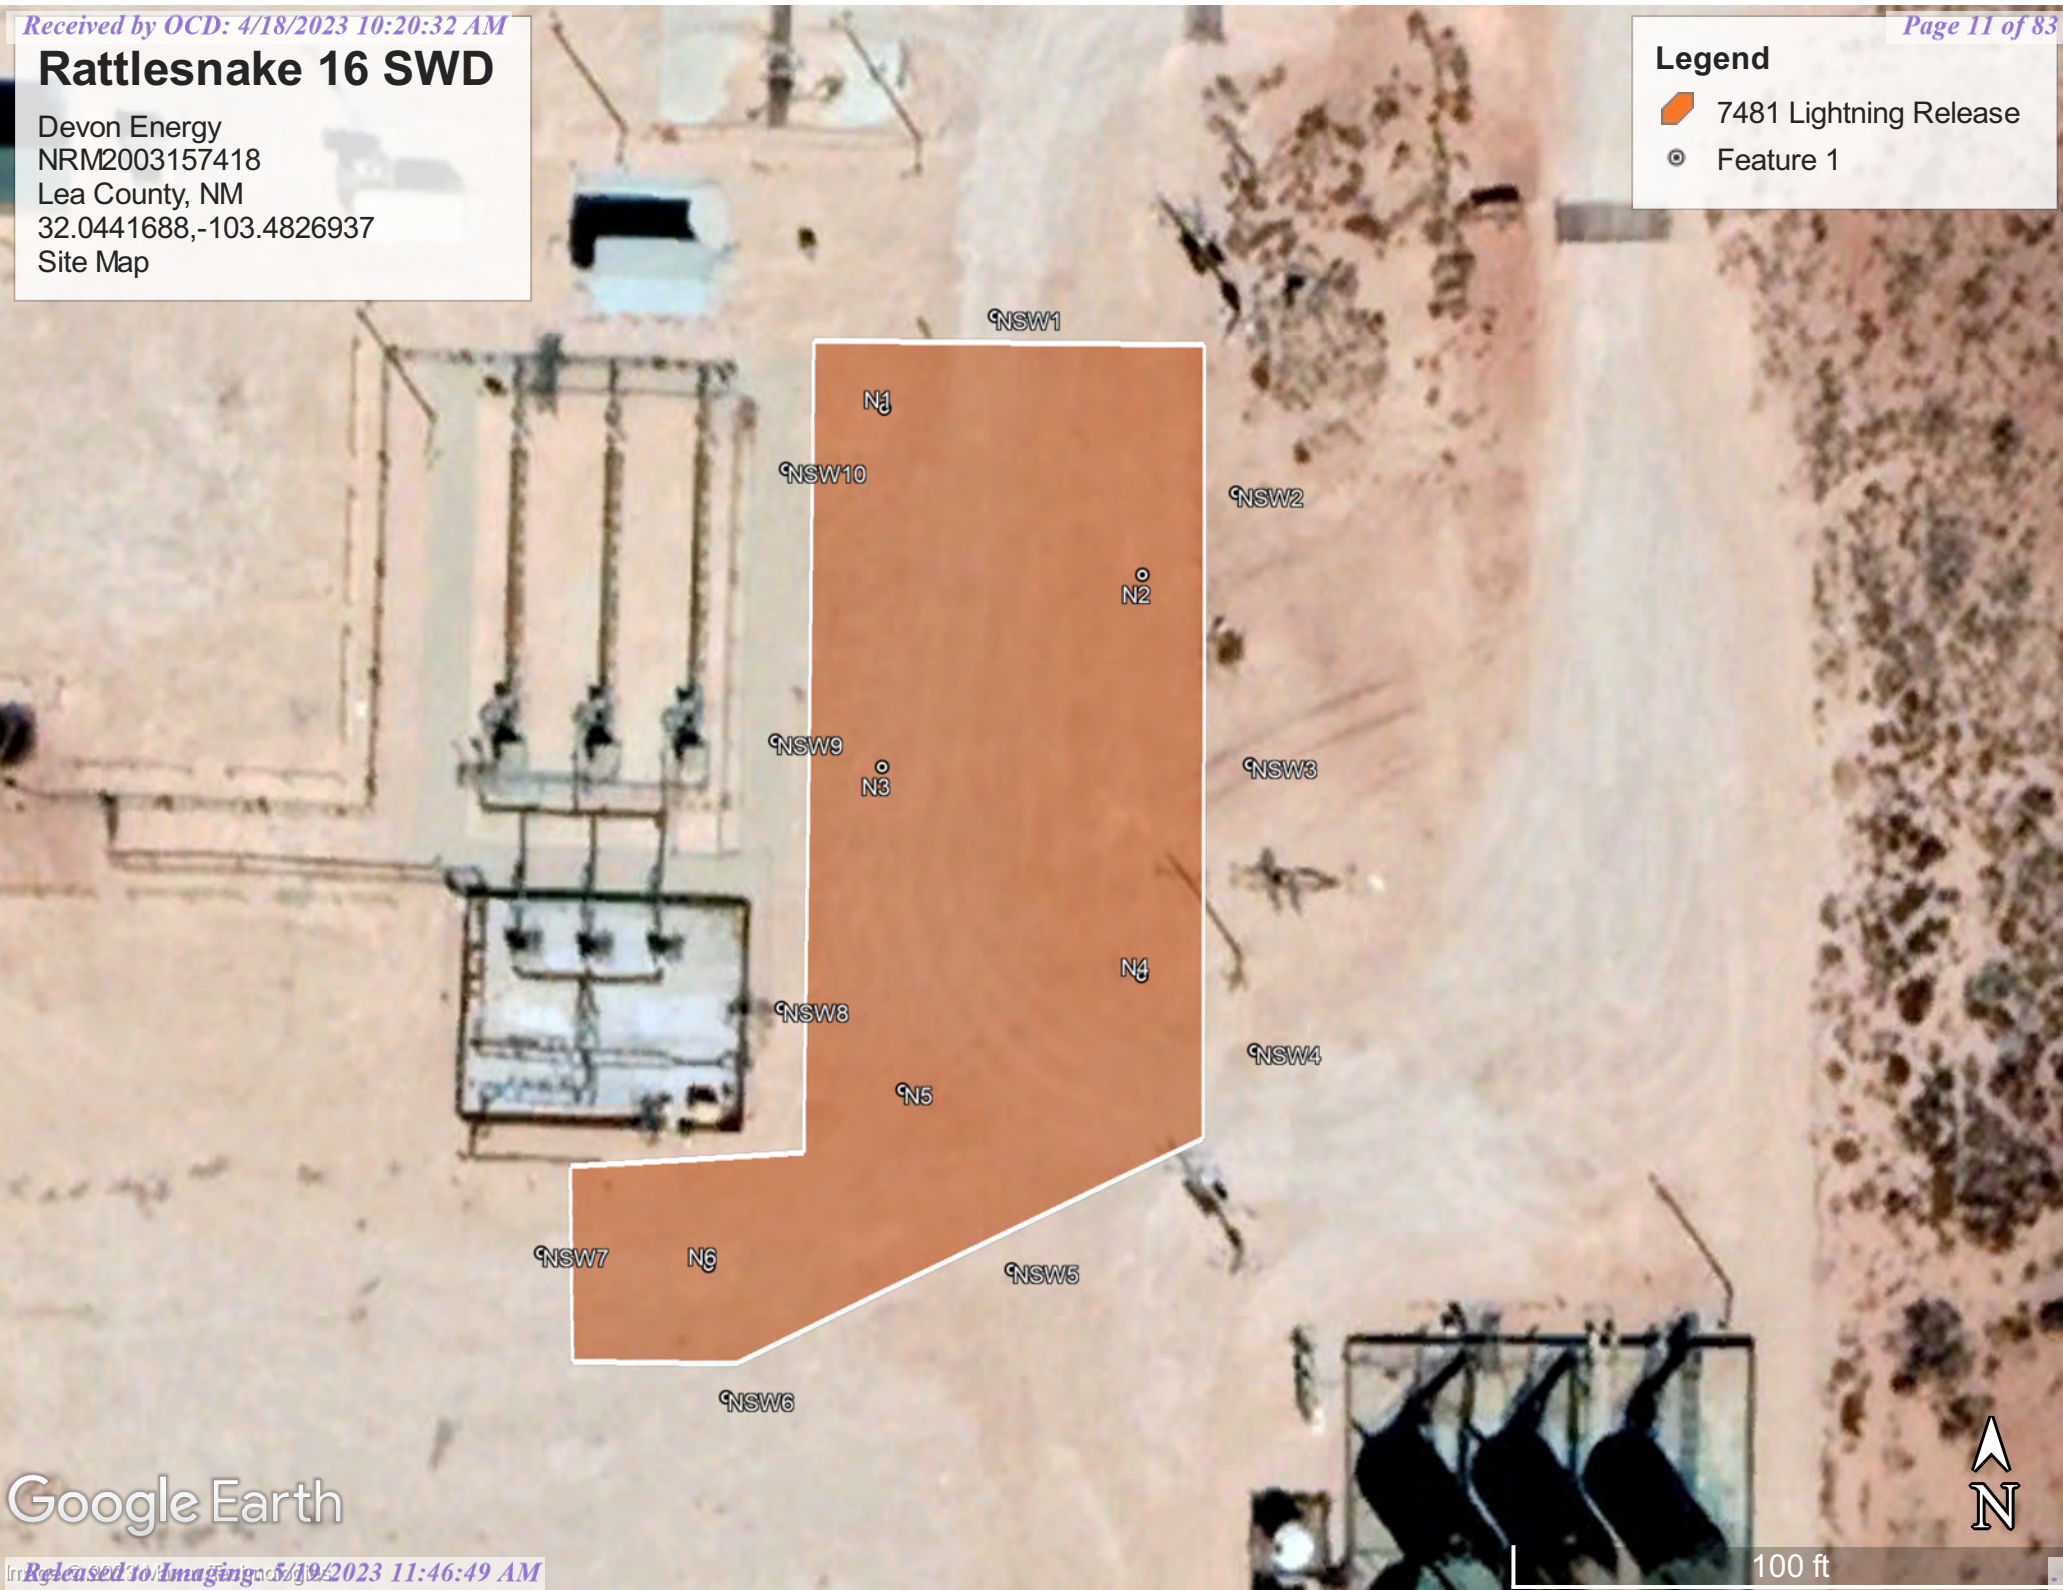
4-Site Map

Devon Energy
NRM2003157418
Lea County, NM
32.0441688,-103.4826937
Site Map

- 7481 Lightning Release
- Feature 1

On March 29th, 2023, Pima Environmental mobilized personnel to assess the impacted area. Pima sampled the areas surrounding the H-Pumps and collected a total of twenty-eight soil samples for laboratory analysis. Six bottom samples (N1-N6) were collected at depths of 1, 3 and 4 feet to determine vertical delineation. Additionally, side wall samples (SW1-SW10) were collected at a depth of 6 inches to determine horizontal delineation. An initial site map can be found in Figure 4.

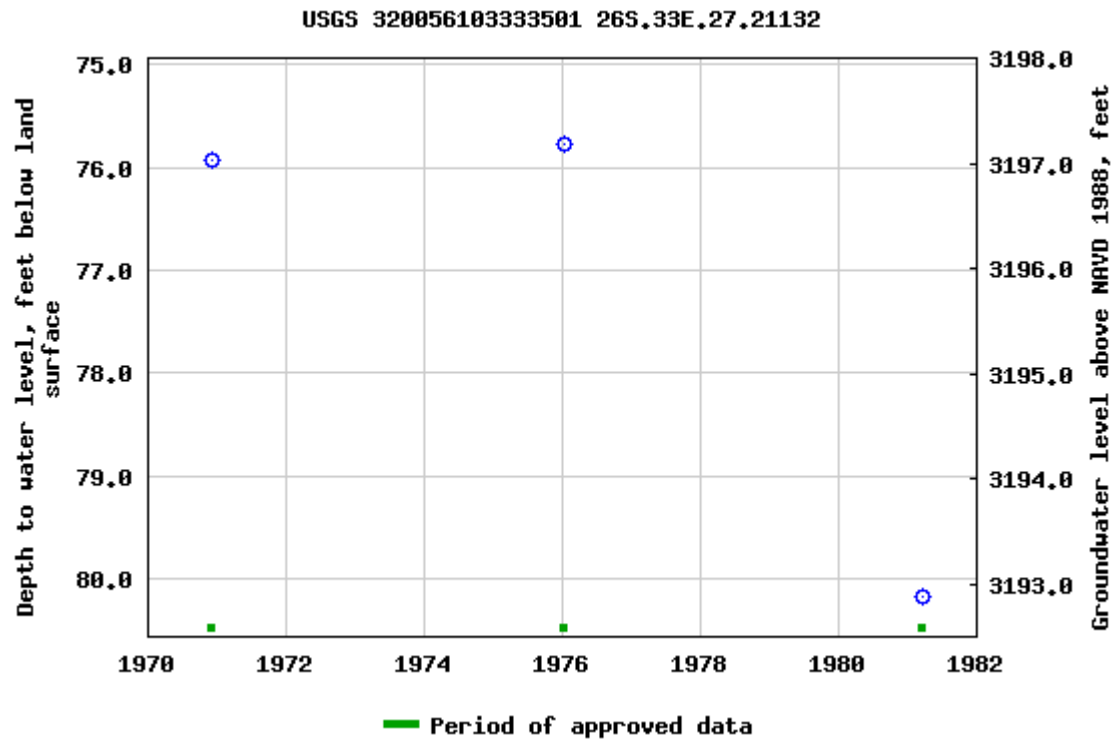
USGS 320056103333501 26S.33E.27.21132

Breaks in the plot represent a gap of at least one year between field measurements.

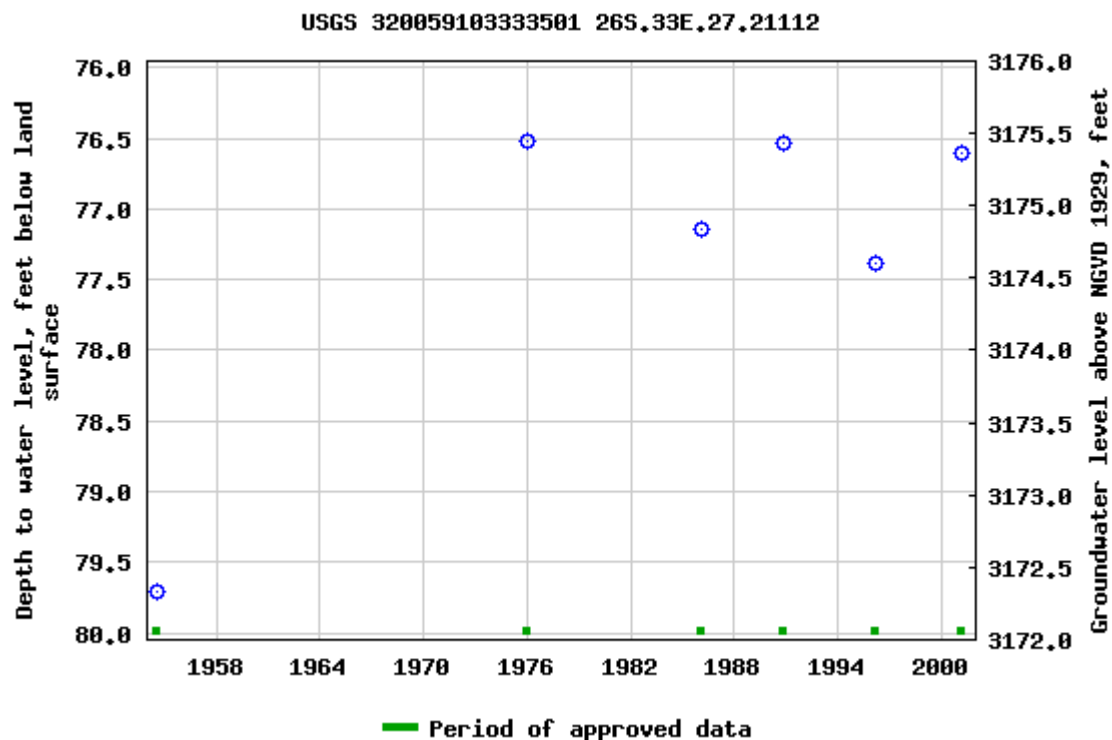
USGS 320059103333501 26S.33E.27.21112

The depth of the well is 200 feet below land surface.

Breaks in the plot represent a gap of at least one year between field measurements.

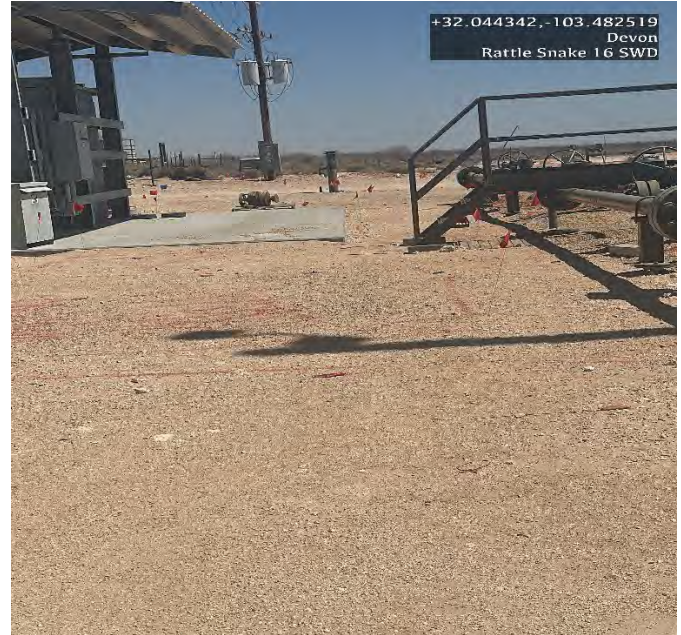
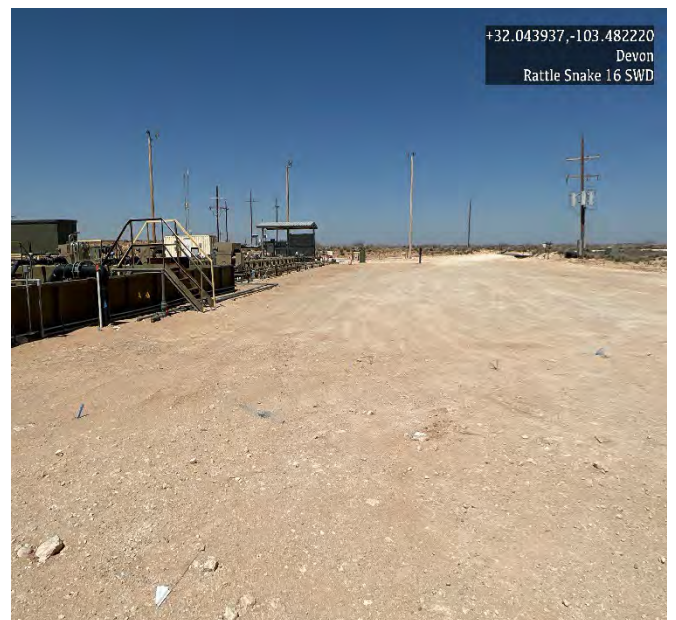
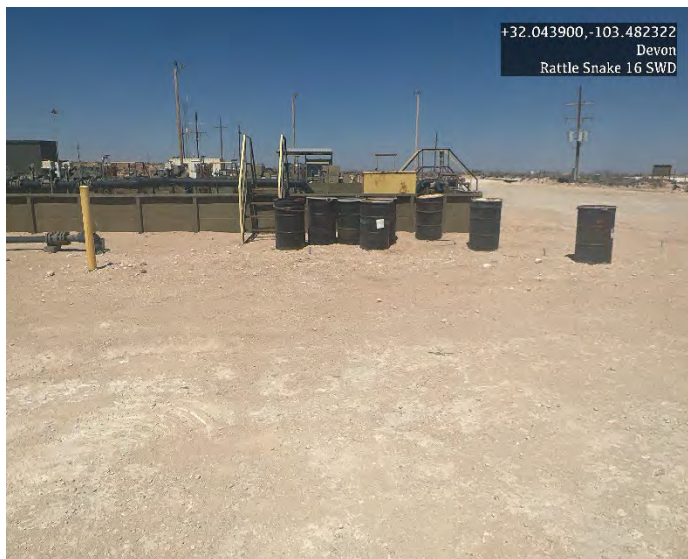
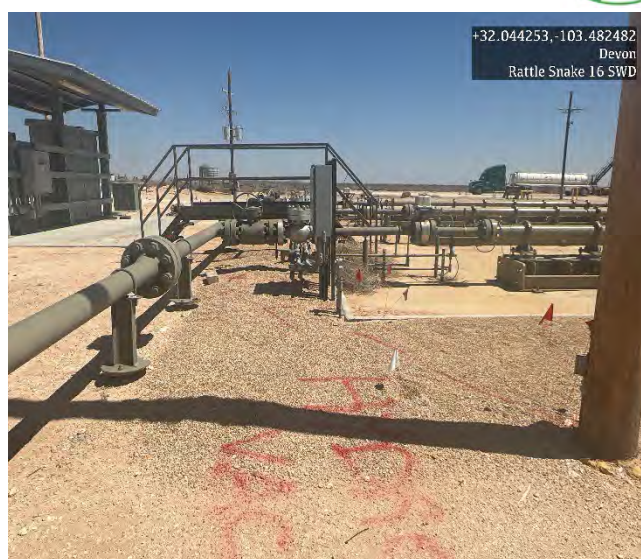
**SITE PHOTOGRAPHS
DEVON ENERGY
RATTLESNAKE 16 SWD 1**

Site Assessment

Based on the sample results, the bottoms and sidewalls are below NMOCD Closure Criteria 19.15.29 NMAC. See Appendix D for Photographic Documentation.
