Vertex Project #: 20E-01925-001

Supplemental Report: Lea State 946
Section 03, Township 18 South, Range 35 East
County: Lea
Incident Report: nRM2019640815

2023 Spill Assessment and Closure
April 2023

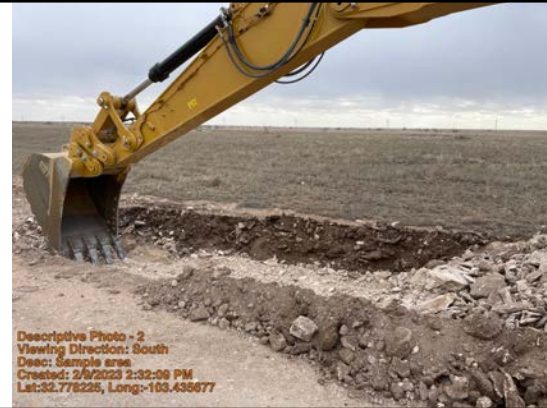
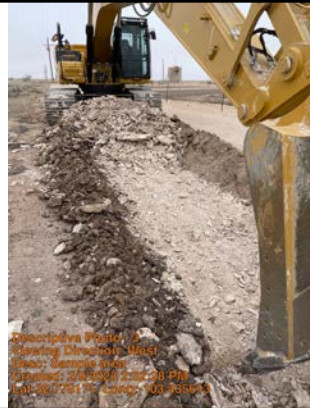
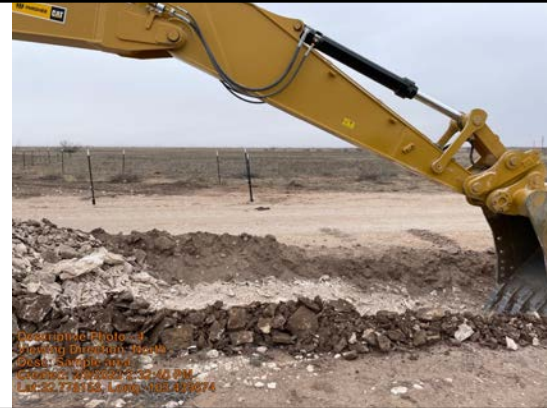
14:15 Excavated down to 2' depth and gathered samples 19 and 20. Samples were tested for chlorides and hydrocarbons. Samples were clean for chlorides and high in hydrocarbons. Results are in the attached soil sample pdf

14:15 Instructed crew to pothole down to 4' for additional sampling, but they hit refusal at 3'. Samples 19 and 20 were gathered at 3'. Samples tested clean for chlorides and high for hydrocarbons. See attached soil sample pdf.

Sample area

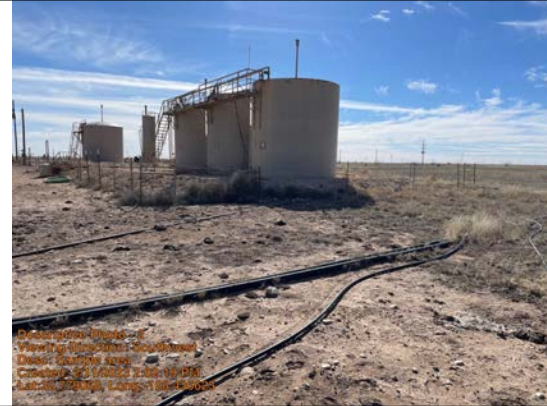
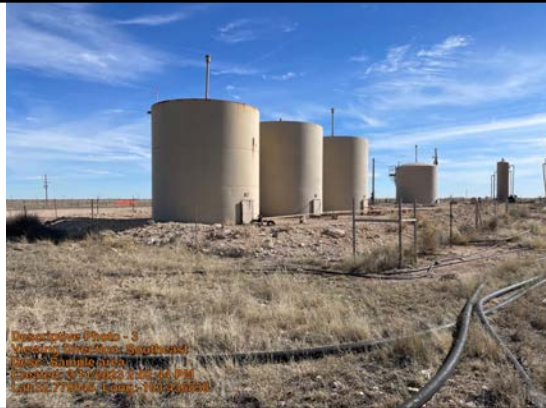
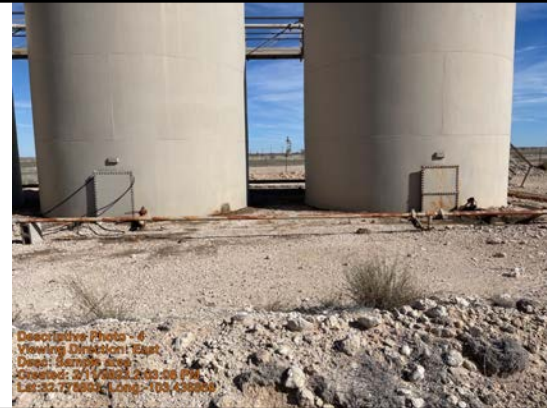
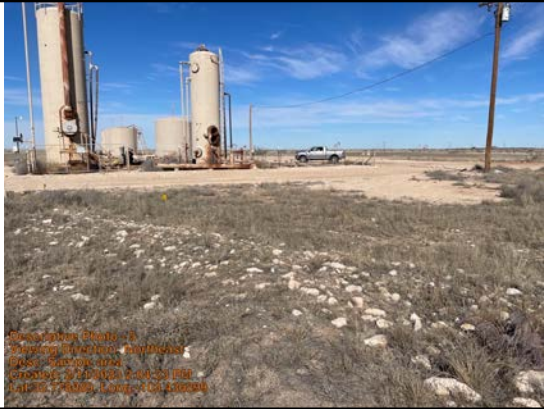
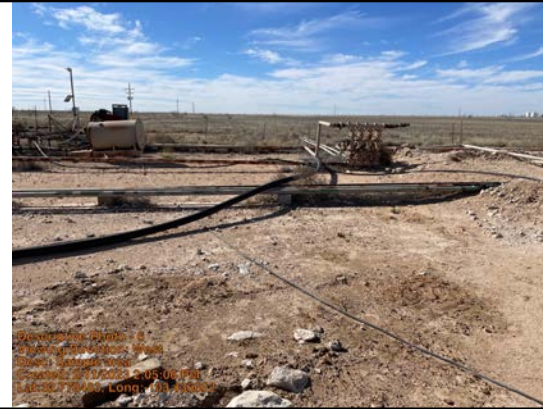
12:20 Gathered borehole samples 1 through 8. Ground is extremely hard and rocky.

Sample area

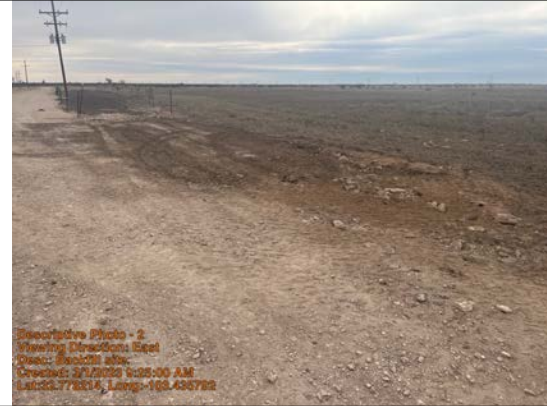
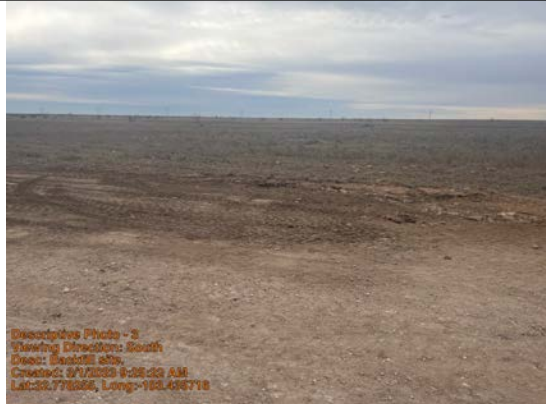
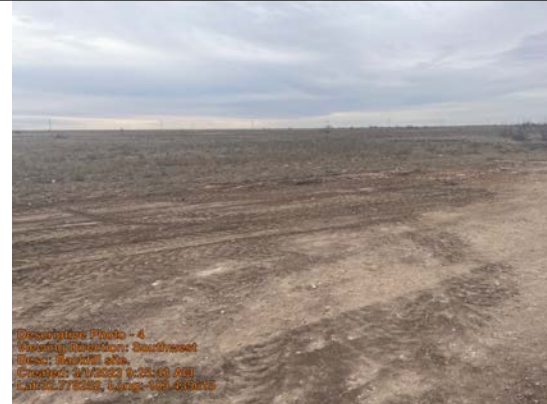
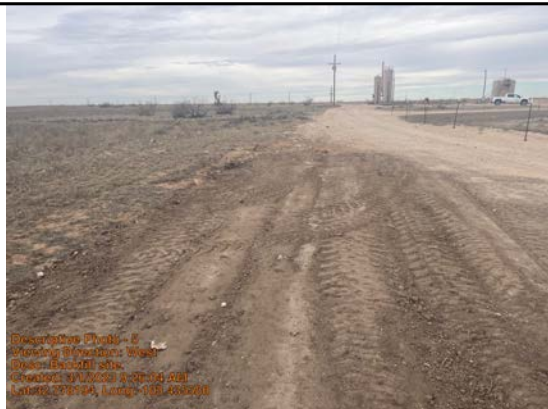
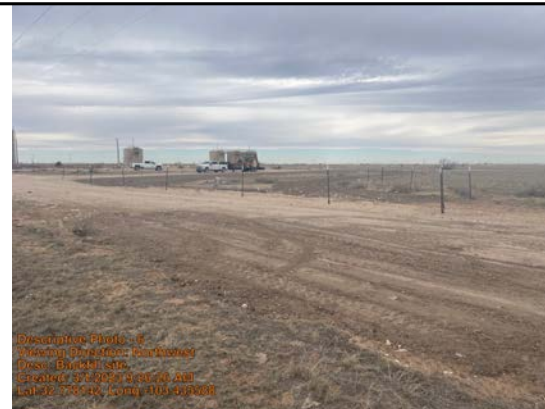
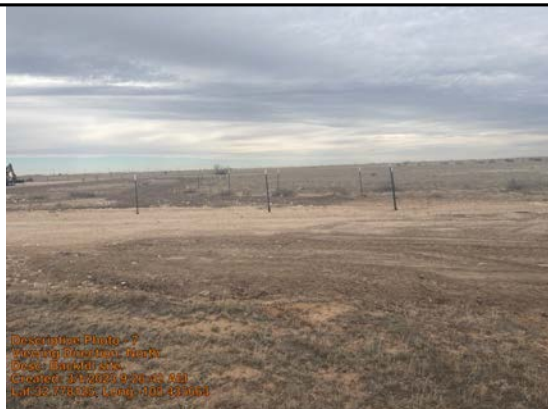
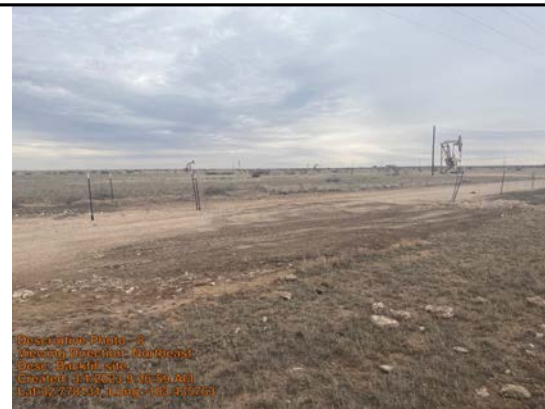
Backfill site.

The spill area was fully delineated, remediated and backfilled with clean local topsoil. Confirmatory sampling notification emails are included in Attachment 4. Confirmatory samples were analyzed by the laboratory and found to be below allowable concentrations as per the New Mexico Administrative Code (NMAC; New Mexico Oil Conservation Division, 2018) Closure Criteria for Soils Impacted by a Release locations “51-100 feet to groundwater”. Based on these findings, HPPC, Inc. requests that this spill be closed.
