CLOSURE REPORT

Schwerdtsferger LS #10A (02/14/23)
Unit Letter D, S31 T28N R8W
San Juan County, New Mexico

New Mexico EMNRD OCD Incident ID No. NAPP2304533224

Ensolum Project No. 05A1226228

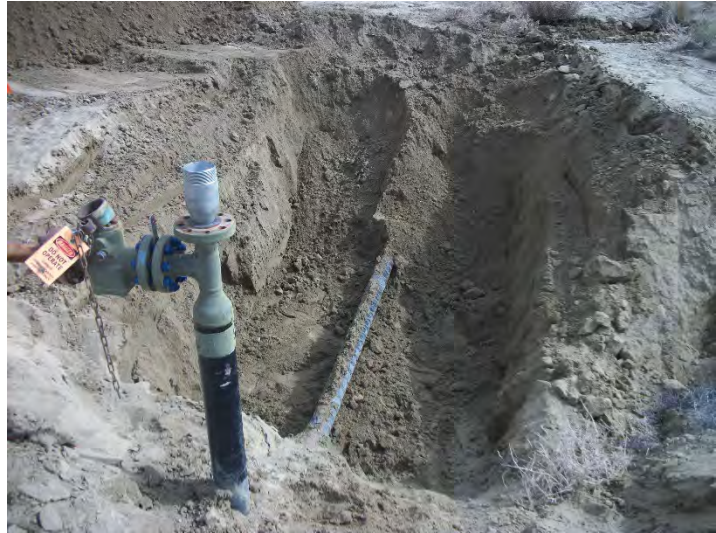
**Photograph 1**

Photograph Description: View of the in-process excavation activities.

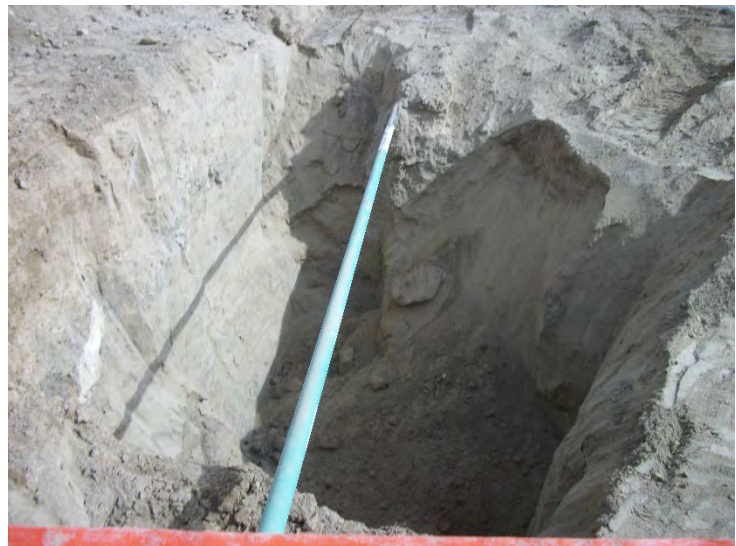
**Photograph 2**

Photograph Description: View of the in-process excavation activities.

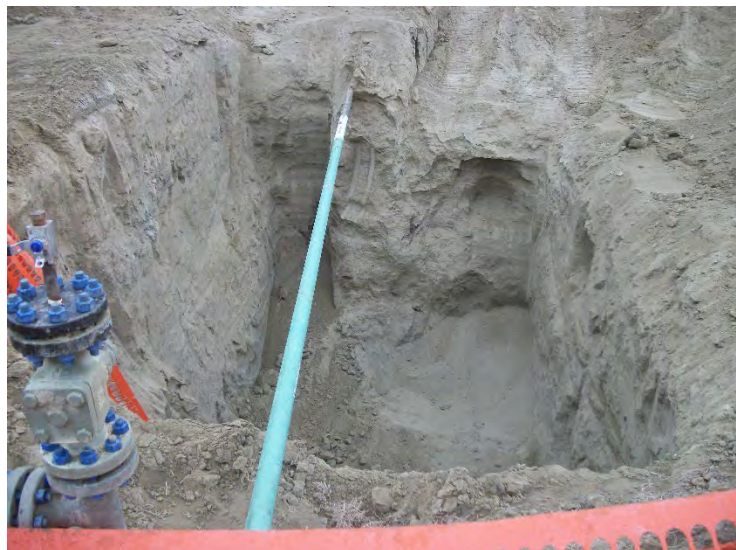
**Photograph 3**

Photograph Description: View of the excavation (second sampling event).

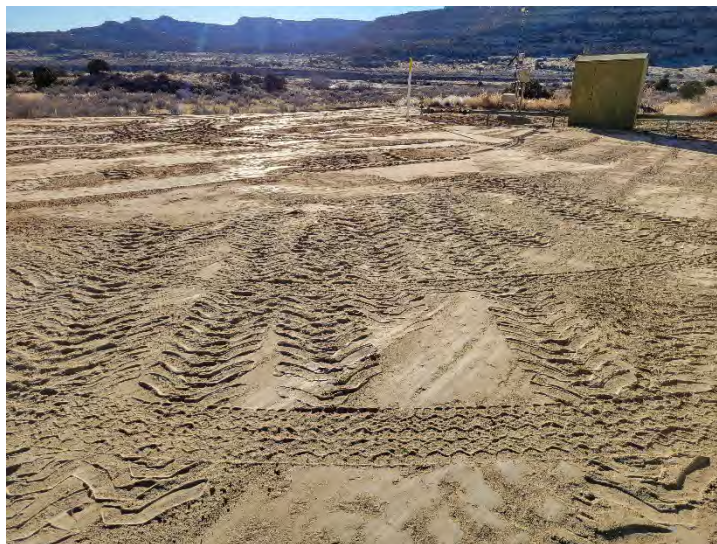
**Photograph 4**

Photograph Description: View of the site after initial restoration.

The excavation was backfilled with imported fill and then contoured to the surrounding topography. Enterprise will re-seed the Site with an approved seeding mixture.

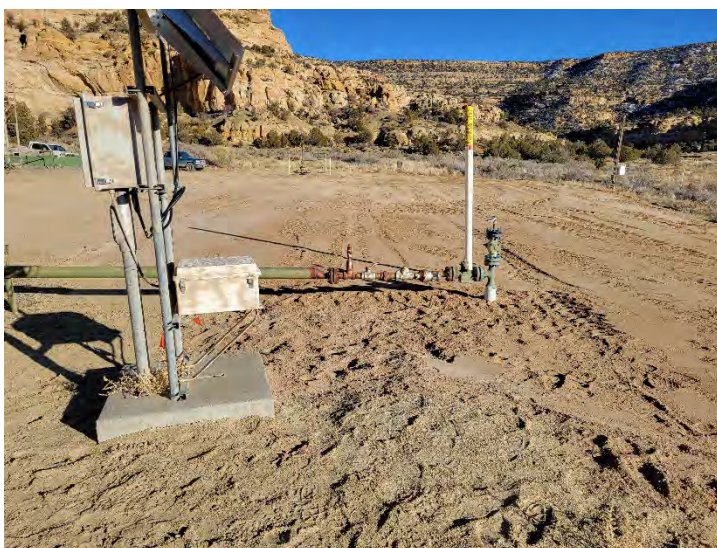
**Photograph 5**

Photograph Description: View of the site after initial restoration.
