**Re: Closure Report
ConocoPhillips
Heritage Concho
Canvasback 13 Federal #002H
Unit Letter I, Section 13, Township 24 South, Range 31 East
Eddy County, New Mexico
Incident ID# nAB1817150139**

Closure Report
May 22, 2023

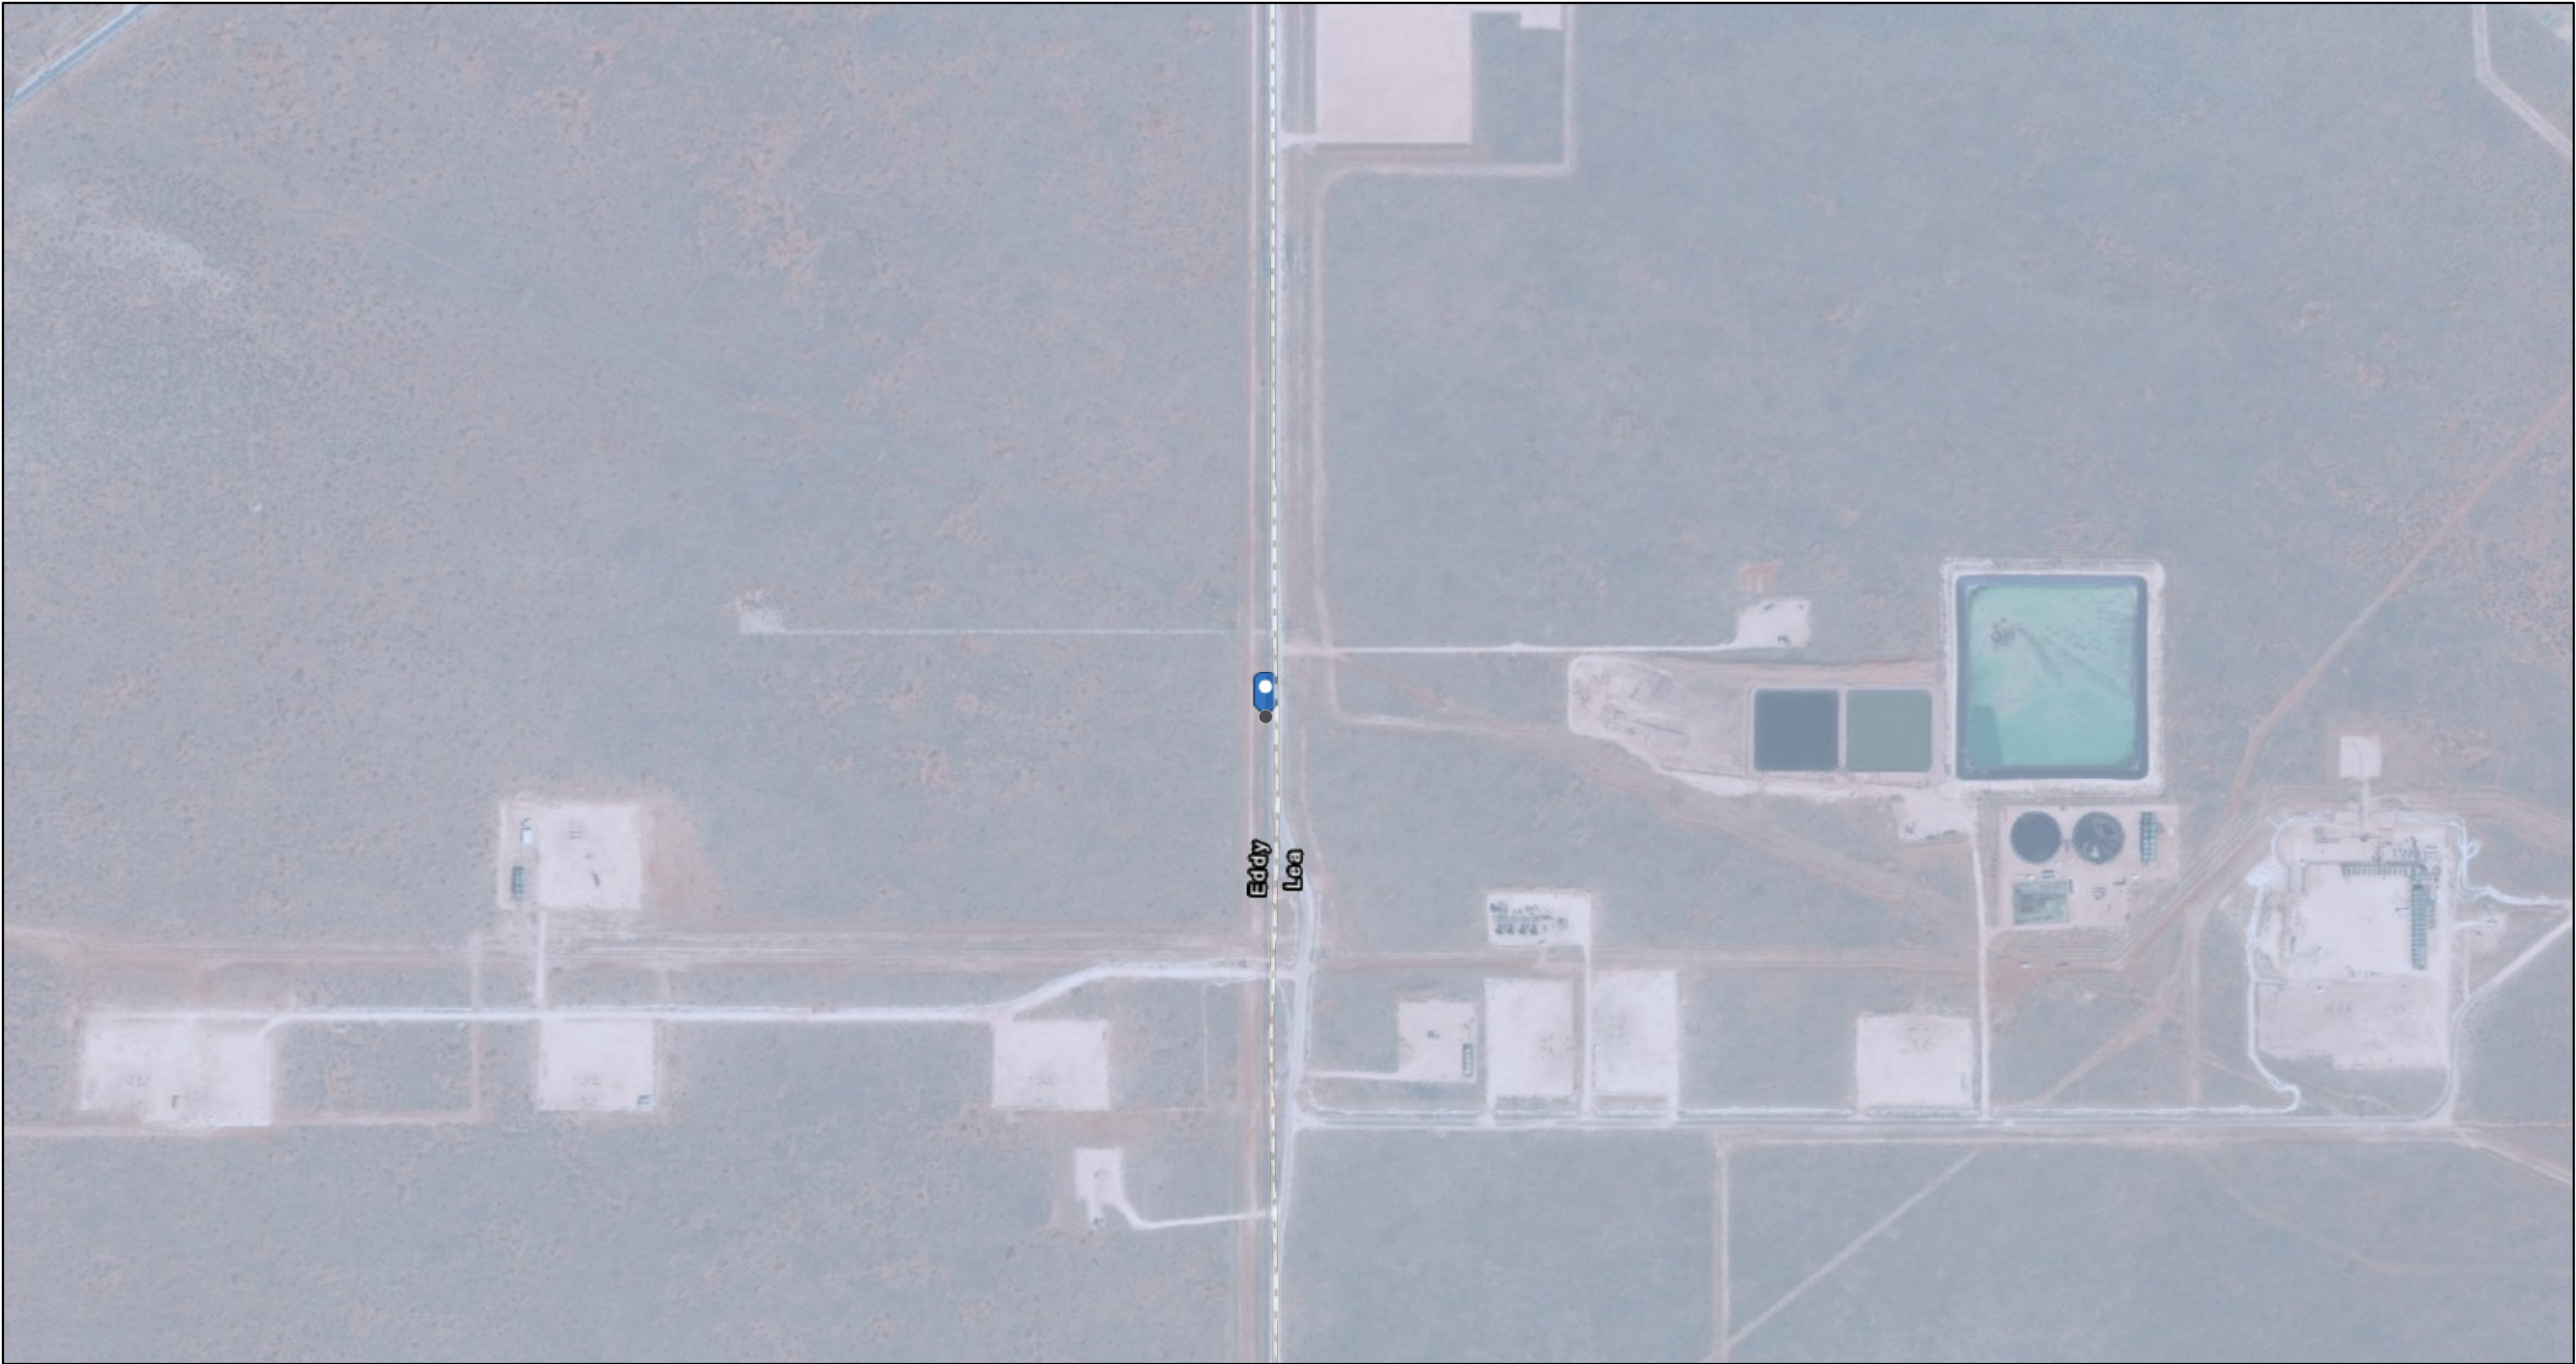
OCD Karst Potential Map

A site characterization was performed and no sinkholes, residences, schools, hospitals, institutions, churches, springs, private domestic water wells, wetlands, incorporated municipal boundaries, subsurface mines, or floodplains are located within the distances specified in 19.15.29 New Mexico Administrative Code (NMAC). The Site is in an area of low karst potential.

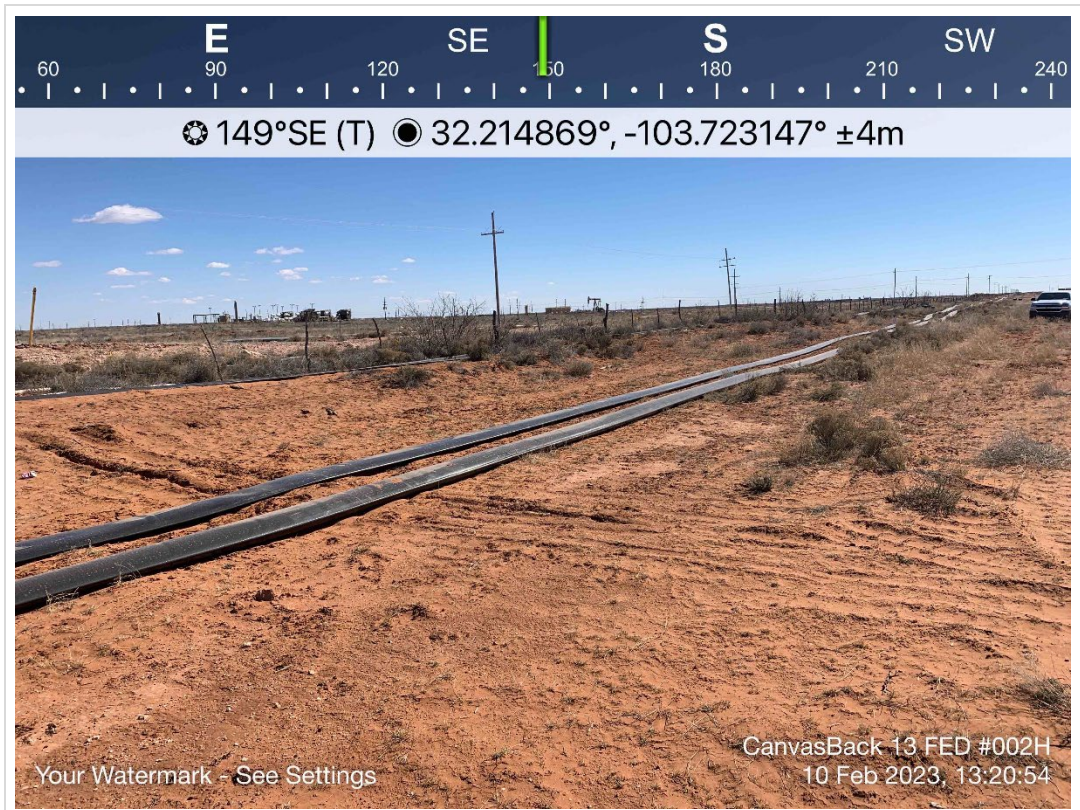
TETRA TECH, INC. PROJECT NO. 212C-MD-03003	DESCRIPTION	View south/southeast of surface polylines and fence line.	3
	SITE NAME	Canvasback 13 Fed #002H	2/10/2023

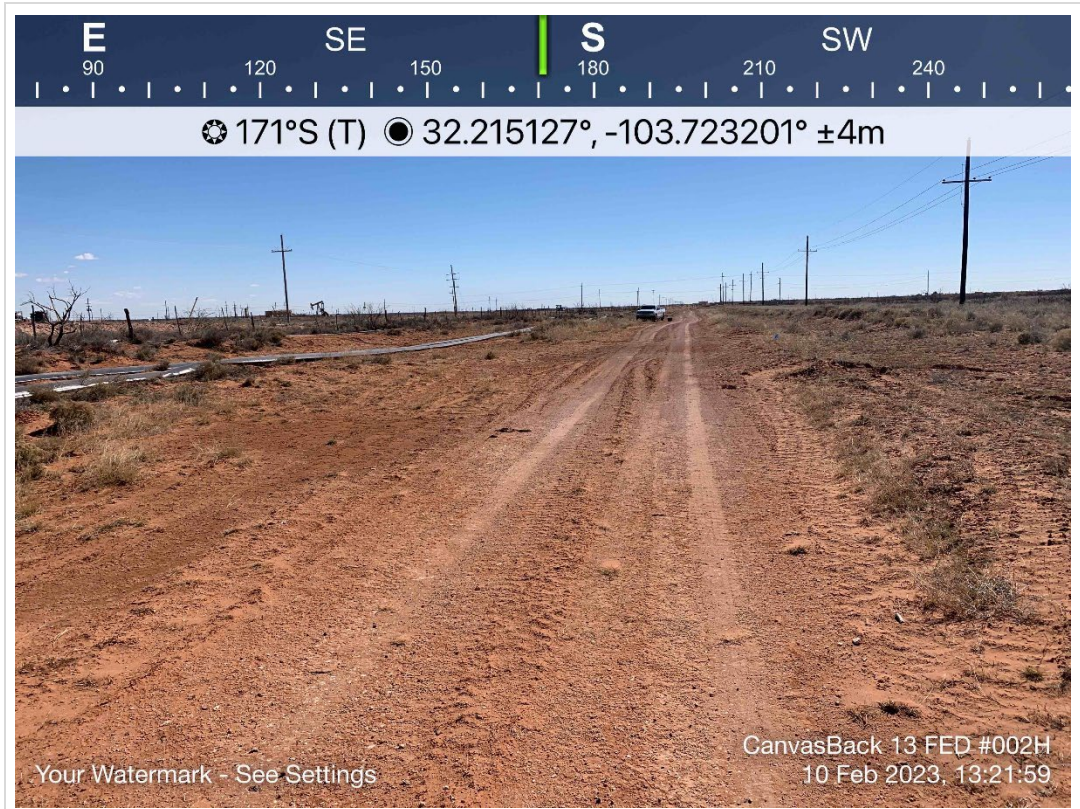
TETRA TECH, INC. PROJECT NO. 212C-MD-03003	DESCRIPTION	View south of general Site conditions. Surface polylines shown to the east.	4
	SITE NAME	Canvasback 13 Fed #002H	2/10/2023
