Site Assessment/Characterization

Closure

Re: Site Assessment, Remediation, and Closure Report
Rigel 20 Fed Com #1H
API No. 30-015-39393
GPS: Latitude 32.6519922 Longitude -103.8990173
UL -- D, Sec. 20, T19S, R31E
Eddy County, NM
NMOCD Ref. No. NJMW1319349423

Pima Environmental Services, LLC. (Pima) has been contracted by Devon Energy Production Company, LP (Devon) to perform a spill assessment, remediation activities, and submit this closure report for a crude oil release that occurred at the Rigel 20 Fed Com #1H (Rigel). The initial C-141 was submitted on July 5th, 2022 (Appendix C). This incident was assigned Incident ID NJMW1319349423 by the New Mexico Oil Conservation Division (NMOCD).

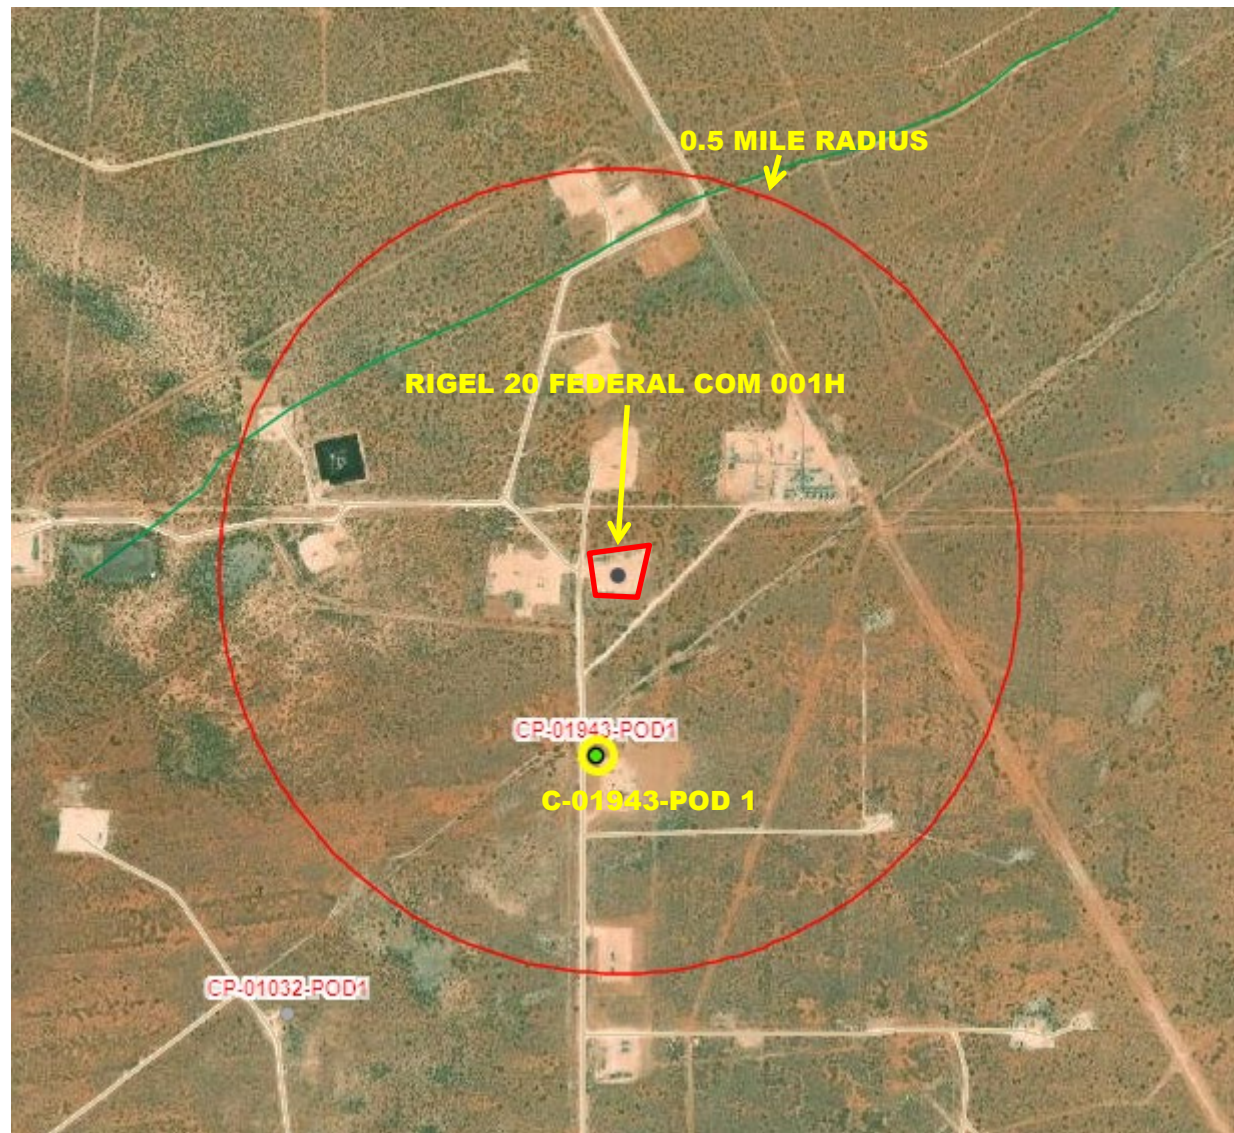
| FIGURE 1: NM OSE POD LOCATIONS | |

C-01943- POD1 (51 feet) = 0.2 miles from location (4/6/2023)
