**RE: Site Assessment, Remediation, and Closure Report
Cannonball #001H
API No. 30-01538569
GPS: Latitude 32.734333 Longitude -104.3966675
UL "H", Section 20, Township 18S, Range 26E,
Eddy County, NM
NMOCD Reference No. nAB1819057637**

Raybaw Operating, LLC (Raybaw) has contracted Pima Environmental Services, LLC (Pima) to perform a site assessment, remediation, and prepare this closure report for a crude oil release that happened at the Cannonball #001H (Cannonball). An initial C-141 was submitted on June 29, 2018, and can be found in Appendix C. This incident was assigned Incident ID NAB1819057637, by the New Mexico Oil Conservation Division (NMOCD).

Raybaw Operating
API #30-015-38569
Eddy County, NM
Excavation Map
nAB1919057637

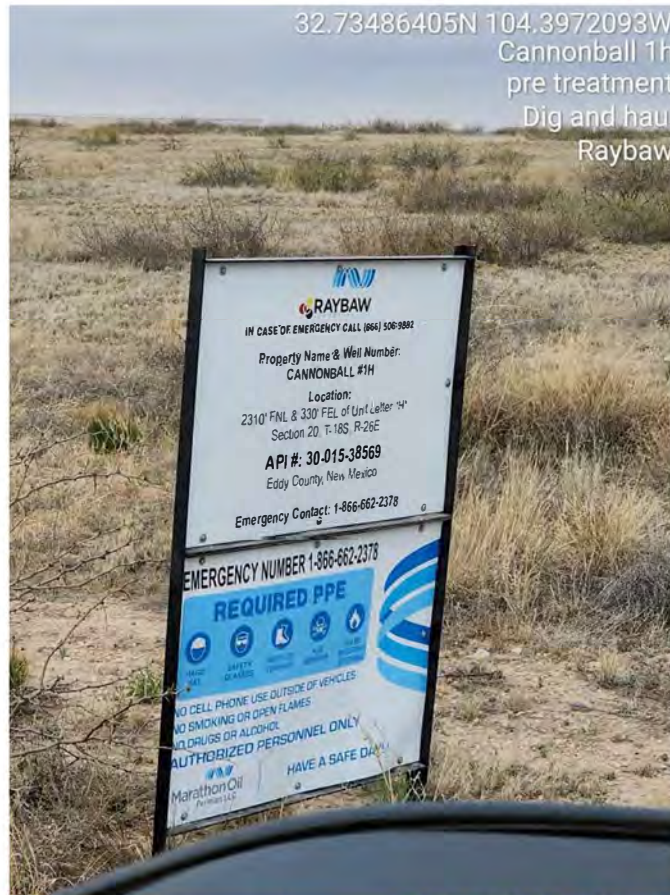
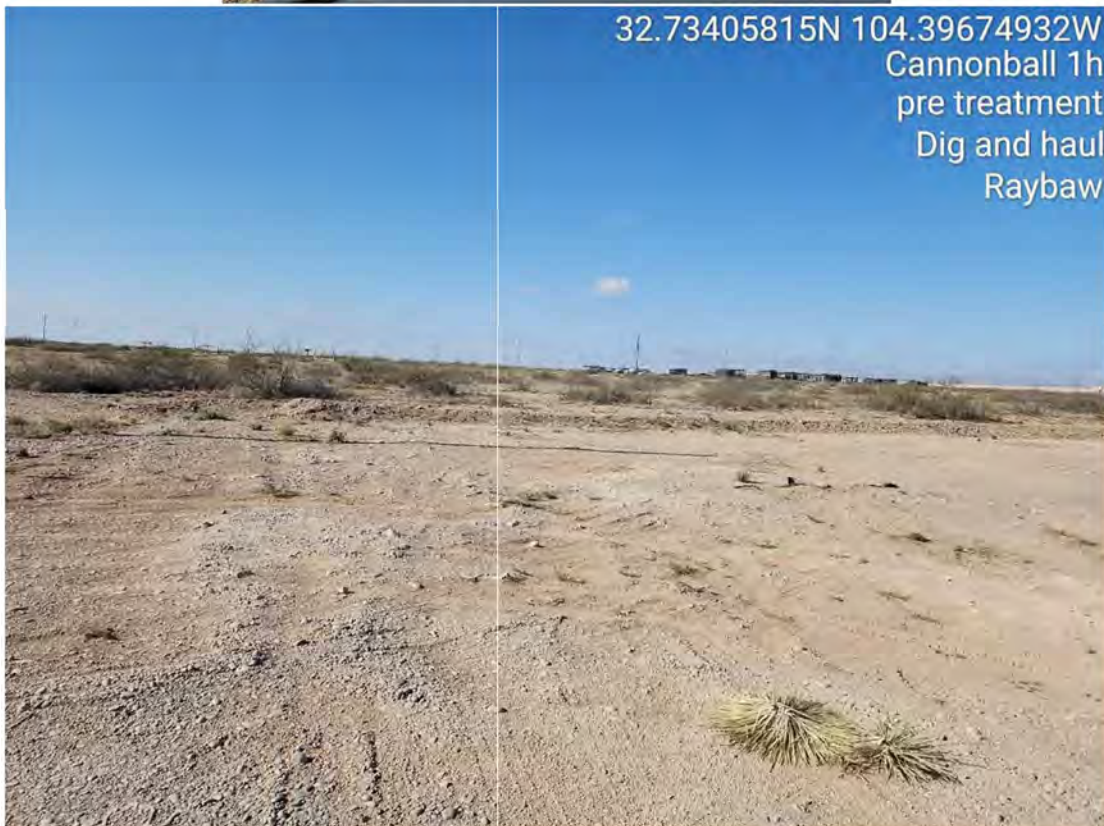
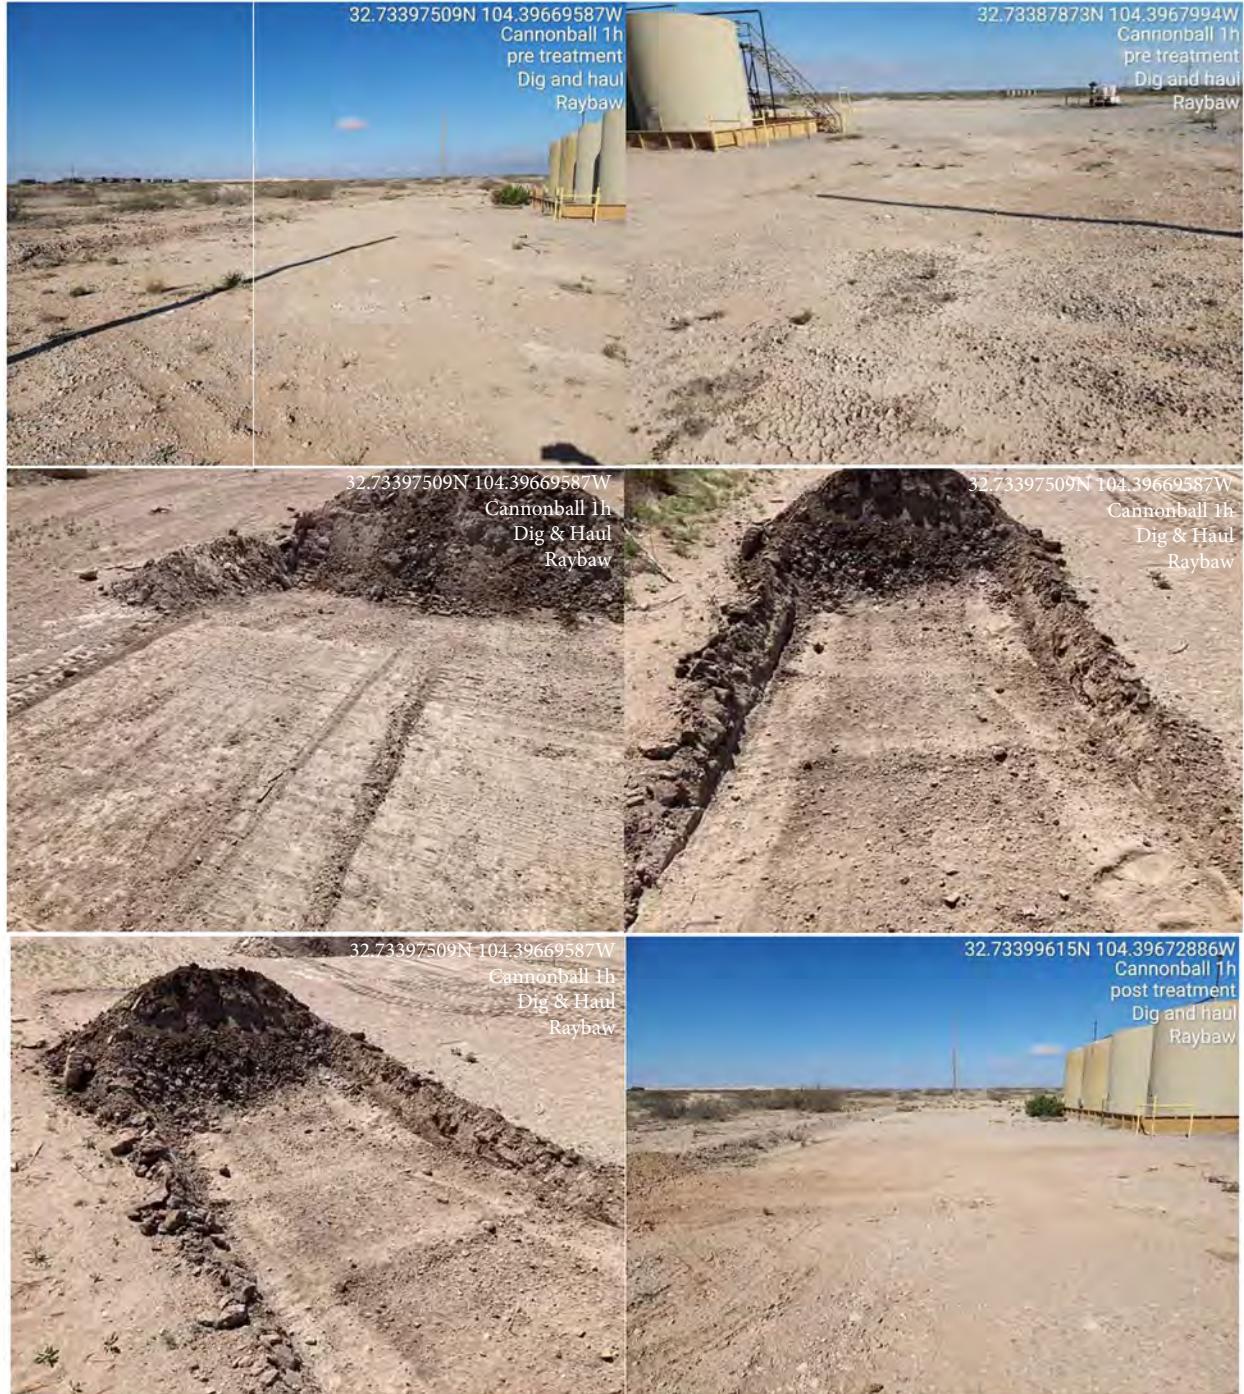
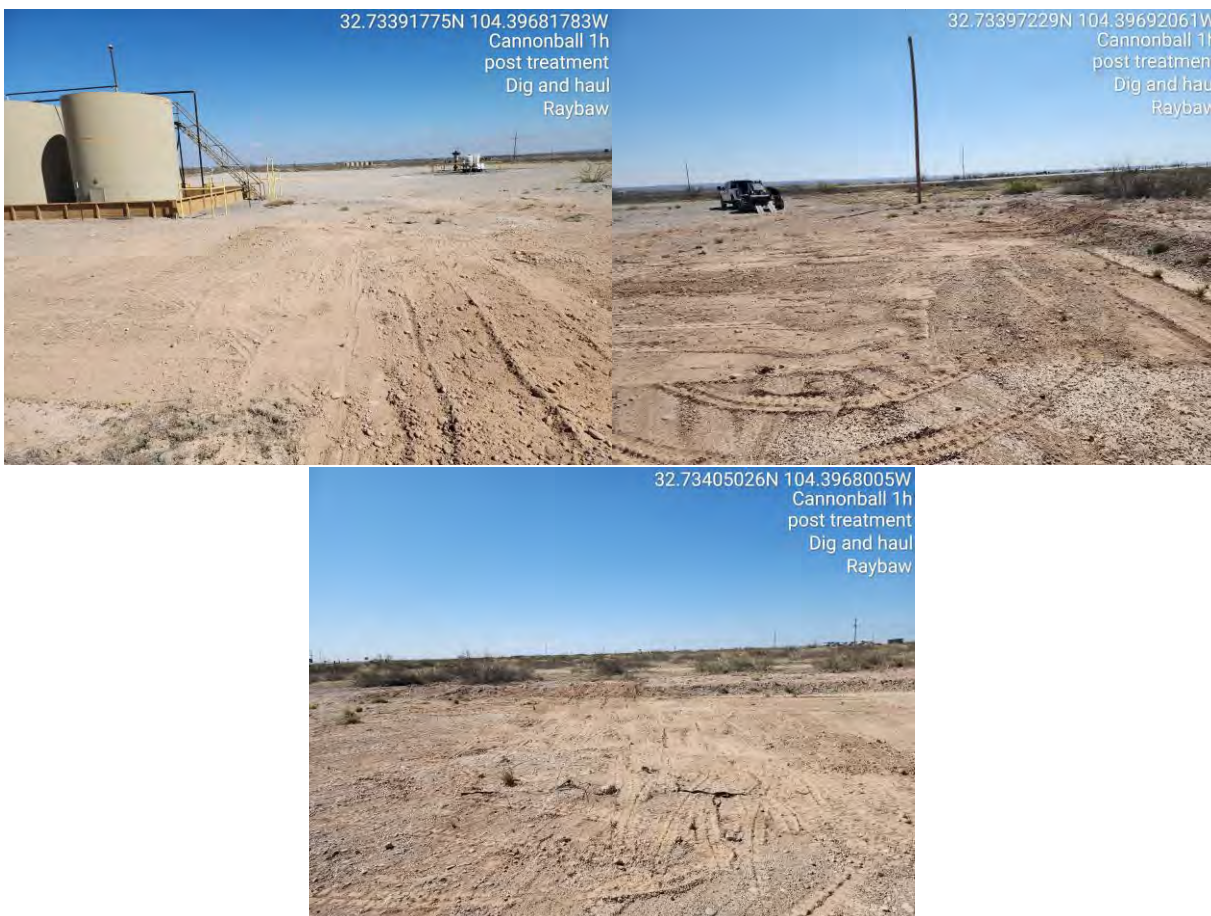
On April 12, 2023, Pima personnel mobilized personnel and equipment to the site to excavate the areas surrounding sample points SW2 and SW3 to a depth 1' bgs. We then took 5-point composite samples of the base and sidewalls of each excavated area. The results of this sampling event can be found in the following data table. Approximately 8 cubic yards of contaminated soil was hauled to an approved, lined disposal facility and clean like material was hauled in for backfill. A New Site Map can be found in Figure 4. Photographic Documentation can be found in Appendix D. An Excavation Map can be found in Figure 5.

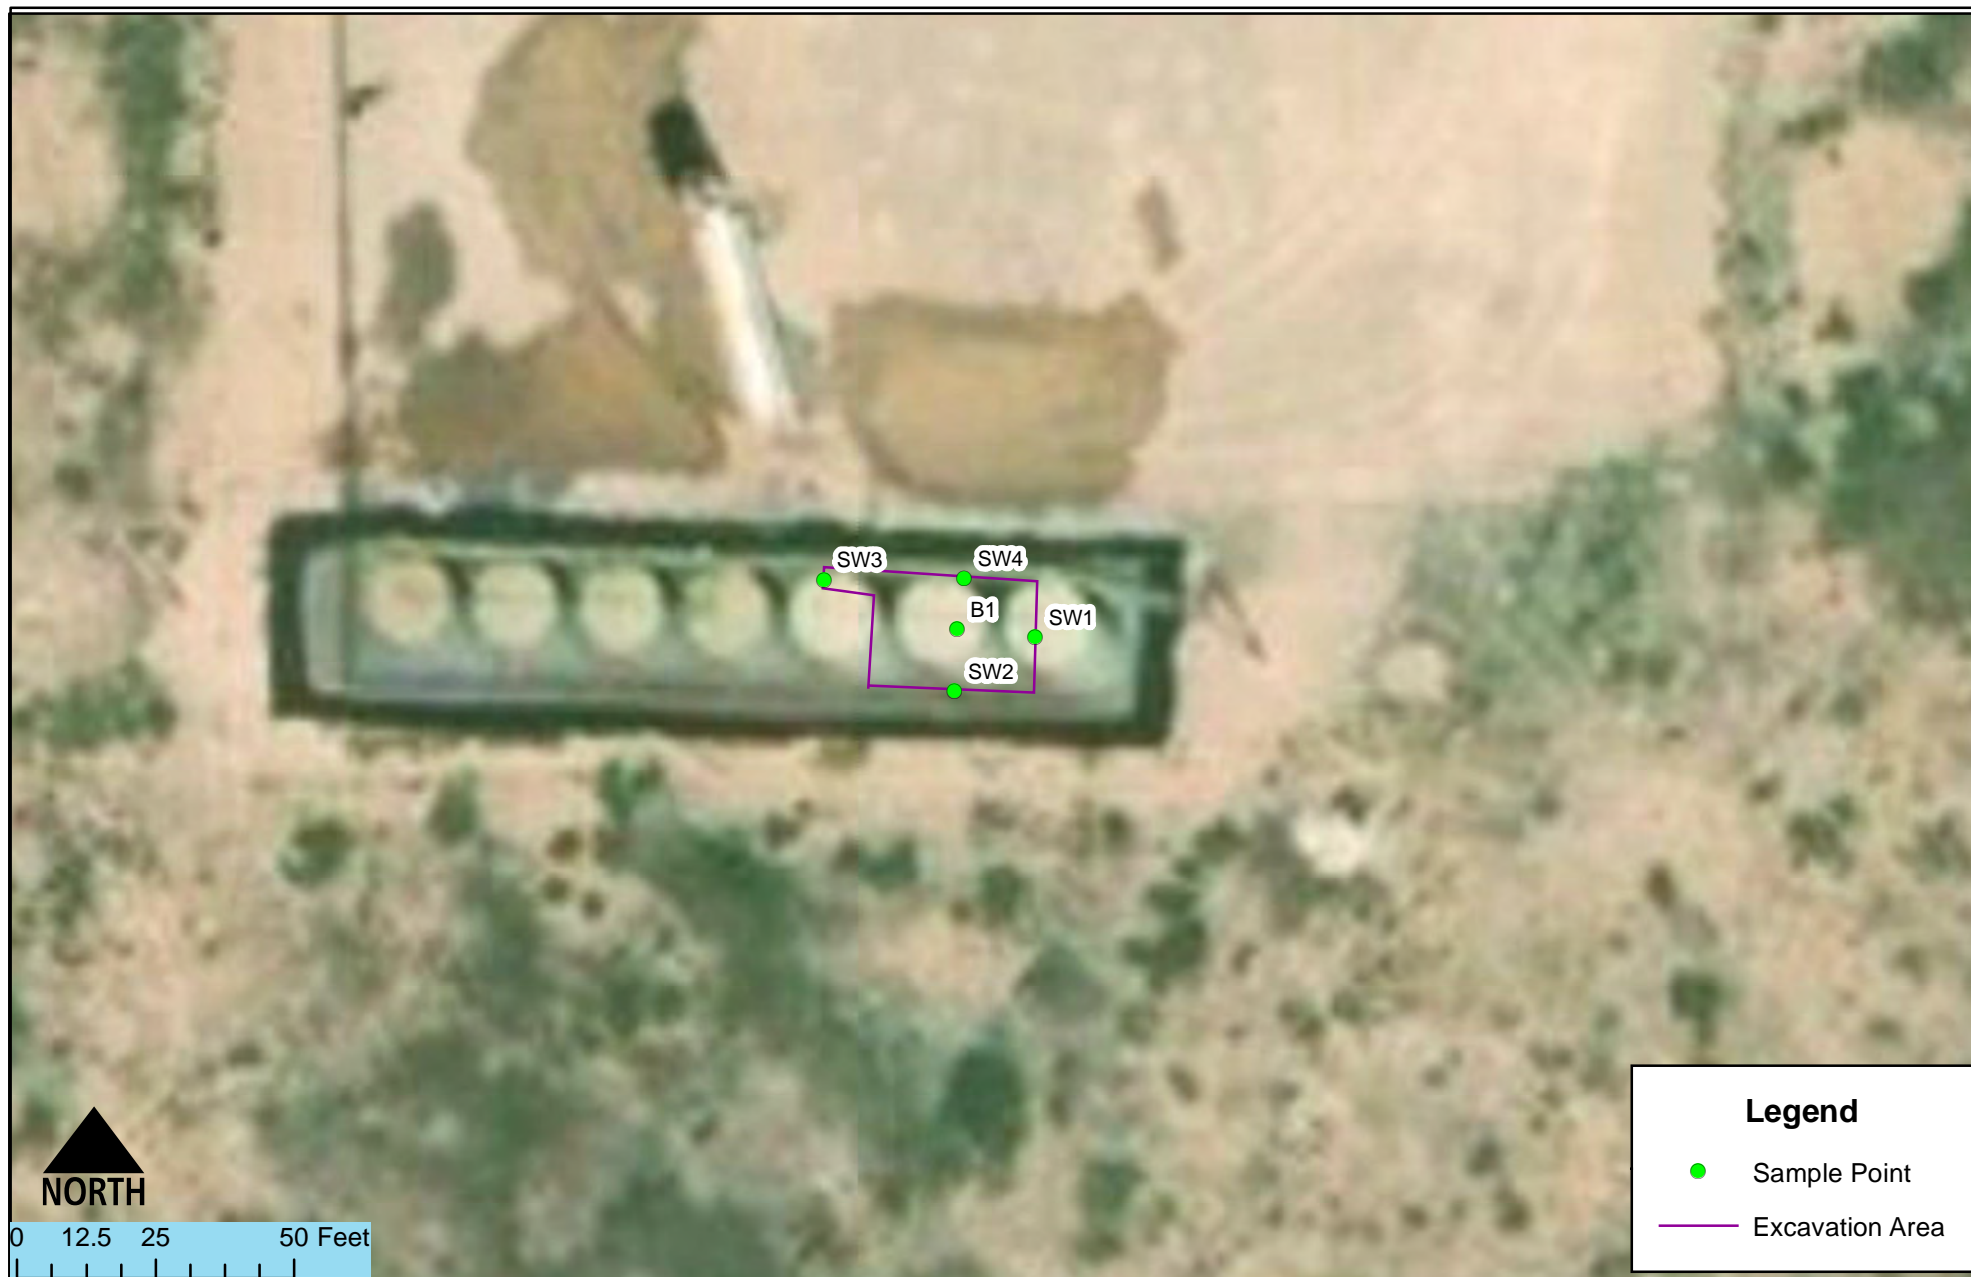
Figure 2

On July 17, 2018, SMA oversaw removal of visually impacted soils with the aid of a backhoe service. The total excavation depth ranged from approximately 3 inches bgs to 10 inches bgs. Four sidewall samples (SW1-SW4) were collected to demonstrate horizontal delineation. Sidewall samples were field screened for hydrocarbon impact using a Dexsil® PetroFLAG TPH Analyzer and sent to HEAL for confirmation analysis of TPH (EPA Method 8015D). Visually stained soils were removed and replaced with clean backfill material to return the surface to previous contours. The contaminated soil was transported for proper disposal at an NMOCD permitted disposal facility. No further action is recommended at this time. Sample locations are depicted on Figure 2. All laboratory results are summarized in Table 3. Laboratory reports are included in Appendix C.

Site and Sample Location Map
 Cannonball 1H - Marathon
 S 20-T18S-R26E, New Mexico
