# REVISED REMEDIATION SUMMARY AND SITE CLOSURE REQUEST

CR-222 Tank Station  
June 2022 Crude Oil Release  
Latitude 32.772268, Longitude -103.884449  
Eddy County, New Mexico  
NMOCD Incident No. nAPP2215951311

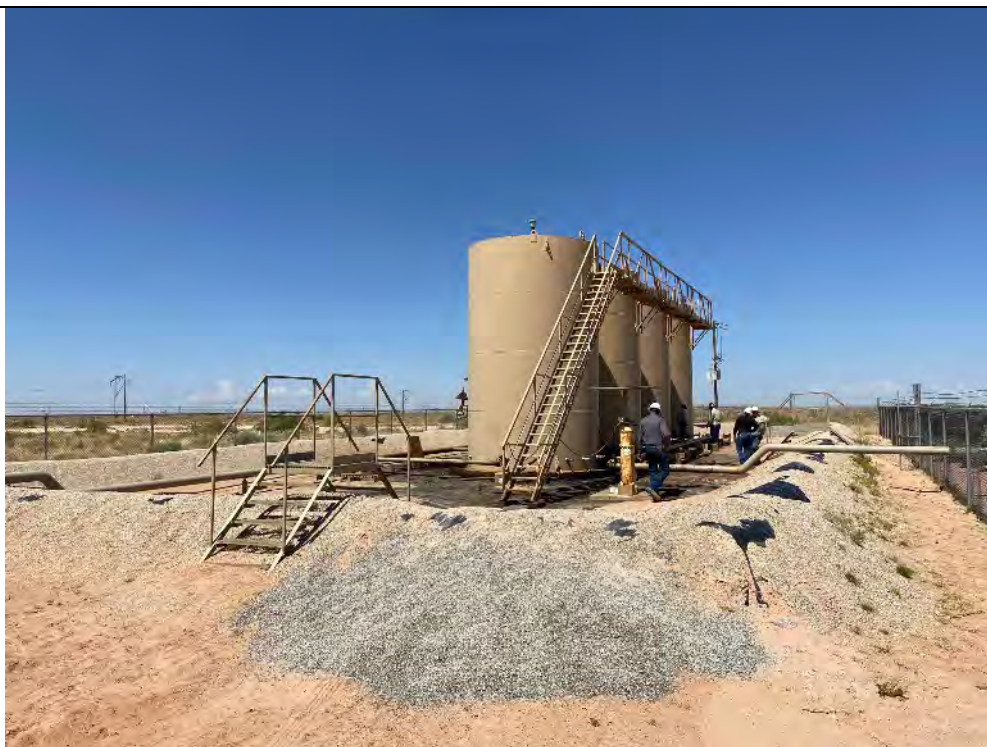
Photo 1: View southwest of the northern portion of the Site showing tanks, infrastructure, stairway, and walkway. The release occurred within the lined secondary containment area.

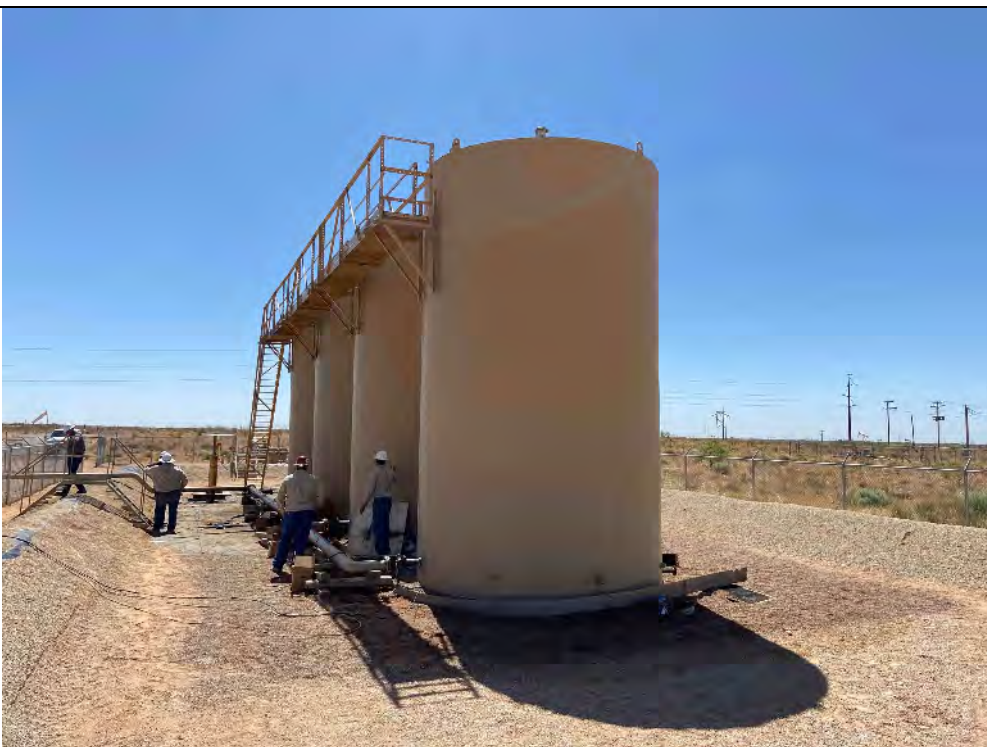
Photo 2: View east of the northern portion of the Site showing tanks, infrastructure, stairway, and walkway. The release occurred within the lined secondary containment area.

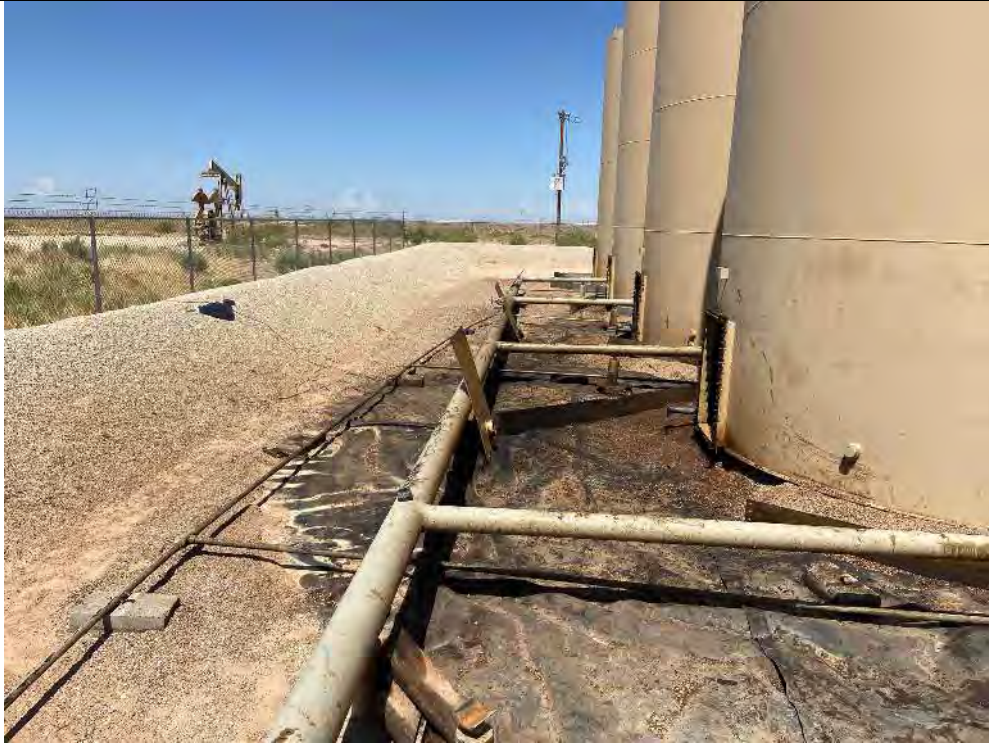
Photo 3: View west of the southern portion of the Site showing liner, tanks, infrastructure, stairway, and walkway.

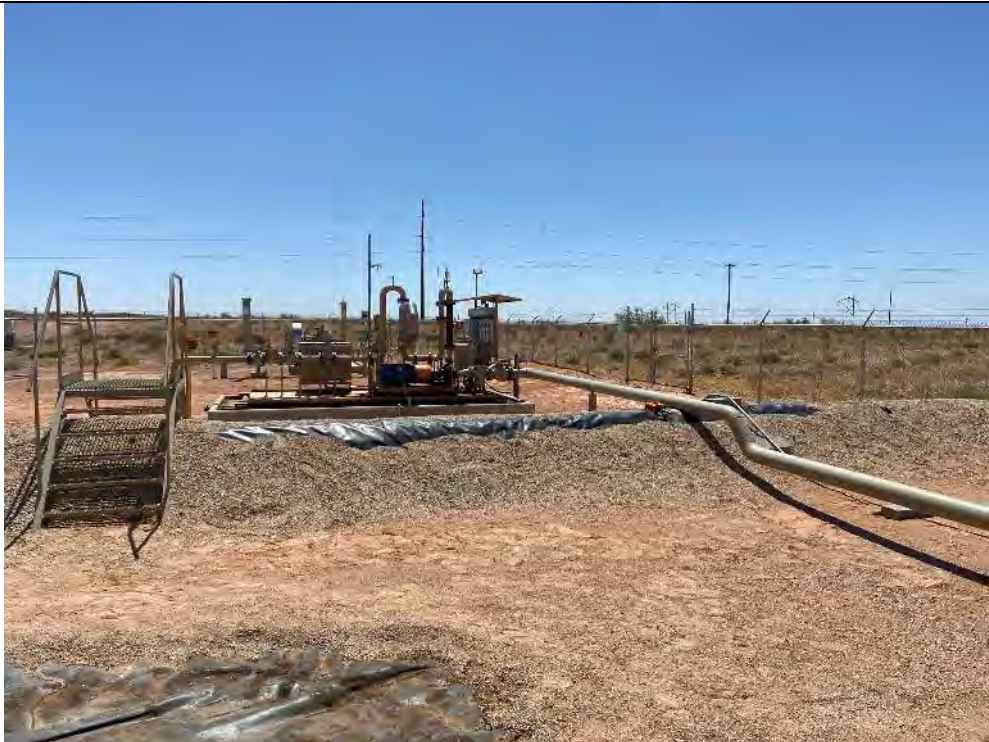
Photo 4: View east of the pump and associated pad, with aboveground steel piping extending into the lined secondary containment area.

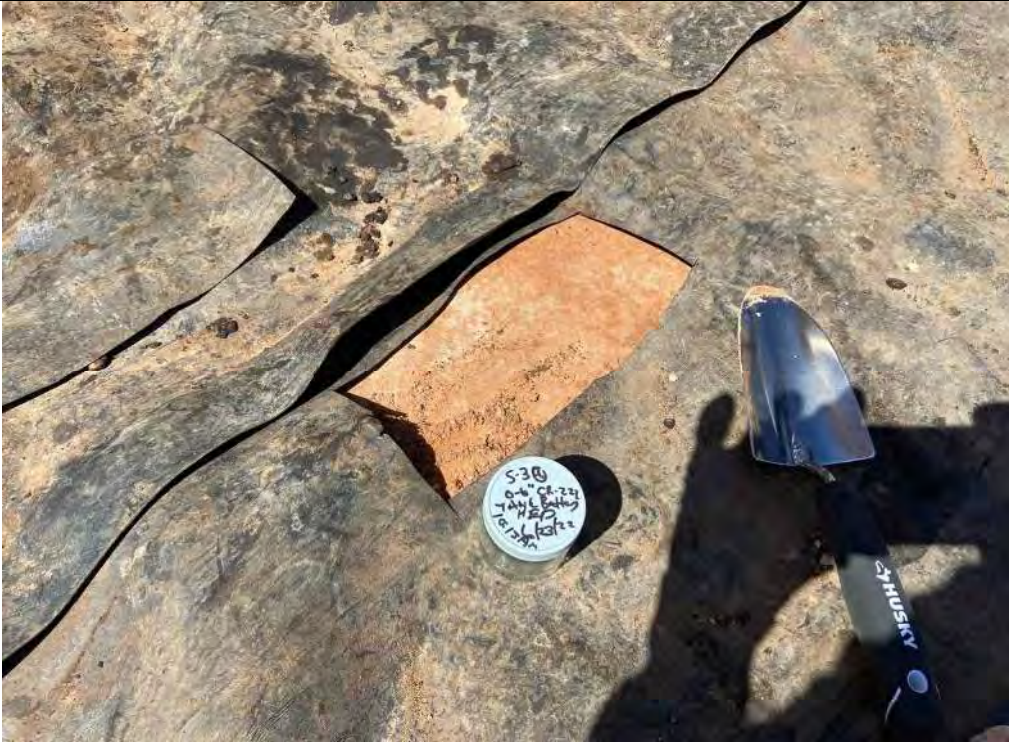
During excavation and removal of the crude oil-affected pea gravel, five small holes or tears up to one inch in extent were observed in the liner by HEP. The small liner holes were located within or adjacent to the crude oil-affected surface area. HEP requested that TRC conduct a third-party liner inspection and investigate the potential presence of affected soil underlying the small holes. On June 7, 2022, TRC notified NMOCD of the intent to inspect the liner and collect soil samples in accordance with NMAC 19.15.29.12 D(1)(a). On June 23, 2022, TRC inspected the liner, confirmed the presence of five small holes in the liner within or adjacent to the crude oil-affected surface area, and collected soil samples beneath each of the liner holes. The investigation activities were conducted in accordance with the NMOCD rule 19.15.29 NMAC.

Photo 7: View of S-3 sample location. Holes in the liner were expanded for access and samples were collected directly beneath liner holes.

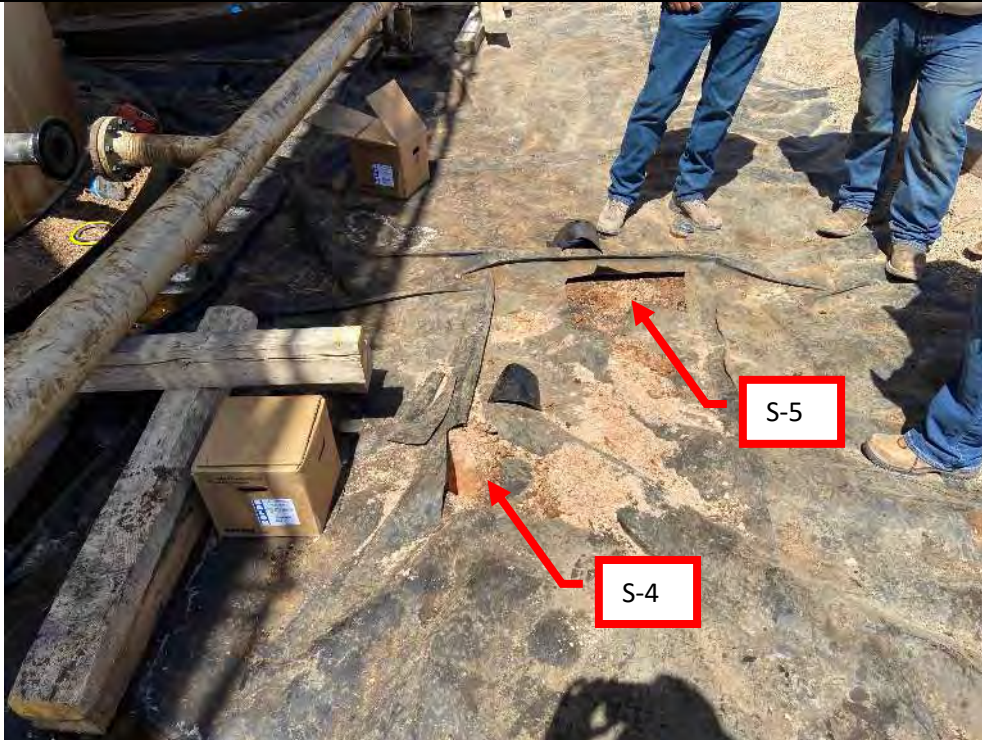
Photo 8: Sample locations S-4 and S-5 are located approximately 2 to 3 feet from the aboveground steel piping on the northern side of the tanks.

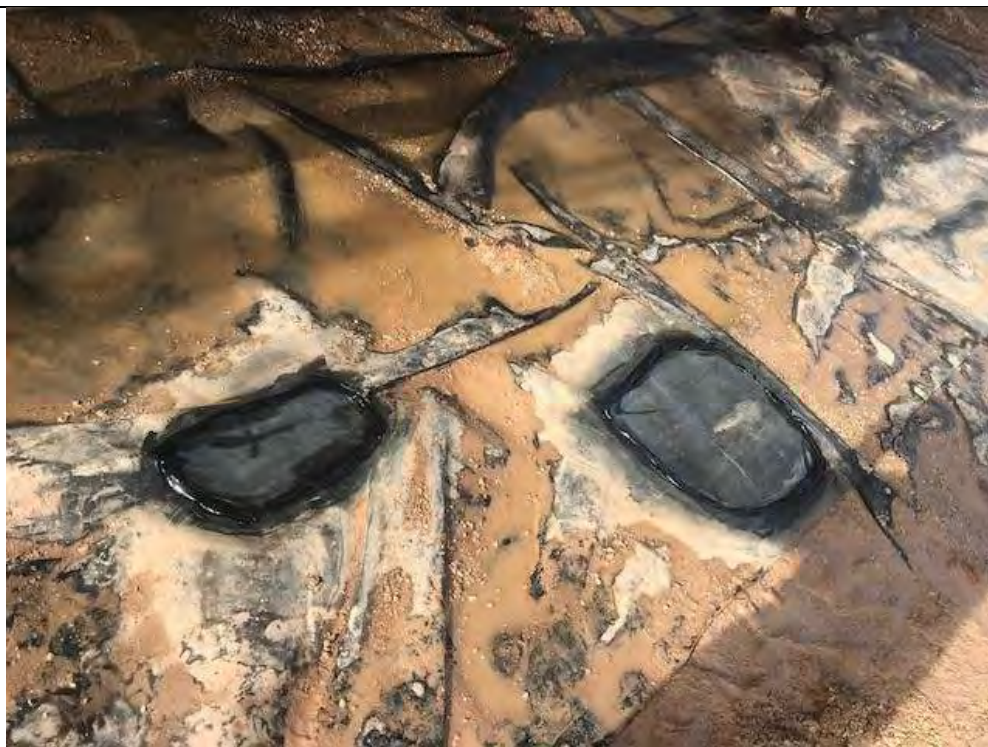
Photo 9: View of the repaired liner in the S-4 and S-5 area. The secondary containment liner has been repaired, inspected, and determined to be in good condition. The repaired liner will prevent vertical migration of contaminants of concern (COCs) left in situ.

As discussed in Section 4.5, affected soils are present beneath two of the five small holes observed in the liner within the bermed containment area. The affected soils were investigated and delineated to the extent practicable in accordance with NMODC guidelines, including along the edge of the release area and outside of the bermed containment area. Excavation and/or additional delineation of the affected soils beneath the liner are impracticable due to the proximity of active and sensitive industrial equipment and infrastructure. The liner has been repaired, inspected, and determined to be in good condition.

- The PVC liner has been repaired and will inhibit future stormwater infiltration through the affected soil and the potential for vertical migration of any remaining COCs.

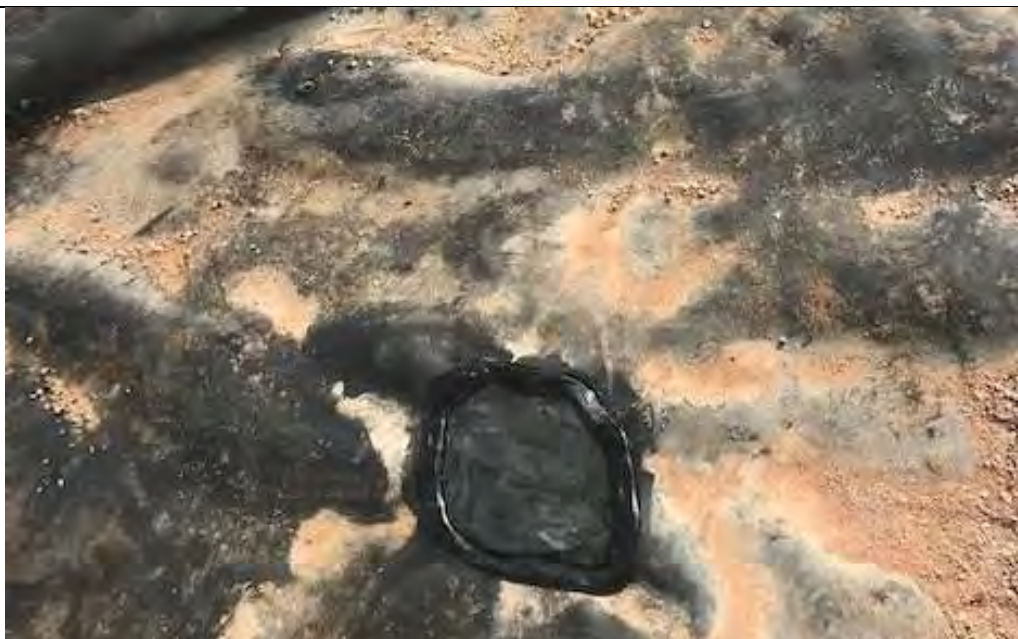
Photo 10: View of the repaired liner in the S-2 area. The secondary containment liner has been repaired, inspected, and determined to be in good condition. The repaired liner will prevent vertical migration of COCs left in situ.

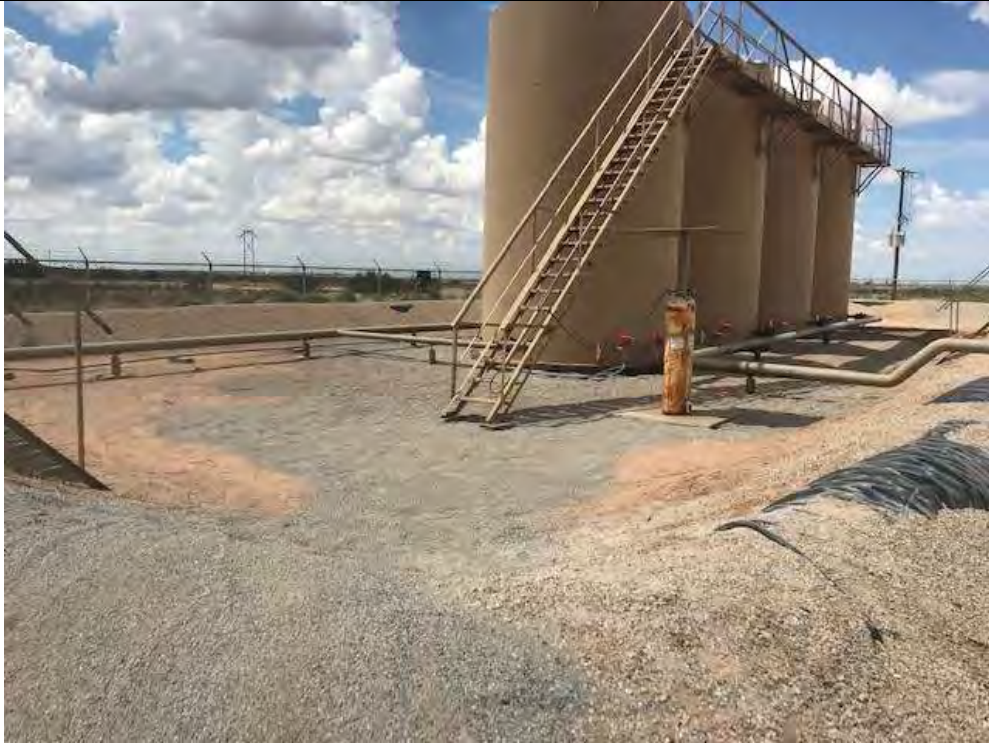
Photo 11: View southwest of the backfill of the lined secondary containment area. Clean pea gravel was placed over the repaired liner.

Following sampling, the sample locations were backfilled with native soil and the five small holes in the liner were repaired by HEP. The excavated and removed pea gravel within the secondary containment area was replaced with clean pea gravel on August 26, 2022.

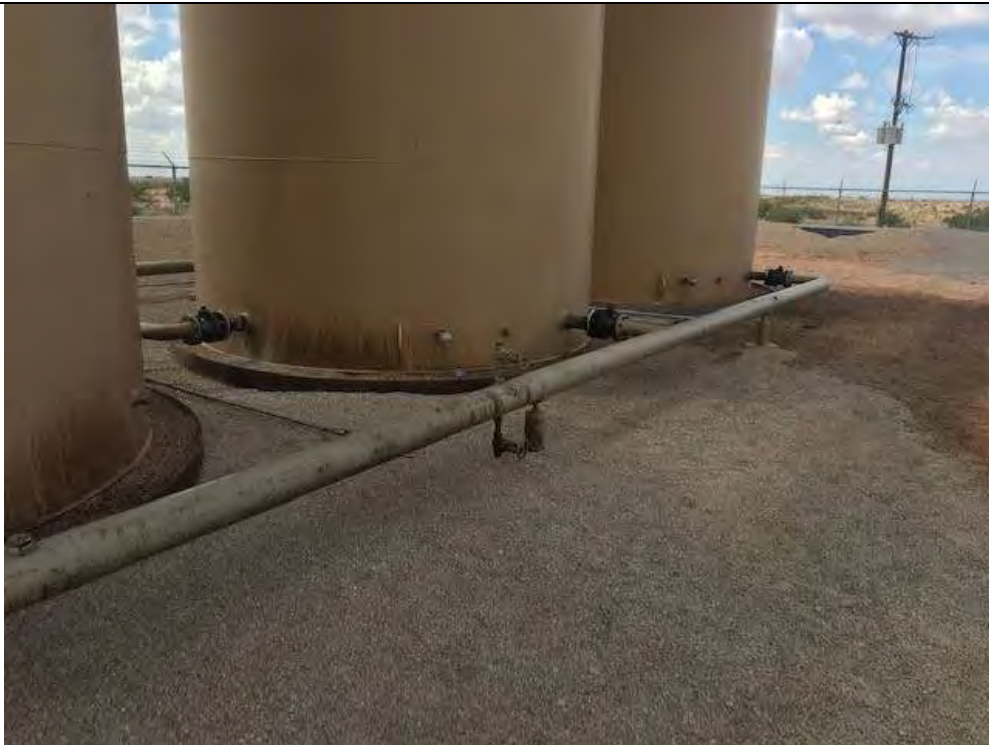
Photo 12: View southwest of the backfill of the lined secondary containment area. Clean pea gravel was placed over the repaired liner.

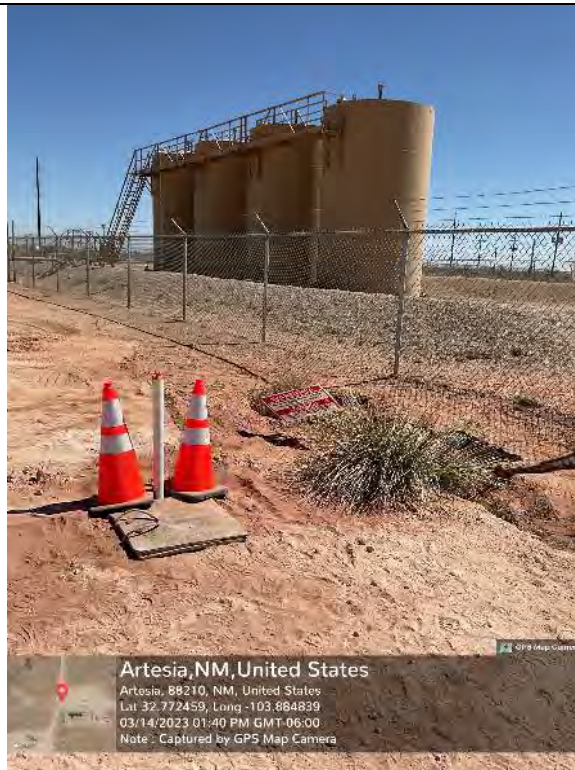
Photo 14: View southwest of TMW-1 installed.

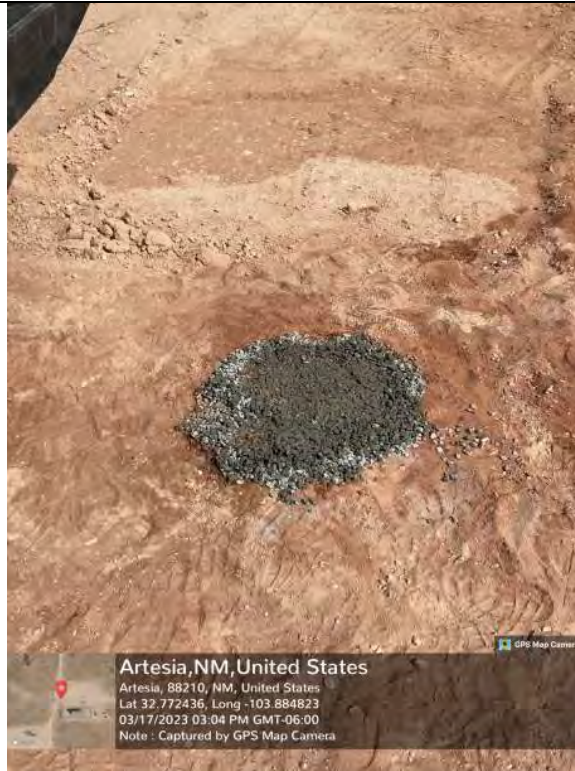
Photo 15: View of TMW-1 plugged after gauging (no water).
