**Re: Remediation Work Plan
ConocoPhillips
James A Battery Line Release
Unit Letter J, Section 2, Township 22 South, Range 30 East
Eddy County, New Mexico
2RP-406
Incident ID nMLB1011352696**

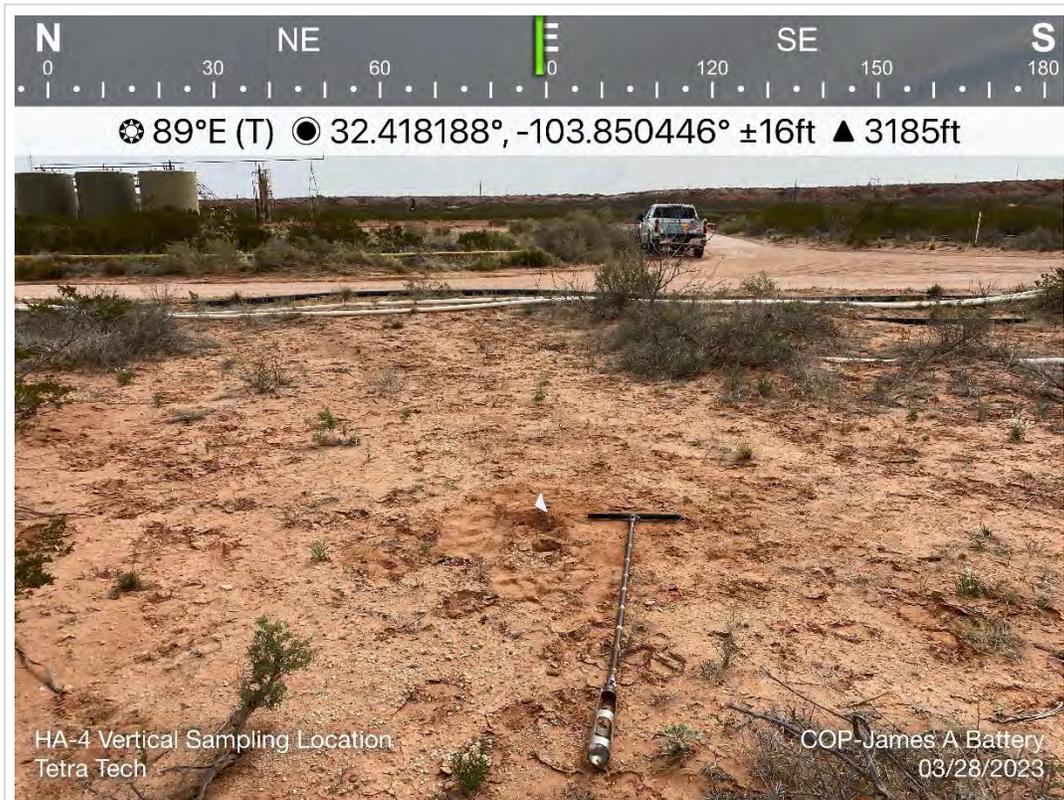
TETRA TECH, INC. PROJECT NO. 212C-MD-02355	DESCRIPTION	View east from HA-4 vertical sampling location.	1
	SITE NAME	James A Battery (2RP-406) Release	3/28/2023

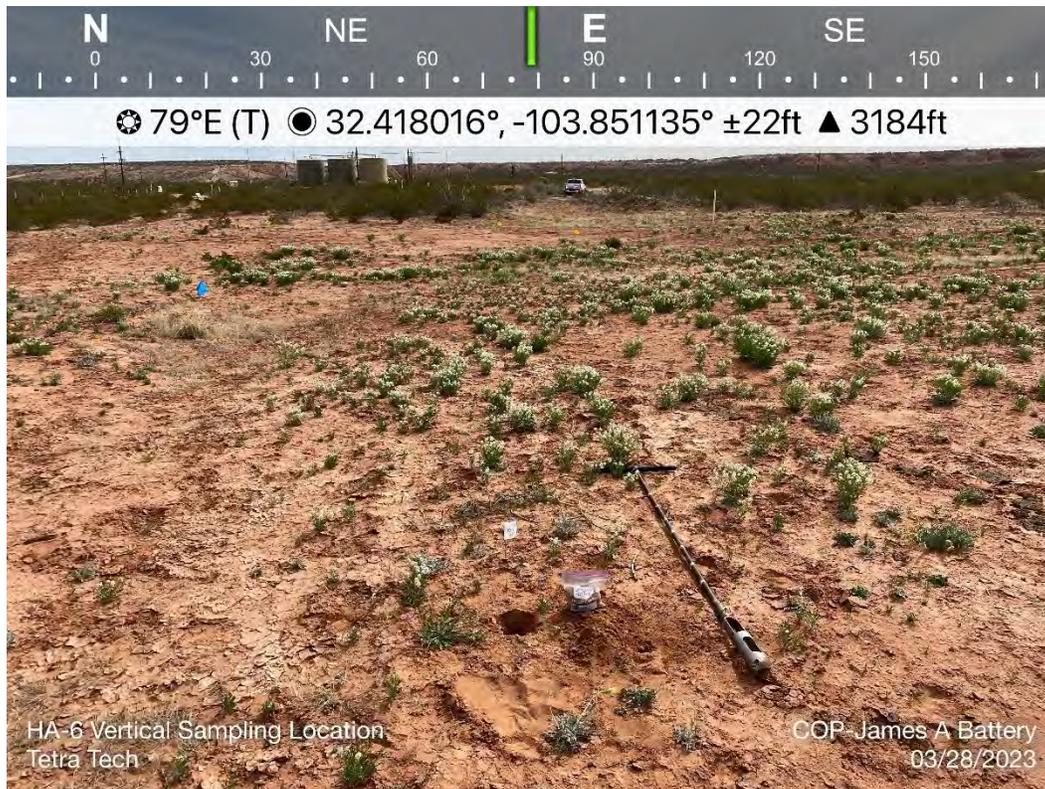
TETRA TECH, INC. PROJECT NO. 212C-MD-02355	DESCRIPTION	View east from HA-6 vertical sampling location.	2
	SITE NAME	James A Battery (2RP-406) Release	3/28/2023

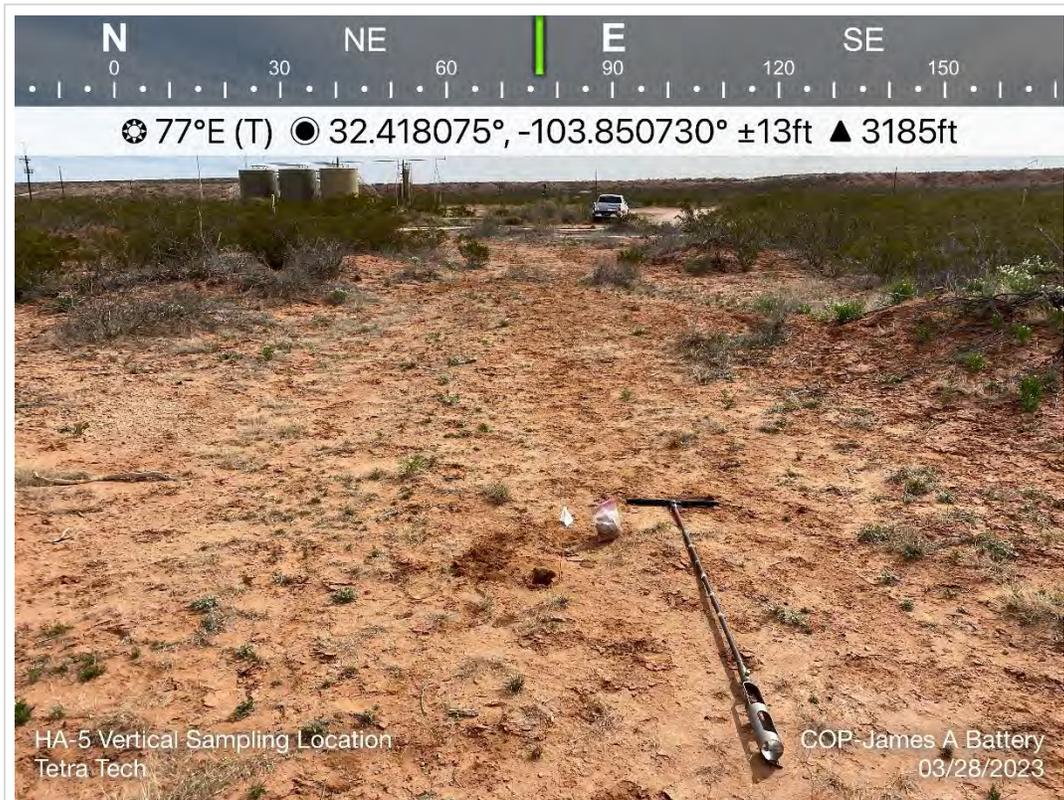
TETRA TECH, INC. PROJECT NO. 212C-MD-02355	DESCRIPTION	View east from HA-5 vertical sampling location.	3
	SITE NAME	James A Battery (2RP-406) Release	3/28/2023

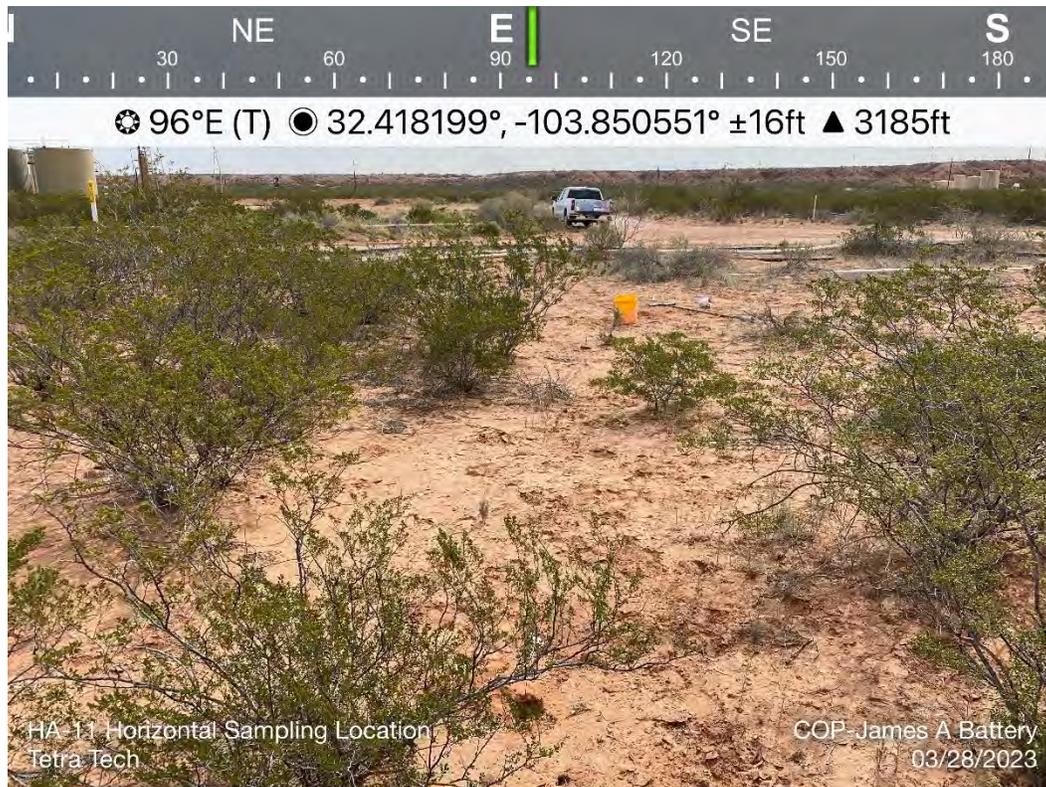
TETRA TECH, INC. PROJECT NO. 212C-MD-02355	DESCRIPTION	View east from HA-11 horizontal sampling location.	4
	SITE NAME	James A Battery (2RP-406) Release	3/28/2023

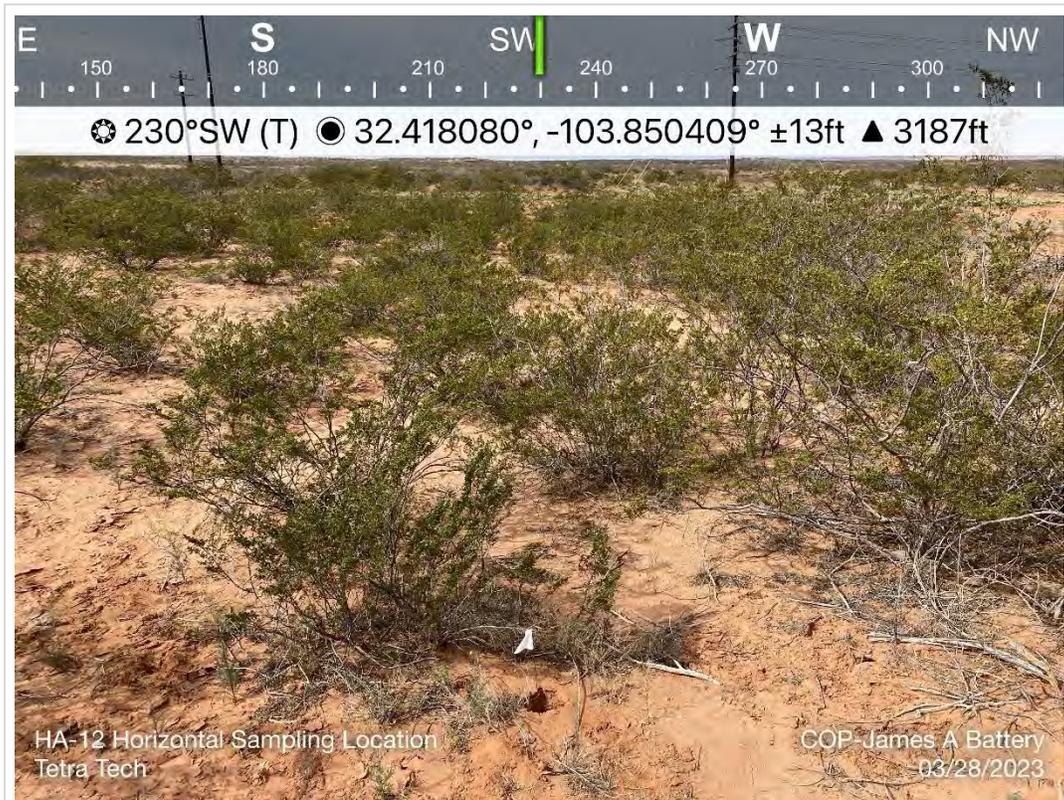
TETRA TECH, INC. PROJECT NO. 212C-MD-02355	DESCRIPTION	View southwest from HA-12 horizontal sampling location.	5
	SITE NAME	James A Battery (2RP-406) Release	3/28/2023

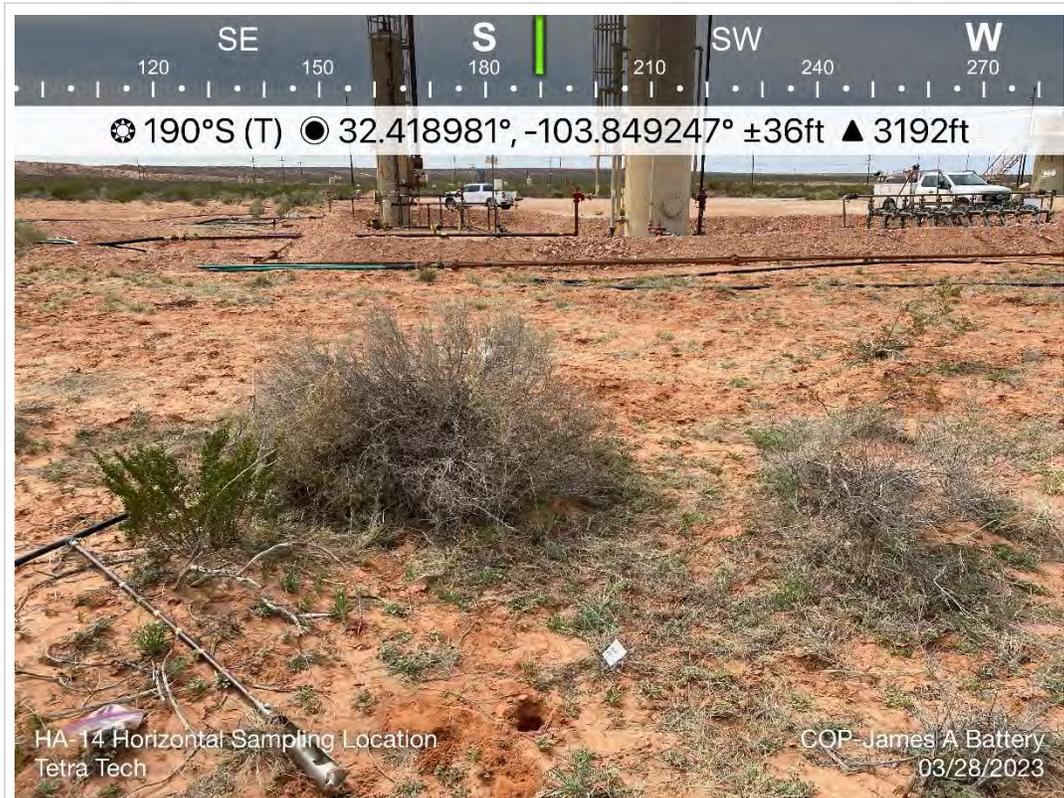
TETRA TECH, INC. PROJECT NO. 212C-MD-02355	DESCRIPTION	View south from HA-14 horizontal sampling location.	6
	SITE NAME	James A Battery (2RP-406) Release	3/28/2023

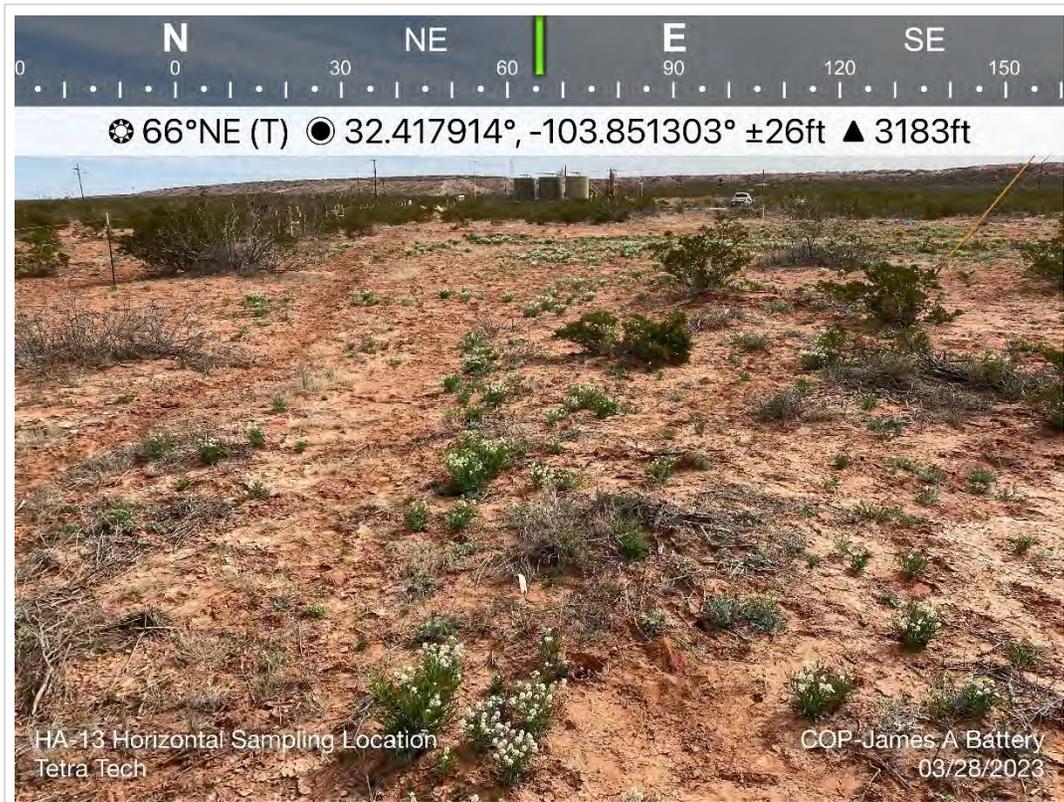
TETRA TECH, INC. PROJECT NO. 212C-MD-02355	DESCRIPTION	View east-northeast from HA-13 horizontal sampling location.	7
	SITE NAME	James A Battery (2RP-406) Release	3/28/2023

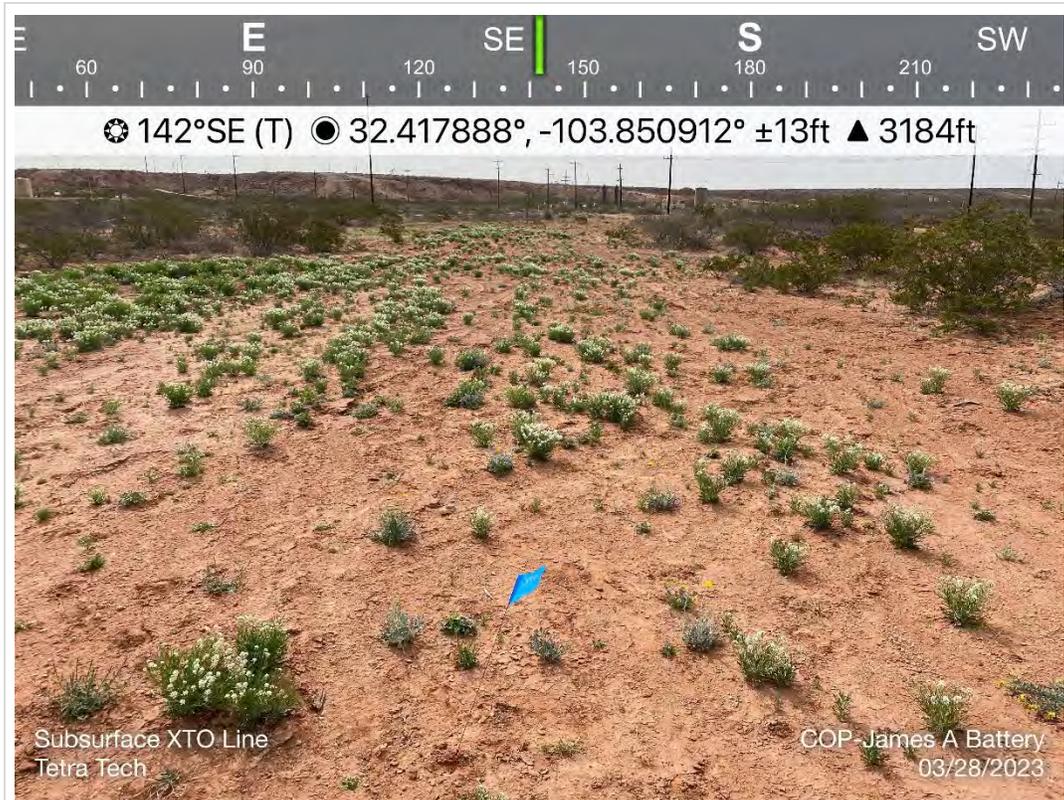
TETRA TECH, INC. PROJECT NO. 212C-MD-02355	DESCRIPTION	View southeast of subsurface XTO line.	8
	SITE NAME	James A Battery (2RP-406) Release	3/28/2023

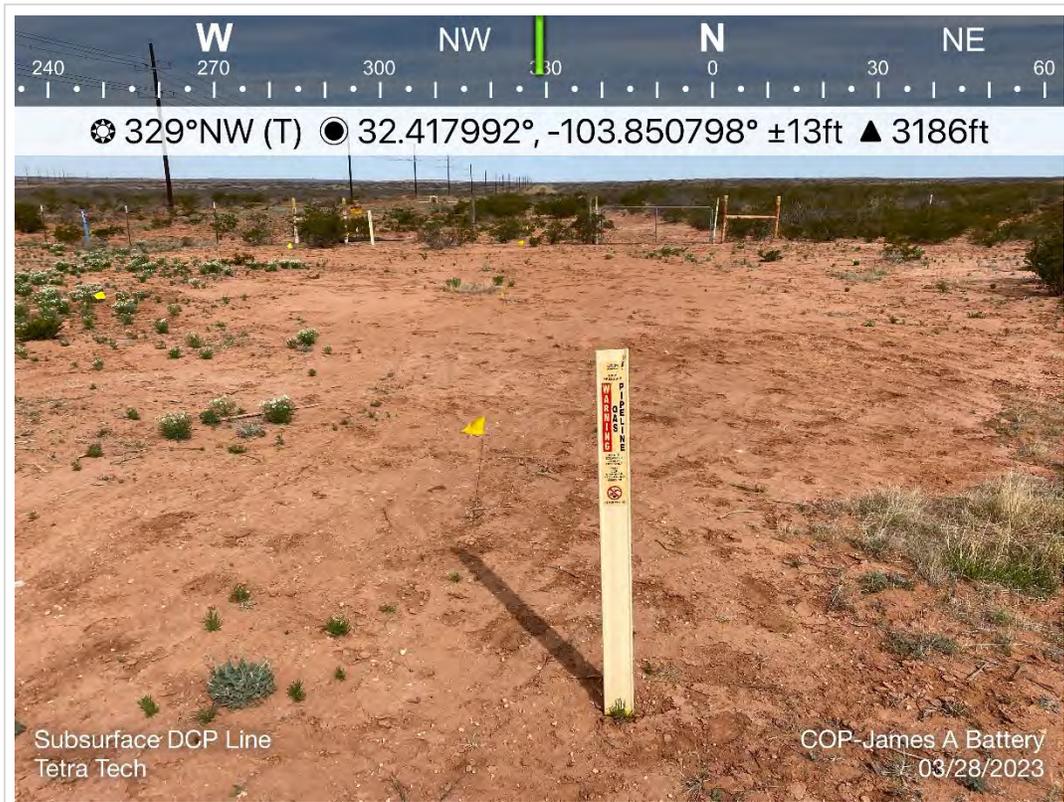
TETRA TECH, INC. PROJECT NO. 212C-MD-02355	DESCRIPTION	View northwest of subsurface DCP line.	9
	SITE NAME	James A Battery (2RP-406) Release	3/28/2023

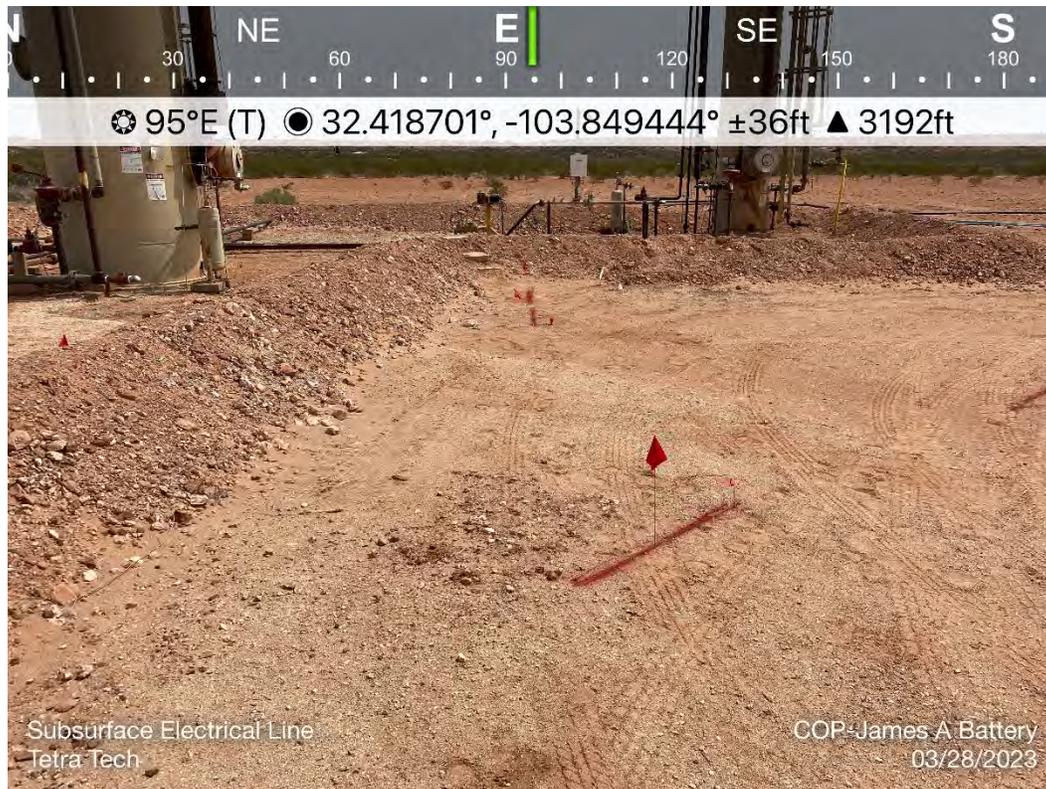
TETRA TECH, INC. PROJECT NO. 212C-MD-02355	DESCRIPTION	View east of subsurface electrical line.	10
	SITE NAME	James A Battery (2RP-406) Release	3/28/2023

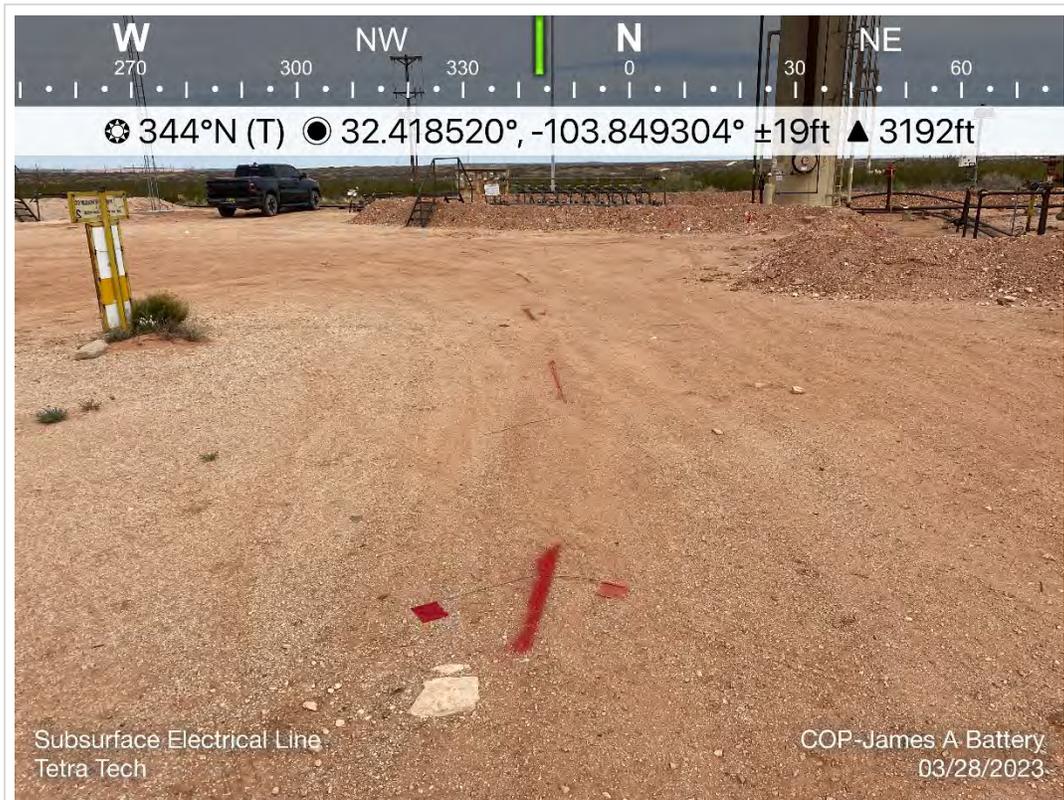
TETRA TECH, INC. PROJECT NO. 212C-MD-02355	DESCRIPTION	View north-northwest of subsurface electrical line.	11
	SITE NAME	James A Battery (2RP-406) Release	3/28/2023

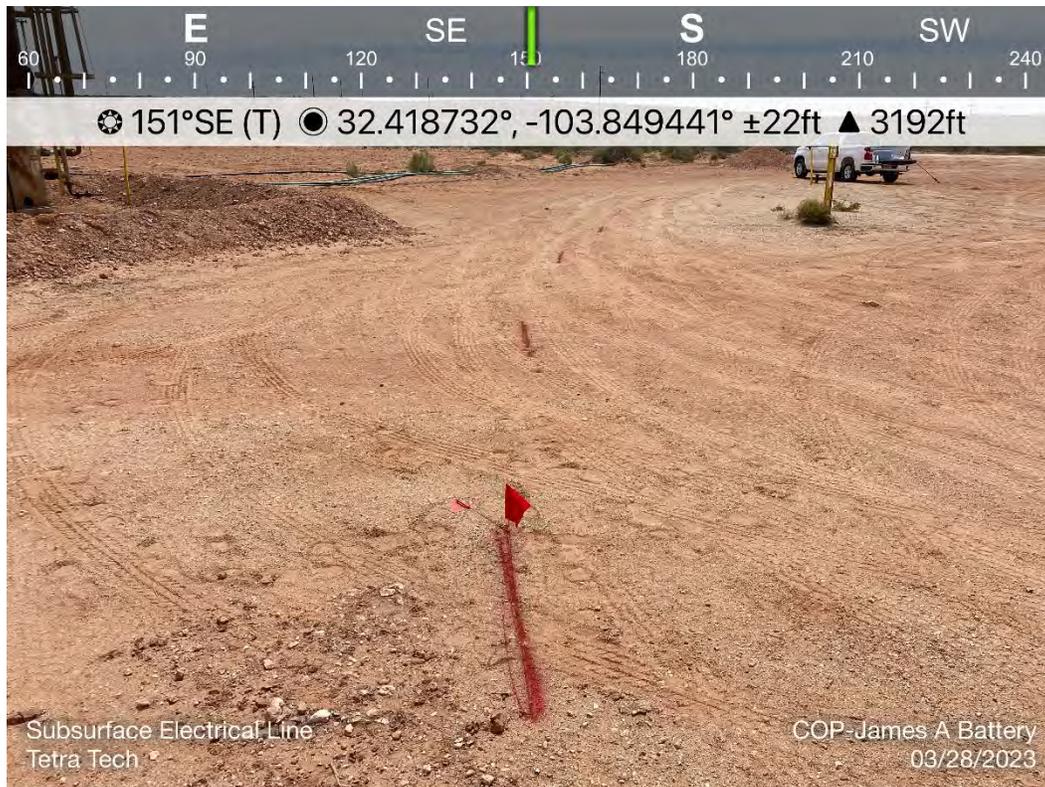
TETRA TECH, INC. PROJECT NO. 212C-MD-02355	DESCRIPTION	View south-southeast of subsurface electrical line.	12
	SITE NAME	James A Battery (2RP-406) Release	3/28/2023

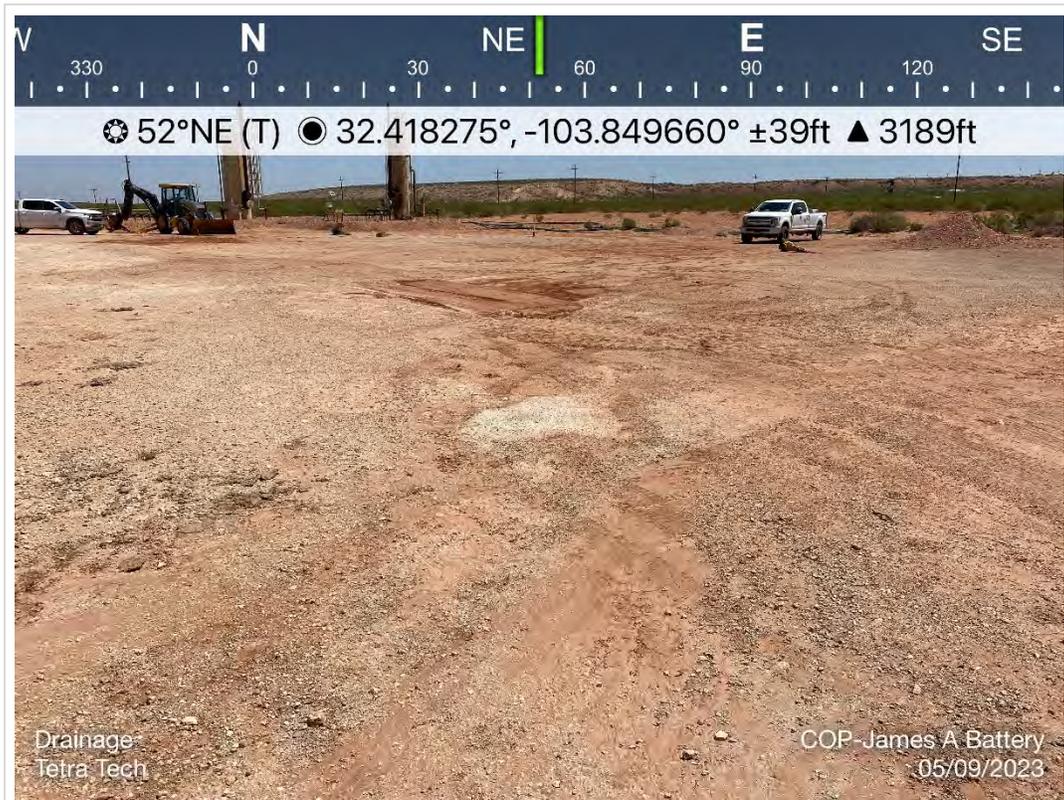
TETRA TECH, INC. PROJECT NO. 212C-MD-02355	DESCRIPTION	View northeast of the northern portion of the release footprint on the lease pad.	13
	SITE NAME	James A Battery (2RP-406) Release	5/9/2023

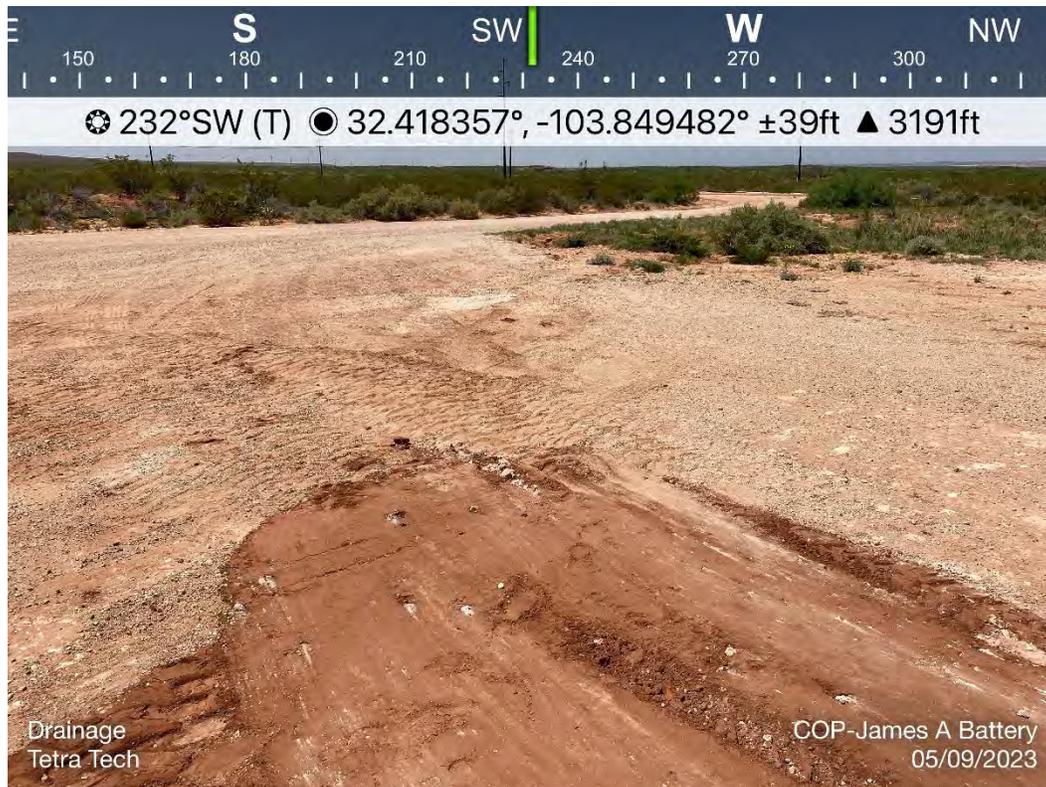
TETRA TECH, INC. PROJECT NO. 212C-MD-02355	DESCRIPTION	View southwest of the release footprint near the southwestern corner of the lease pad.	14
	SITE NAME	James A Battery (2RP-406) Release	5/9/2023
