Remediation Summary and Closure Request

**Frontier Field Services, LLC
Cedar Breaks 6" Steel LP Line
Eddy County, New Mexico
Unit Letter "N", Section 2, Township 18 South, Range 30 East
Latitude 32.772833 North, Longitude 103.945011 West
NMOCD Incident # nAPP2203941818**

January 2023

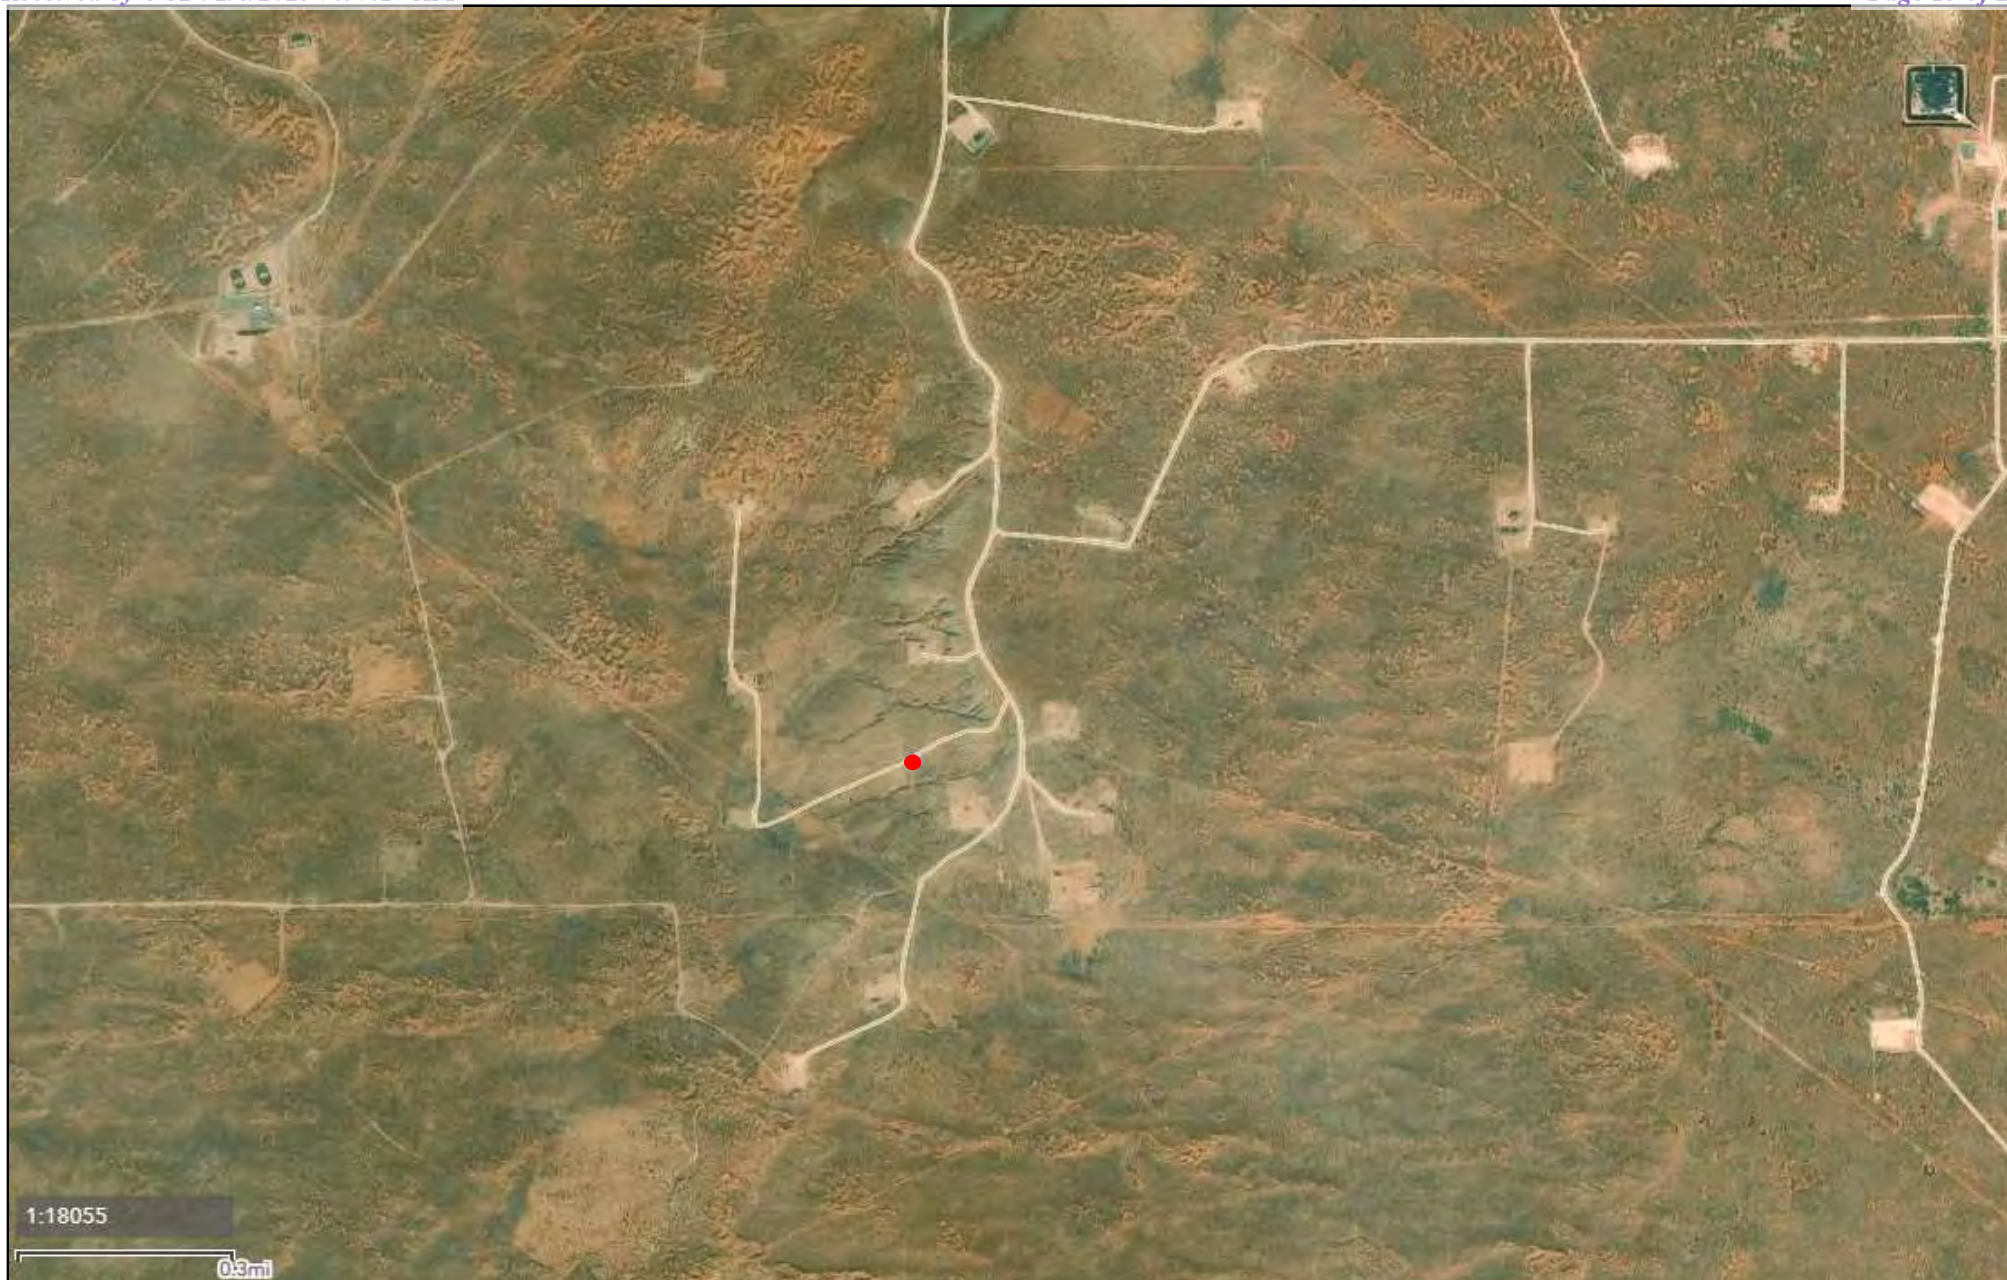
**Figure 2**

A search of the New Mexico Office of the State Engineer (NMOSE) and United States Geological Survey (USGS) groundwater databases was completed in an effort to determine the horizontal distance to known water sources within a half mile radius of the Release Site. Approximate depth to groundwater was determined using maintained and published water well data. Karst mapping indicates the site is not located in a Karst designated area. Karst and Wetland Maps are provided as Attachment I. Depth to groundwater information is provided as Attachment IV and the results are depicted on Figures 2 & 3.

OSE POD Locations Map
Frontier Field Services, LLC
Cedar Breaks 6" Steel LP Line
GPS: 32.772833, -103.945011
Eddy County

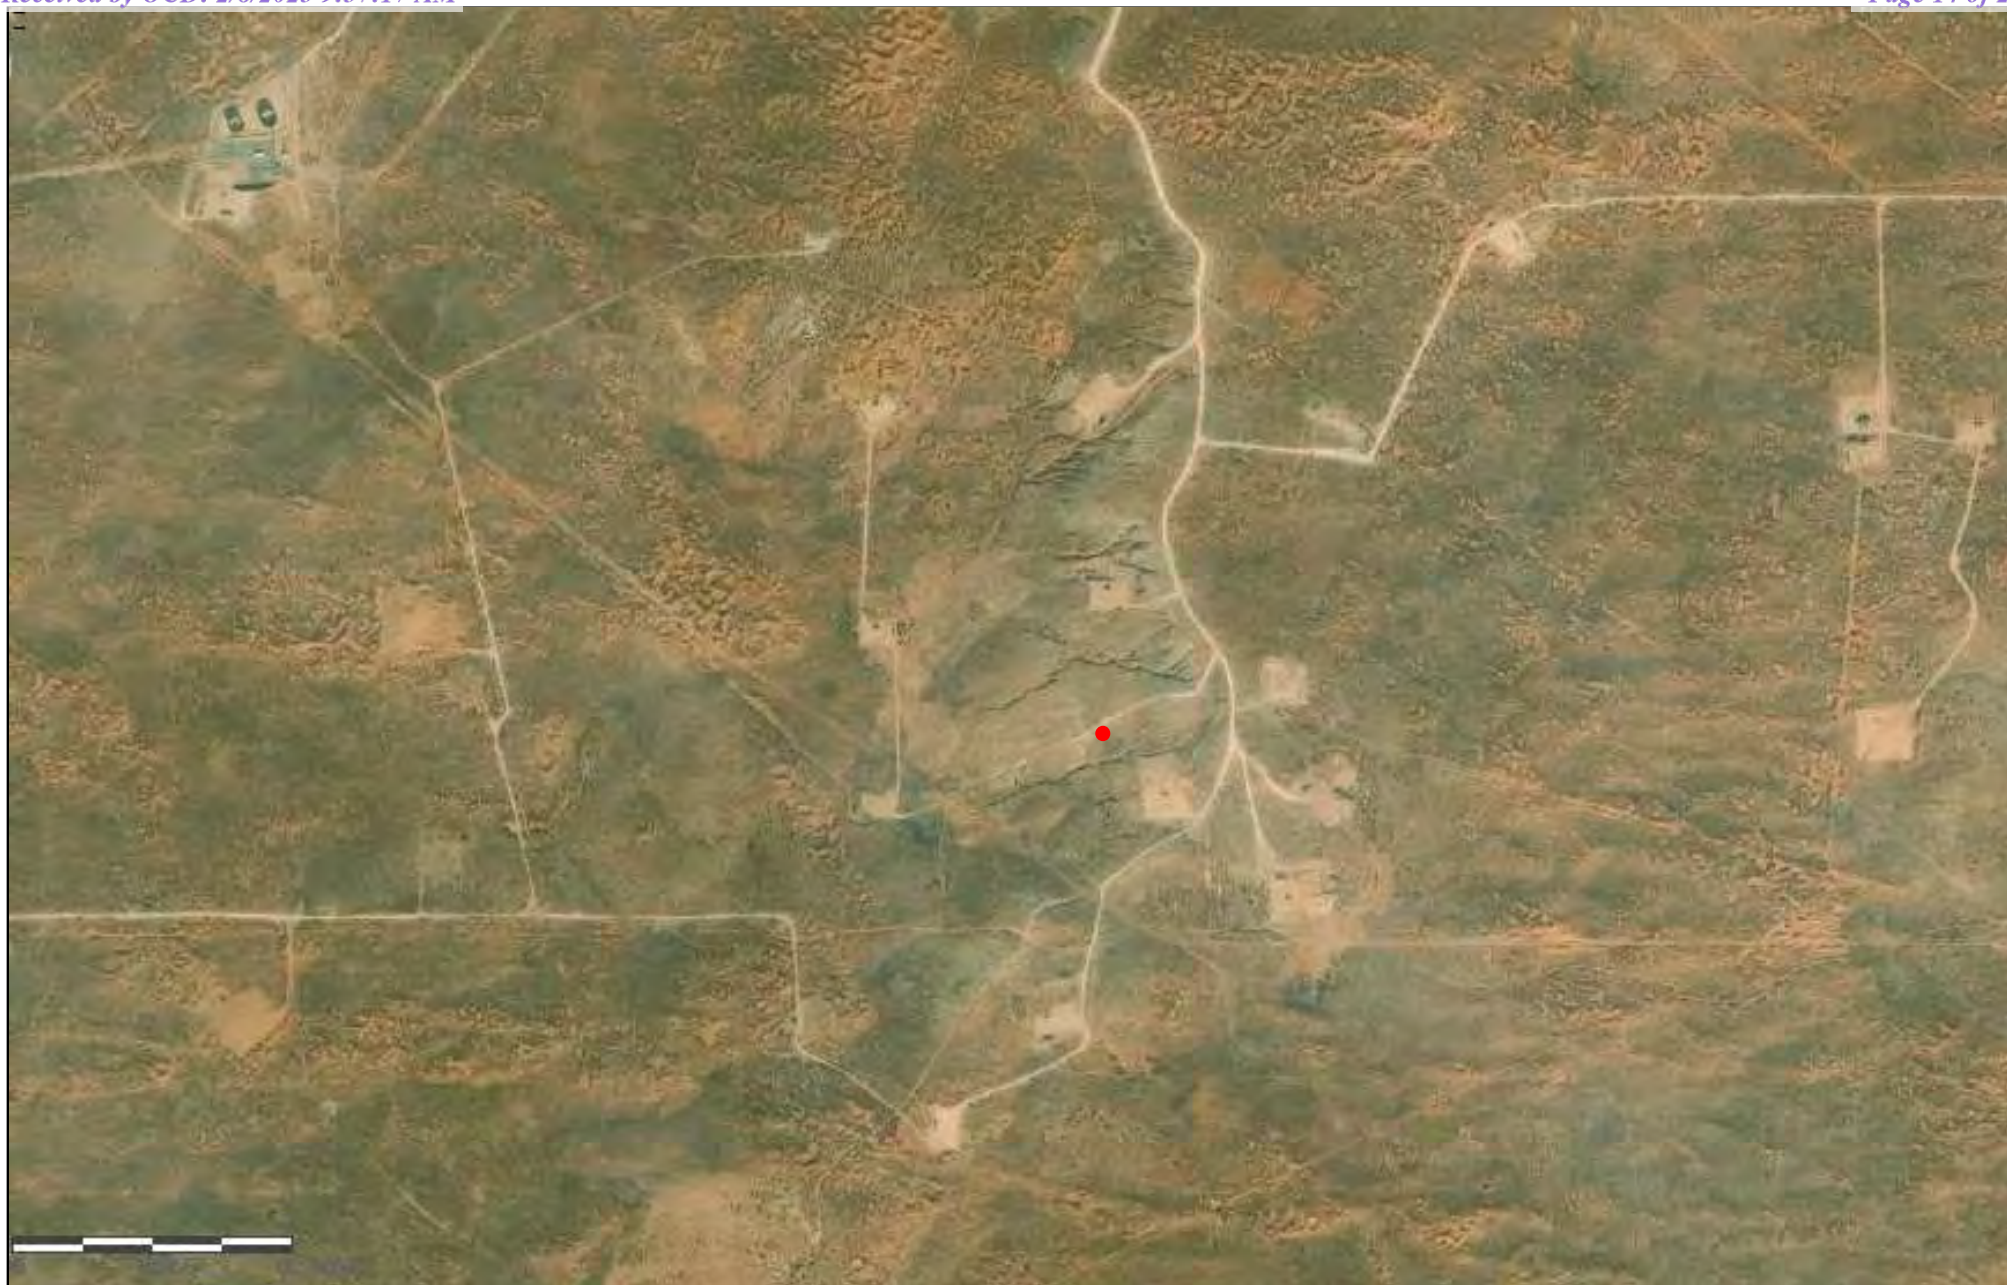
**Figure 3**

USGS Well Locations Map
Frontier Field Services, LLC
Cedar Breaks 6" Steel LP Line
GPS: 32.772833, -103.945011
Eddy County

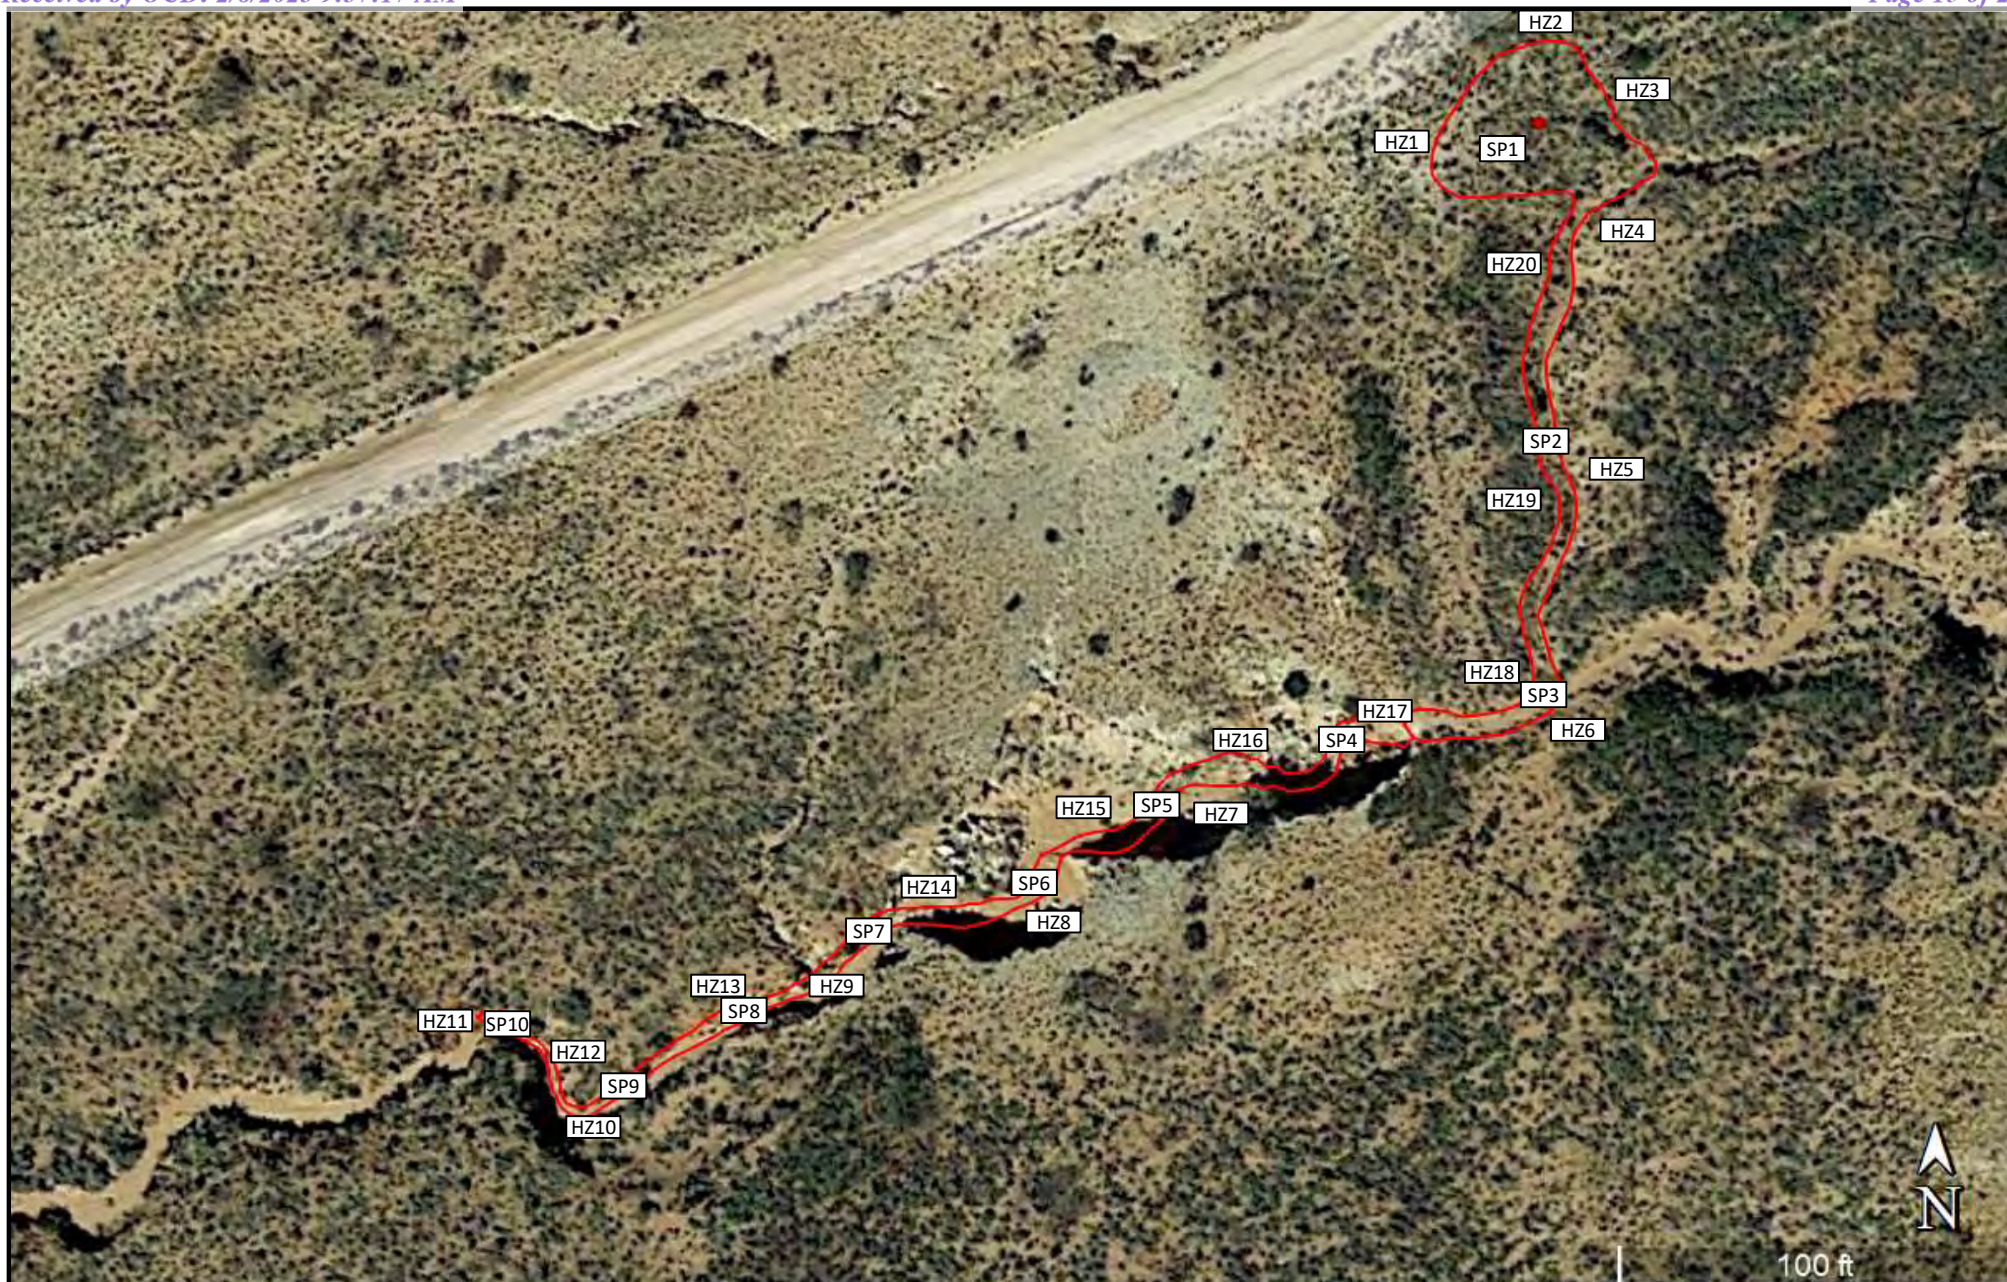
**Figure 4**

Delineation Sample Map
 Frontier Field Services, LLC
 Cedar Breaks 6" Steel LP Line
 GPS: 32.772833, -103.945011
 Eddy County

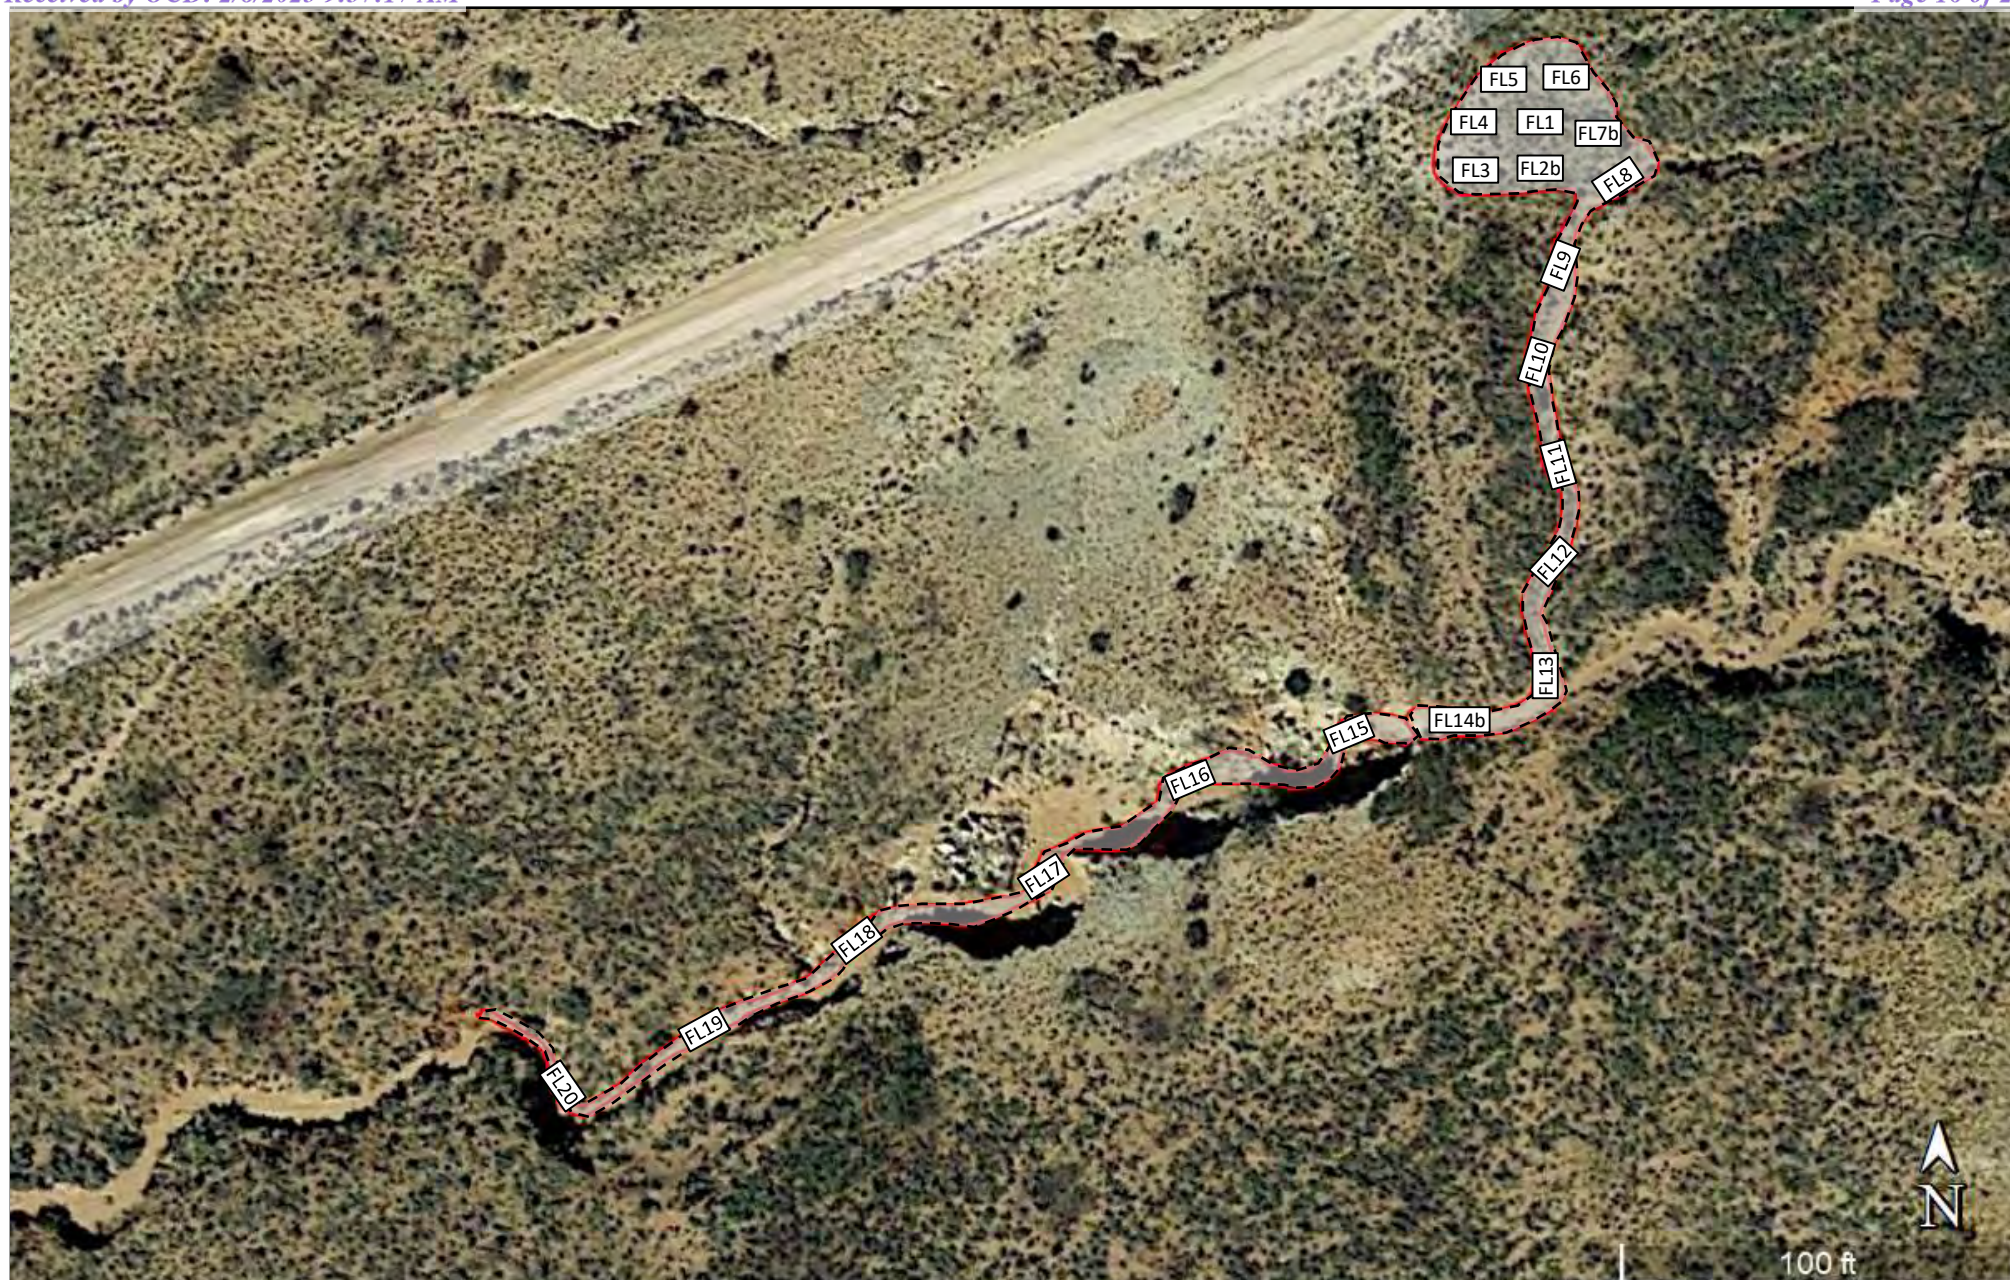
**Figure 5**

Excavation Floor Sample Map
 Frontier Field Services, LLC
 Cedar Breaks 6" Steel LP Line
 GPS: 32.772833, -103.945011
 Eddy County

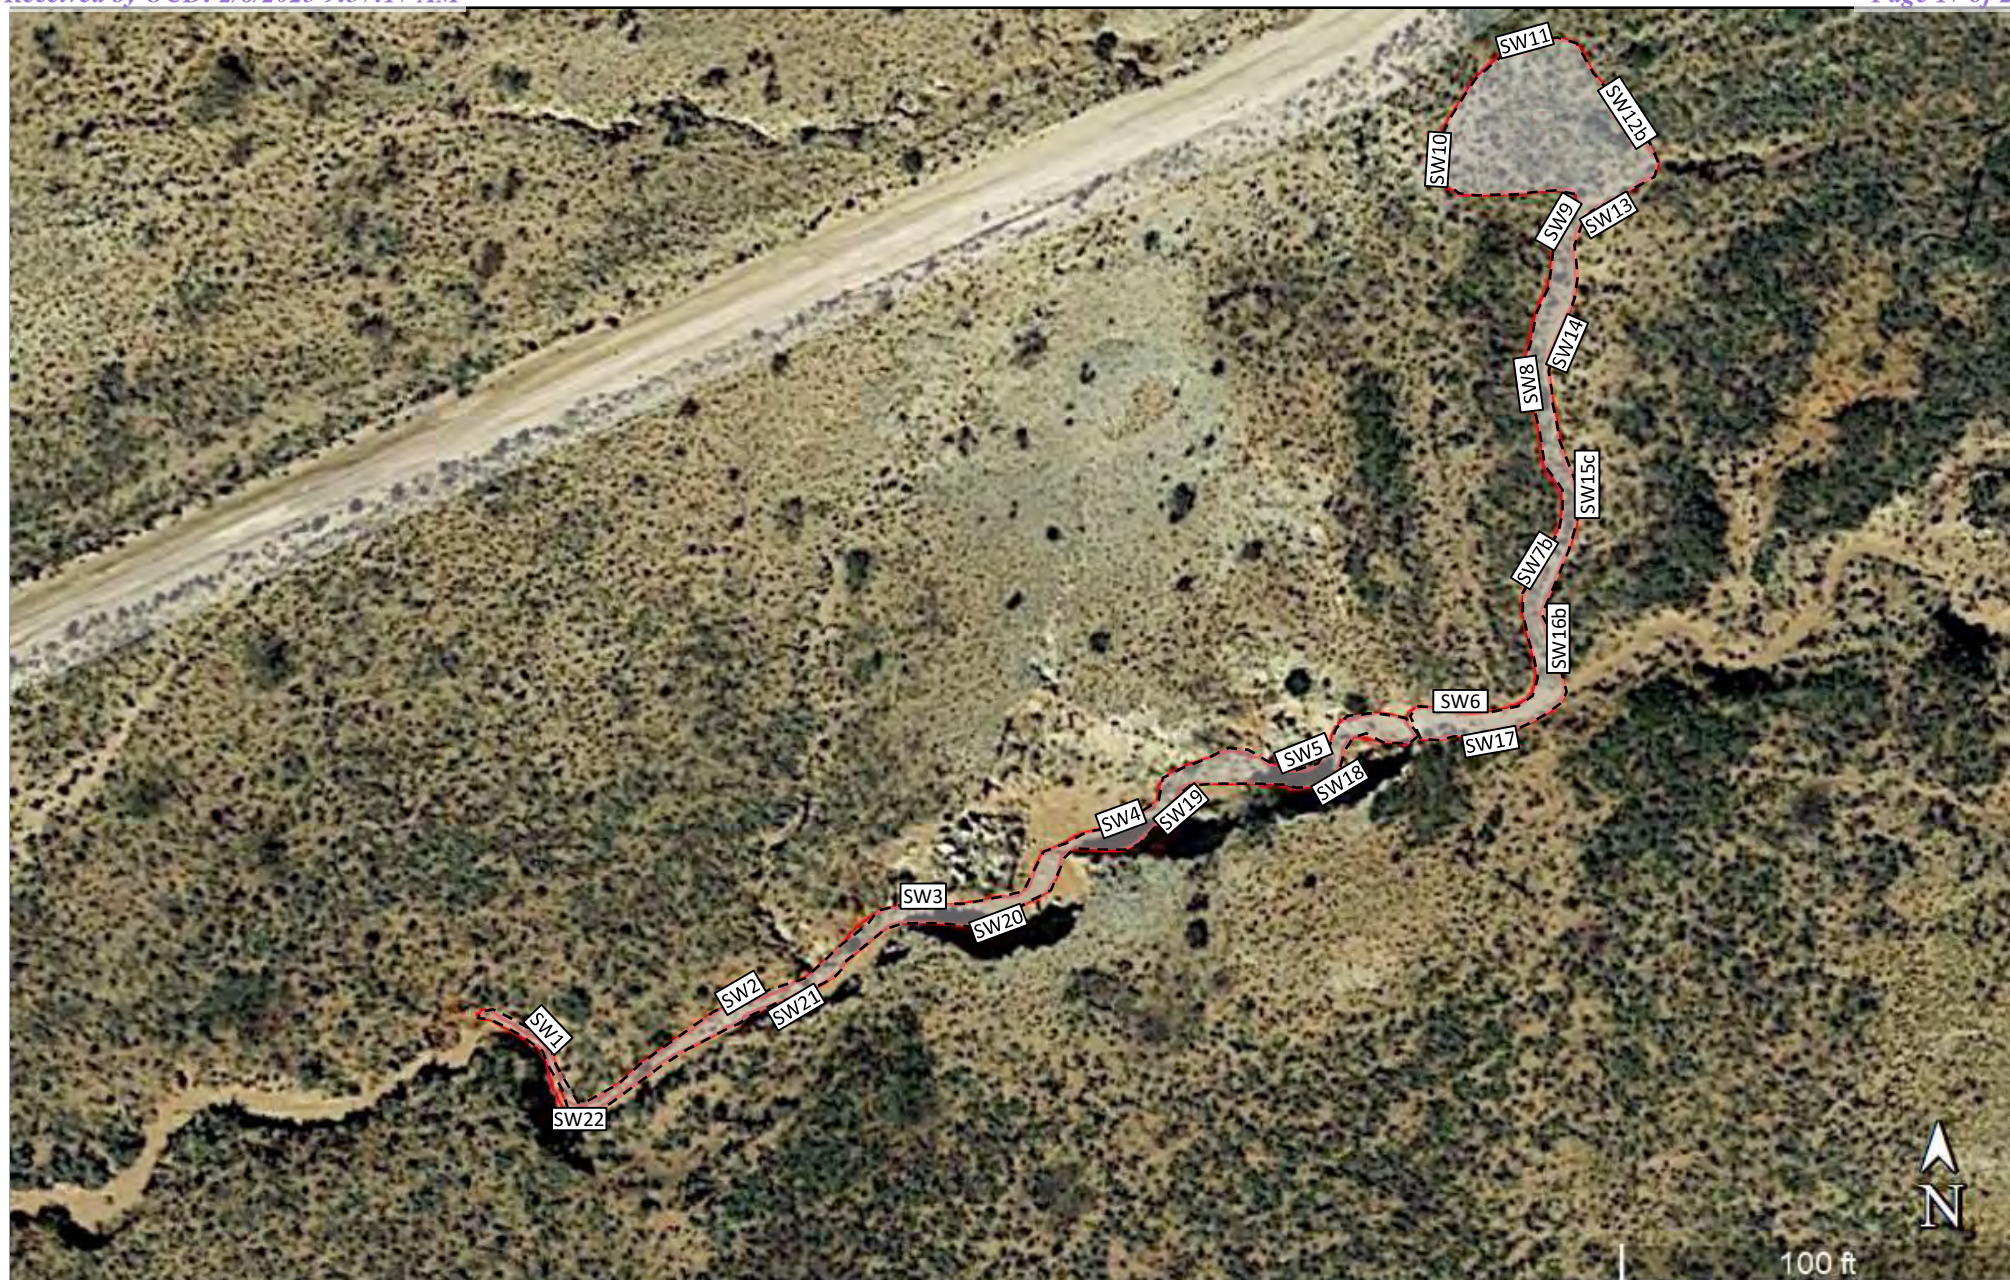
**Figure 6**

Excavation Sidewall Sample Map
 Frontier Field Services, LLC
 Cedar Breaks 6" Steel LP Line
 GPS: 32.772833, -103.945011
 Eddy County
