CLOSURE REPORT

Lateral C-28 (08/04/22)
Unit Letter N, S3 T27N R9W
San Juan County, New Mexico

New Mexico EMNRD OCD Incident ID No. NAPP2221727230

November 1, 2022

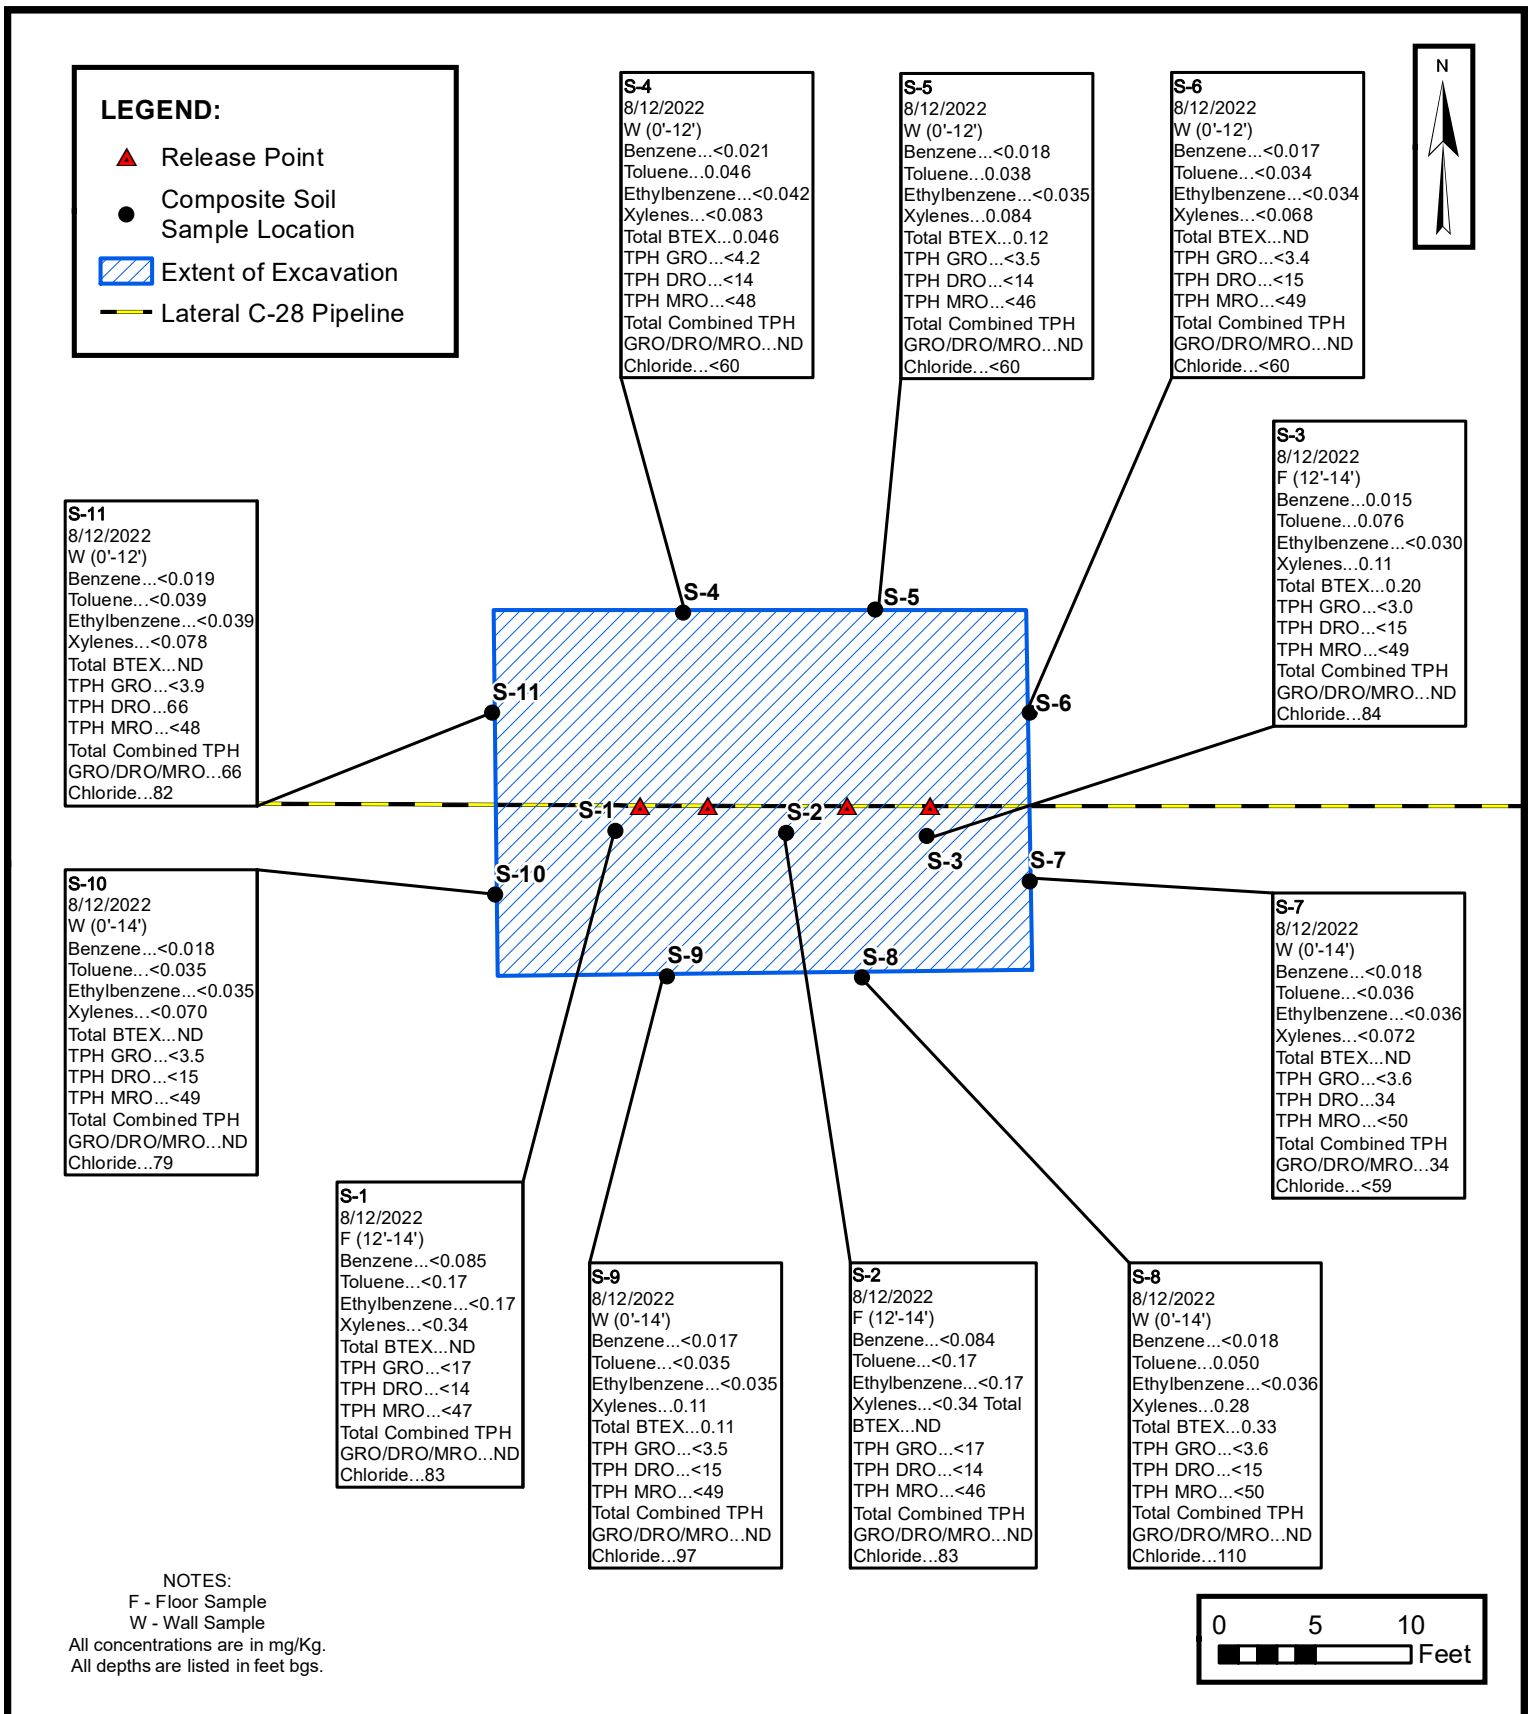
FIGURE
3

Figure 3 is a map that identifies approximate soil sample locations and depicts the approximate dimensions of the excavation with respect to the pipeline (**Appendix A**). Photographic documentation of the field activities is included in **Appendix D**.

SITE MAP WITH SOIL ANALYTICAL RESULTS

The final excavation measured approximately 27.5 feet long and 18 feet wide at the maximum extents. The maximum depth of the excavation measured approximately 14 feet bgs. The lithology encountered during the completion of remediation activities consisted primarily of unconsolidated silty sandy clay underlain by sandstone.

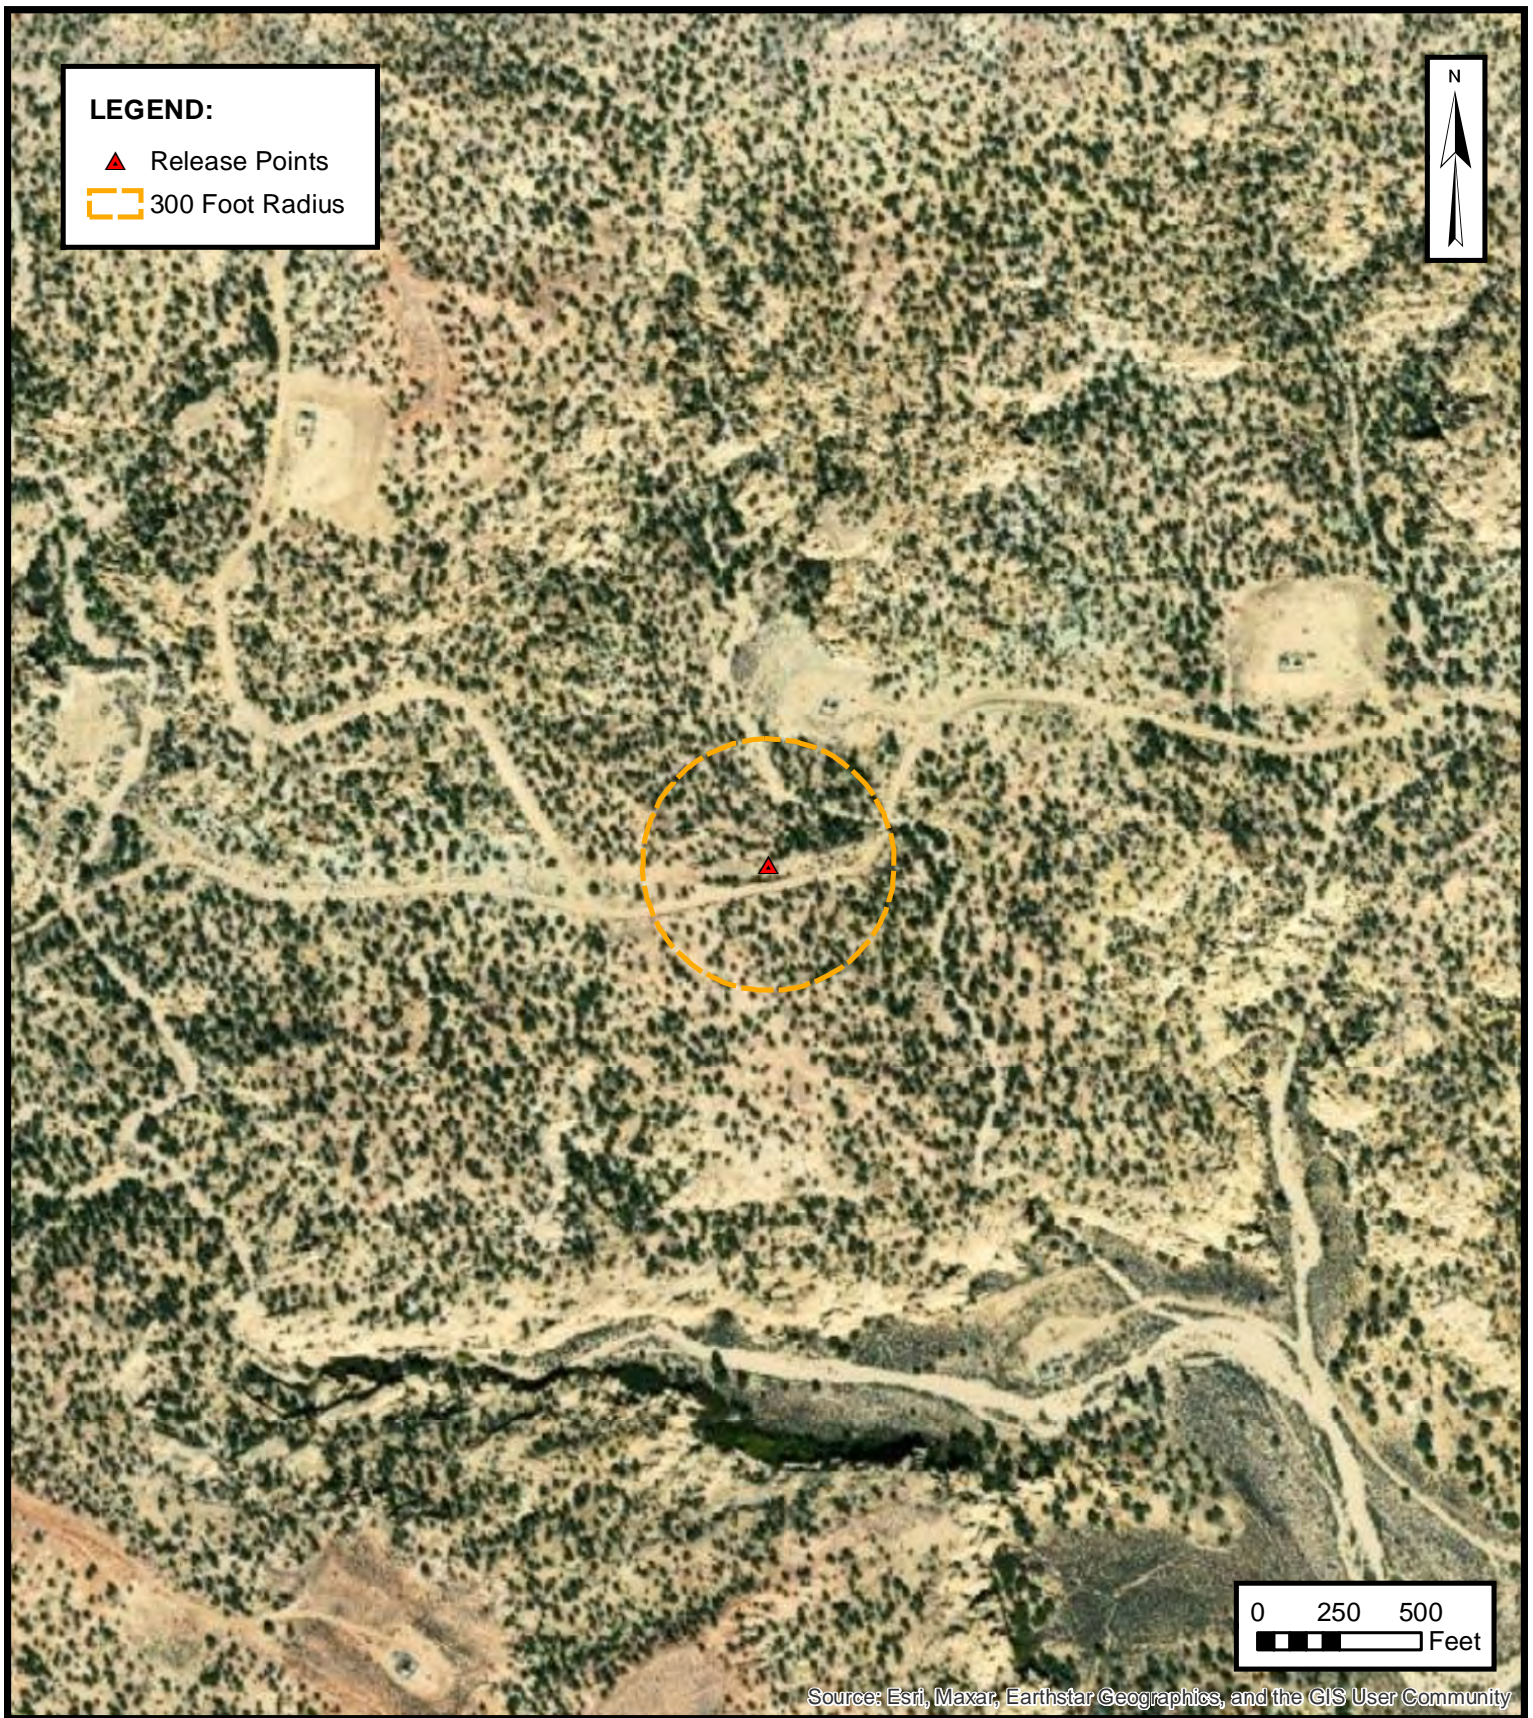
**FIGURE
C**

- The Site is located within 300 feet of a NM EMNRD OCD-defined continuously flowing watercourse or significant watercourse (**Figure C, Appendix B**).

**300 FOOT RADIUS
WATERCOURSE AND DRAINAGE IDENTIFICATION**
ENTERPRISE FIELD SERVICES, LLC
LATERAL C-28 (08/04/22)
Unit Letter N, S3 T27N R9W, San Juan County, New Mexico
36.597674° N, 107.776343° W

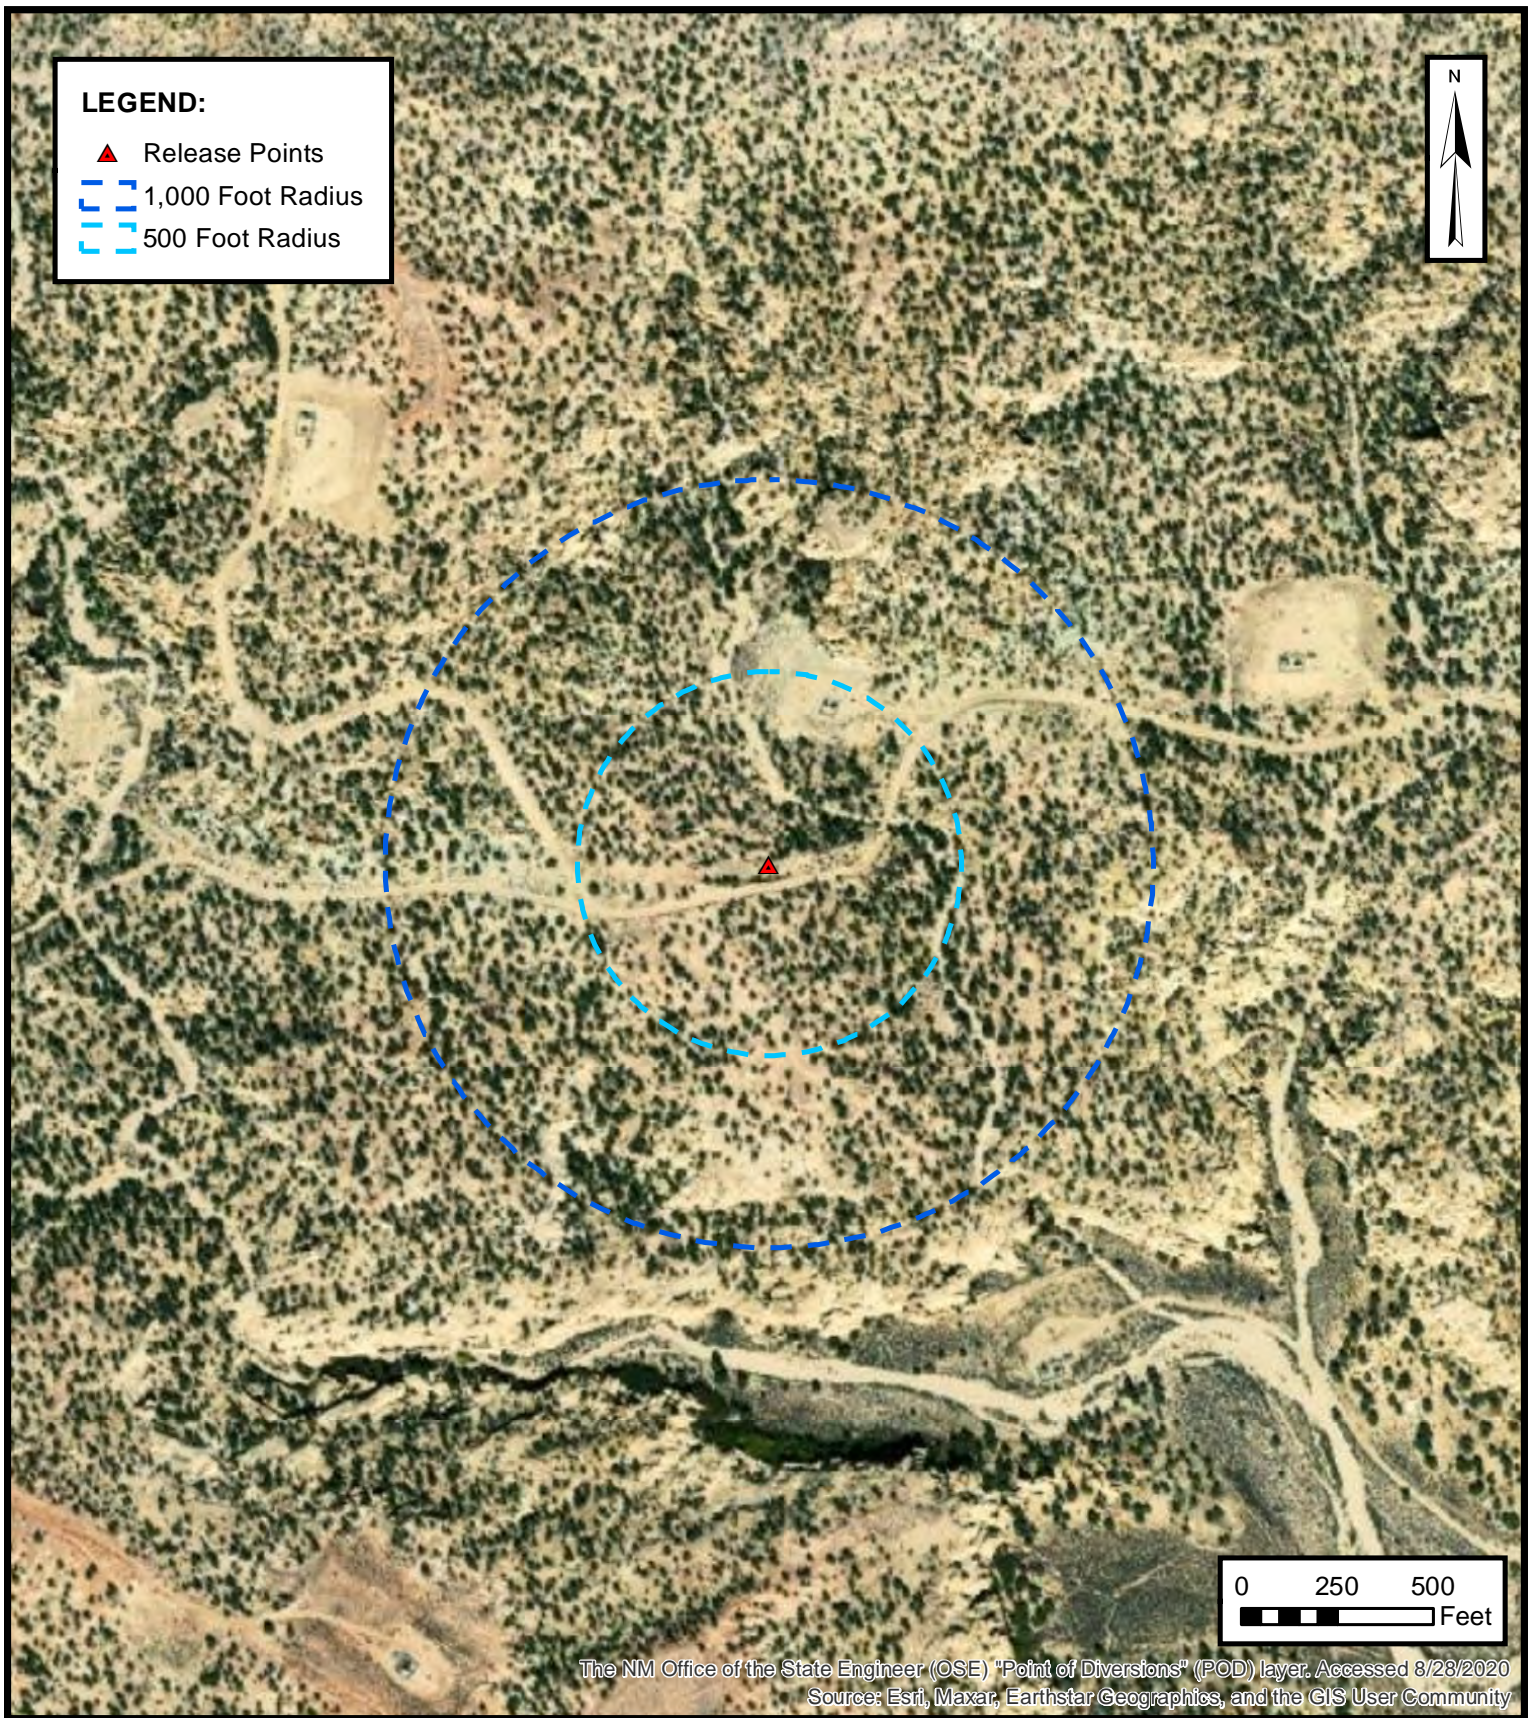
FIGURE
E

- No springs, or private domestic freshwater wells used by less than five households for domestic or stock watering purposes were identified within 500 feet of the Site (**Figure E, Appendix B**).

- No freshwater wells or springs were identified within 1,000 feet of the Site (**Figure E, Appendix B**).
- The Site is not located within incorporated municipal boundaries or within a defined municipal freshwater well field covered under a municipal ordinance adopted pursuant to New Mexico Statutes Annotated (NMSA) 1978, Section 3-27-3.

**WATER WELL AND NATURAL SPRING LOCATION**

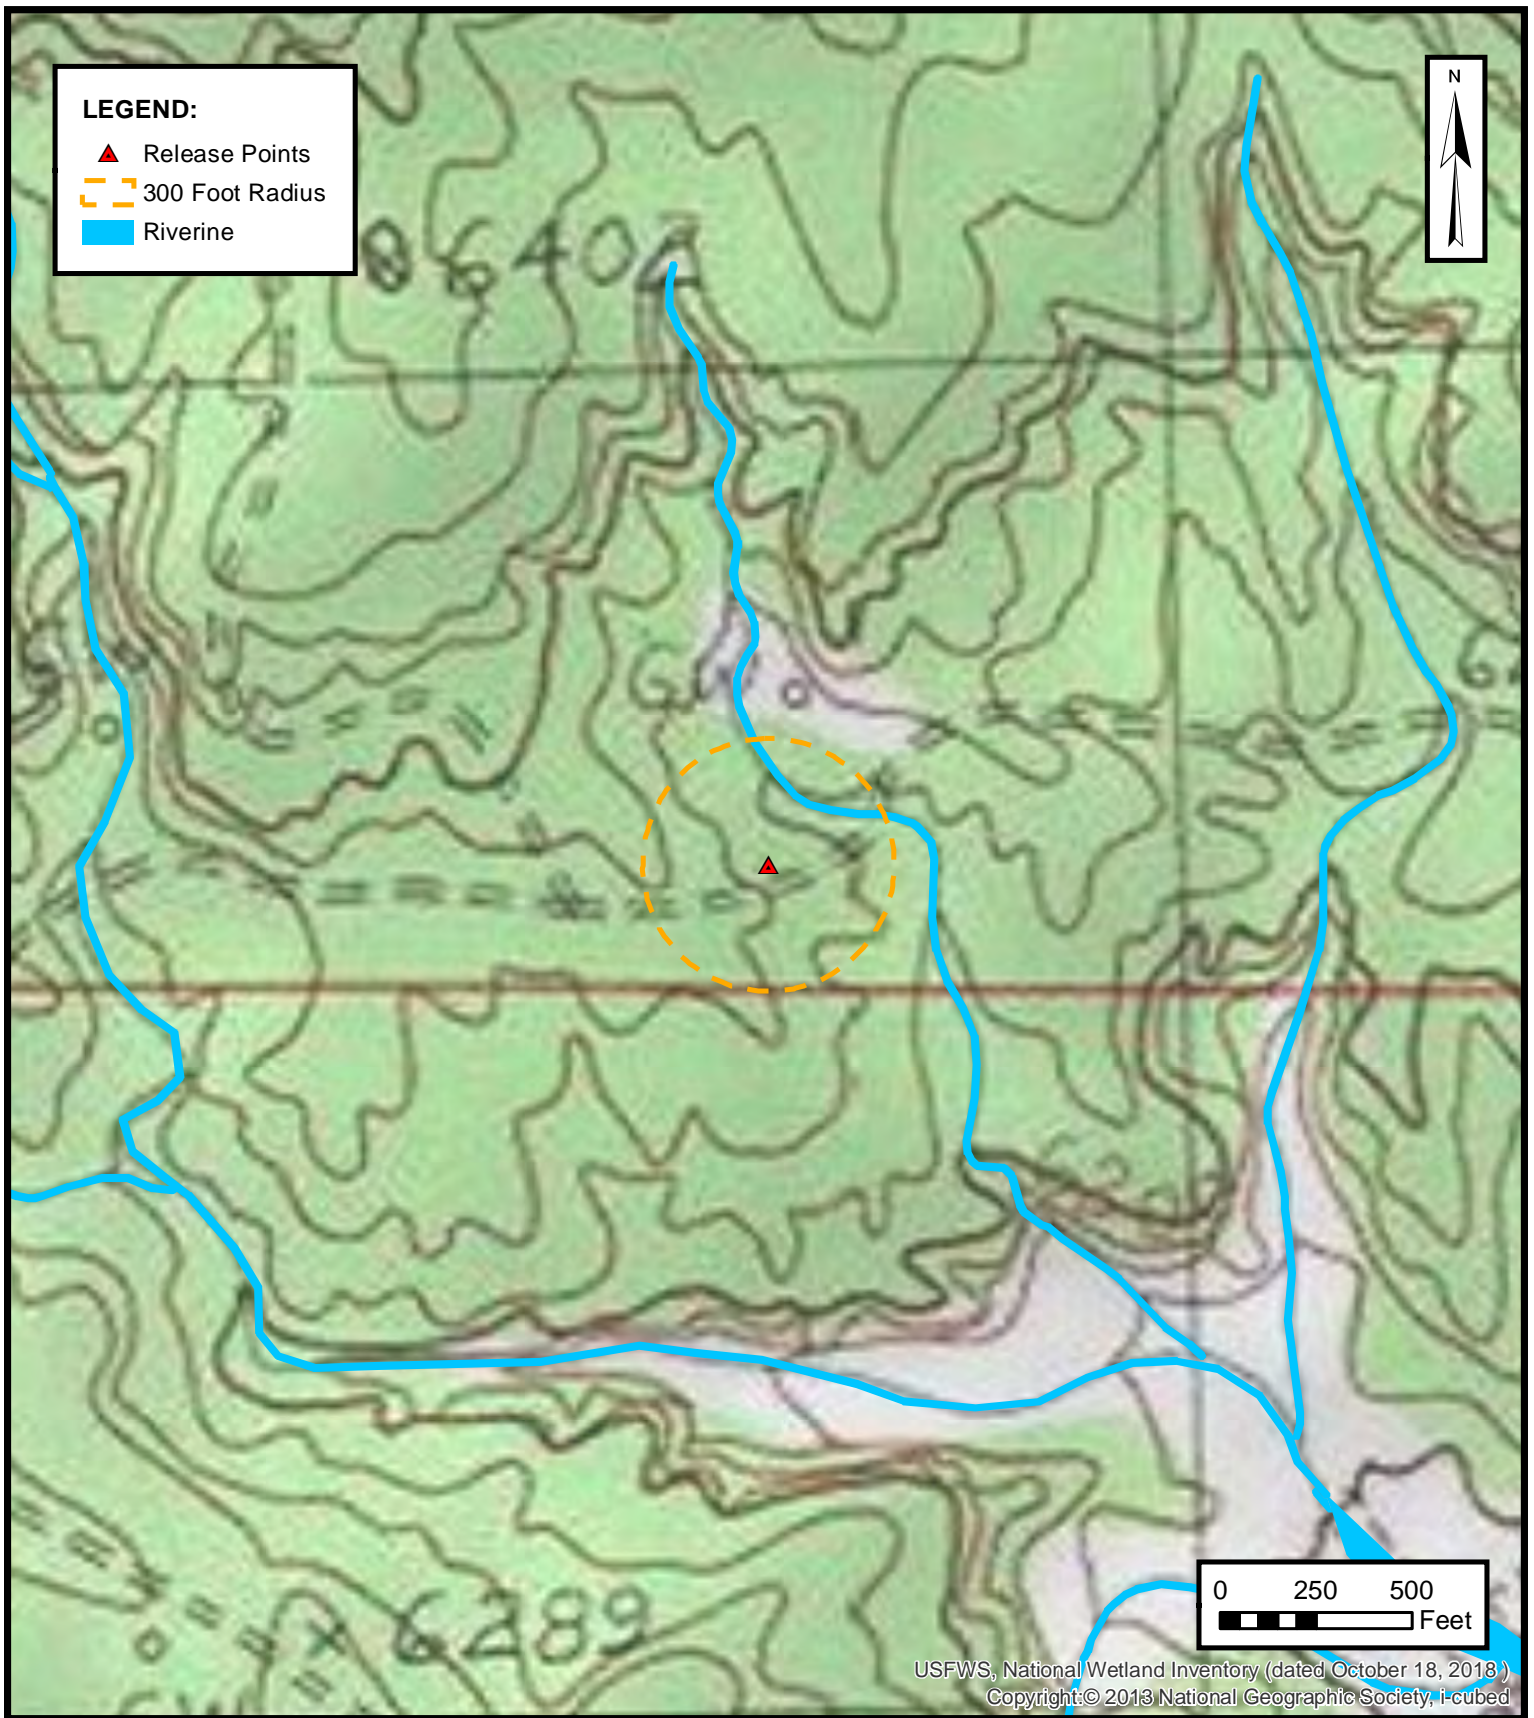
FIGURE**F**

- Based on information identified in the U.S. Fish & Wildlife Service National Wetlands Inventory Wetlands Mapper, the Site is not within 300 feet of a wetland (**Figure F, Appendix B**).

**WETLANDS**

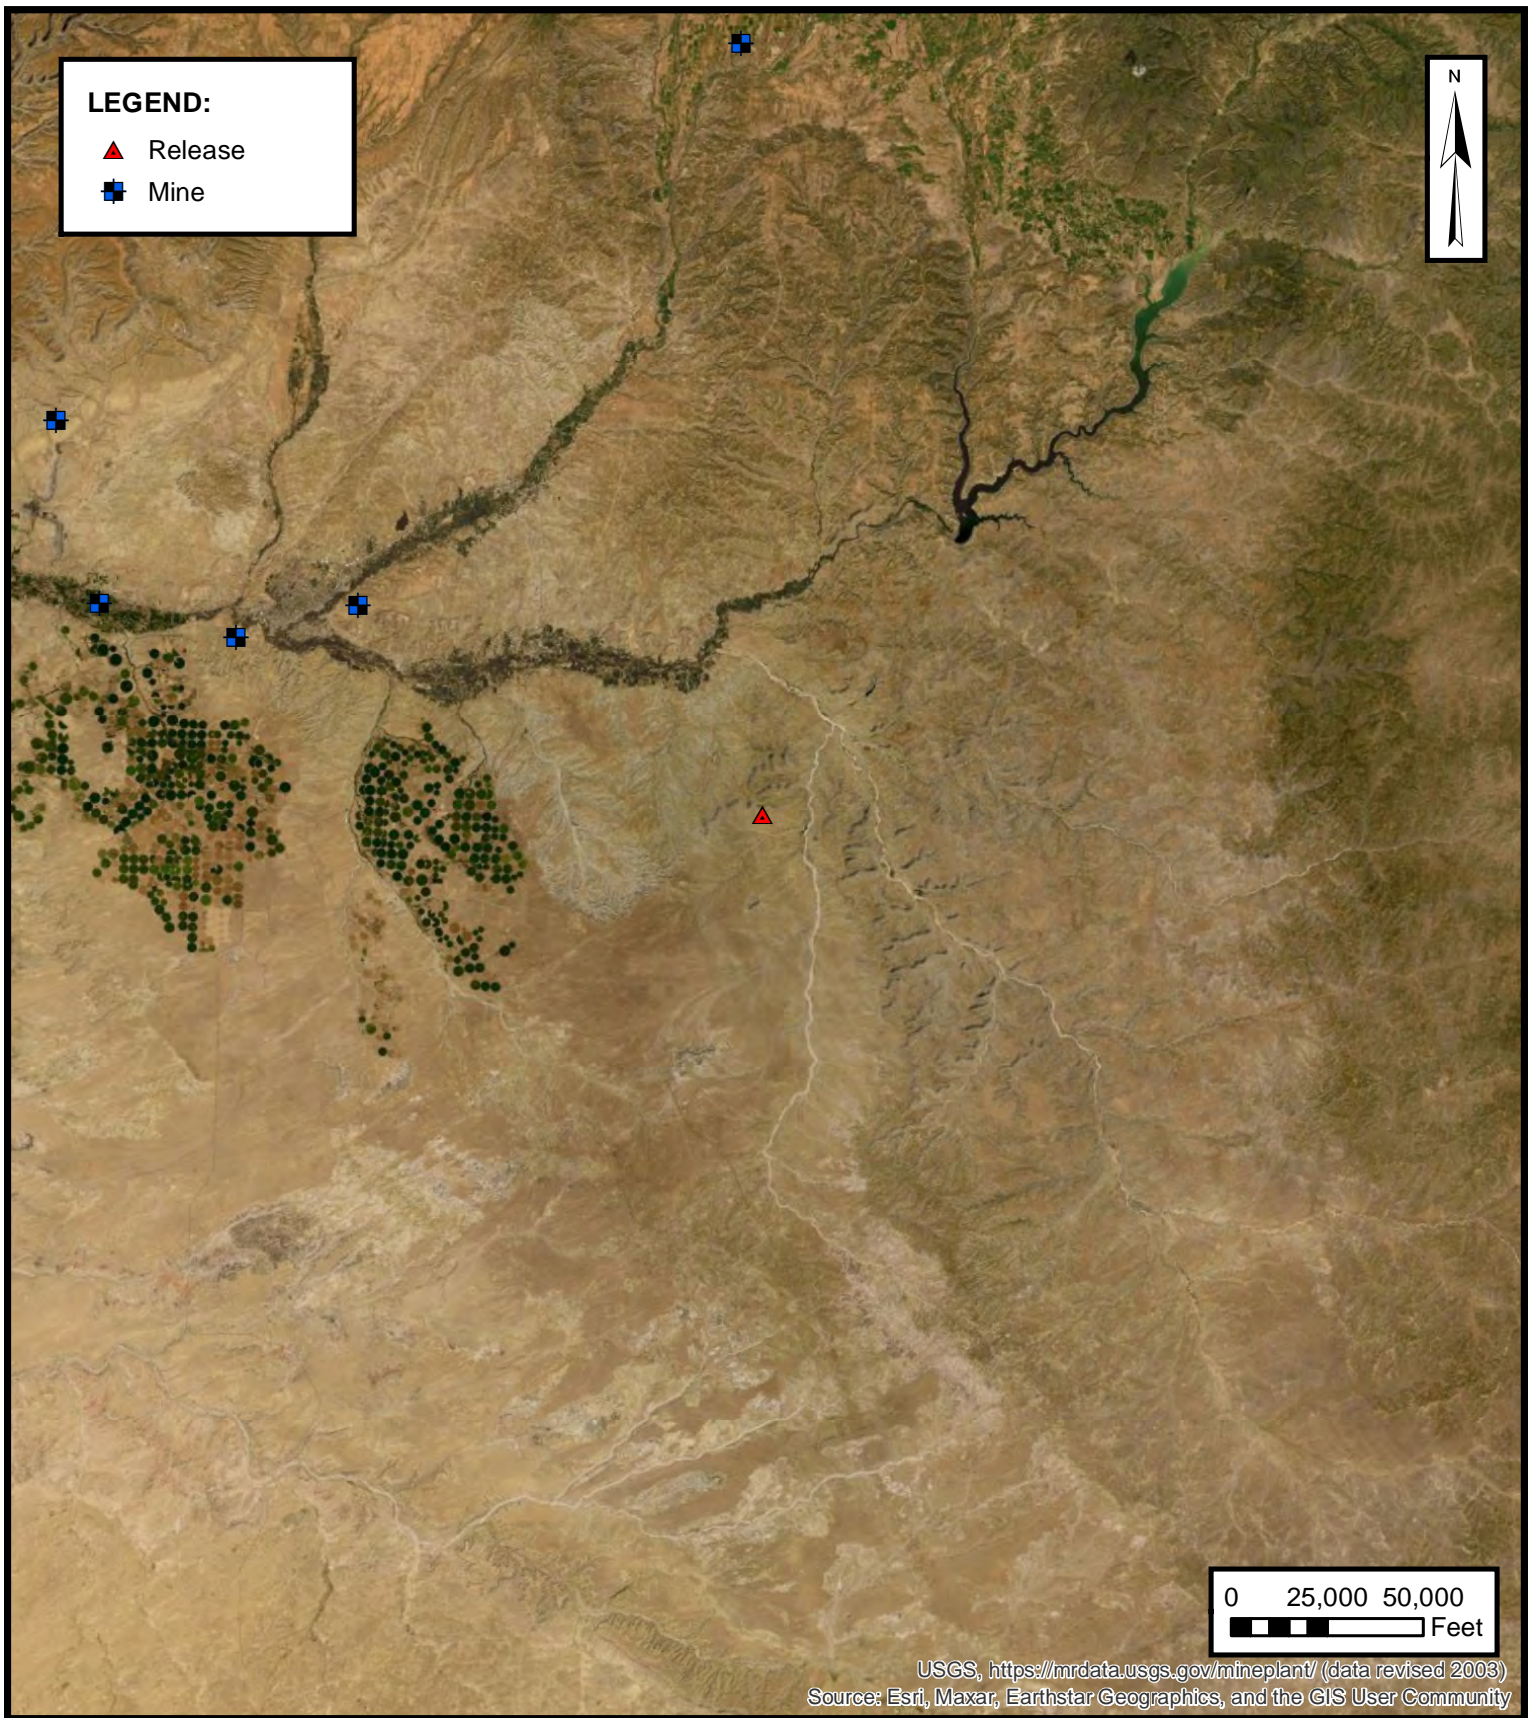
FIGURE**G**

- Based on information identified in the NM Mining and Minerals Division's Geographic Information System (GIS) Maps and Mine Data database, the Site is not within an area overlying a subsurface mine (**Figure G, Appendix B**).

**MINES, MILLS AND QUARRIES**

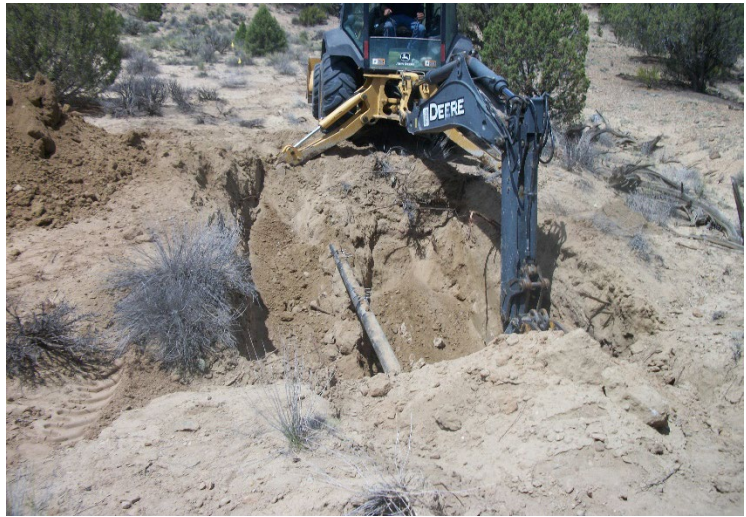
**Photograph 1**

Photograph Description: View of the in-process excavation activities.

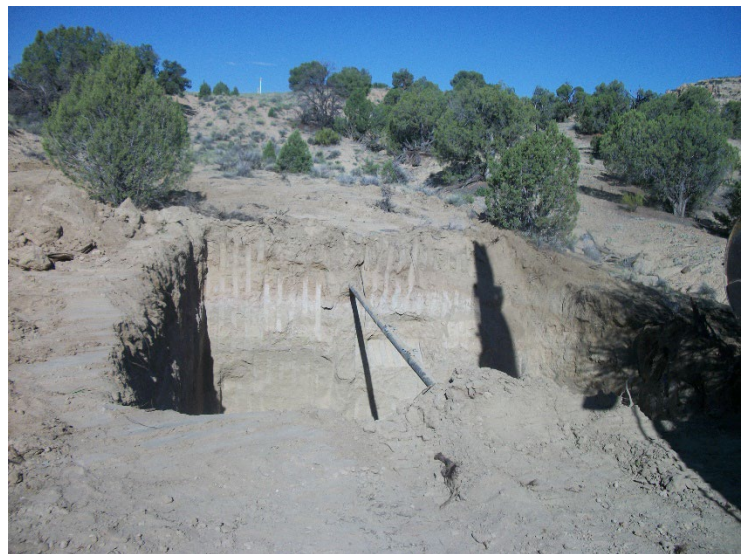
**Photograph 2**

Photograph Description: View of the in-process excavation activities.

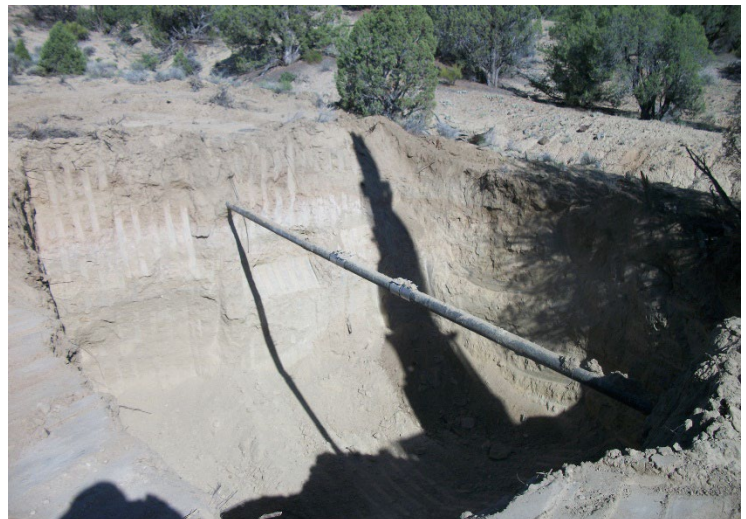
**Photograph 3**

Photograph Description: View of the final excavation.

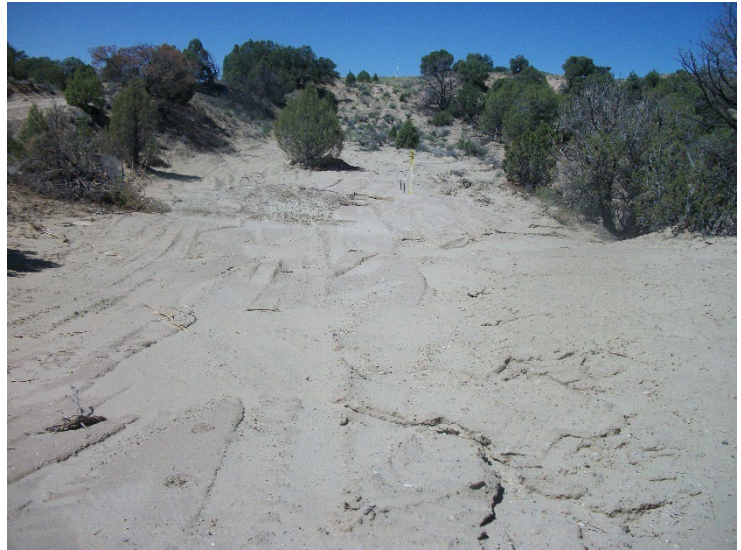
Photograph 4

Photograph Description: View of the site after initial restoration.

The excavation was backfilled with imported fill and then contoured to the surrounding topography. Enterprise will re-seed the Site with an approved seeding mixture.
