## CLOSURE REPORT

**Ludwick LS #25 (08/23/22)**  
Unit Letter C, S5 T29N R10W  
San Juan County, New Mexico

**New Mexico EMNRD OCD Incident ID No. NAPP2223534793**

Ensolum Project No. 05A1226206

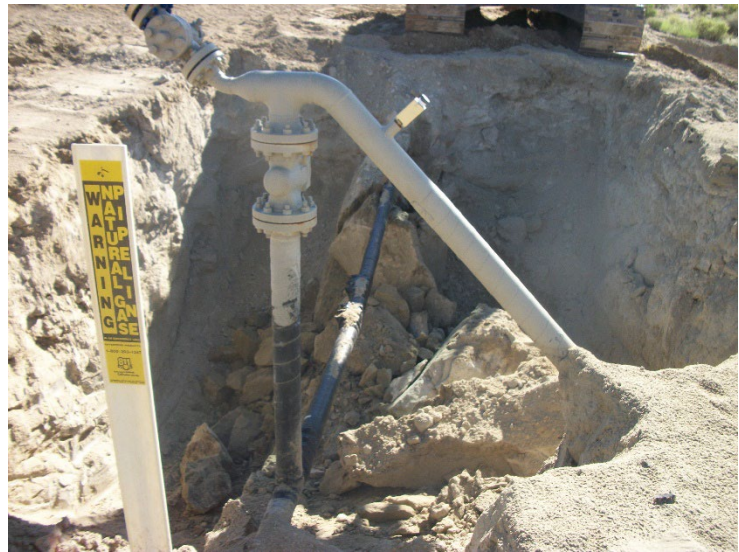
**Photograph 1**

Photograph Description: View of the in-process excavation activities.

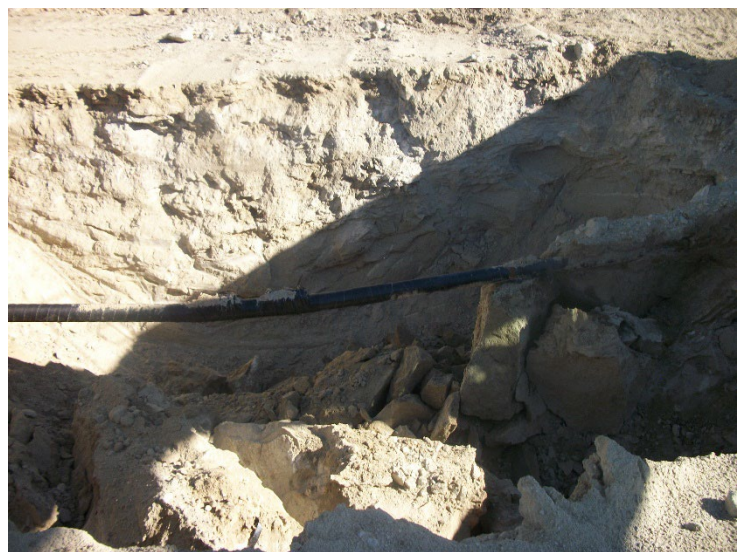
**Photograph 2**

Photograph Description: View of the in-process excavation activities.

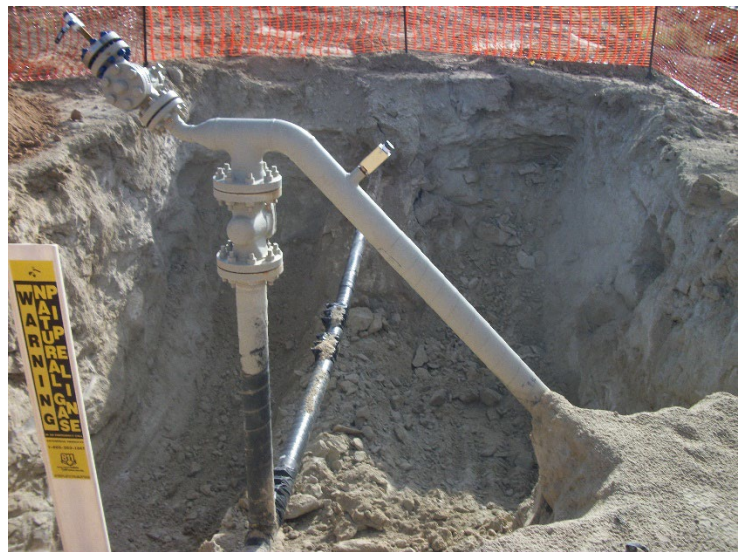
**Photograph 3**

The final excavation measured approximately 24 feet long and 16 feet wide at the maximum extents. The maximum depth of the excavation measured approximately eight feet bgs. The lithology encountered during the completion of remediation activities consisted primarily of silty sand underlain by sandstone.

Photograph Description: View of the final excavation.

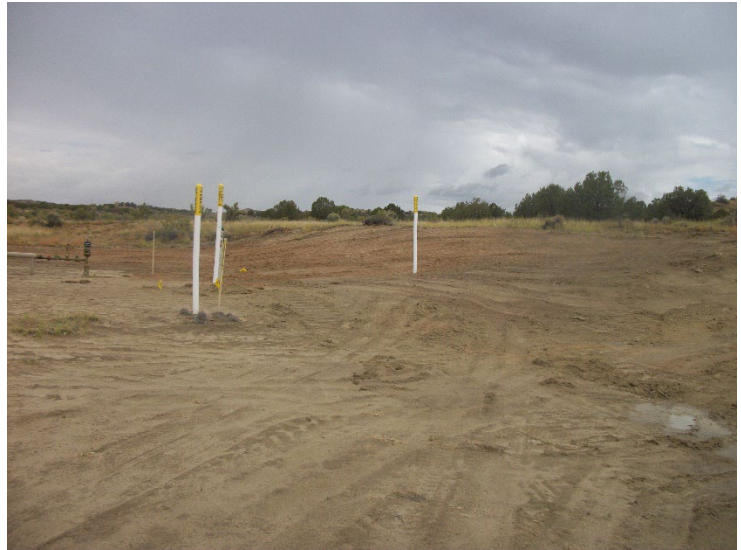
**Photograph 4**

Photograph Description: View of the site after initial restoration.

The excavation was backfilled with imported fill and then contoured to the surrounding topography. Enterprise will re-seed the Site with an approved seeding mixture.

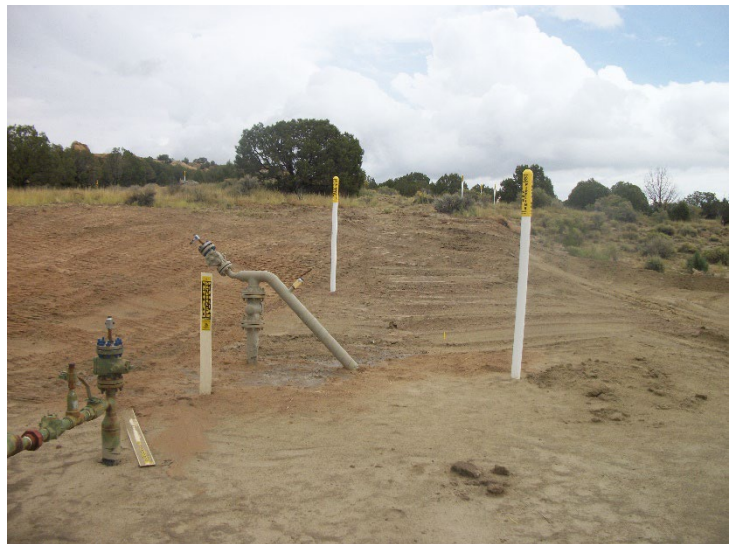
**Photograph 5**

Photograph Description: View of the site after initial restoration.
