CLOSURE REPORT

Tiger #12 (10/10/22)
Unit Letter B, S27 T30N R13W
San Juan County, New Mexico

New Mexico EMNRD OCD Incident ID No. NAPP2228348113

Ensolum Project No. 05A1226217

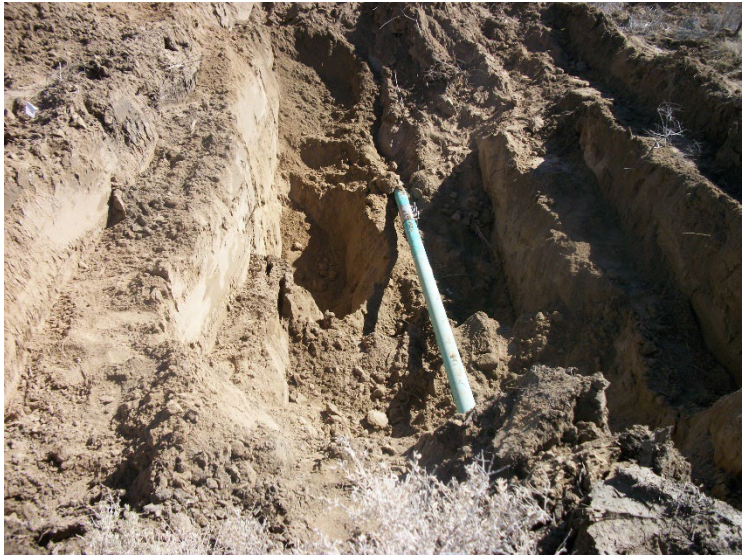
**Photograph 1**

Photograph Description: View of the in-process excavation activities.

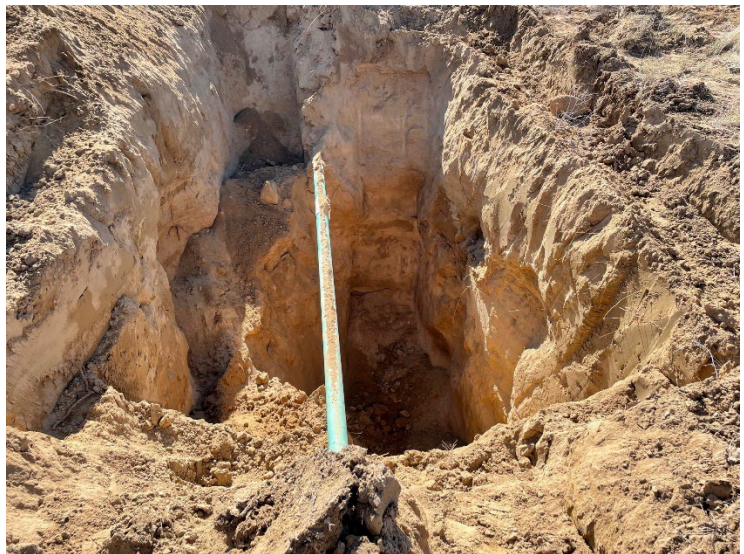
**Photograph 2**

Photograph Description: View of the in-process excavation activities.

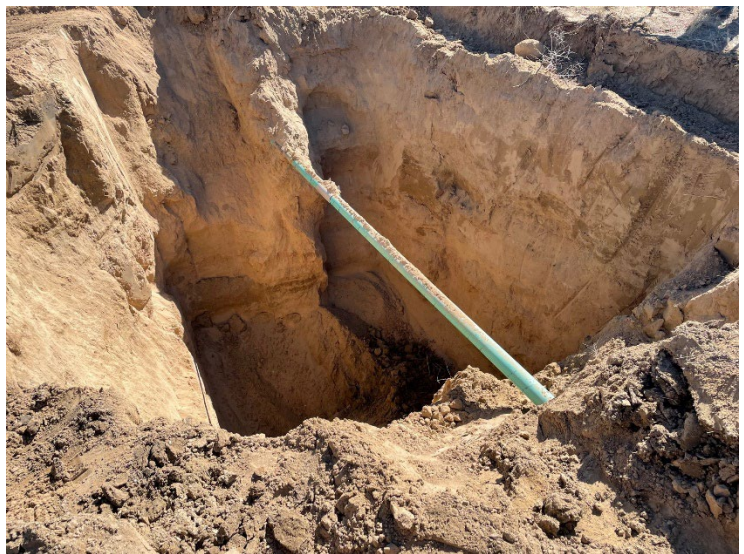
**Photograph 3**

Photograph Description: View of the final excavation.

The final excavation measured approximately 13 feet long and 10 feet wide at the maximum extents. The maximum depth of the excavation measured approximately 15 feet bgs. The lithology encountered during the completion of remediation activities consisted primarily of silty sand and sand.

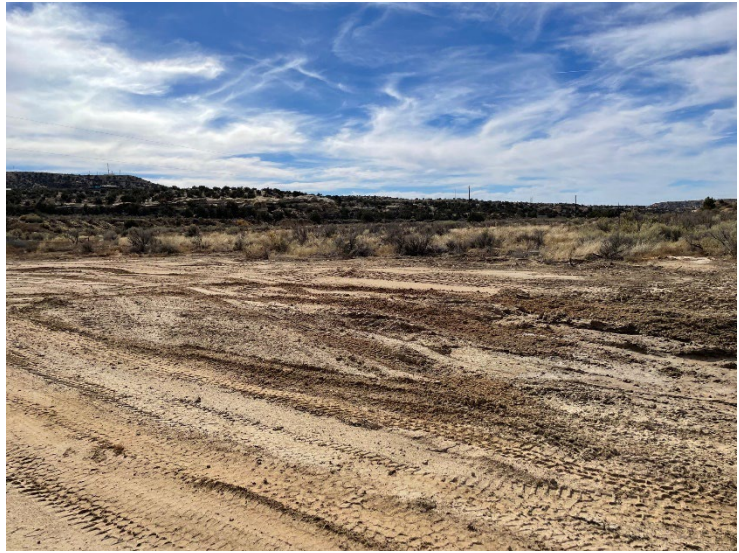
Photograph 4

Photograph Description: View of the site after initial restoration.

The excavation was backfilled with imported fill and then contoured to the surrounding topography. Enterprise will re-seed the Site with an approved seeding mixture.

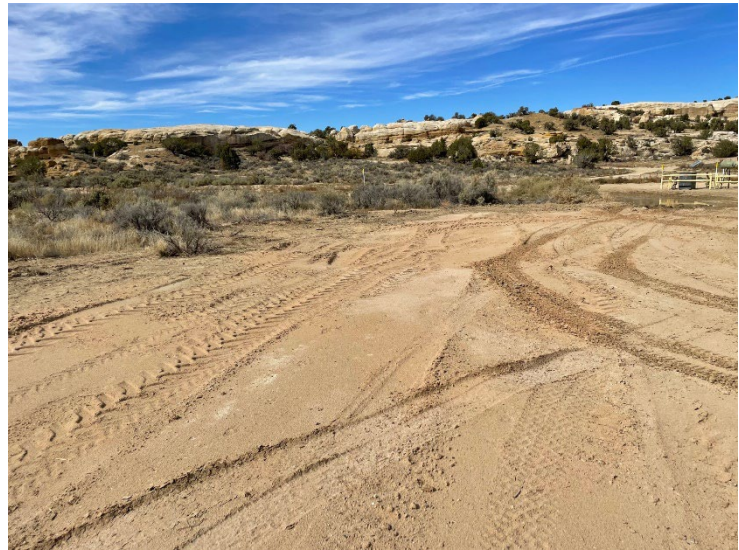
Photograph 5

Photograph Description: View of the site after initial restoration.
