## CLOSURE REPORT

**Lateral 2B-24 (10/10/22)**  
Unit Letter F, S22 T28N R10W  
San Juan County, New Mexico

**New Mexico EMNRD OCD Incident ID No. NAPP2228430992**

**December 5, 2022**

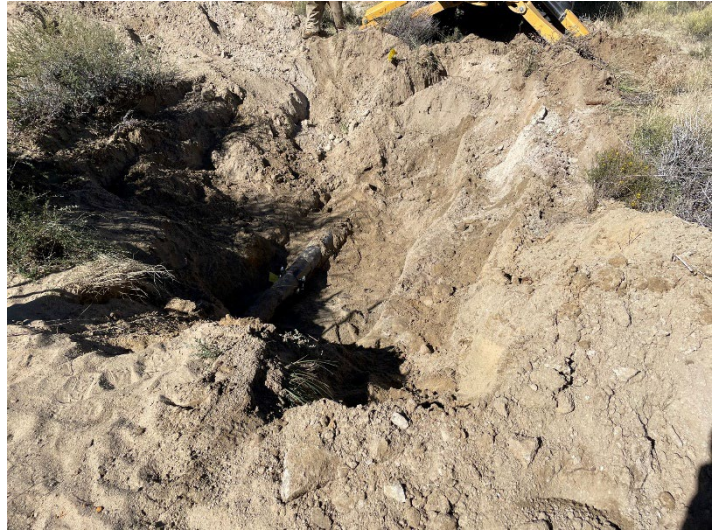
**Photograph 1**

Photograph Description: View of the in-process excavation activities.

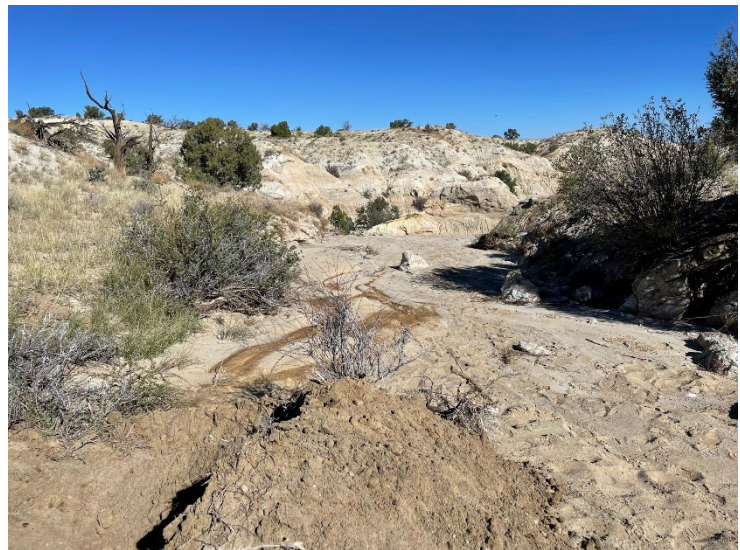
**Photograph 2**

Photograph Description: View of the in-process excavation activities.

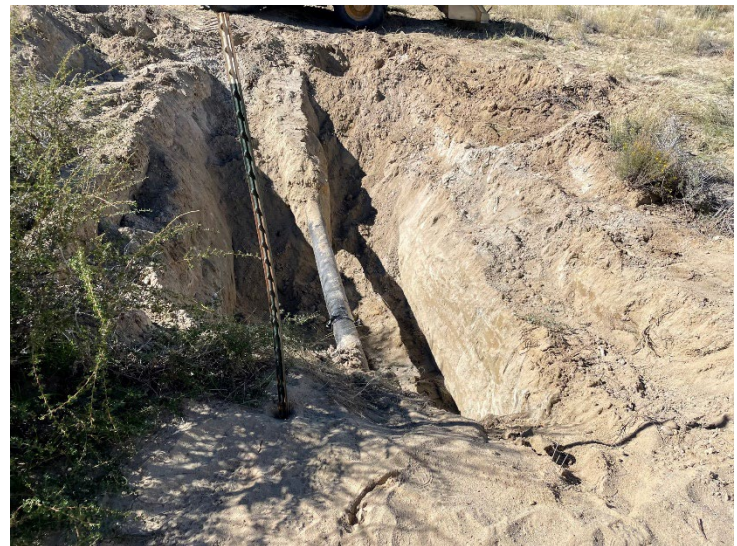
**Photograph 3**

The final pipeline excavation measured approximately 14 feet long and 9 feet wide at the maximum extents. The maximum depth of the excavation measured approximately 6 feet bgs. The flow path excavation measured approximately 34 feet long and 5 feet wide, with an approximate depth of 1 feet bgs. The lithology encountered during the completion of remediation activities consisted primarily of silty sand underlain by weathered sandstone.

Photograph Description: View of the final excavation.

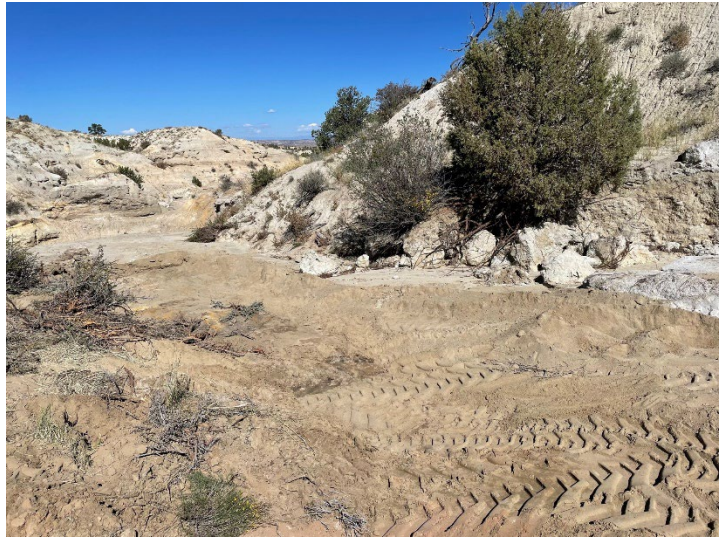
**Photograph 4**

Photograph Description: View of the final flow path excavation.

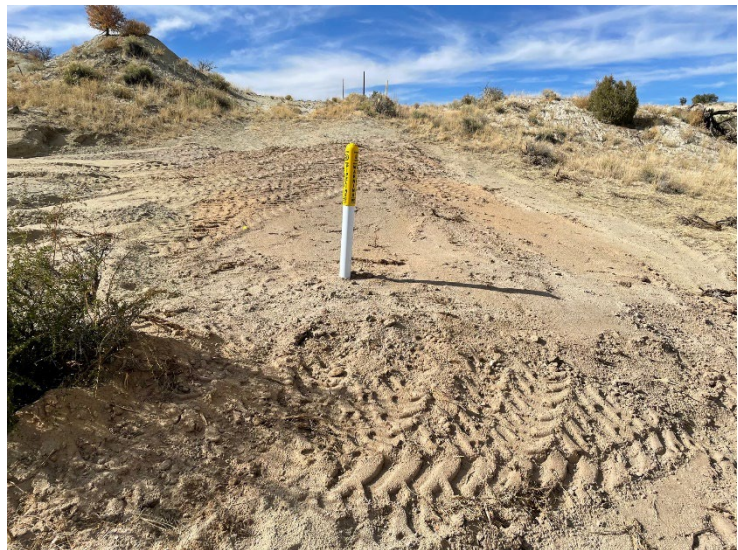
**Photograph 5**

Photograph Description: View of the site after initial restoration.

The excavation was backfilled with imported fill and then contoured to the surrounding topography. Enterprise will re-seed the Site with an approved seeding mixture.

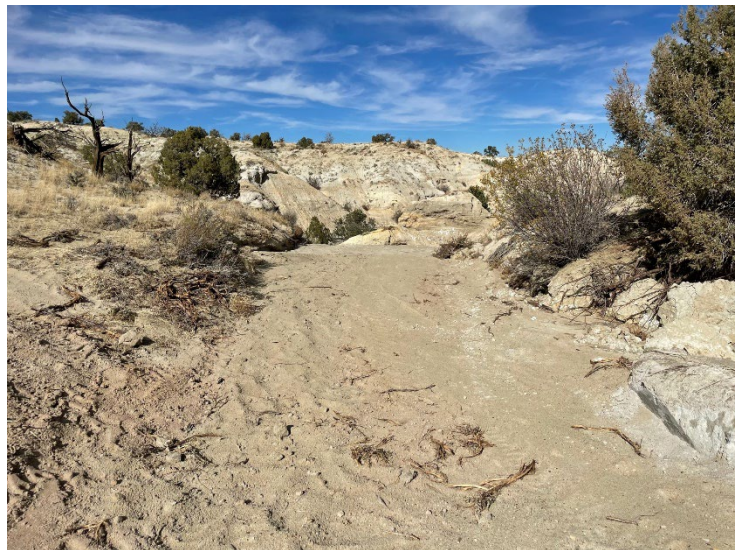
**Photograph 6**

Photograph Description: View of the site after initial restoration.
