May 30, 2023

**Re: Closure Report
Energy Transfer Company
Shurvesa Interconnect Release
Lea County, New Mexico
DOR: 3/10/2022
Incident ID: nAPP2206954187
Approximate Release Point: 32.2411479°, -103.6229372°**

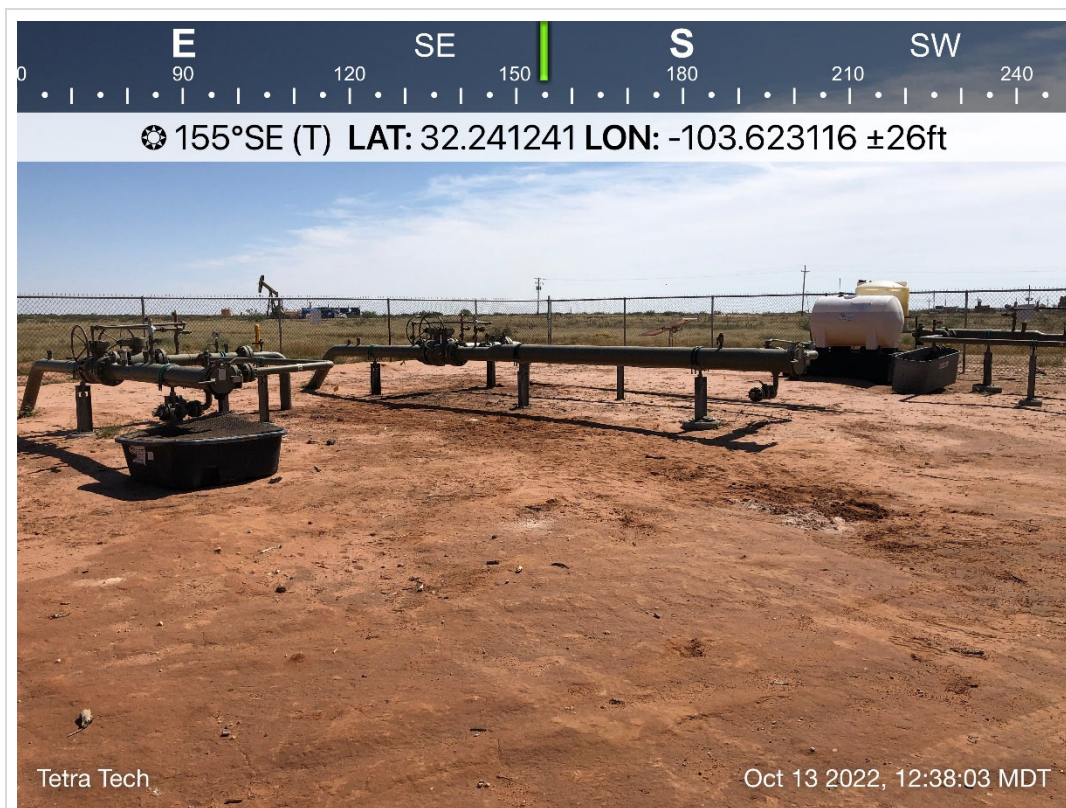
TETRA TECH, INC. PROJECT NO. 212C-MD-03060	DESCRIPTION	View southeast towards the release source point and release area.	1
	SITE NAME	Energy Transfer Shurvessa Interconnect Release	10/13/2022

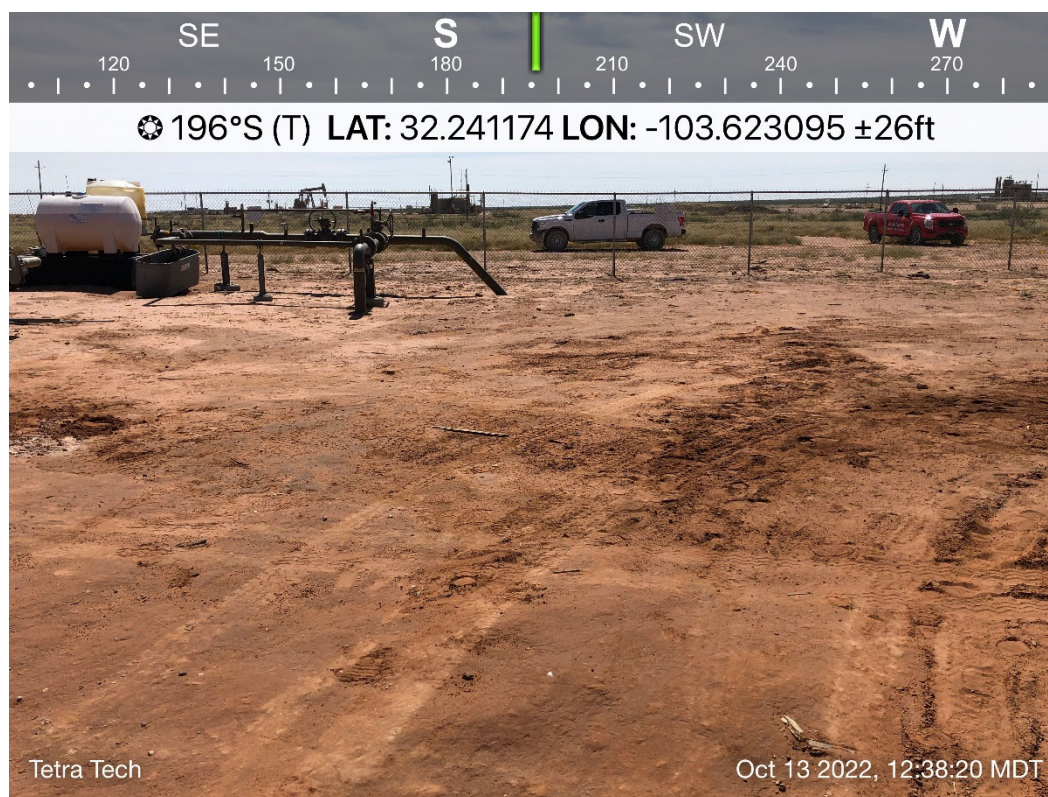
TETRA TECH, INC. PROJECT NO. 212C-MD-03060	DESCRIPTION	View towards the south of the release extent on pad.	2
	SITE NAME	Energy Transfer Shurvessa Interconnect Release	10/13/2022

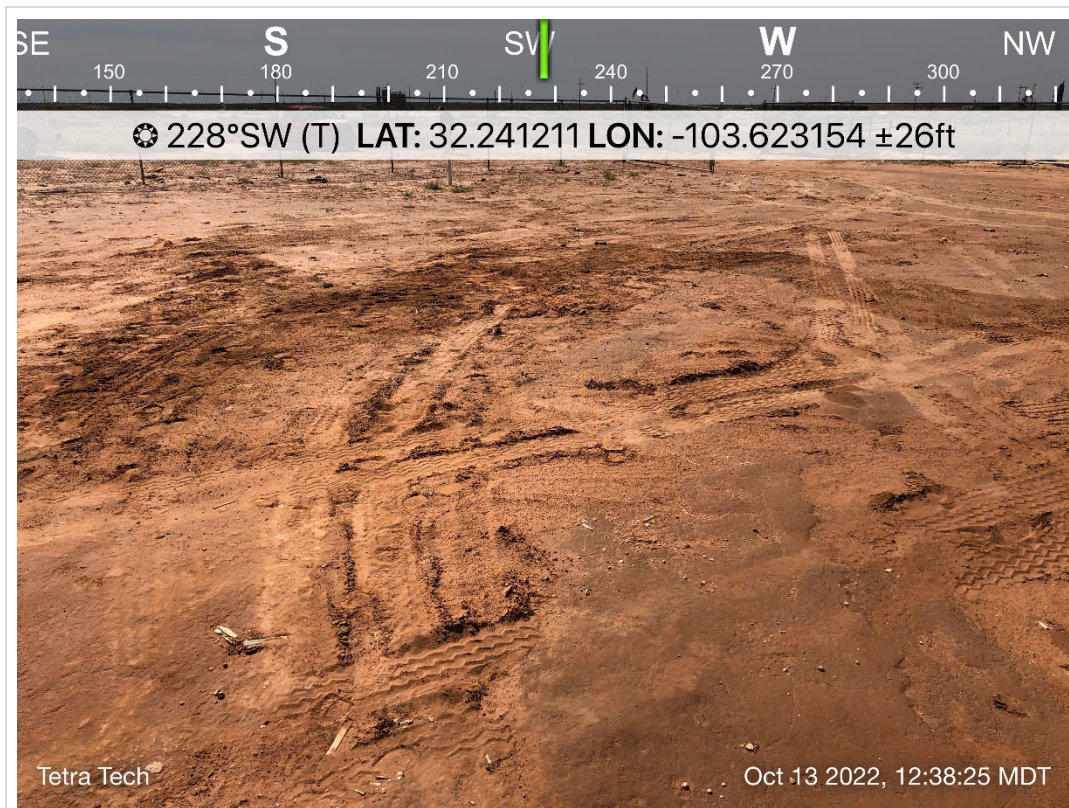
TETRA TECH, INC. PROJECT NO. 212C-MD-03060	DESCRIPTION	View southwest of the release extent on pad.	3
	SITE NAME	Energy Transfer Shurvessa Interconnect Release	10/13/2022

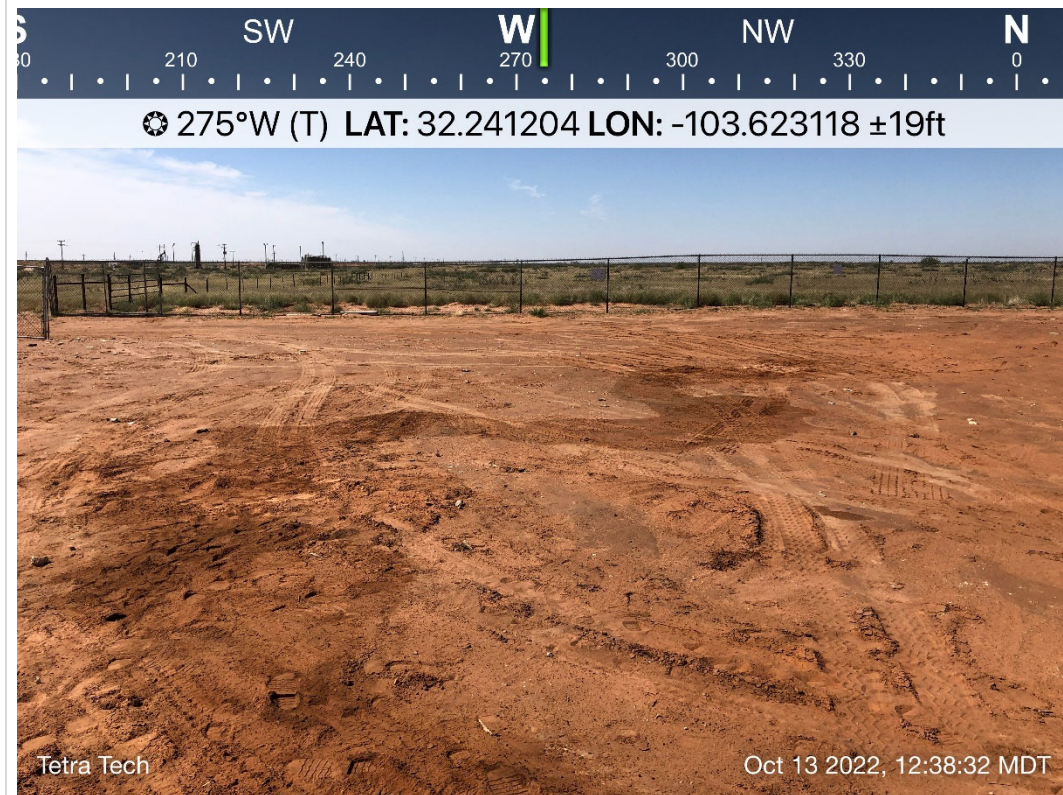
TETRA TECH, INC. PROJECT NO. 212C-MD-03060	DESCRIPTION	View west of the release extent on pad.	4
	SITE NAME	Energy Transfer Shurvessa Interconnect Release	10/13/2022

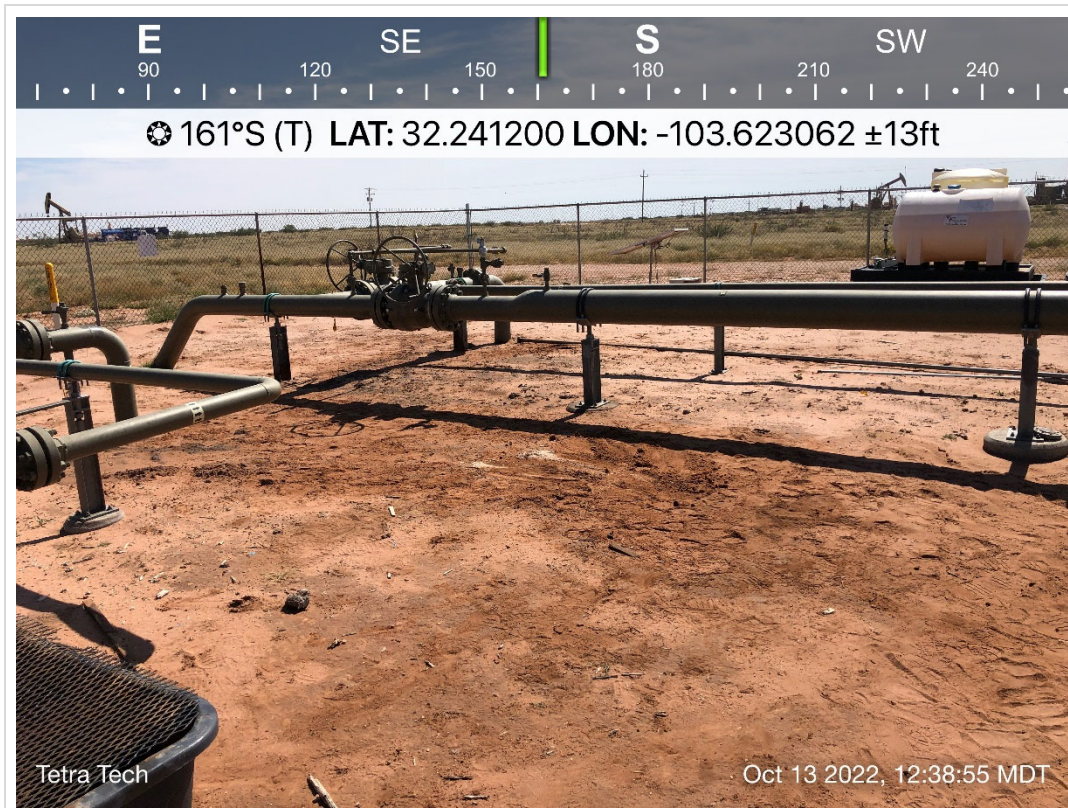
TETRA TECH, INC. PROJECT NO. 212C-MD-03060	DESCRIPTION	View southeast towards the release source point and release area.	5
	SITE NAME	Energy Transfer Shurvessa Interconnect Release	10/13/2022

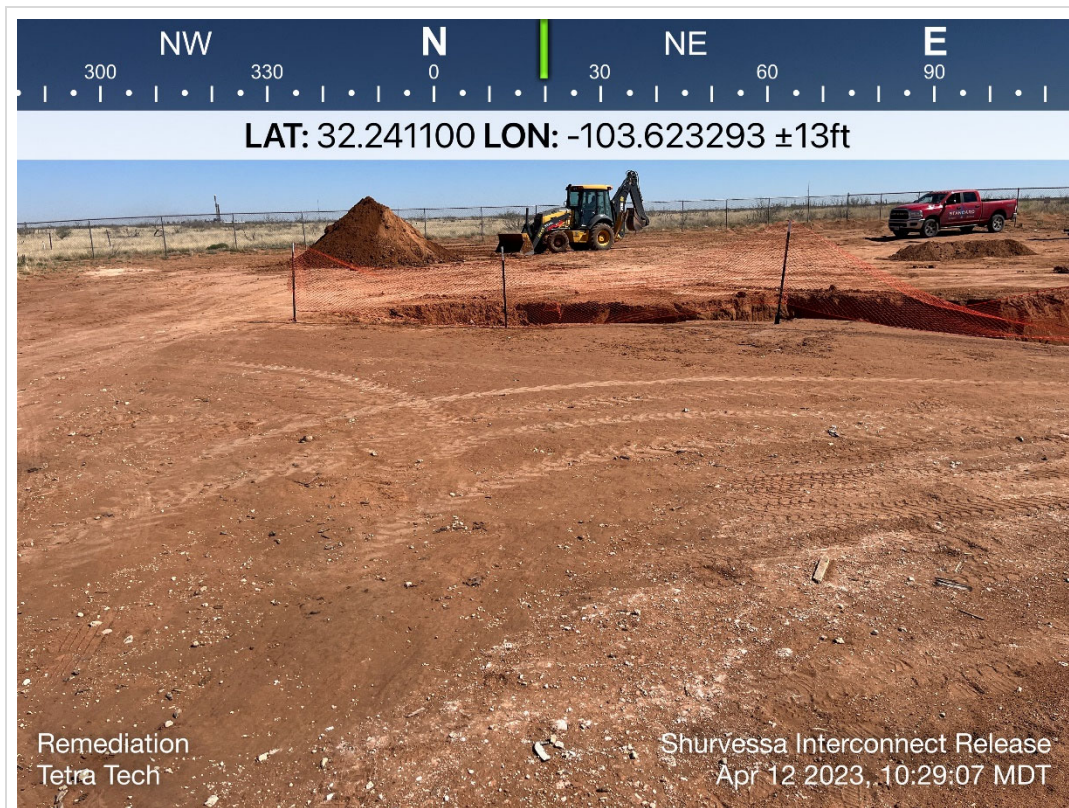
TETRA TECH, INC. PROJECT NO. 212C-MD-03060	DESCRIPTION	View of the excavation extent.	7
	SITE NAME	Energy Transfer Shurvessa Interconnect Release	4/12/2023

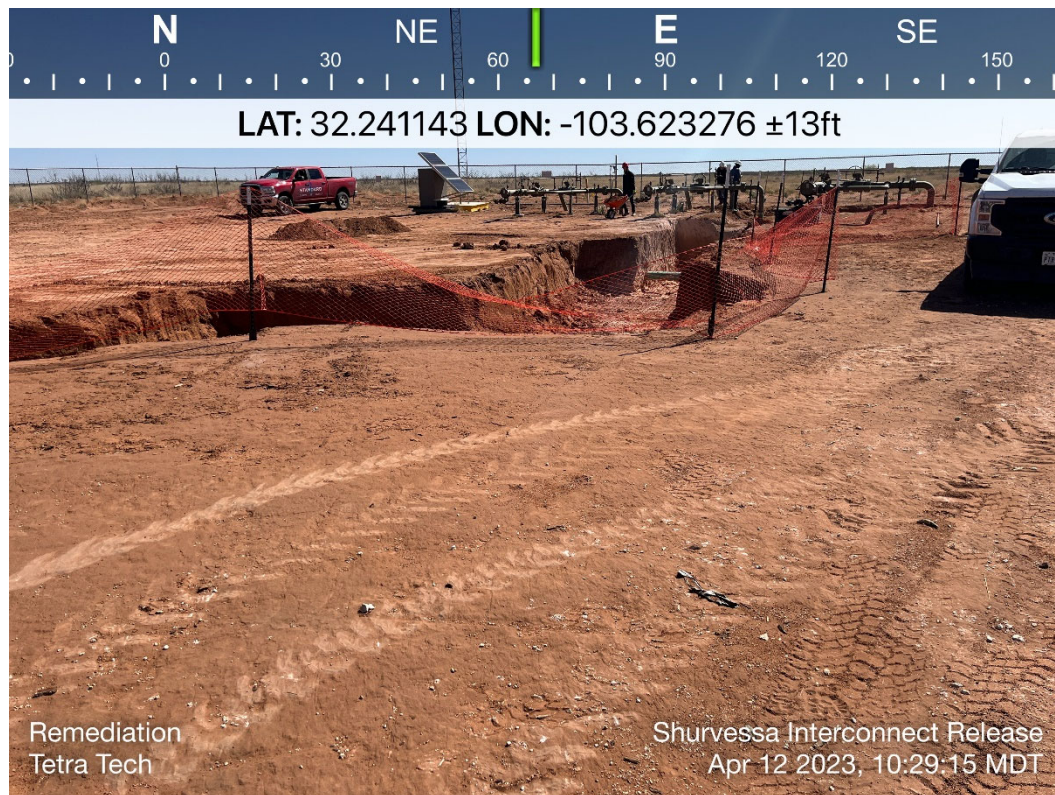
TETRA TECH, INC. PROJECT NO. 212C-MD-03060	DESCRIPTION	View of the excavation extent.	8
	SITE NAME	Energy Transfer Shurvessa Interconnect Release	4/12/2023

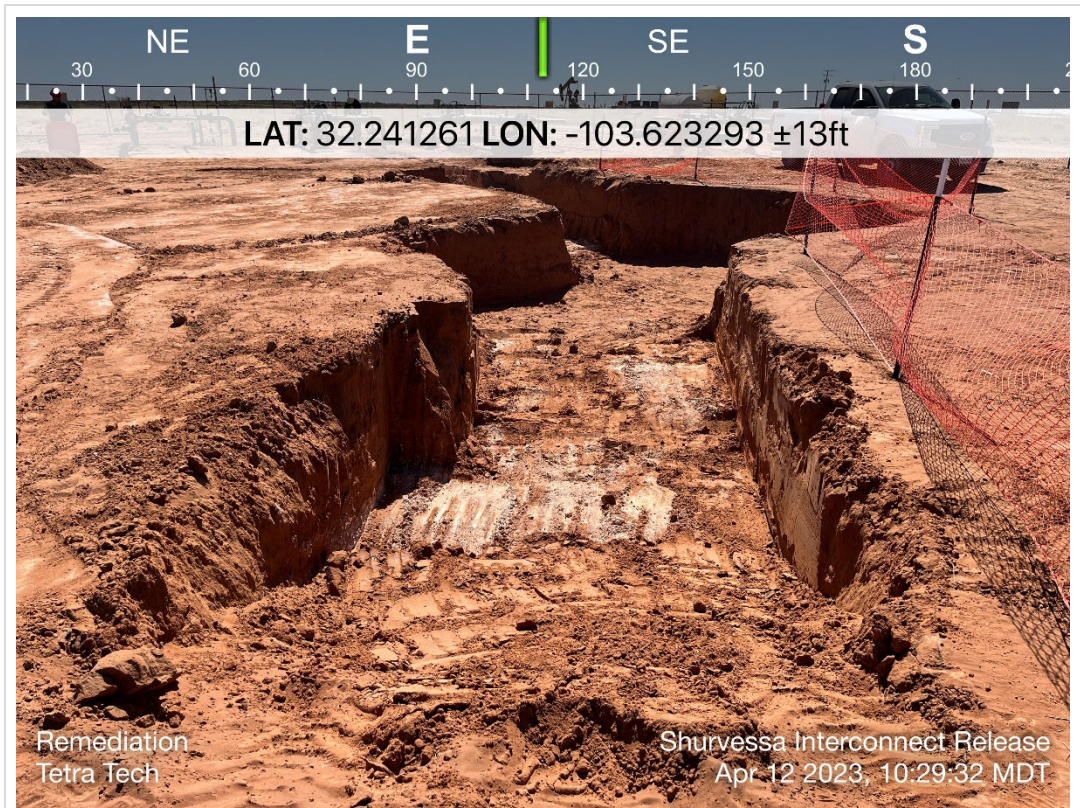
TETRA TECH, INC. PROJECT NO. 212C-MD-03060	DESCRIPTION	View of the excavation extent.	9
	SITE NAME	Energy Transfer Shurvessa Interconnect Release	4/12/2023

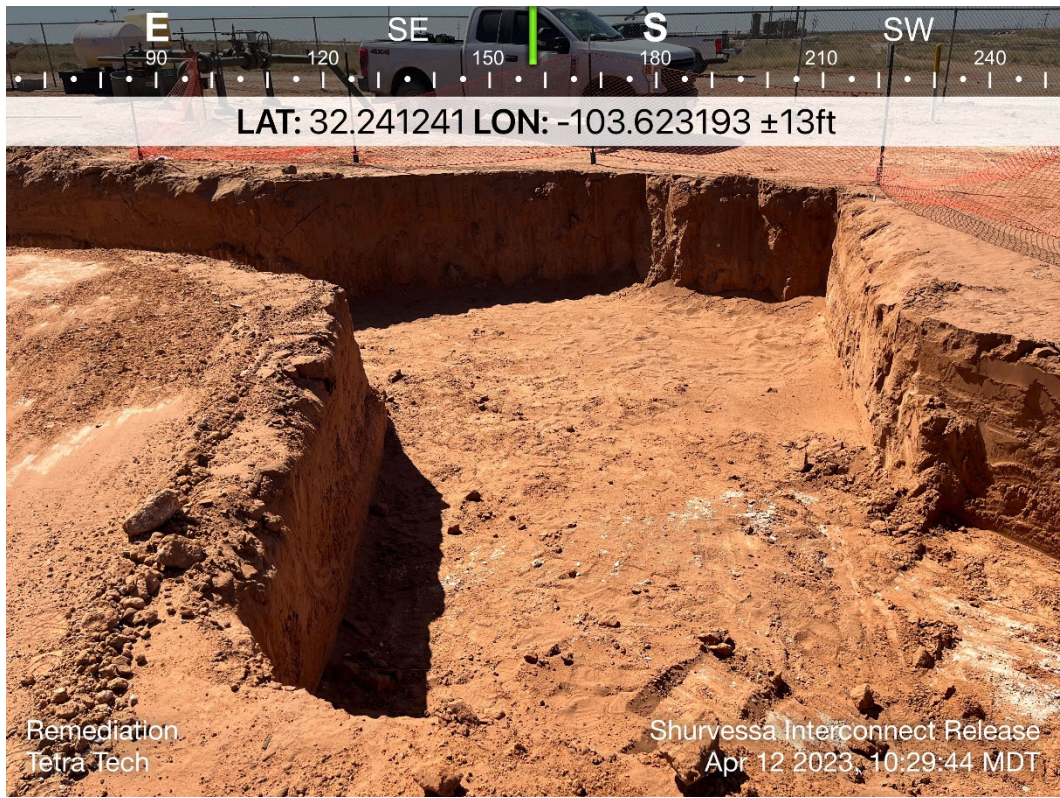
TETRA TECH, INC. PROJECT NO. 212C-MD-03060	DESCRIPTION	View of the excavation extent.	10
	SITE NAME	Energy Transfer Shurvessa Interconnect Release	4/12/2023

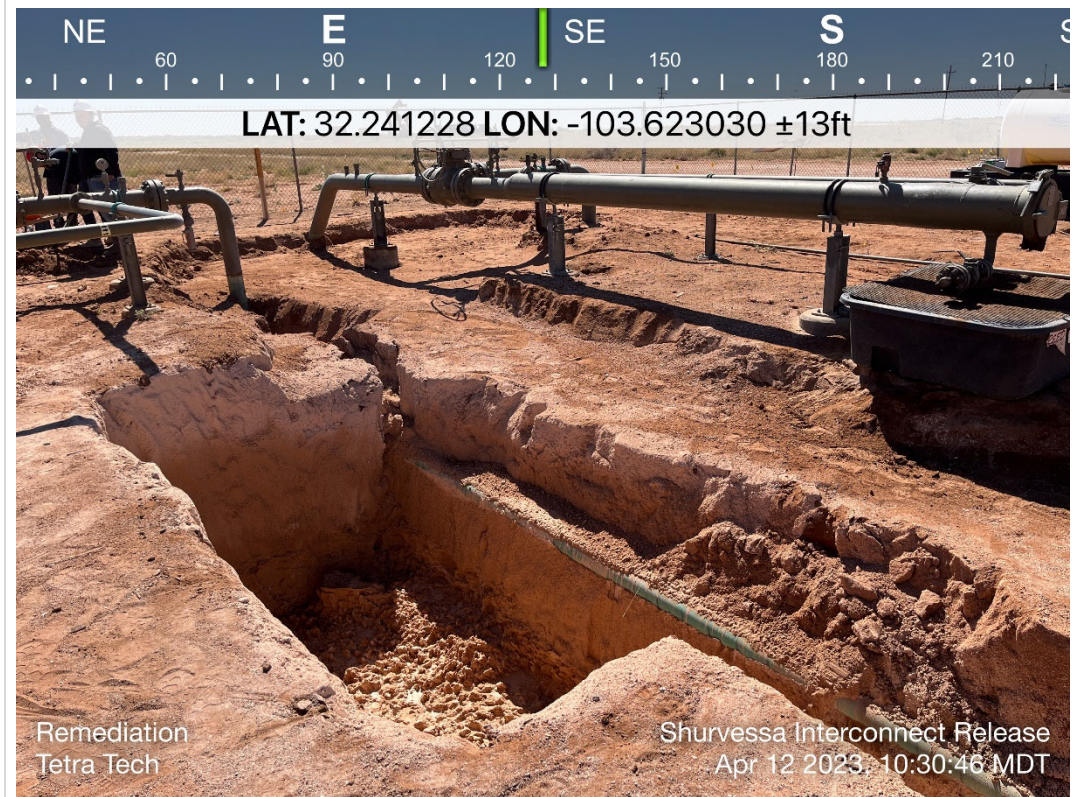
TETRA TECH, INC. PROJECT NO. 212C-MD-03060	DESCRIPTION	View of the excavation extent.	12
	SITE NAME	Energy Transfer Shurvessa Interconnect Release	4/12/2023

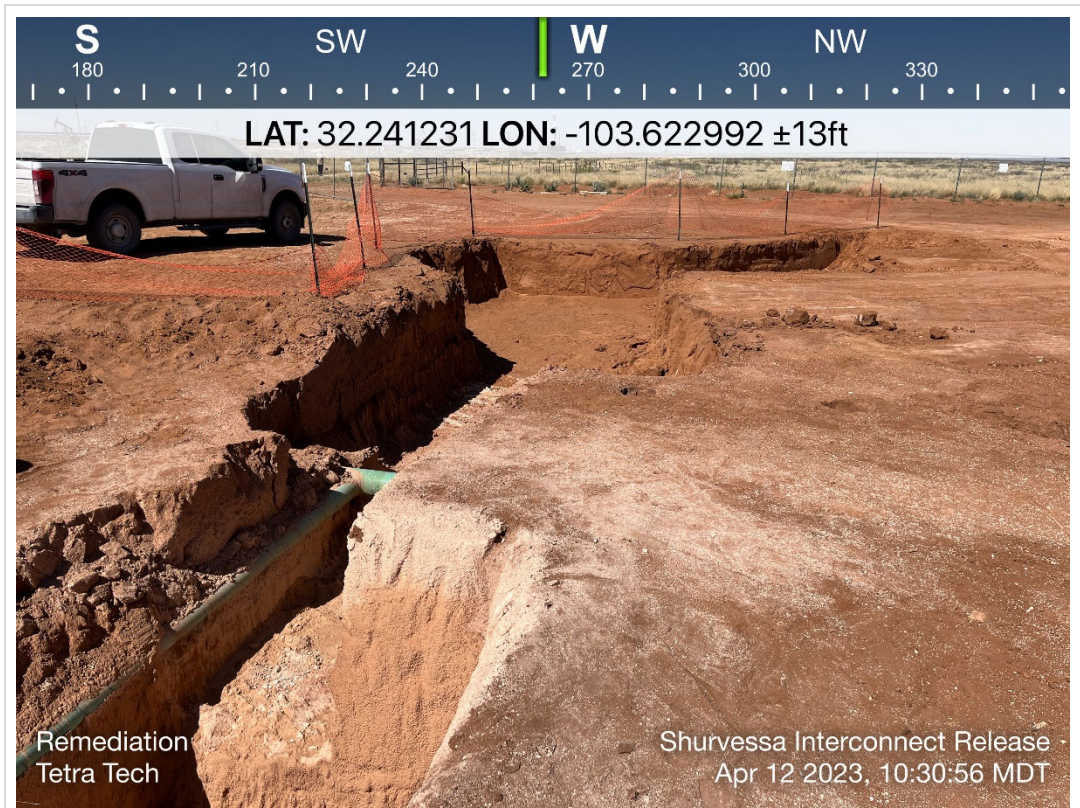
TETRA TECH, INC. PROJECT NO. 212C-MD-03060	DESCRIPTION	View of the excavation extent.	13
	SITE NAME	Energy Transfer Shurvessa Interconnect Release	4/12/2023

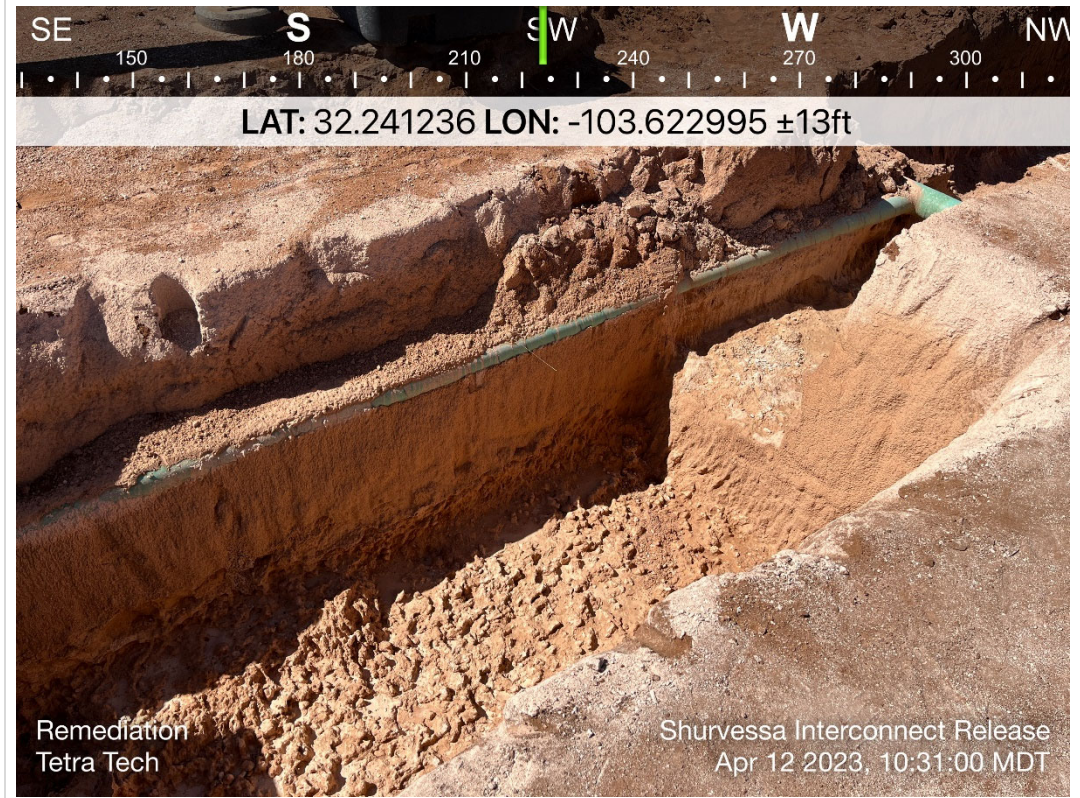
TETRA TECH, INC. PROJECT NO. 212C-MD-03060	DESCRIPTION	View of the excavation extent.	14
	SITE NAME	Energy Transfer Shurvessa Interconnect Release	4/12/2023

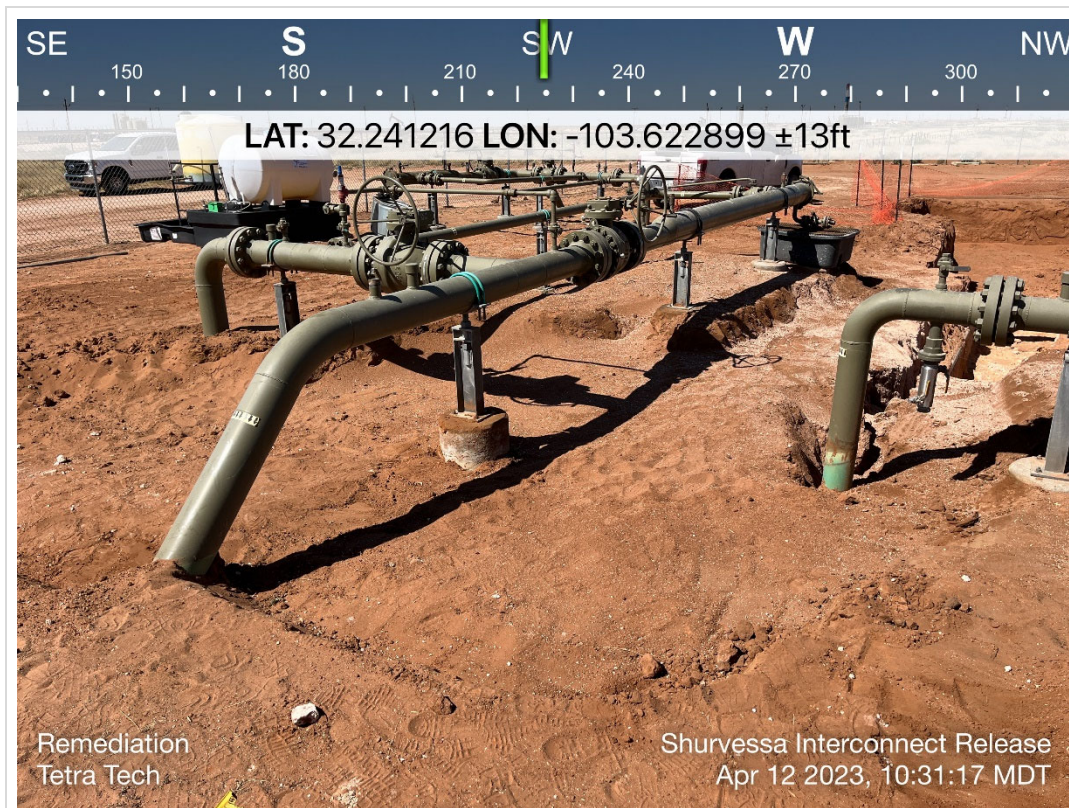
TETRA TECH, INC. PROJECT NO. 212C-MD-03060	DESCRIPTION	View of the excavation extent.	15
	SITE NAME	Energy Transfer Shurvessa Interconnect Release	4/12/2023

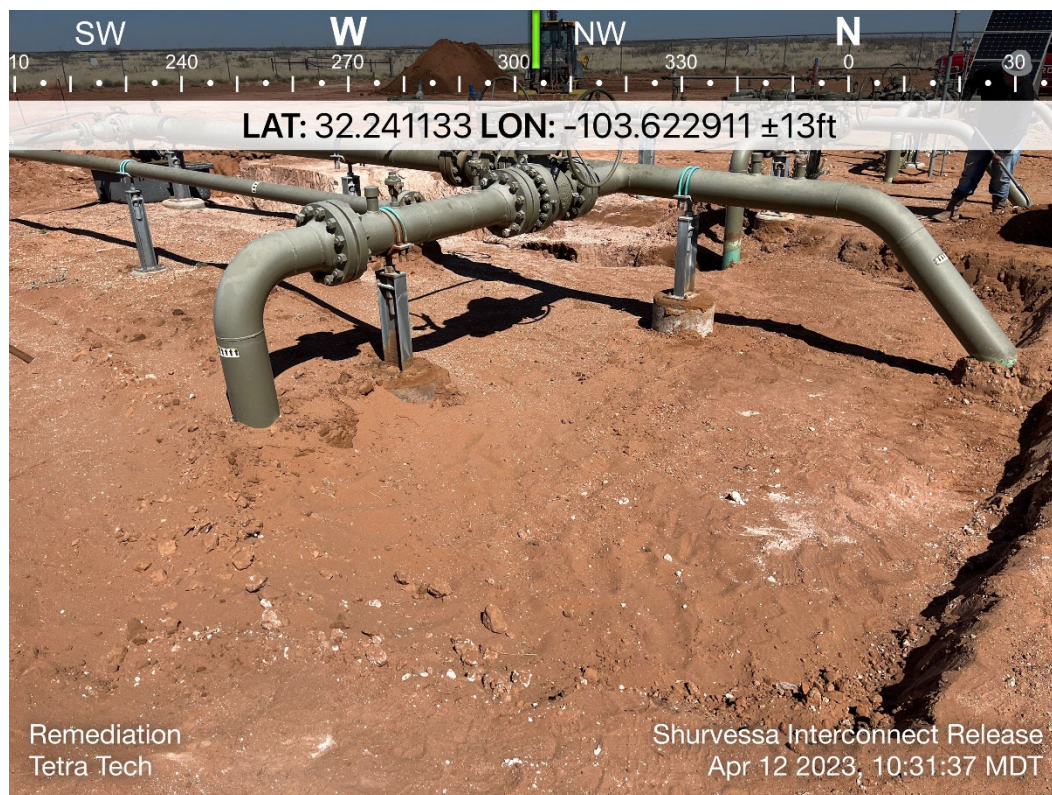
TETRA TECH, INC. PROJECT NO. 212C-MD-03060	DESCRIPTION	View of the excavation extent.	16
	SITE NAME	Energy Transfer Shurvessa Interconnect Release	4/12/2023

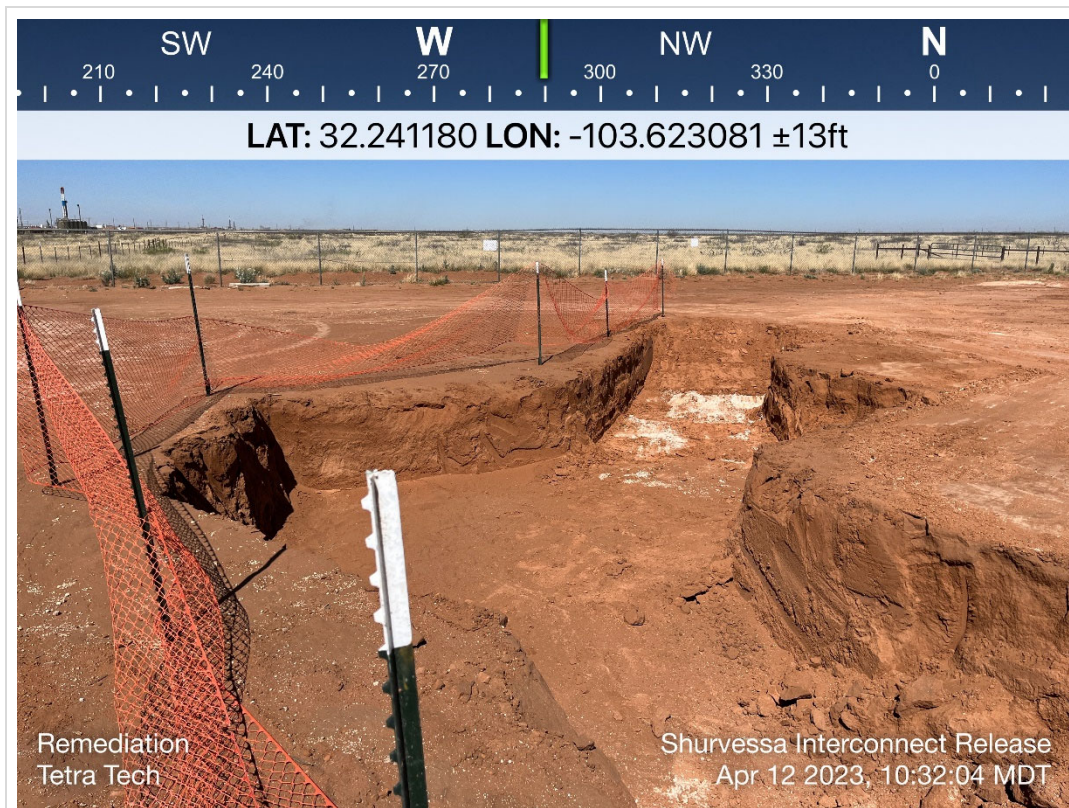
TETRA TECH, INC. PROJECT NO. 212C-MD-03060	DESCRIPTION	View of the excavation extent.	17
	SITE NAME	Energy Transfer Shurvessa Interconnect Release	4/12/2023

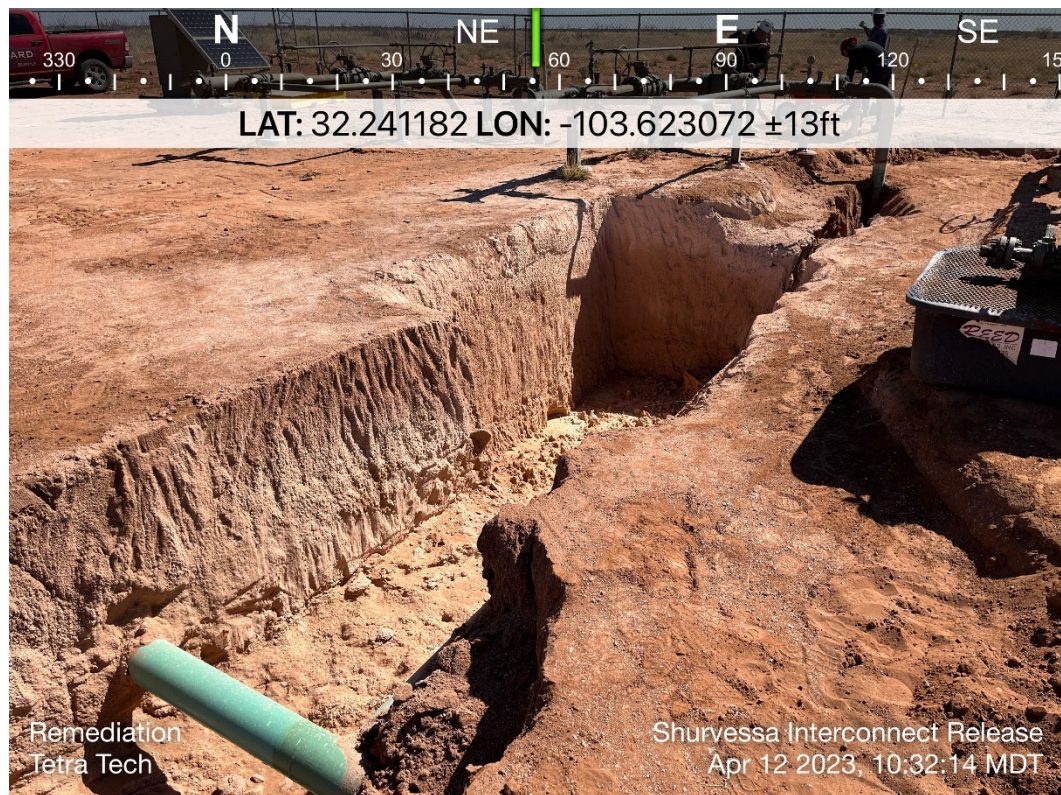
TETRA TECH, INC. PROJECT NO. 212C-MD-03060	DESCRIPTION	View of the excavation extent.	18
	SITE NAME	Energy Transfer Shurvessa Interconnect Release	4/12/2023

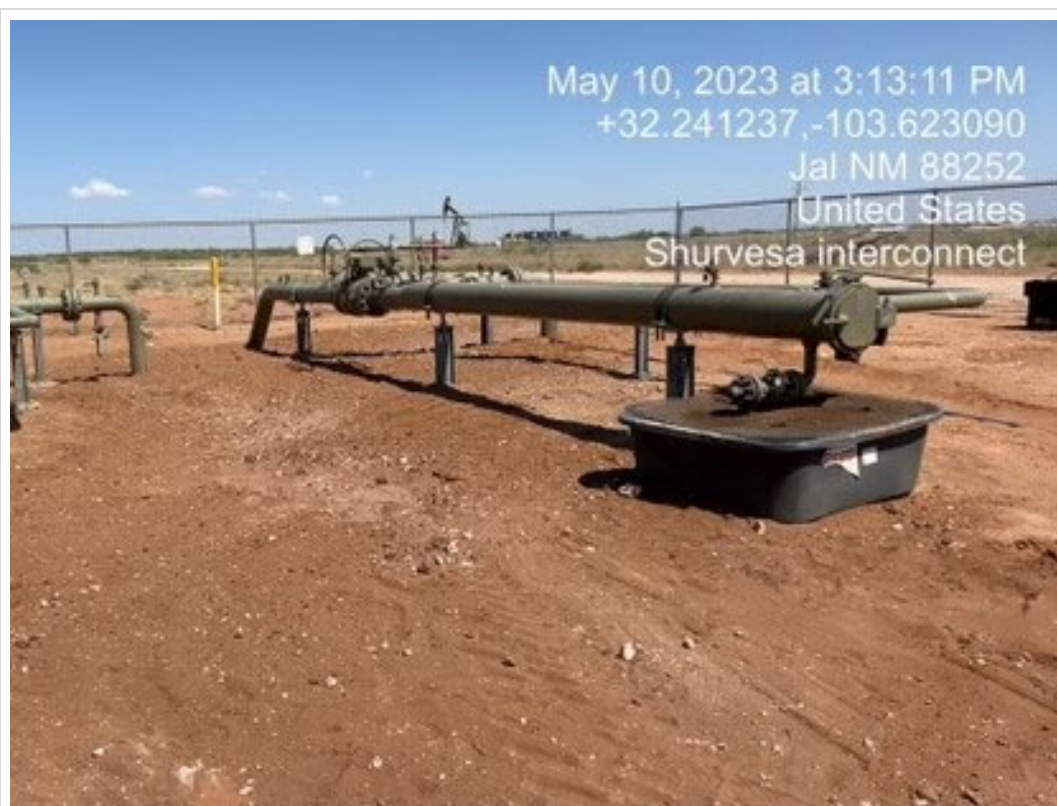
TETRA TECH, INC. PROJECT NO. 212C-MD-03060	DESCRIPTION	View of the backfilled exaction extent.	19
	SITE NAME	Energy Transfer Shurvesa Interconnect Release	5/10/2023

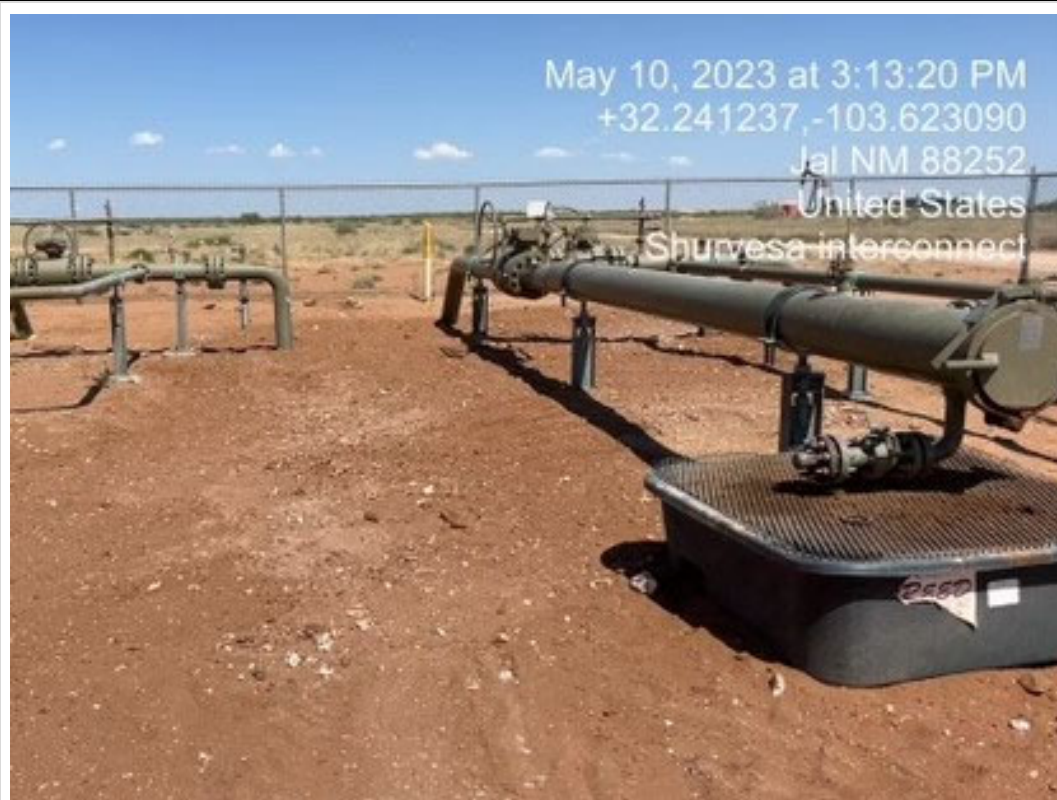
TETRA TECH, INC. PROJECT NO. 212C-MD-03060	DESCRIPTION	View of the backfilled exaction extent.	20
	SITE NAME	Energy Transfer Shurvesa Interconnect Release	5/10/2023

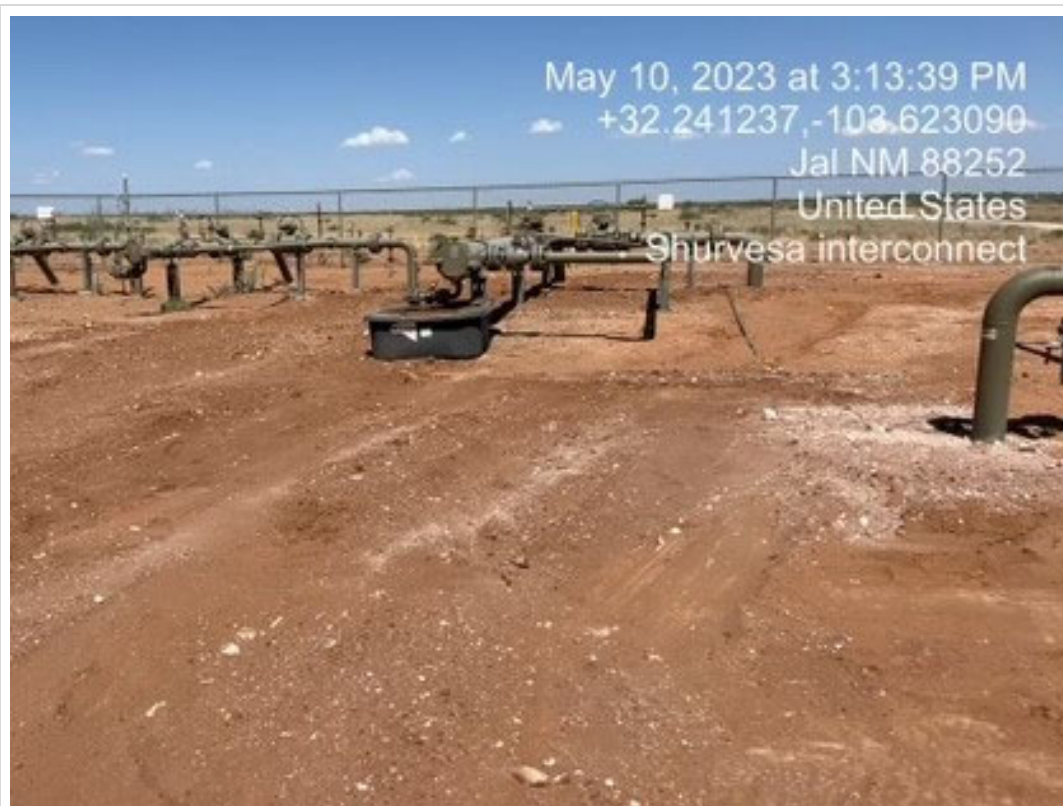
TETRA TECH, INC. PROJECT NO. 212C-MD-03060	DESCRIPTION	View of the backfilled exaction extent.	21
	SITE NAME	Energy Transfer Shurvesa Interconnect Release	5/10/2023

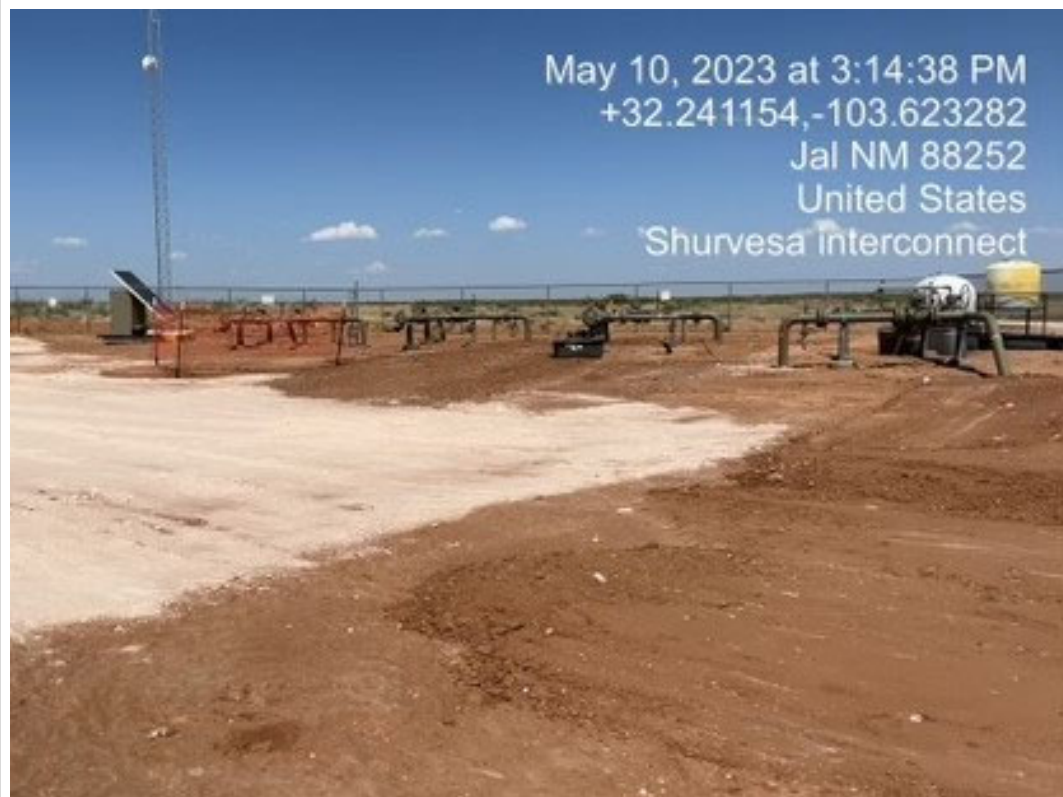
TETRA TECH, INC. PROJECT NO. 212C-MD-03060	DESCRIPTION	View of the backfilled exaction extent.	22
	SITE NAME	Energy Transfer Shurvesa Interconnect Release	5/10/2023

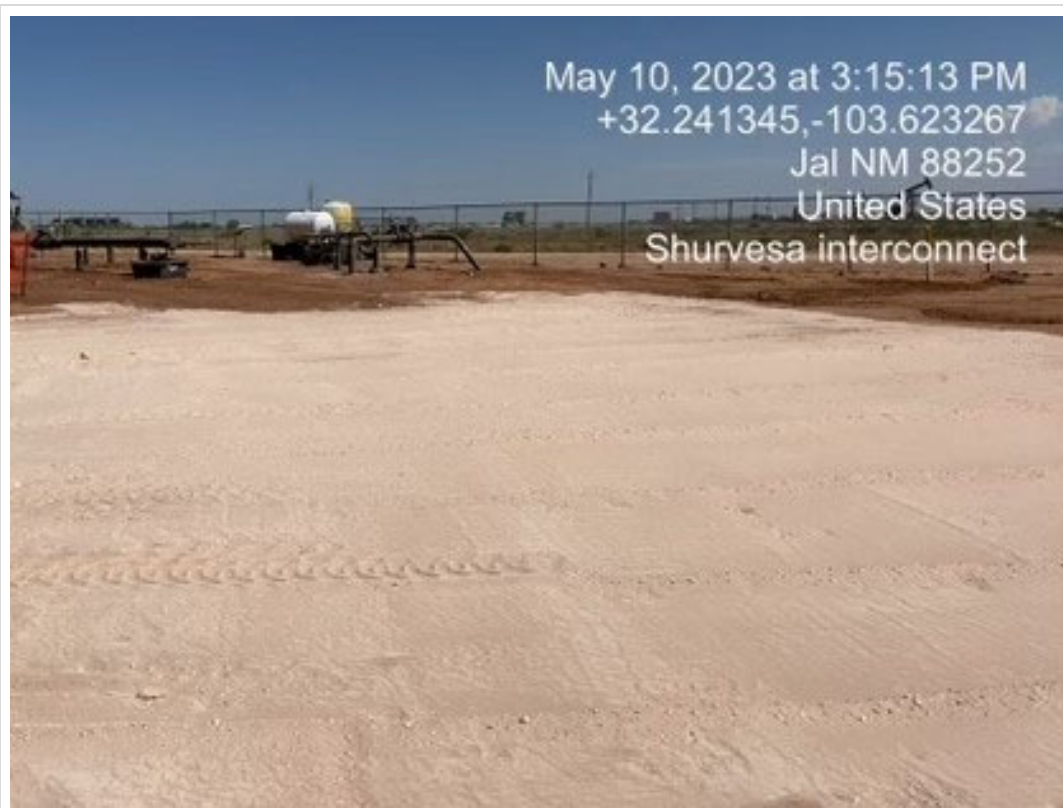
TETRA TECH, INC. PROJECT NO. 212C-MD-03060	DESCRIPTION	View of the backfilled exaction extent.	23
	SITE NAME	Energy Transfer Shurvessa Interconnect Release	5/10/2023

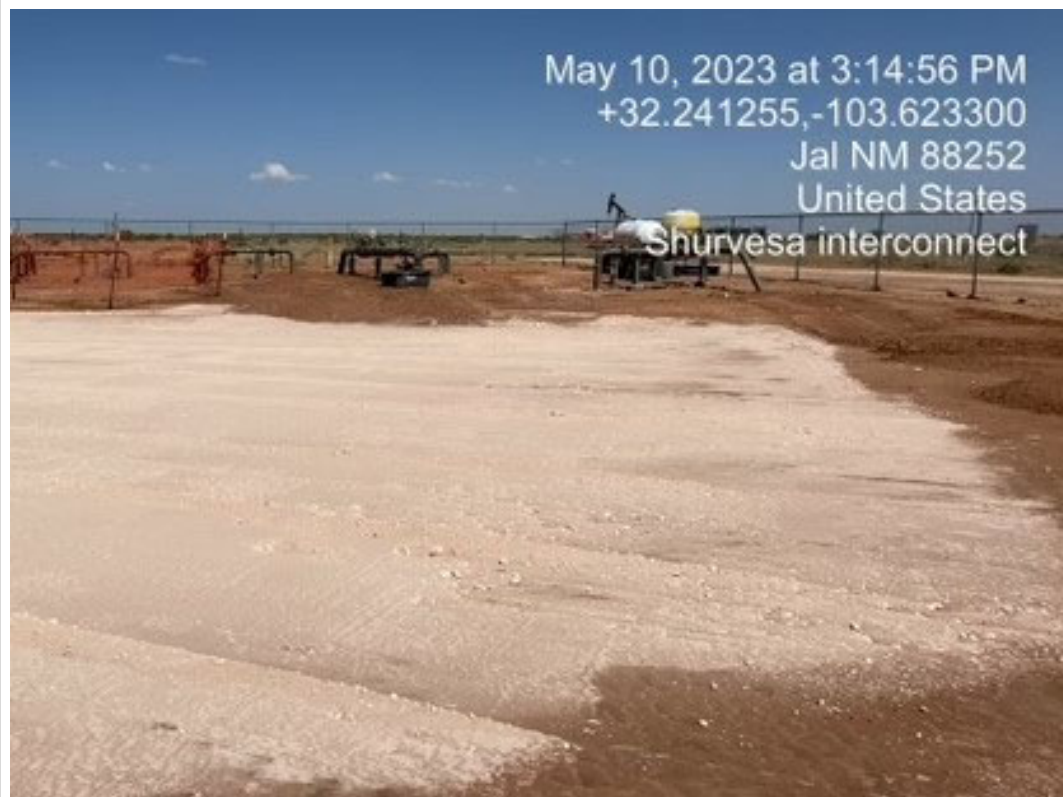
TETRA TECH, INC. PROJECT NO. 212C-MD-03060	DESCRIPTION	View of the backfilled exaction extent.	24
	SITE NAME	Energy Transfer Shurvessa Interconnect Release	5/10/2023
