June 9, 2023

**Re: Closure Request
Chiso 14 #3 & 4 / Chiso 14 State 8711 #3H Flare Stack
Incident Numbers nOY1829542961 and nCH1903548008
Lea County, New Mexico**

BTA Oil Producers, LLC
Closure Request
Chiso 14 #3 / 4 and Chiso 14 State 711 #3H Flare Stack

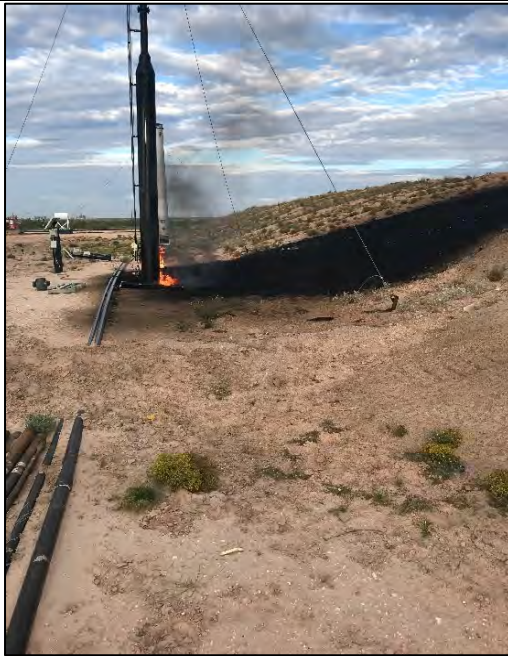
Photograph: 1 Date: 10/4/2018
Description: Incident Number nOY1829542961 release footprint

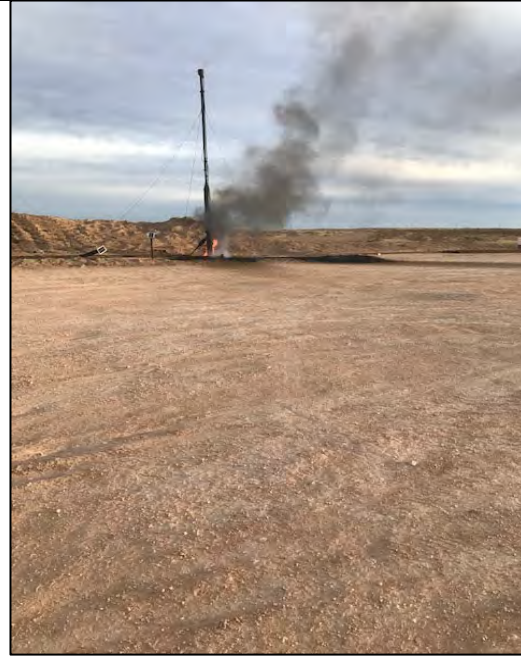
Photograph: 2 Date: 1/8/2019
Description: Incident Number nCH1903548008 release footprint

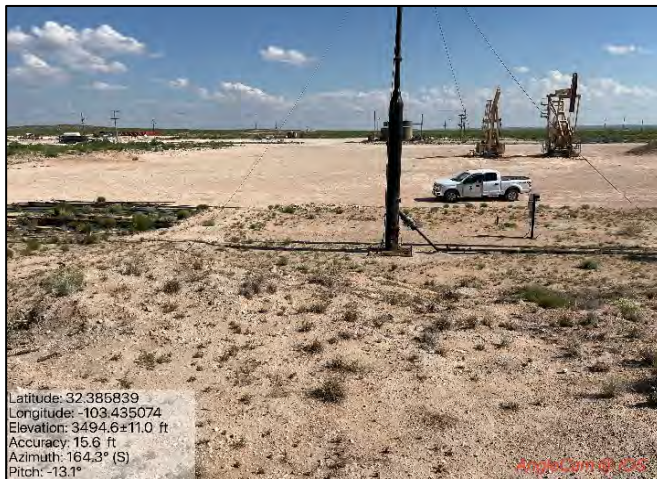
Photograph: 3 Date: 5/25/2023
Description: Assessment activities
View: southeast

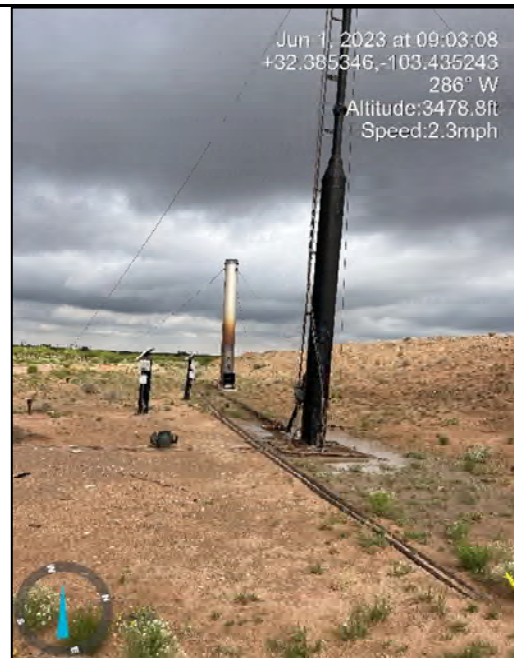
Photograph: 4 Date: 6/1/2023
Description: Assessment activities
View: West

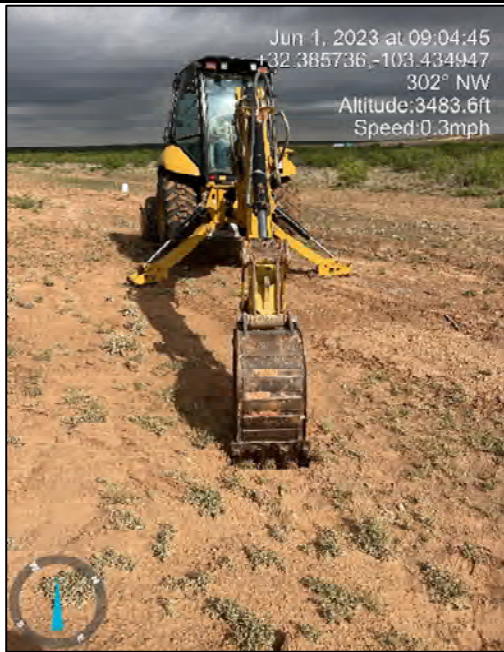
Photograph: 1 Date: 6/1/2023
Description: Assessment activities
View: Northwest

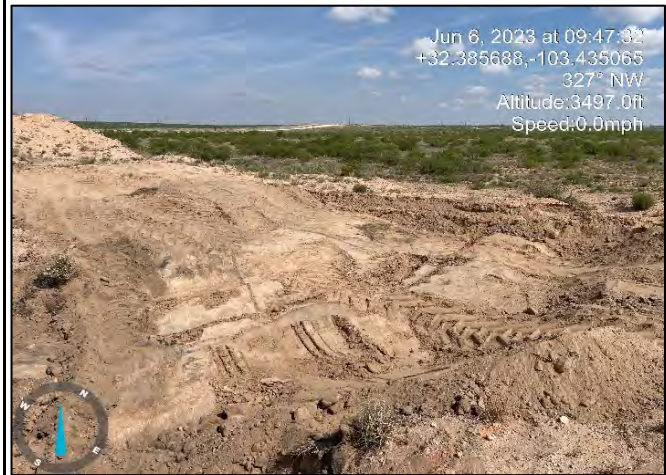
Photograph: 2 Date: 6/6/2023
Description: Excavation activities
View: Northwest

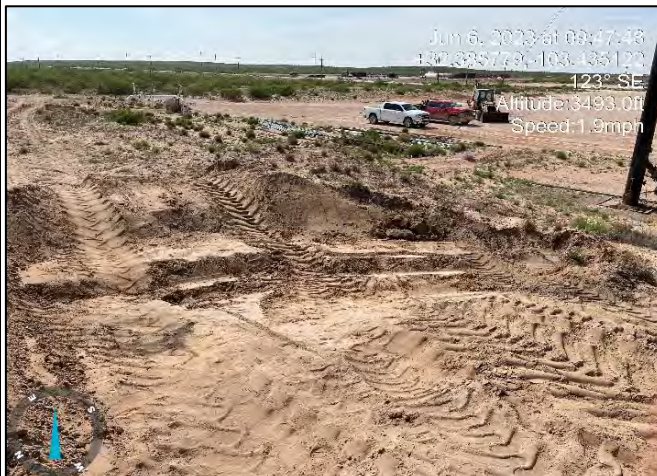
Photograph: 3 Date: 6/6/2023
Description: Excavation activities
View: Southeast

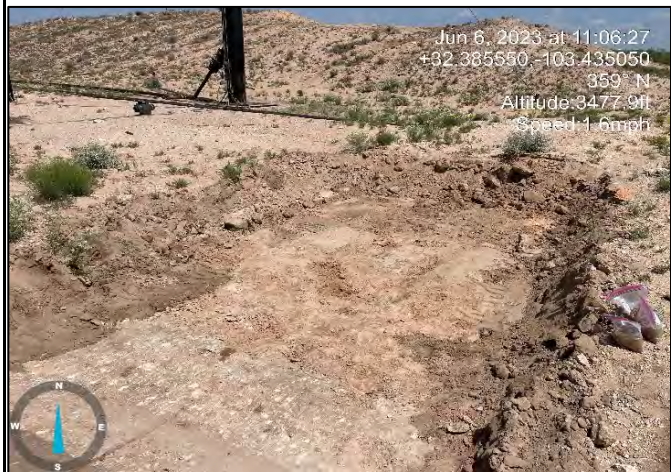
Photograph: 4 Date: 6/6/2023
Description: Excavation activities
View: North
