Incident ID	NAPP2300554747
District RP	
Facility ID	
Application ID

Re: Site Investigation Report and Remediation Work Plan

San Juan 27-5 Unit 111
Rio Arriba County, New Mexico
Hilcorp Energy Company
NMOCD Incident Number: NAPP2300554747

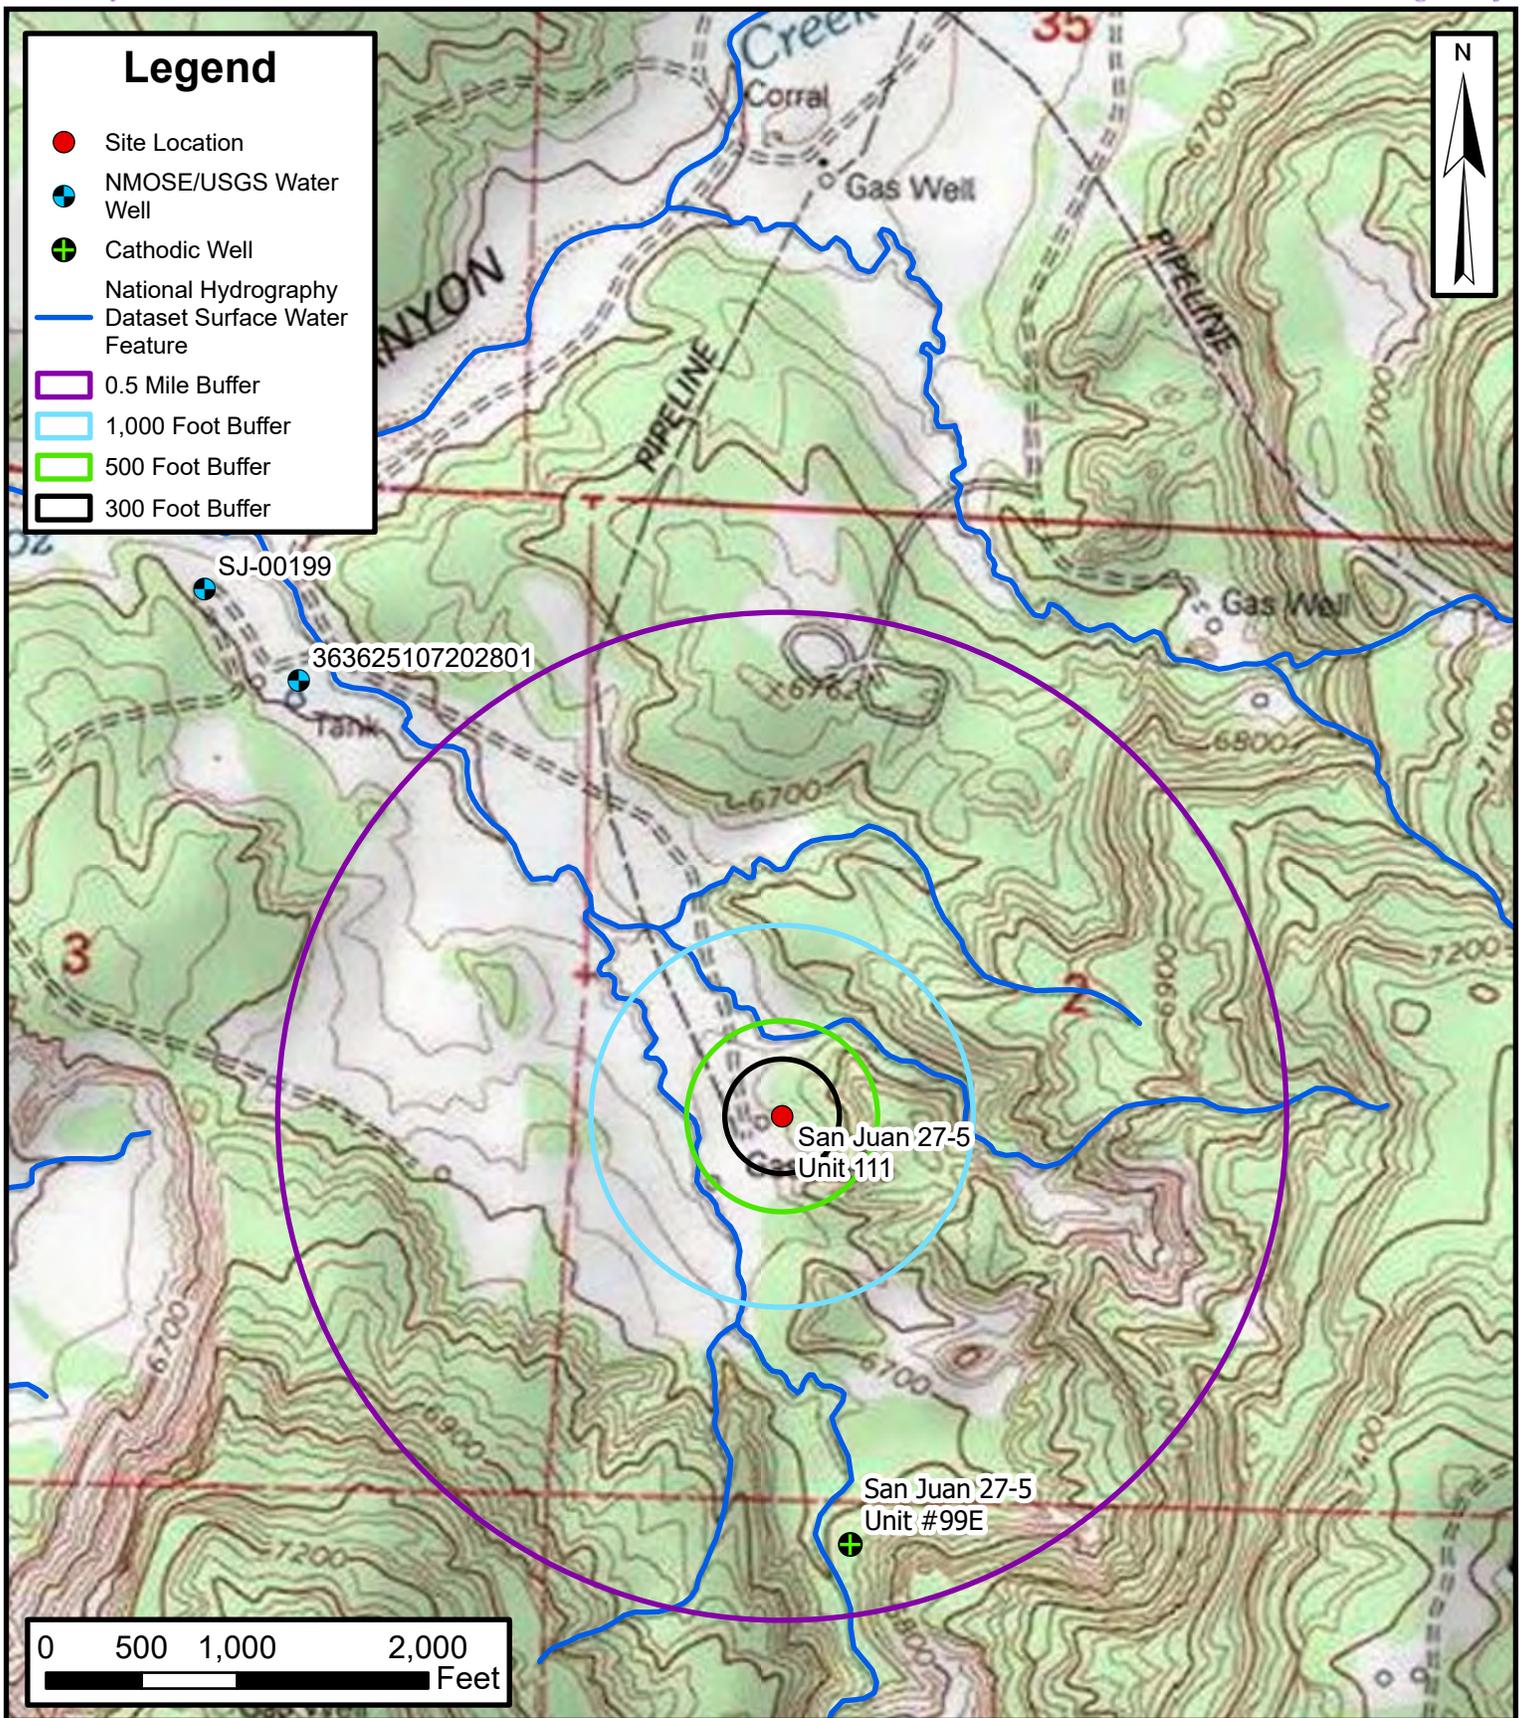
FIGURE
1

The Site is greater than 200 feet from any lakebed, sinkhole, or playa lake, and greater than 300 feet from any wetland (Figure 1). No wellhead protection areas, springs, or domestic/stock wells are located within a ½-mile from the Site (Figure 1). The Site is not within a 100-year floodplain, overlying a subsurface mine, or located within an area underlain by unstable geology (area designated as low potential karst by the Bureau of Land Management). Schools, hospitals, institutions, churches, and/or other occupied permanent residence or structures are not located within 300 feet of the Site.

Site Receptor Map
 San Juan 27-5 Unit 111
 Hilcorp Energy Company
 Unit L, Sec 2, T27N, R5W
 36.60065, -107.332672
 Rio Arriba County, New Mexico

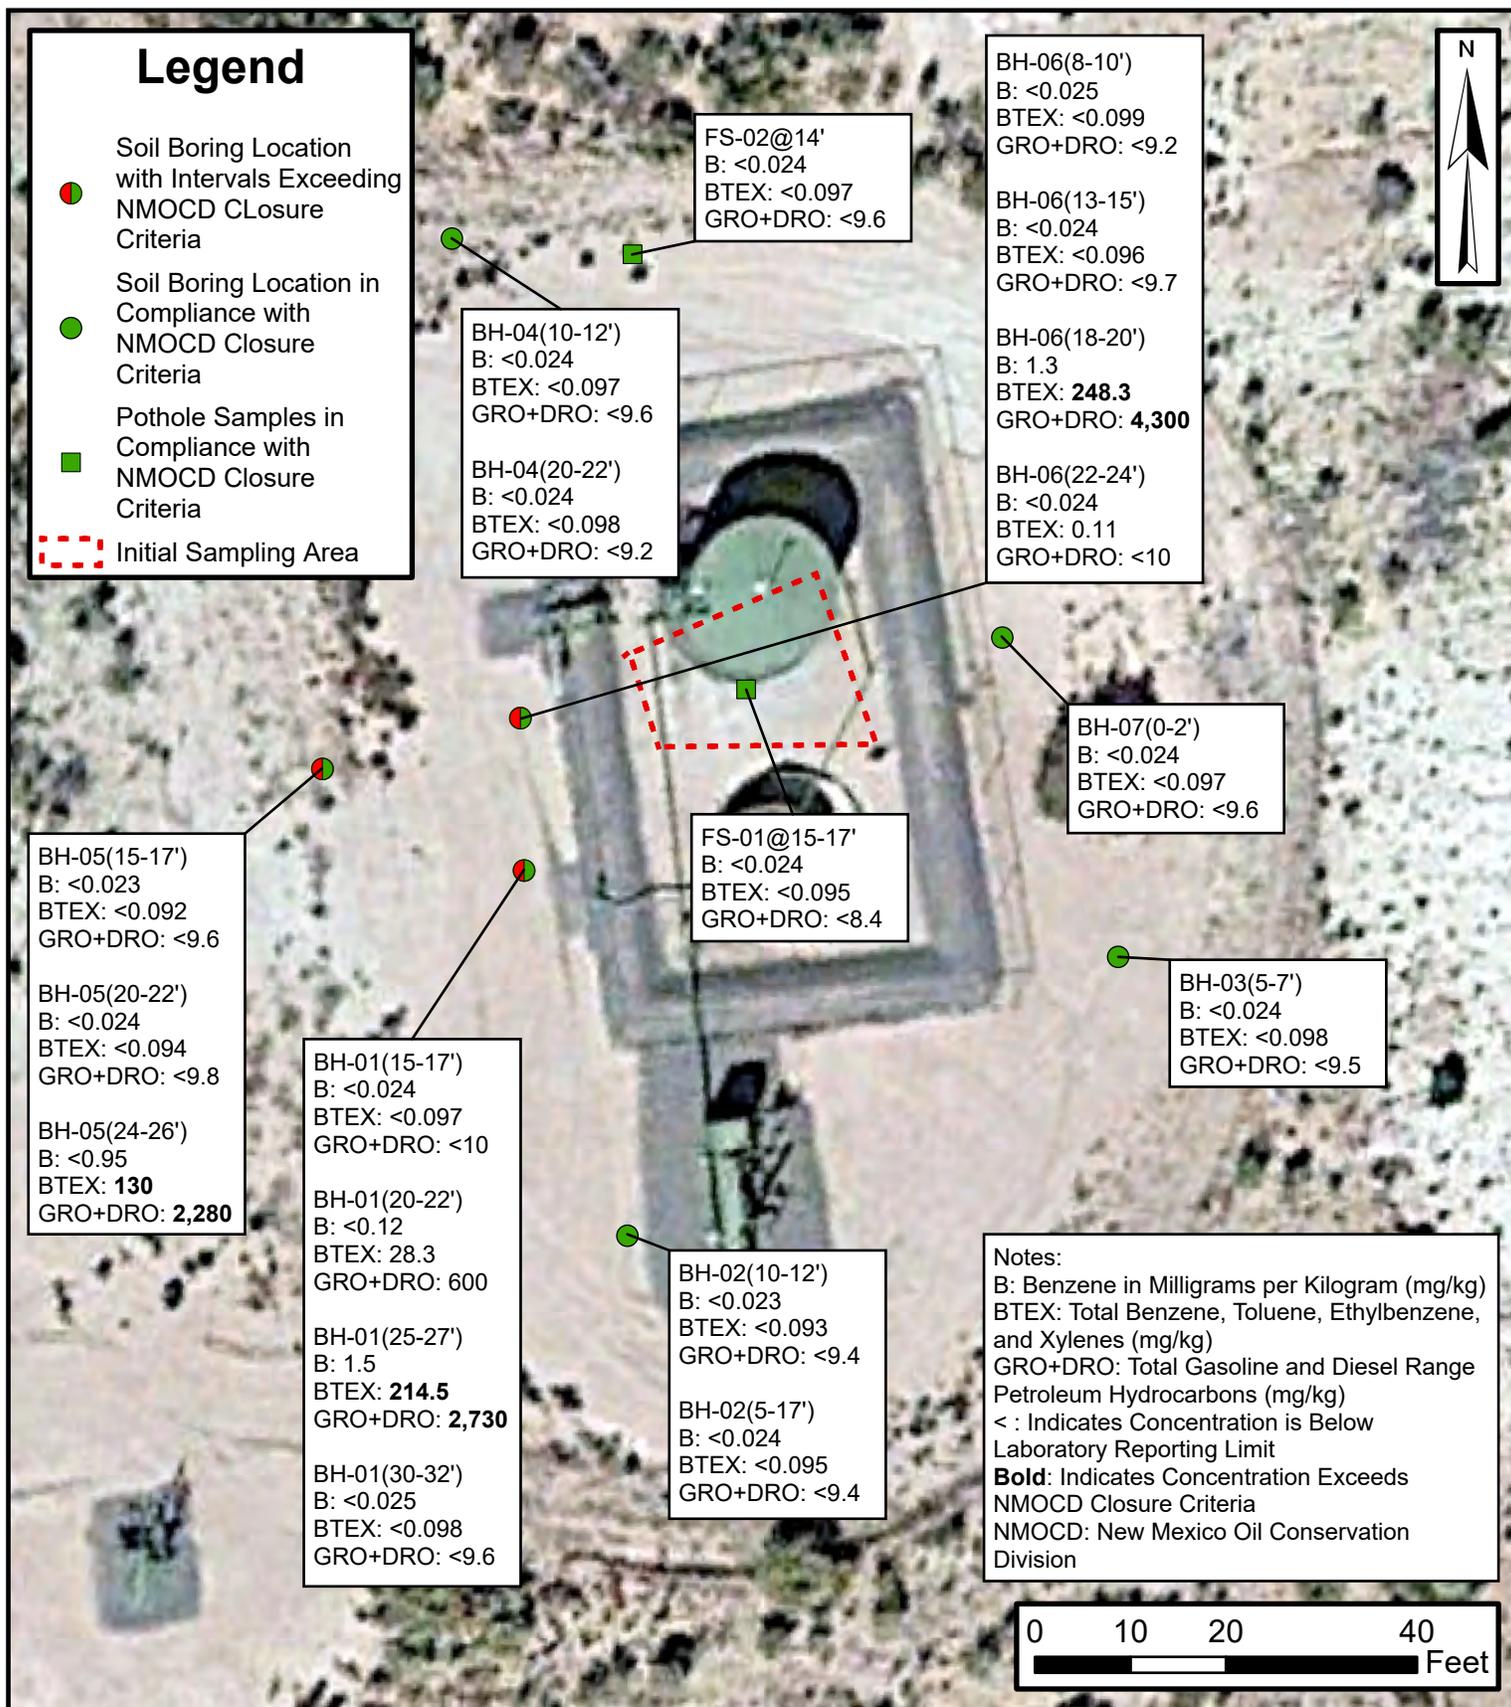
FIGURE
2

Based on the initial field screening and sampling results, further delineation activities were warranted using a drill rig. Specifically, soil borings BH01 through BH07 were advanced at the locations indicated on Figure 2, using a hollow-stem auger drill rig in order to delineate the lateral and vertical extent of soil impacts. During delineation activities, a geologist logged soil lithology and field screened for the presence of VOCs using the methods described above. Soil descriptions were noted in the field soil boring logs attached as Appendix C. The NMOCD was notified at least 48 hours in advance of any field activities performed at the Site. Notifications and correspondence with the NMOCD are attached in Appendix D.

Delineation Soil Analytical Results
 San Juan 27-5 Unit 111
 Hilcorp Energy Company
 Unit L, Sec 2, T27N, R5W
 36.60065, -107.332672
 Rio Arriba County, New Mexico

Concentrations of total BTEX, TPH-GRO+TPH-DRO, and Total TPH exceeding the NMOCD Table I Closure Criteria were detected in samples collected from borings BH01, BH05, and BH06. COC concentrations were compliant with the NMOCD Table I Closure Criteria in all other analyzed samples. A summary of analytical results is presented on Table 1 and depicted on Figure 2. Complete laboratory reports are attached in Appendix B. Photographs collected during Site work are included in Appendix E.

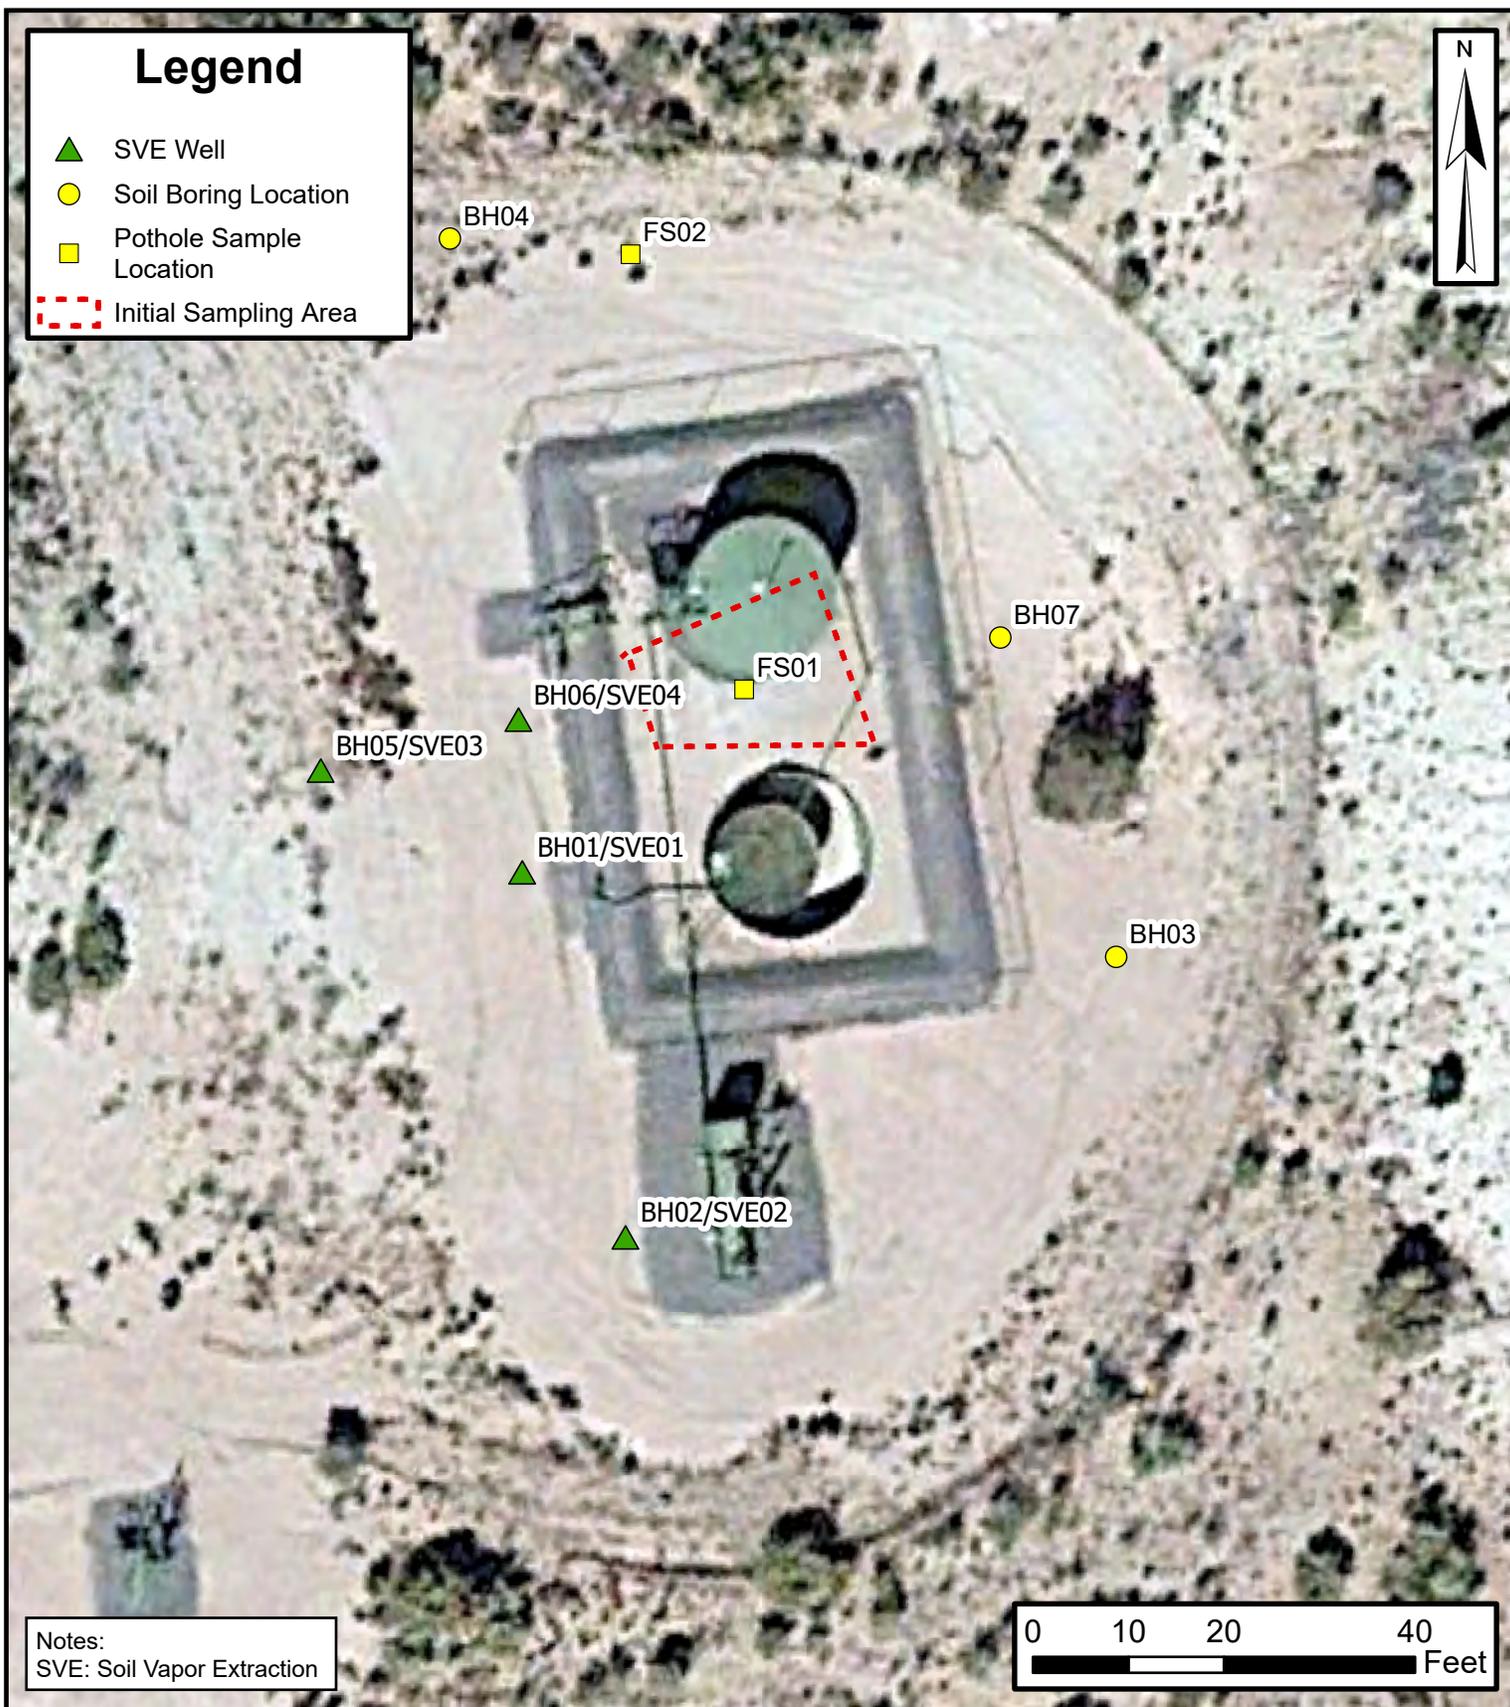
FIGURE
3

Based on field screening observations during drilling, borings BH01, BH02, BH05, and BH06 were completed as SVE wells to potentially be used for future remediation. Screened casing was installed across the subsurface interval with the highest petroleum hydrocarbon impacts based on PID readings in order to direct the applied vacuum to these depth intervals. Well construction details are included on the boring logs attached as Appendix C. SVE wells were constructed with 2-inch diameter Schedule 40 polyvinyl chloride (PVC) casing and 2-inch Schedule 40 PVC 0.010-inch slotted screen. Wells were completed with 10-20 silica sand pack to 2 feet above the screened interval, then hydrated bentonite seal 2 feet above the sand pack and grouted to the surface with cement grout. SVE well locations are indicated on Figure 3.

SVE Well Locations
 San Juan 27-5 Unit 111
 Hilcorp Energy Company
 Unit L, Sec 2, T27N, R5W
 36.60065, -107.332672
 Rio Arriba County, New Mexico

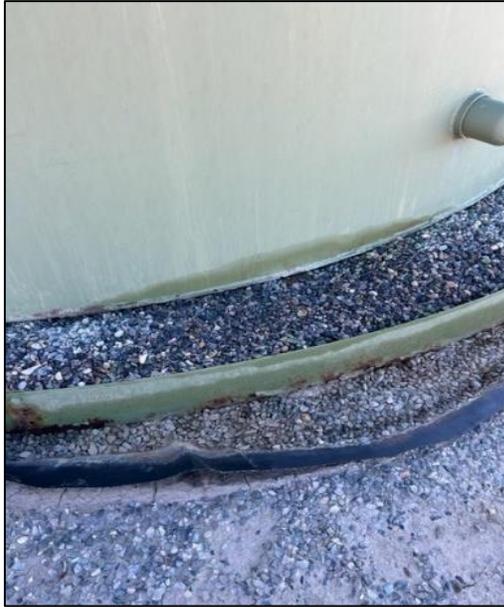
On December 21, 2022, Hilcorp discovered a release of 9.0 barrels (bbls) of produced water and 90.5 bbls of condensate due to corrosion at the bottom of the on-Site condensate aboveground storage tank (AST). Fluids stayed within the secondary containment berm but none were recovered. Upon discovery, the tank was immediately emptied. The release volume was determined based on the operator's monthly tank gauging data. Hilcorp reported the release via email to the New Mexico Oil Conservation Division (NMOCD) on December 22, 2022, and subsequently submitted a Form C-141, *Release Notification* to the NMOCD on January 5, 2023. The release was assigned NMOCD Incident Number NAPP2300554747.

Photograph: 1 Date: 12/21/2022
Description: Staining around condensate tank
View: East

To address heavily impacted soils at the Site, Hilcorp conducted initial sampling activities within the secondary containment in December 2022. Soil was removed from the area indicated on Figure 2 using a track hoe, up to a depth of approximately 14 feet bgs. Four sidewall soil samples and a floor soil sample were collected by Hilcorp personnel from the area and submitted to Hall Environmental Analysis Laboratory (Hall) for analysis of BTEX following United States Environmental Protection Agency (EPA) Method 8021B, TPH-GRO, TPH-DRO, TPH-MRO following EPA Method 8015M/D, and chloride following EPA Method 300.0. Concentrations of benzene, BTEX, and TPH exceeded the NMOCD Table I Closure Criteria in all soil samples collected during these activities. Chloride was not detected above the laboratory reporting limits

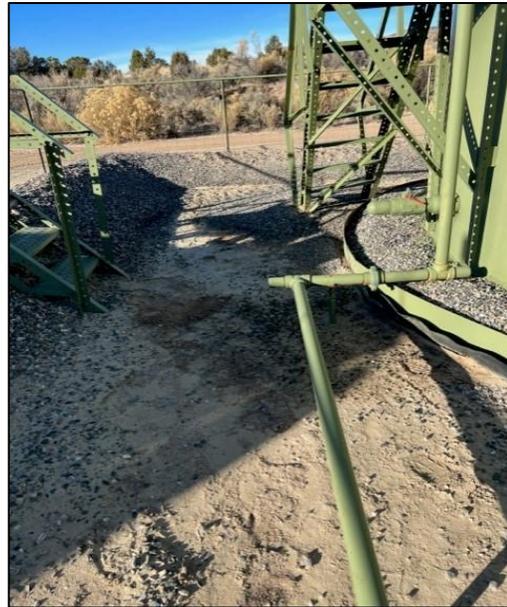
Photograph: 2 Date: 12/21/2022
Description: Soil staining in release area
View: North

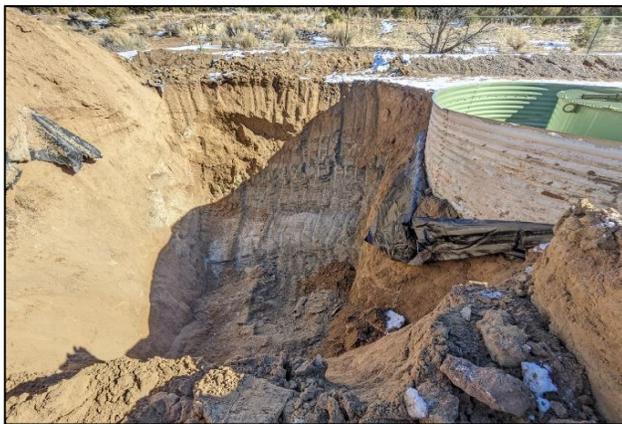
Based on the data collected during the initial sampling event, Hilcorp retained Ensolum to perform delineation activities at the Site. On January 12, 2023, initial investigation efforts were conducted using an excavator to advance potholes at the Site shown on Figure 2. Potholes FS-01 and FS-02 were advanced to depths up to 17 feet bgs. During the investigation, an Ensolum geologist logged soil lithology and inspected the soil for petroleum hydrocarbon staining and odors. Soil descriptions were noted in field books/boring logs and generally followed the Unified Soil Classification System (USCS), as specified in American Society for Testing and Materials (ASTM) method D2488.

Photograph: 3 Date: 1/12/2023
Description: Pothole FS-01
View: East

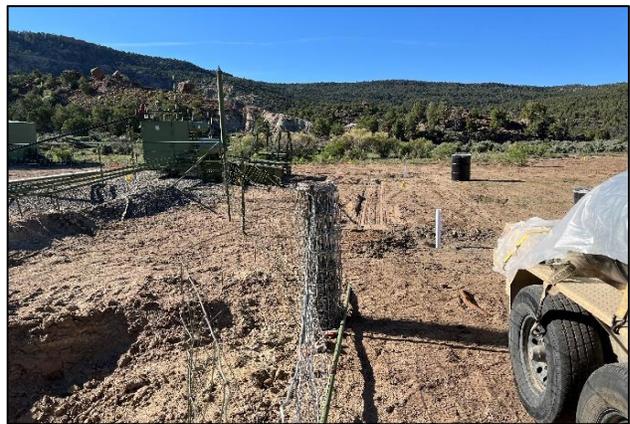
Photograph: 4 Date: 5/17/2023
Description: SVE wells in borings BH01 and BH06
View: South

Ensolum recommends performing a SVE pilot test to evaluate the effectiveness of SVE for the Site and, if applicable, assess the Site-specific flow and vacuum rates required to volatilize and remove contaminants from the impacted subsurface. Data collected during the SVE pilot test will be used to estimate the system's radius-of-influence (ROI) and radius-of-effect (ROE) to determine well spacing and the need for additional SVE wells at the Site.
