Review of the 2022 Annual
GW Monitoring Report for
RICE, BD SWD System:

RE: **2022 Annual Groundwater Report**
Rice Operating Company – BD SWD System
BD F-29 (1R426-16) and F-29-1 (1R426-15): UL/F, Sec. 29, T21S, R37E

ROC - BD F-29 (1R426-16) & F-29-1 (1R426-15)**Unit Letter F, Section 29, T21S, R37E**

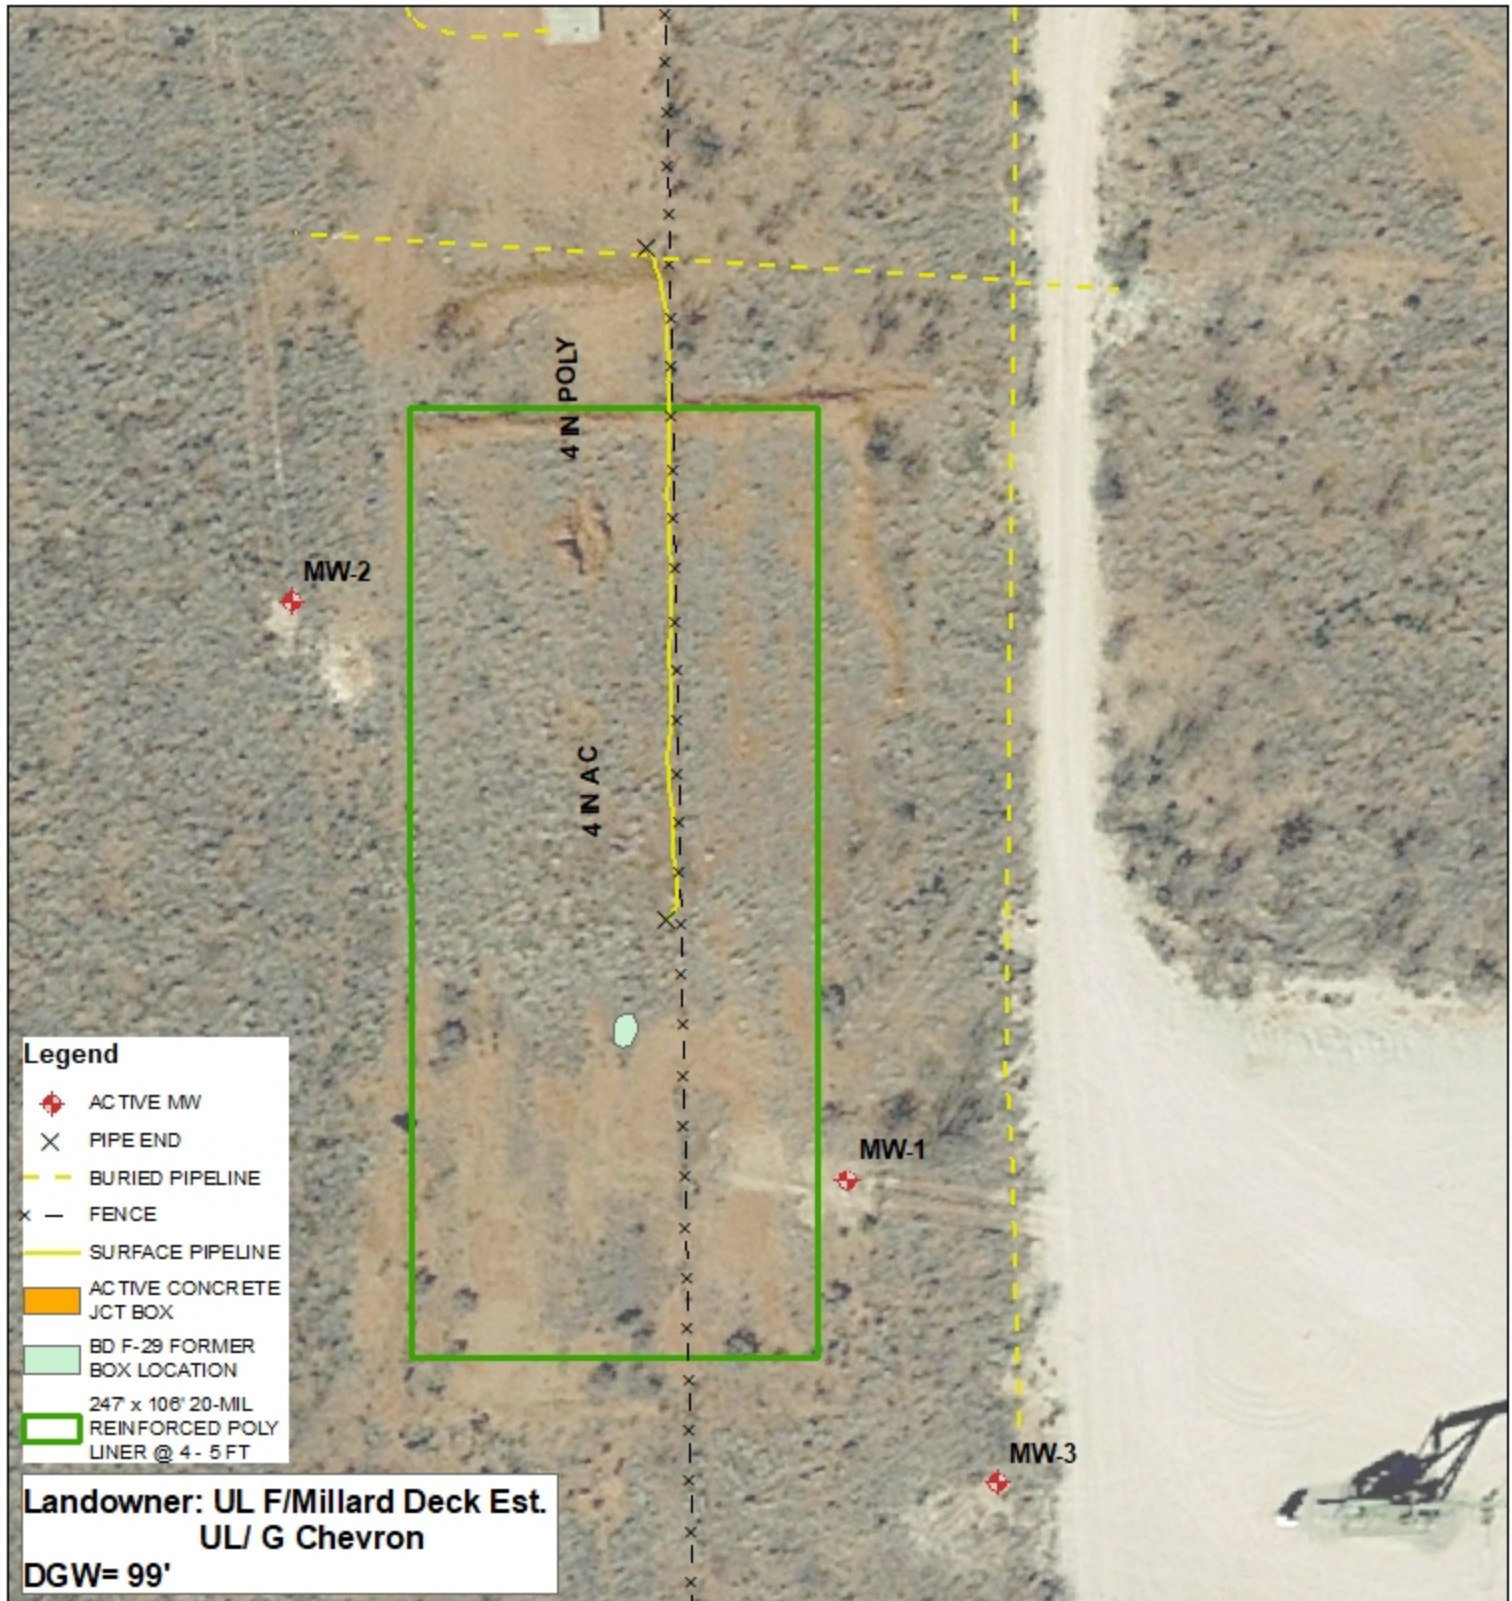
Monitor Well Location

On November 13th, 2018, a near-source monitor well (MW-1) was installed approximately 70 ft southeast of the former junction boxes. On December 10th, 2018, an up-gradient well (MW-2) was installed approximately 133 ft northwest and a down-gradient well (MW-3) was installed approximately 170 ft southeast of the former junction boxes. These wells were developed and have been sampled regularly. The most recent sampling event resulted in a chloride concentration of 500 mg/L in MW-1, 210 mg/L in MW-2, and 332 mg/L in MW-3. BTEX concentrations remained below detectable limits since the wells were installed. In 2020, ROC received NMOCD approval to cease BTEX sampling. On February 4th, 2022, and again on December 13th, 2022, NMOCD granted approval to cease sampling in the up-gradient well, MW-2. NMOCD also granted approval to cease sulfate analysis in MW-1, MW-2, and MW-3. ROC will continue to grab samples from MW-2, as needed, to ensure there are no non-ROC, up-gradient sources contributing to the degradation of groundwater quality. ROC will continue quarterly sampling in 2023.

BD
F-29 & F-29-1 JCT

1R426-16 & 1R426-15
UL F & G SECTION 29
T-21-S R-37-E
LEA COUNTY, NM
