**Re: Remediation Work Plan
Rojo AE 7811 JV-P Fed 001H
Incident Number NCH1836251271
Lea County, New Mexico**

Ensolum, LLC (Ensolum), on behalf of BTA Oil Producers, LLC (BTA), has prepared the following *Remediation Work Plan (Work Plan)* to document remedial activities completed to date at the Rojo AE 7811 JV-P Fed 001H (Site) and propose additional remedial actions based on deficiencies documented by the New Mexico Oil Conservation Division (NMOCD) in their denial email dated March 3, 2020. The following *Work Plan* proposes to collect the appropriate number of confirmation floor and sidewall soil samples that were not completed in December 2018 as well as collect lateral delineation soil samples to verify the lateral extent of the release.

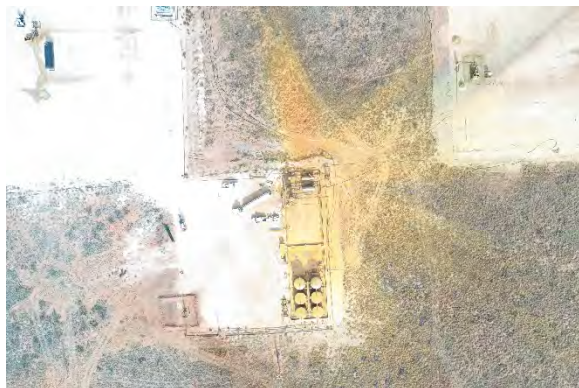
Aerial View of spill

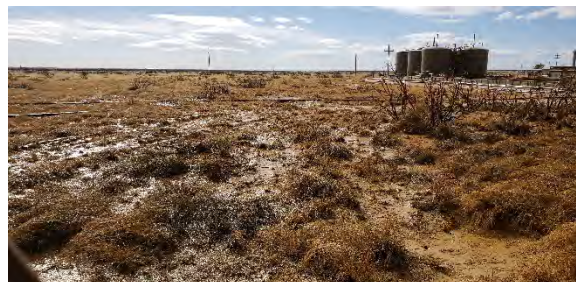
Spill Looking South

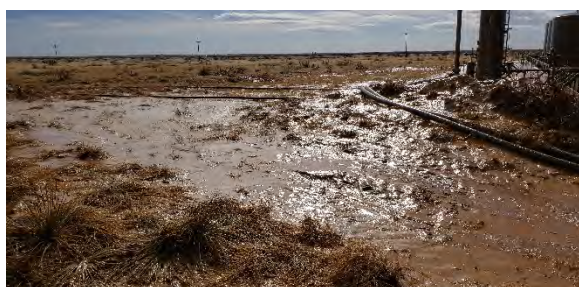
Spill Northeast View

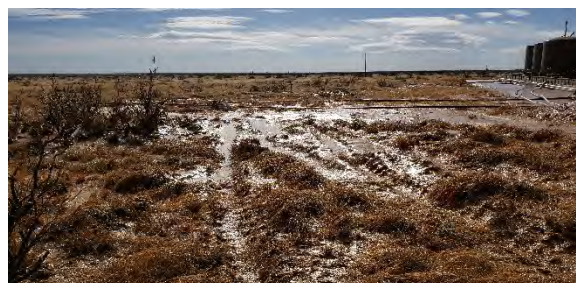
Spill Looking Southeast

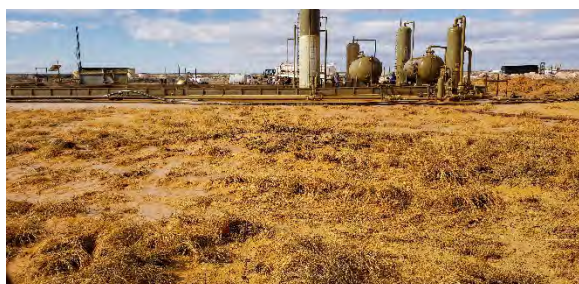
Spill Looking west

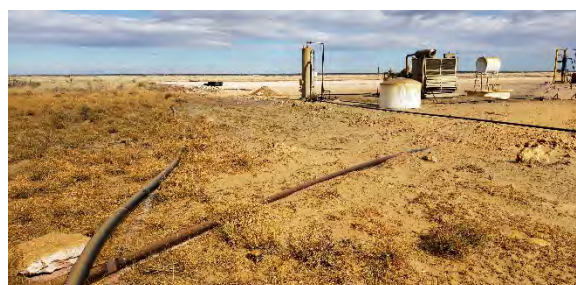
Spill looking southeast

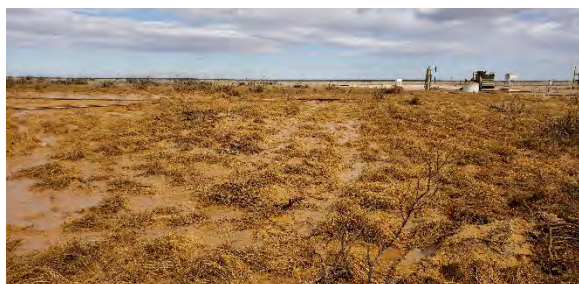
Spill Looking west
