RE: Revised Closure Report

ConocoPhillips Heritage Concho Federal 19 #001

Unit Letter A, Section 19, Township 23 South, Range 34 East

Lea County, New Mexico Incident ID: nOY1715329950

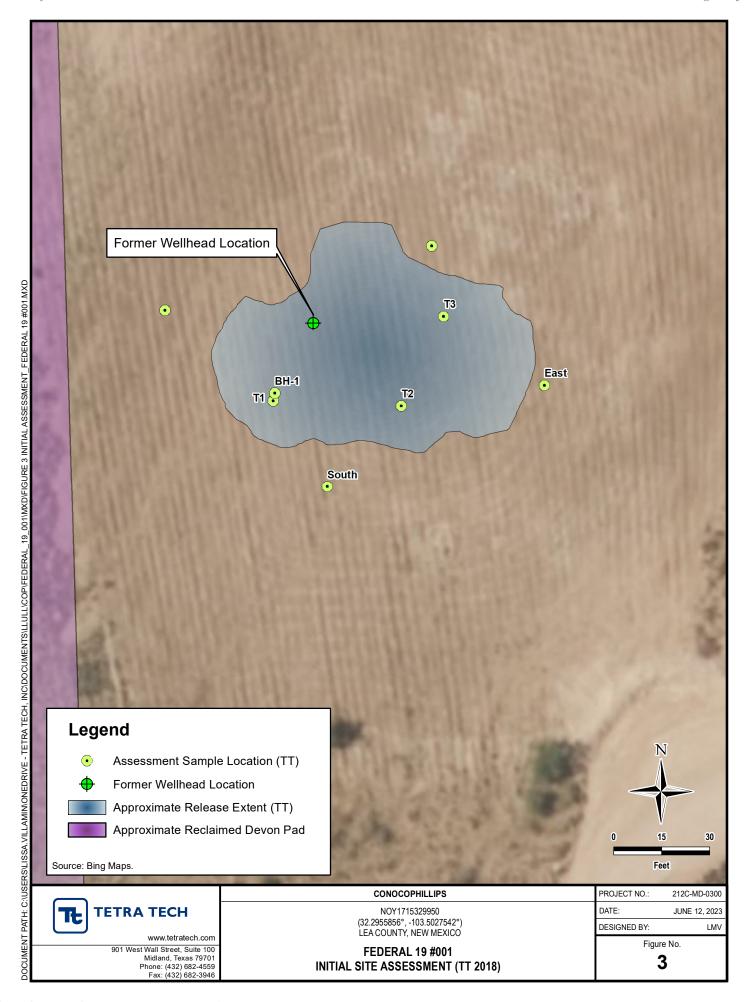
Figure 3 – Initial Site Assessment (TT 2018)

Tetra Tech had conducted the initial site assessment in 2017 on behalf of COG Operating LLC (Concho), which consisted of advancing three (3) trenches (T-1 through T-3) to total depths of 15 feet, 12 feet, and 10 feet below ground surface (bgs), respectively. Four (4) additional sample points (north, south, east, and west) were installed to depths of 1 feet bgs each. To obtain vertical delineation for chloride concentrations in the area of T-1, a borehole (BH-1) was advanced to a depth of 30 feet below surface. Figure 3 shows the approximate release extent and sample locations from the initial assessment. The results of the initial soil assessment are summarized in Table 1. Tetra Tech submitted a Work Plan Report to NMOCD, which was approved on May 1, 2018.

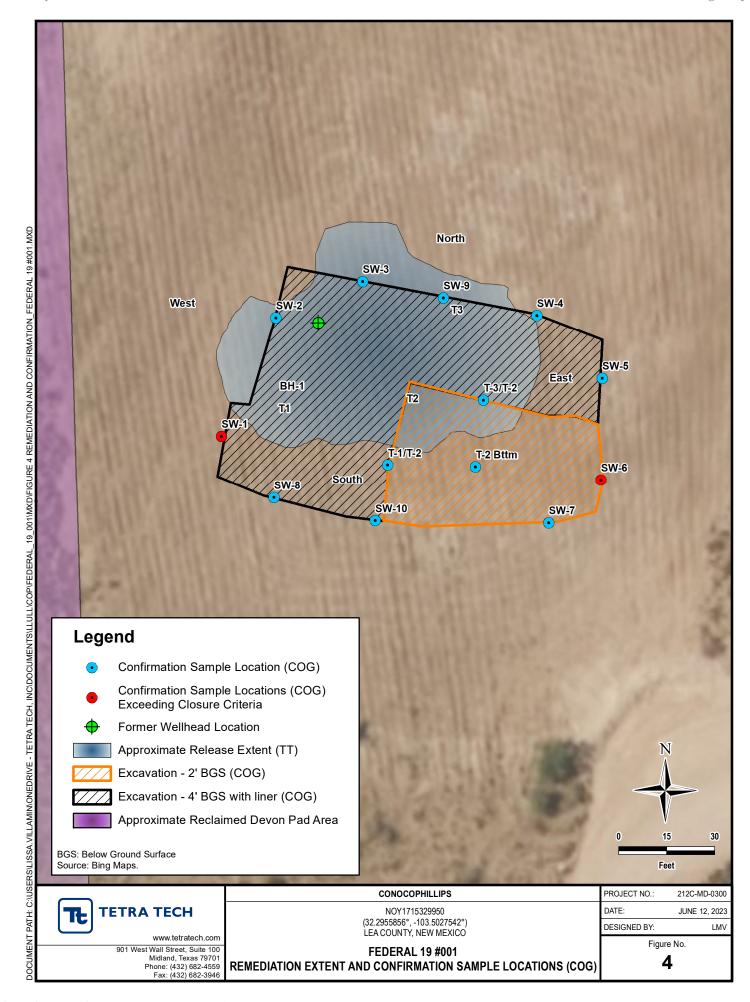
Figure 4 – Remediation Extent and Confirmation Sample Locations (COG)

COG Operating LLC (Concho) conducted remedial activities in accordance with the approved Work Plan in December 2018. The impacted area in the vicinity of T-1 and T-3 was excavated to a depth of 4 feet bgs. A twenty (20) mil reinforced liner was installed at the base of the excavation. The impacted area in the vicinity of T-2 was excavated to a depth of 2 feet bgs. Confirmation samples were collected and analyzed for chlorides. The results of the confirmation sampling are summarized in Table 2. The 2018 excavation extent and confirmation sampling locations are presented in Figure 4.

- "Samples SW-1 and SW-6 exceed closure criteria.
- Follow up confirmation samples for "Soil Status Removed" areas were not collected. See the table
 in the submitted report for these locations.
- SW-1 appears to be along undeveloped Devon well sites that were reclaimed. Devon well sites 30-025-36065 and 30-025-34950.
- Historical documentation indicates that the pit was located in different location to the northwest of the release area. Refer to the online imaging for pit documentation. The document detailing pit location information was uploaded on 6/11/2003 (258 kB - 6/11/2003) and is located on page 8.
- Submit a work plan or closure report via the OCD permitting portal by March 17, 2023."

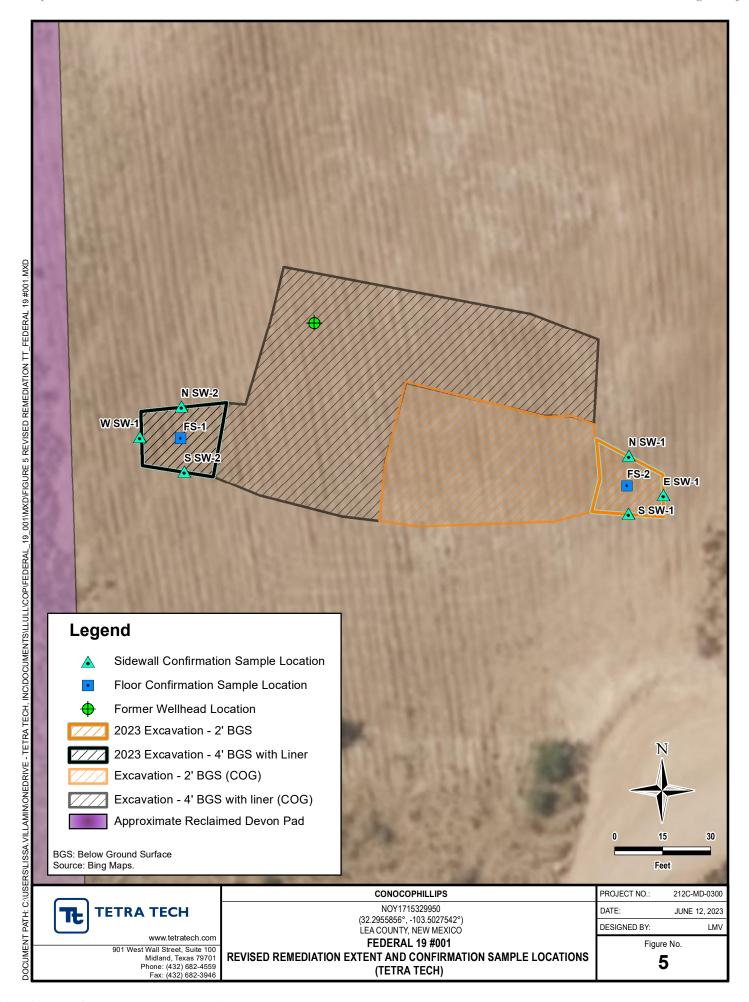
Figure 5 – Revised Remediation Extent and Confirmation Sample Locations (Tetra Tech)

Per the conditions of the NMOCD approval of the Work Plan, confirmation samples were collected such that each discrete sample (sidewall and floor) were representative of no more than 200 square feet of excavated area. A total of two (2) floor sample locations and six (6) sidewall sample locations were used during the remedial activities. Confirmation sidewall sample locations were labeled with "SW"-#, and confirmation floor sample locations were labeled with "FS"-#. Analytical results for all confirmation soil samples (floor and sidewall) were below the respective RRALs for chloride, BTEX, and TPH. The results of the May 2023 confirmation sampling events are summarized in Table 2. Laboratory analytical data is included in Appendix F. Excavated areas, depths and confirmation sample locations are shown in Figure 5.

In May 2023, Tetra Tech personnel were onsite to complete remediation of the release based on the NMOCD rejection of the 2019 Closure Report, including excavation, disposal and backfill. The 4-foot excavation area was expanded to remove impacted soils in the area of SW-1, and a twenty (20) mil

reinforced liner was installed at the base of the excavation. The 2-foot excavation area was expanded to remove impacted soils in the area of SW-6. Photographs from the excavated areas prior to backfill are provided in Appendix D.

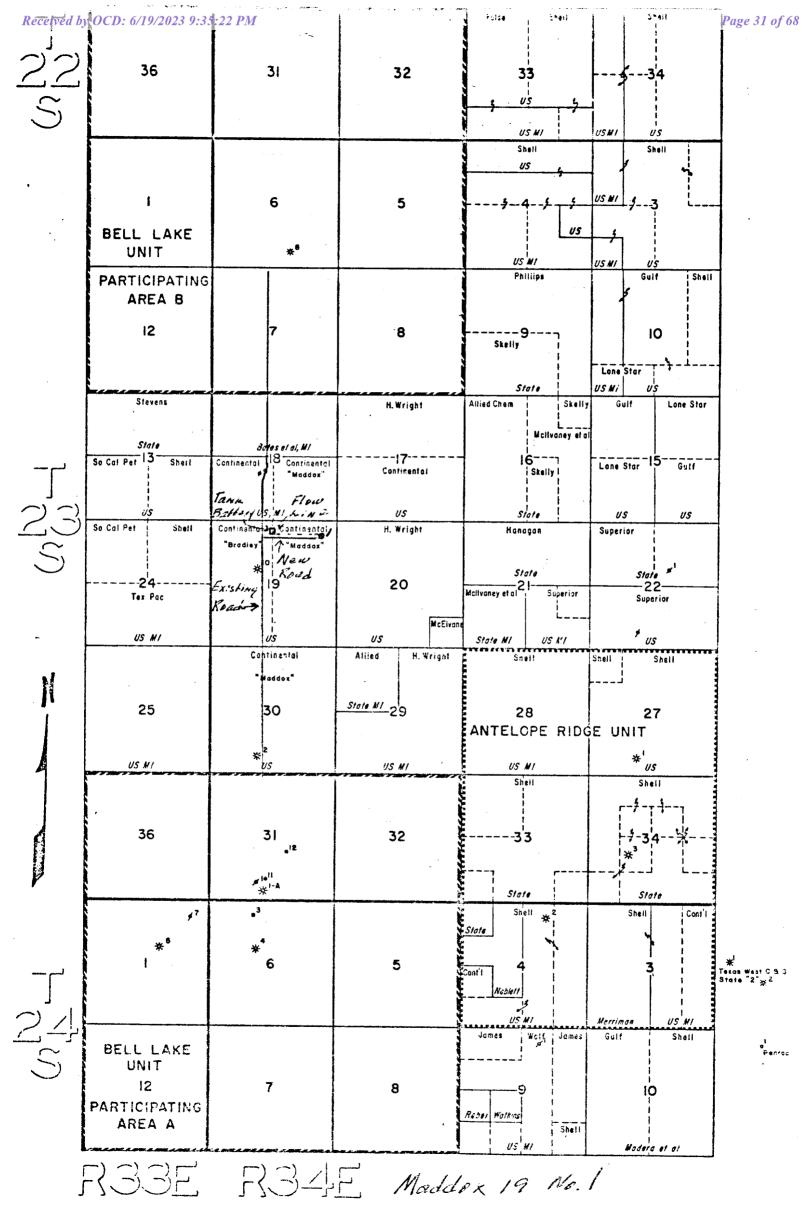
DRAWING B

CONTINENTAL OIL COMPANY Blow-out Preventer Specifications

MADDOX "19" WELL No. 1

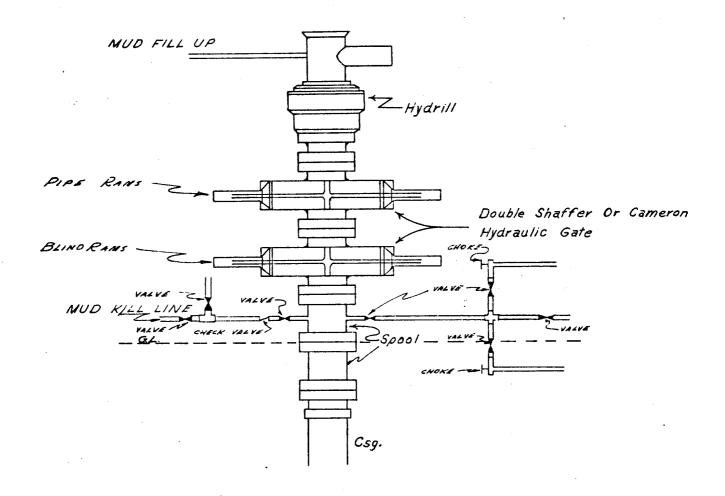
Manual and Hydraulic controls with closing unit no less than 75' from well head. Remote controls on rig floor.

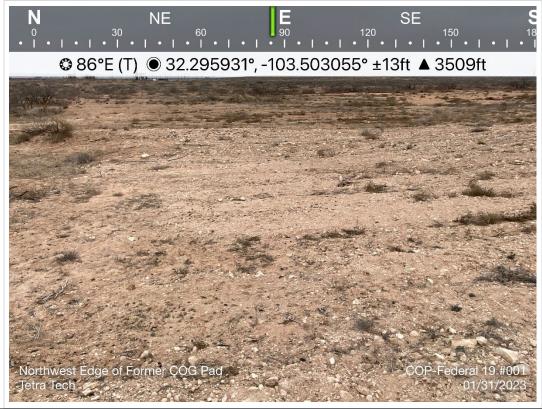
TETRA TECH, INC.	DESCRIPTION	View east. Former lease pad.	1
PROJECT NO. 212C-MD-03000	SITE NAME	ConocoPhillips Federal 19 #001	1/31/2023

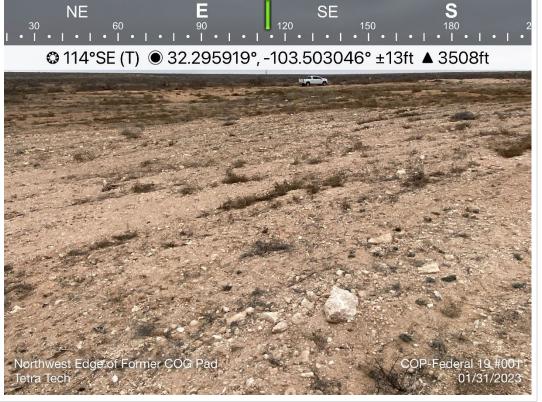
TETRA TECH, INC.	DESCRIPTION	View east/southeast. View of former production equipment location. Vegetation present.	2
PROJECT NO. 212C-MD-03000	SITE NAME	ConocoPhillips Federal 19 #001	1/31/2023

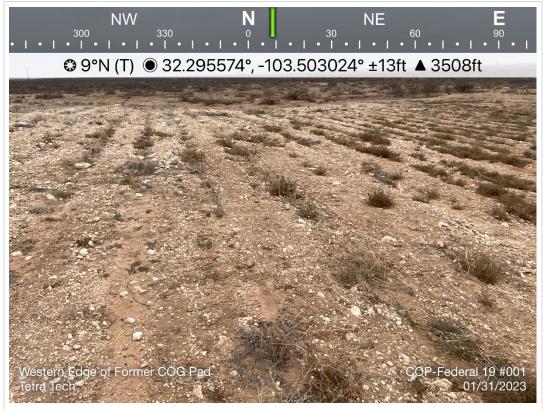
TETRA TECH, INC.	DESCRIPTION	View north. View of former production equipment location. Vegetation present.	3
PROJECT NO. 212C-MD-03000	SITE NAME	ConocoPhillips Federal 19 #001	1/31/2023

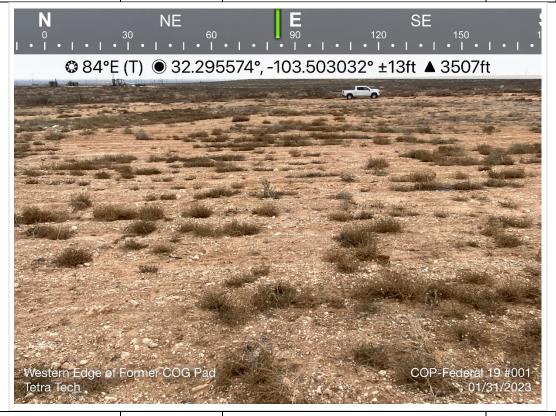
TETRA TECH, INC. PROJECT NO.	DESCRIPTION	View east. Site pad conditions with vegetation present.	4
212C-MD-03000	SITE NAME	ConocoPhillips Federal 19 #001	1/31/2023

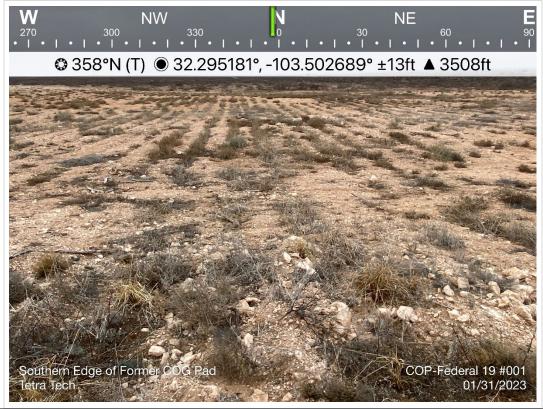
TETRA TECH, INC.	DESCRIPTION	View north of Site pad conditions.	5
PROJECT NO. 212C-MD-03000	SITE NAME	ConocoPhillips Federal 19 #001	1/31/2023

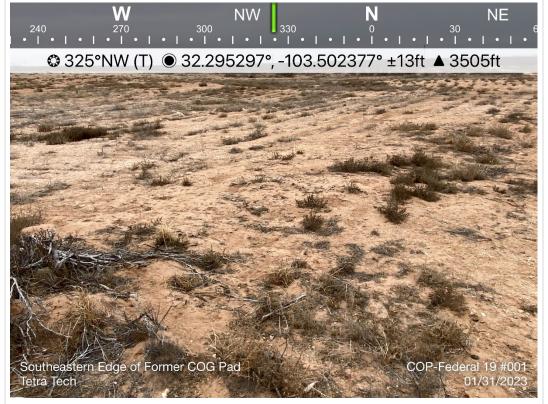
TETRA TECH, INC.	DESCRIPTION	View northwest. Southeastern area of former lease pad. Vegetation present.	6
PROJECT NO. 212C-MD-03000	SITE NAME	ConocoPhillips Federal 19 #001	1/31/2023

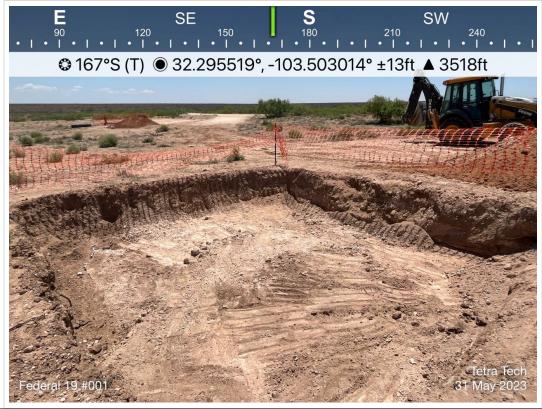
TETRA TECH, INC. PROJECT NO. 212C-MD-03000	DESCRIPTION	View southeast. View of 4-ft excavated area.	7
	SITE NAME	ConocoPhillips Federal 19 #001	5/31/2023

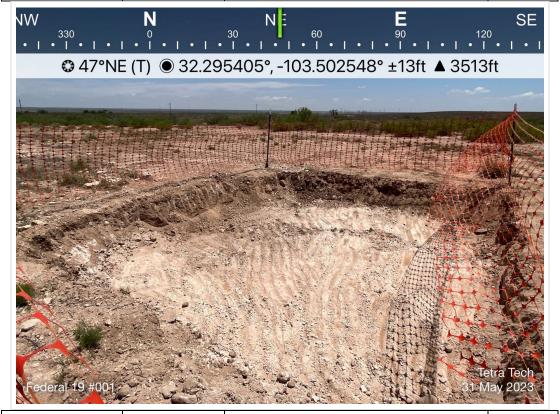
TETRA TECH, INC. PROJECT NO.	DESCRIPTION	View northeast. View of the 2-foot excavated area.	8
212C-MD-03000	SITE NAME	ConocoPhillips Federal 19 #001	5/31/2023

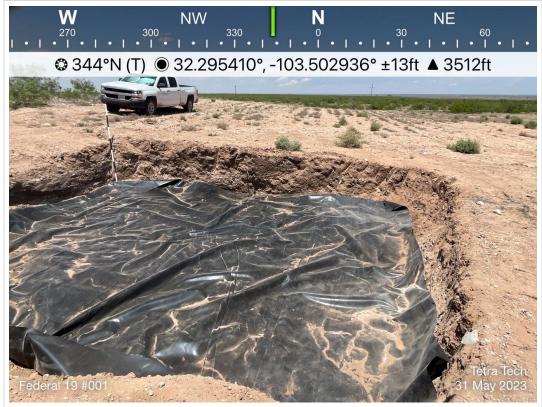
TETRA TECH, INC. PROJECT NO. 212C-MD-03000	DESCRIPTION	View northwest. View of 4-foot excavation area with liner installation.	9
	SITE NAME	ConocoPhillips Federal 19 #001	5/31/2023

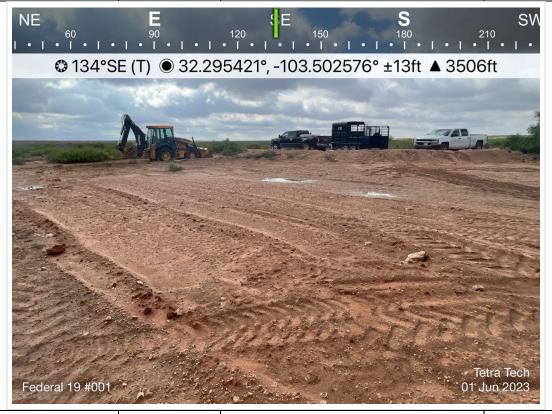
TETRA TECH, INC. PROJECT NO.	DESCRIPTION	View southeast. View of 2-foot excavated area, backfilled and compacted.	10
212C-MD-03000	SITE NAME	ConocoPhillips Federal 19 #001	5/31/2023

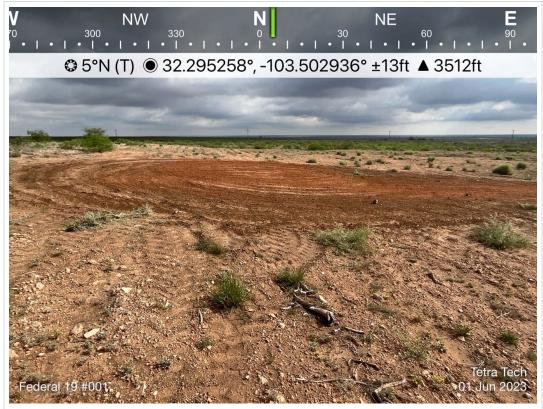
TETRA TECH, INC. PROJECT NO.	DESCRIPTION	View north. View of 4-foot excavated area, backfilled, compacted and re-seeded.	11
212C-MD-03000	SITE NAME	ConocoPhillips Federal 19 #001	5/31/2023

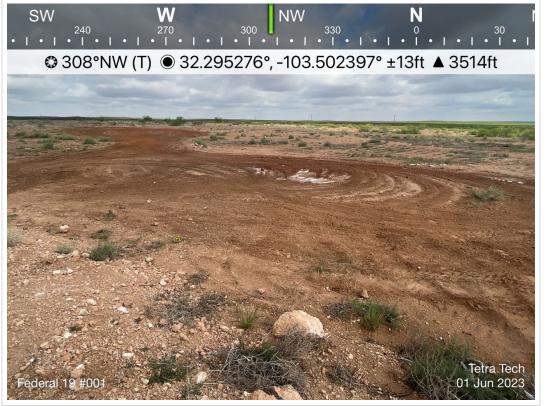
TETRA TECH, INC.	DESCRIPTION	View northwest. View of 2-foot excavation after reseeding.	12
PROJECT NO. 212C-MD-03000	SITE NAME	ConocoPhillips Federal 19 #001	5/31/2023
