Report Type: Closure 1RP-4975

Site:	Hound 30 Federal Water Line					
Company:	EOG Resources, Inc.					
Section, Township and Range	Unit L	Sec. 30	T 25S	R 34E		
Lease Number:	API No. 30-025-43574					
County:	Lea County					
GPS:	32.0998° N			103.5171° W		
Surface Owner:	Federal					
Mineral Owner:						
Directions:	From the intersection of HWY 128 and CR 1, travel south on CR 1 for 10.4 miles, turn east onto lease road for 7.5 miles to Y in the road, take a left at the Y and continue for 2.8 miles, turn left and continue for 0.9 miles to location on the west side of the lease road.

Re: Work Plan for the EOG Resources, Hound 30 Federal Water Line, Unit L, Section 30, Township 25 South, Range 34 East, Lea County, New Mexico. 1RP-4975.

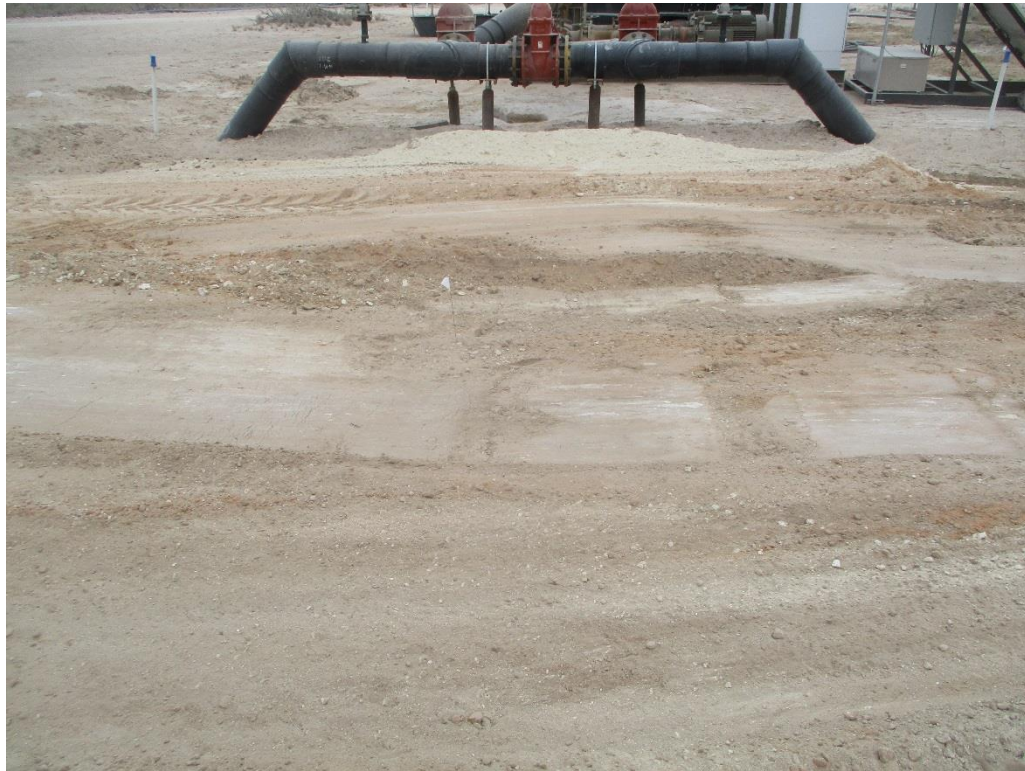
Referring to Table 1, the sampling results showed a shallow chloride impact to the soils. The area of trench (T-1) showed a chloride high of 195 mg/kg at 0-1' below surface, which further declined with depth. The areas of trenches (T-2, T-3, T-4, T-5 and T-6) showed elevated chloride concentrations in the shallow soils (0-1') of 4,160 mg/kg, 3,960 mg/kg, 643 mg/kg, 7,220 mg/kg, and 2,230 mg/kg, respectively. The chloride concentrations in these areas declined with depth to below the 600 mg/kg threshold at 2.0' below surface. Additionally, none of the deeper samples collected showed any significant chloride concentrations to the soils.

View North - Area of T-1

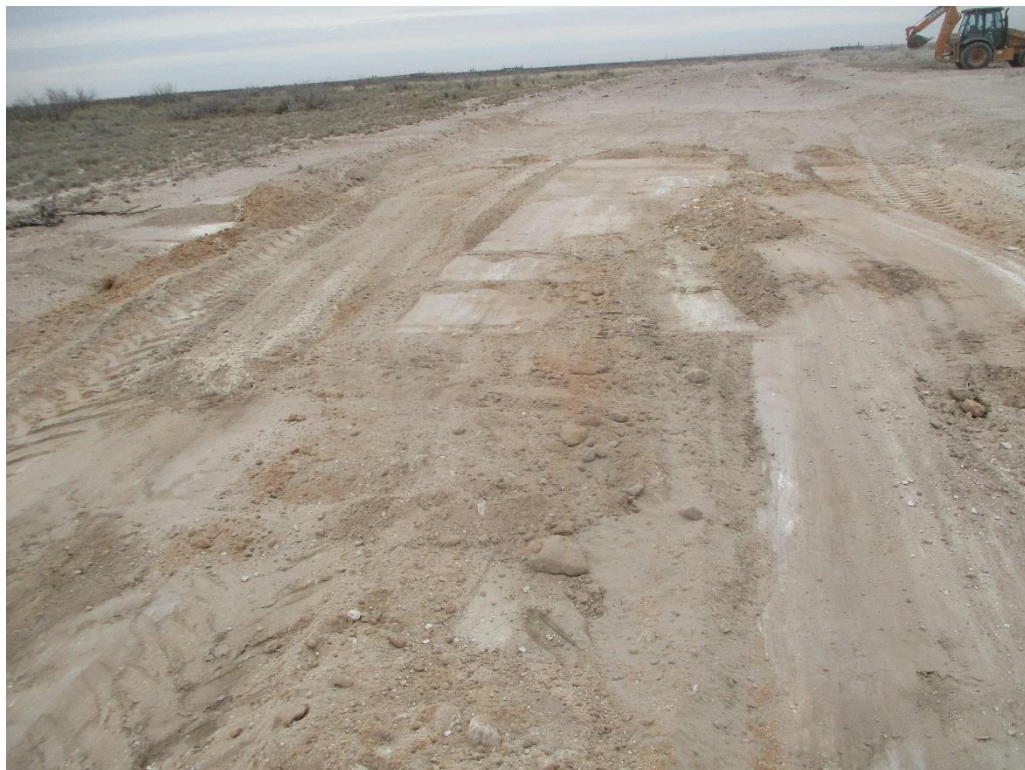
View East – Area of T-2

On May 23-25, 2018 Tetra Tech personnel were onsite to sample and to supervise the excavation areas of T-2, T-3, T-4, T-5, and T-6 highlighted (green) on Table 1. The areas of trenches (T-2, T-3, T-4, T-5, and T-6) were excavated to depths approximately 1.5' to 2.0' below surface. The samples were analyzed for TPH method 8015 extended, BTEX method 8021B, and chlorides by EPA method 300.0. The sampling results are summarized in Table 1. The excavated locations are shown in Figure 4.

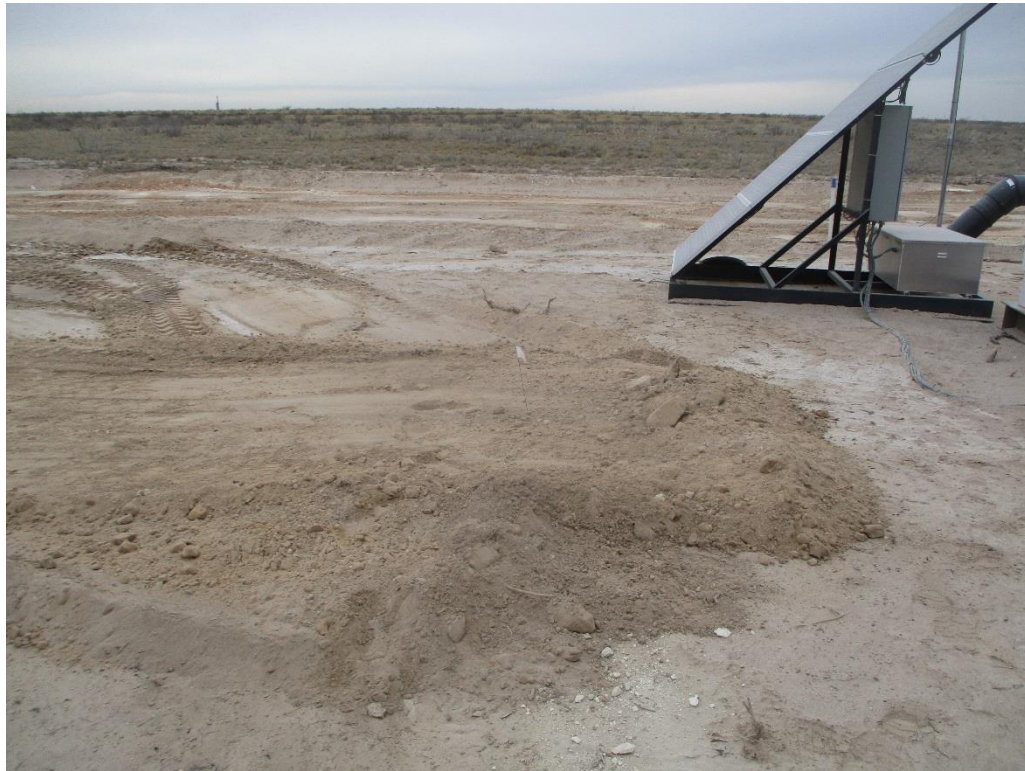
View East – Area of T-3

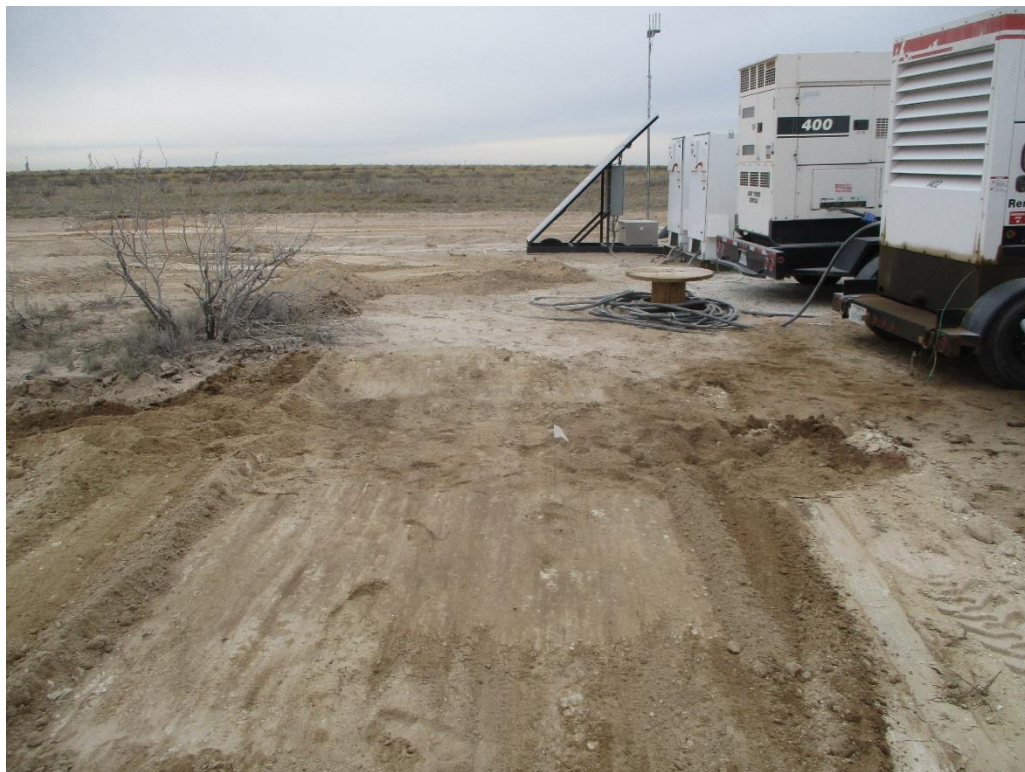
View South – Area of T-4

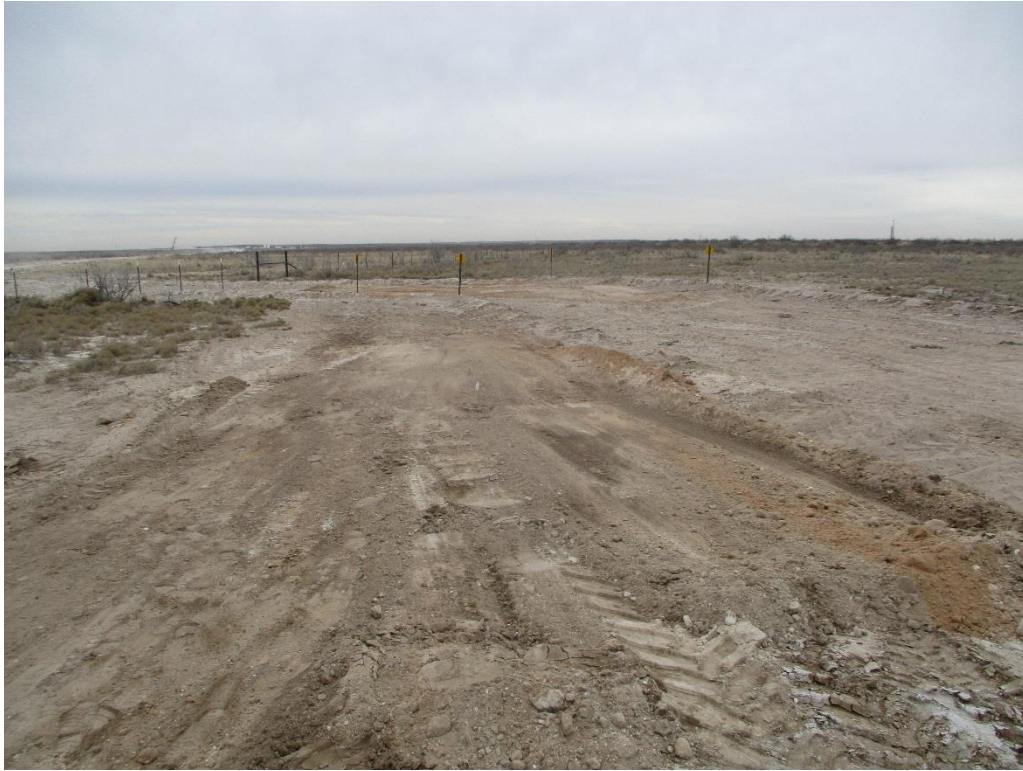
View Northeast – Area of T-5

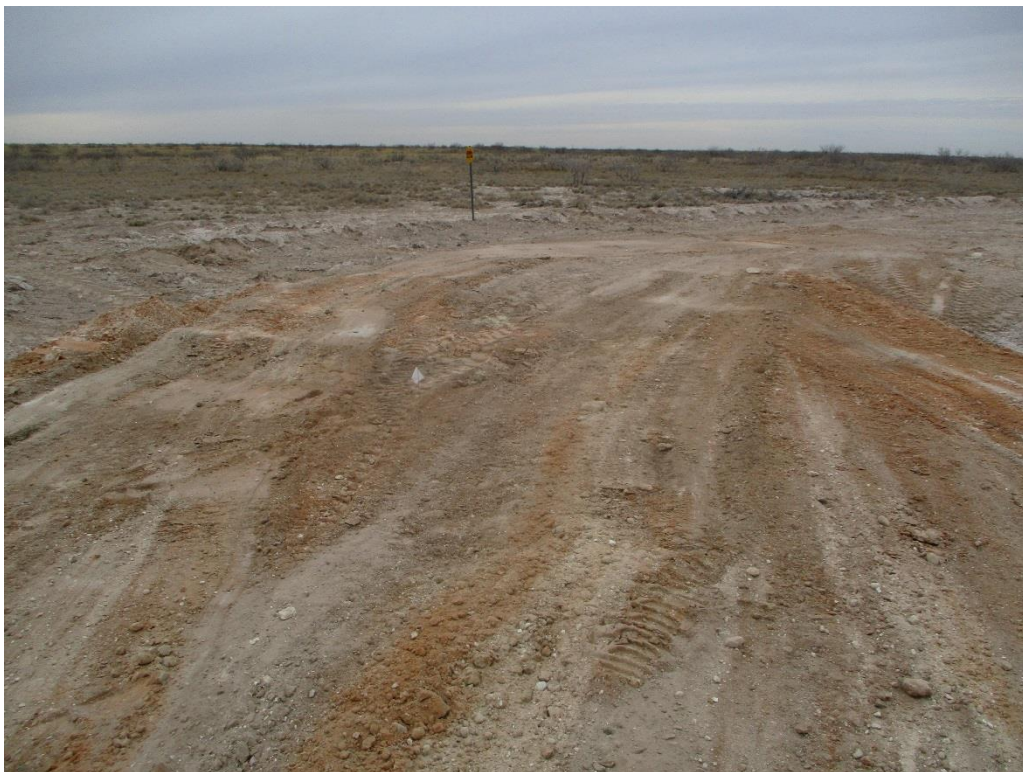
View Southwest – Area of T-6

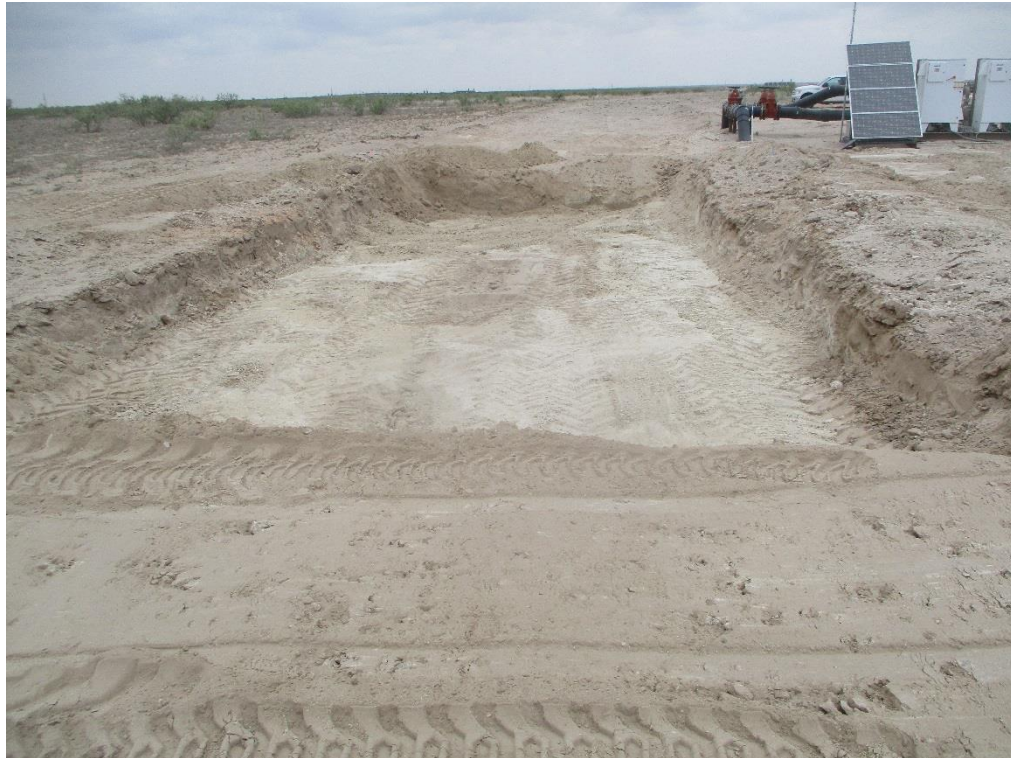
View North – Area of Bottom Hole-1 (T-2)

Referring to Table 1, none of the collected samples exceeded the RRALs for TPH, benzene, or Total BTEX. A total of five (5) bottom hole samples were collected, along with sidewall samples. The areas of (Bottom Hole-1, Bottom Hole-2, Bottom Hole-3, Bottom Hole-4, and Bottom Hole-5) and sidewall samples showed TPH concentrations ranging from <14.9 mg/kg to <15.0 mg/kg. The Chloride concentrations in these areas showed concentrations of 21.5 mg/kg, 7.40 mg/kg, 12.6 mg/kg, 61.8 mg/kg, and 35.7mg/kg all below RRALs. All of the sidewall samples collected didn't exceed the threshold of 600 ppm and showed concentrations ranging from <4.95 mg/kg to 69.5 mg/kg. The excavated areas were backfilled with clean material to surface grade. All of the excavated material was transported offsite for proper disposal.

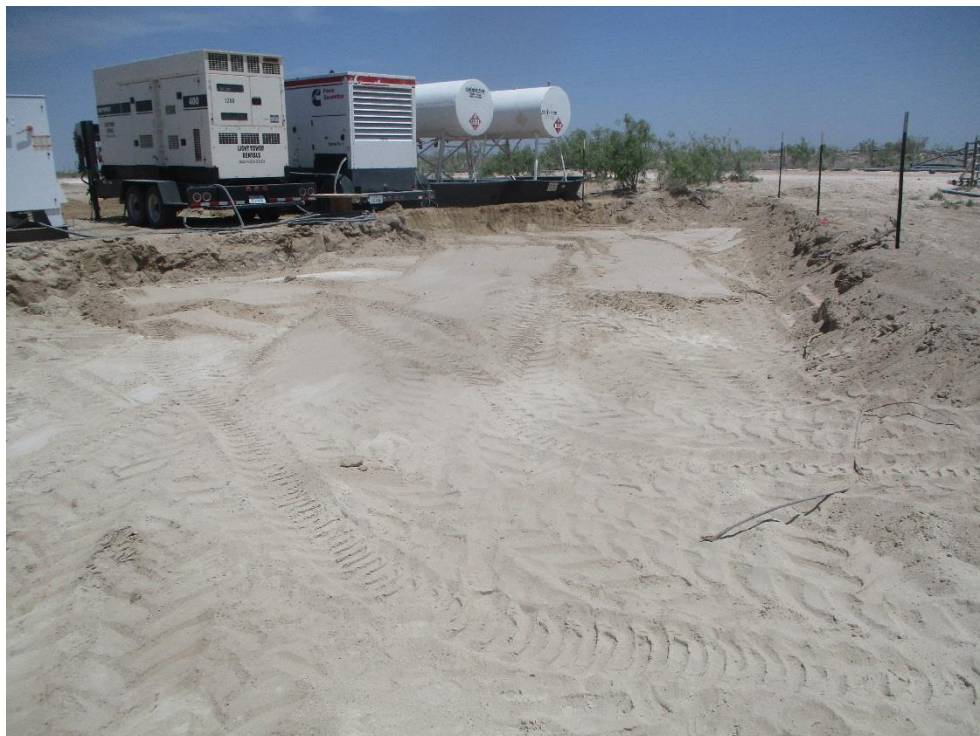
View Northeast – Area Bottom Hole 2&3 (T-3, and T-4)

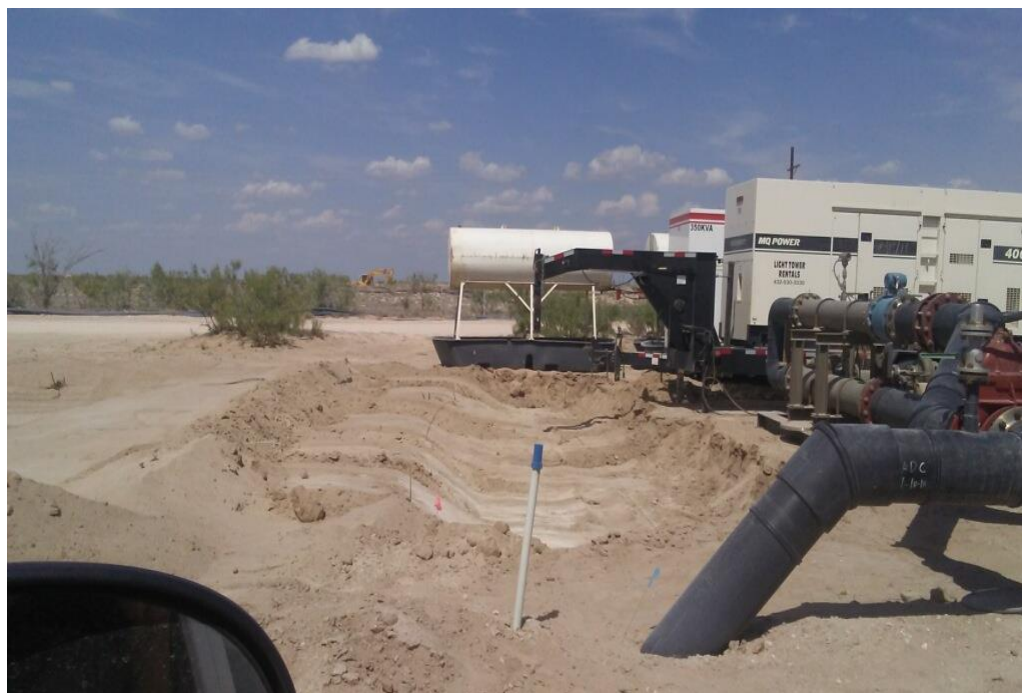
View East – Area of Bottom Hole-2 North Sidewall Area

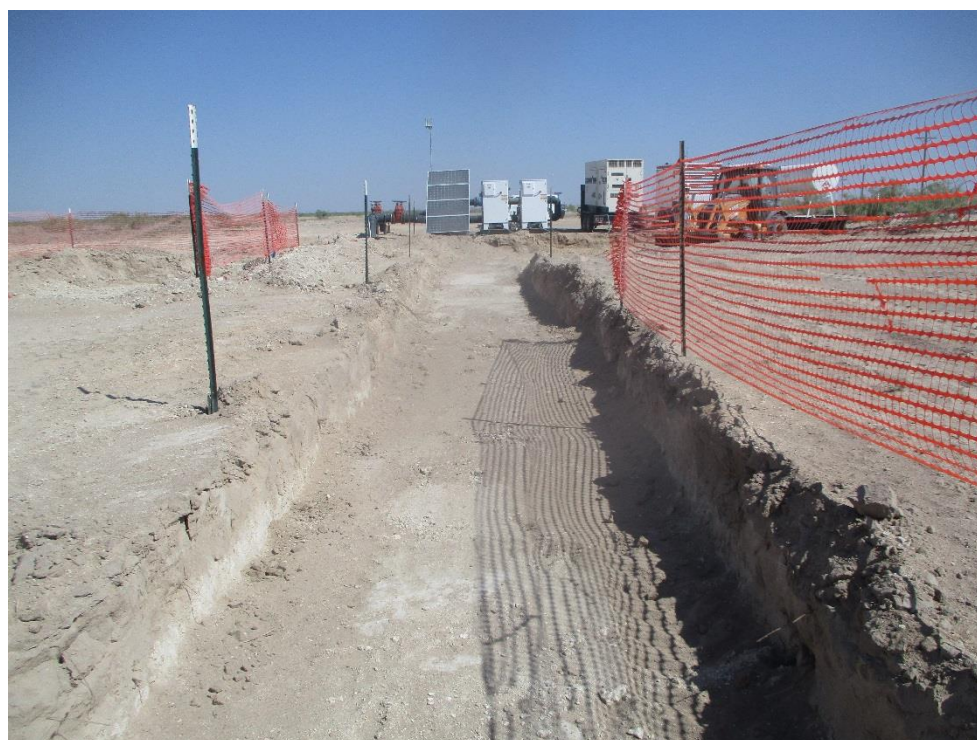
View North – Area of Bottom Hole-4 (T-5)

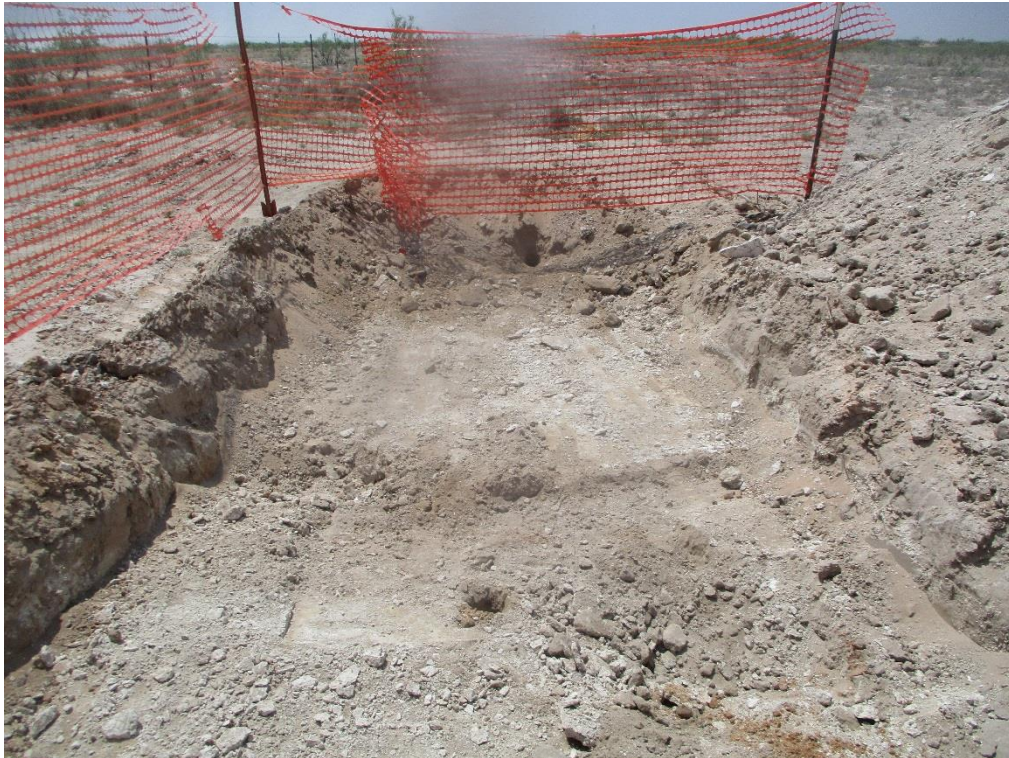
View South – Area of BottomHole-5 (T-6)

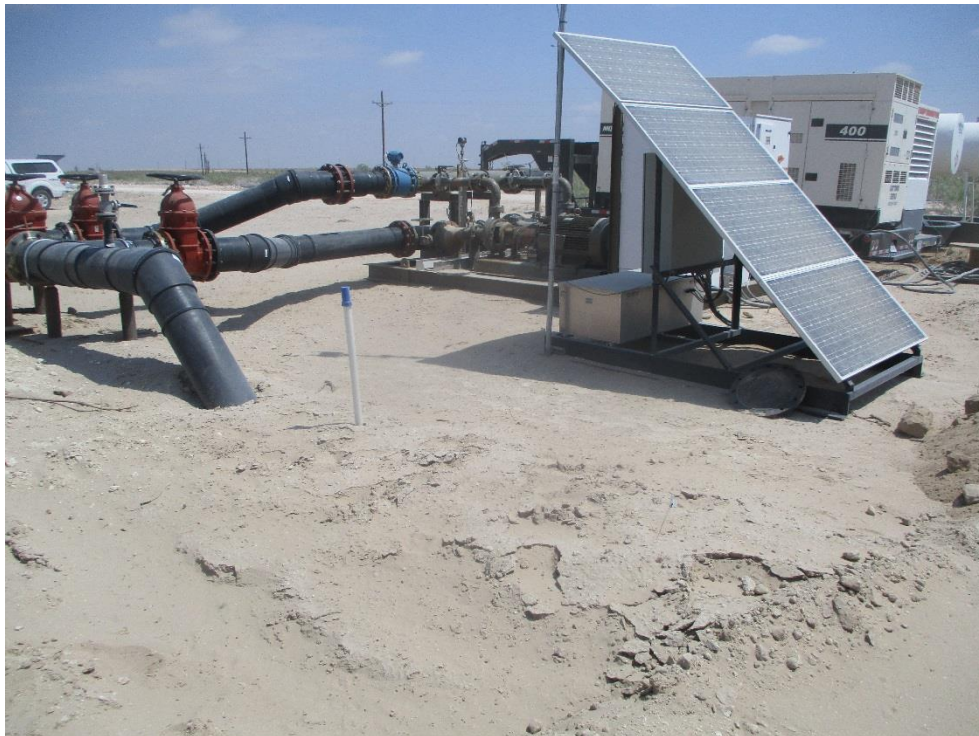
View East – Area of BottomHole-2 (Pipelines in area)
