Site Assessment/Characterization

State of New Mexico
Oil Conservation Division

Closure

Re: Site Assessment, Remediation, and Closure Report
Snapping 2 State 4H
API No. 30-015-39071
GPS: Latitude 32.0657806 Longitude -103.74726834
UL -- P, Sec. 2, T26S, R31E
Eddy County, NM
NMOCD Ref. No. NAB1901827794

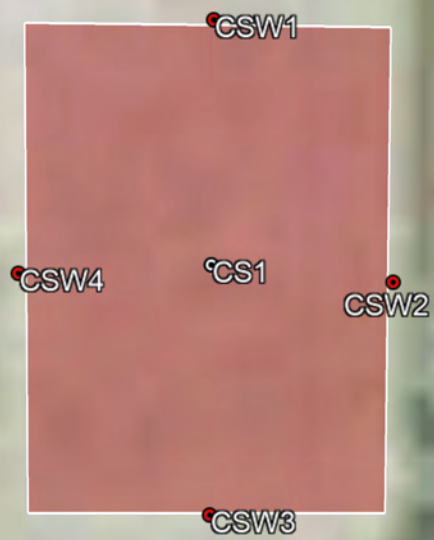
Devon Energy
30-015-39071
NAB1901827794
32.0657806,-103.7426834
Confirmation Sample Map

On April 27th, 2023, after submitting the 48-hour notification (Appendix C), Pima collected confirmation samples. 5-point bottom and sidewall composite samples were obtained to ensure that the vertical and horizontal extents of the contamination had been removed. Each composite sample was representative of no more than 200 square feet. The laboratory results of this sampling event can be found in the following data table.

An area approximately 12 feet by 10 feet by 1.5 foot in depth was excavated utilizing a backhoe.
