## Remediation Summary & Soil Closure Request

### Mewbourne Oil Company Viper 32-29 W2PI Fed Com #1H

Eddy County, New Mexico  
Unit Letter "P", Section 32, Township 23 South, Range 27 East  
Latitude 32.2546560 North, Longitude 104.207808 West  
NMOCD Reference No. nAPP2302744797

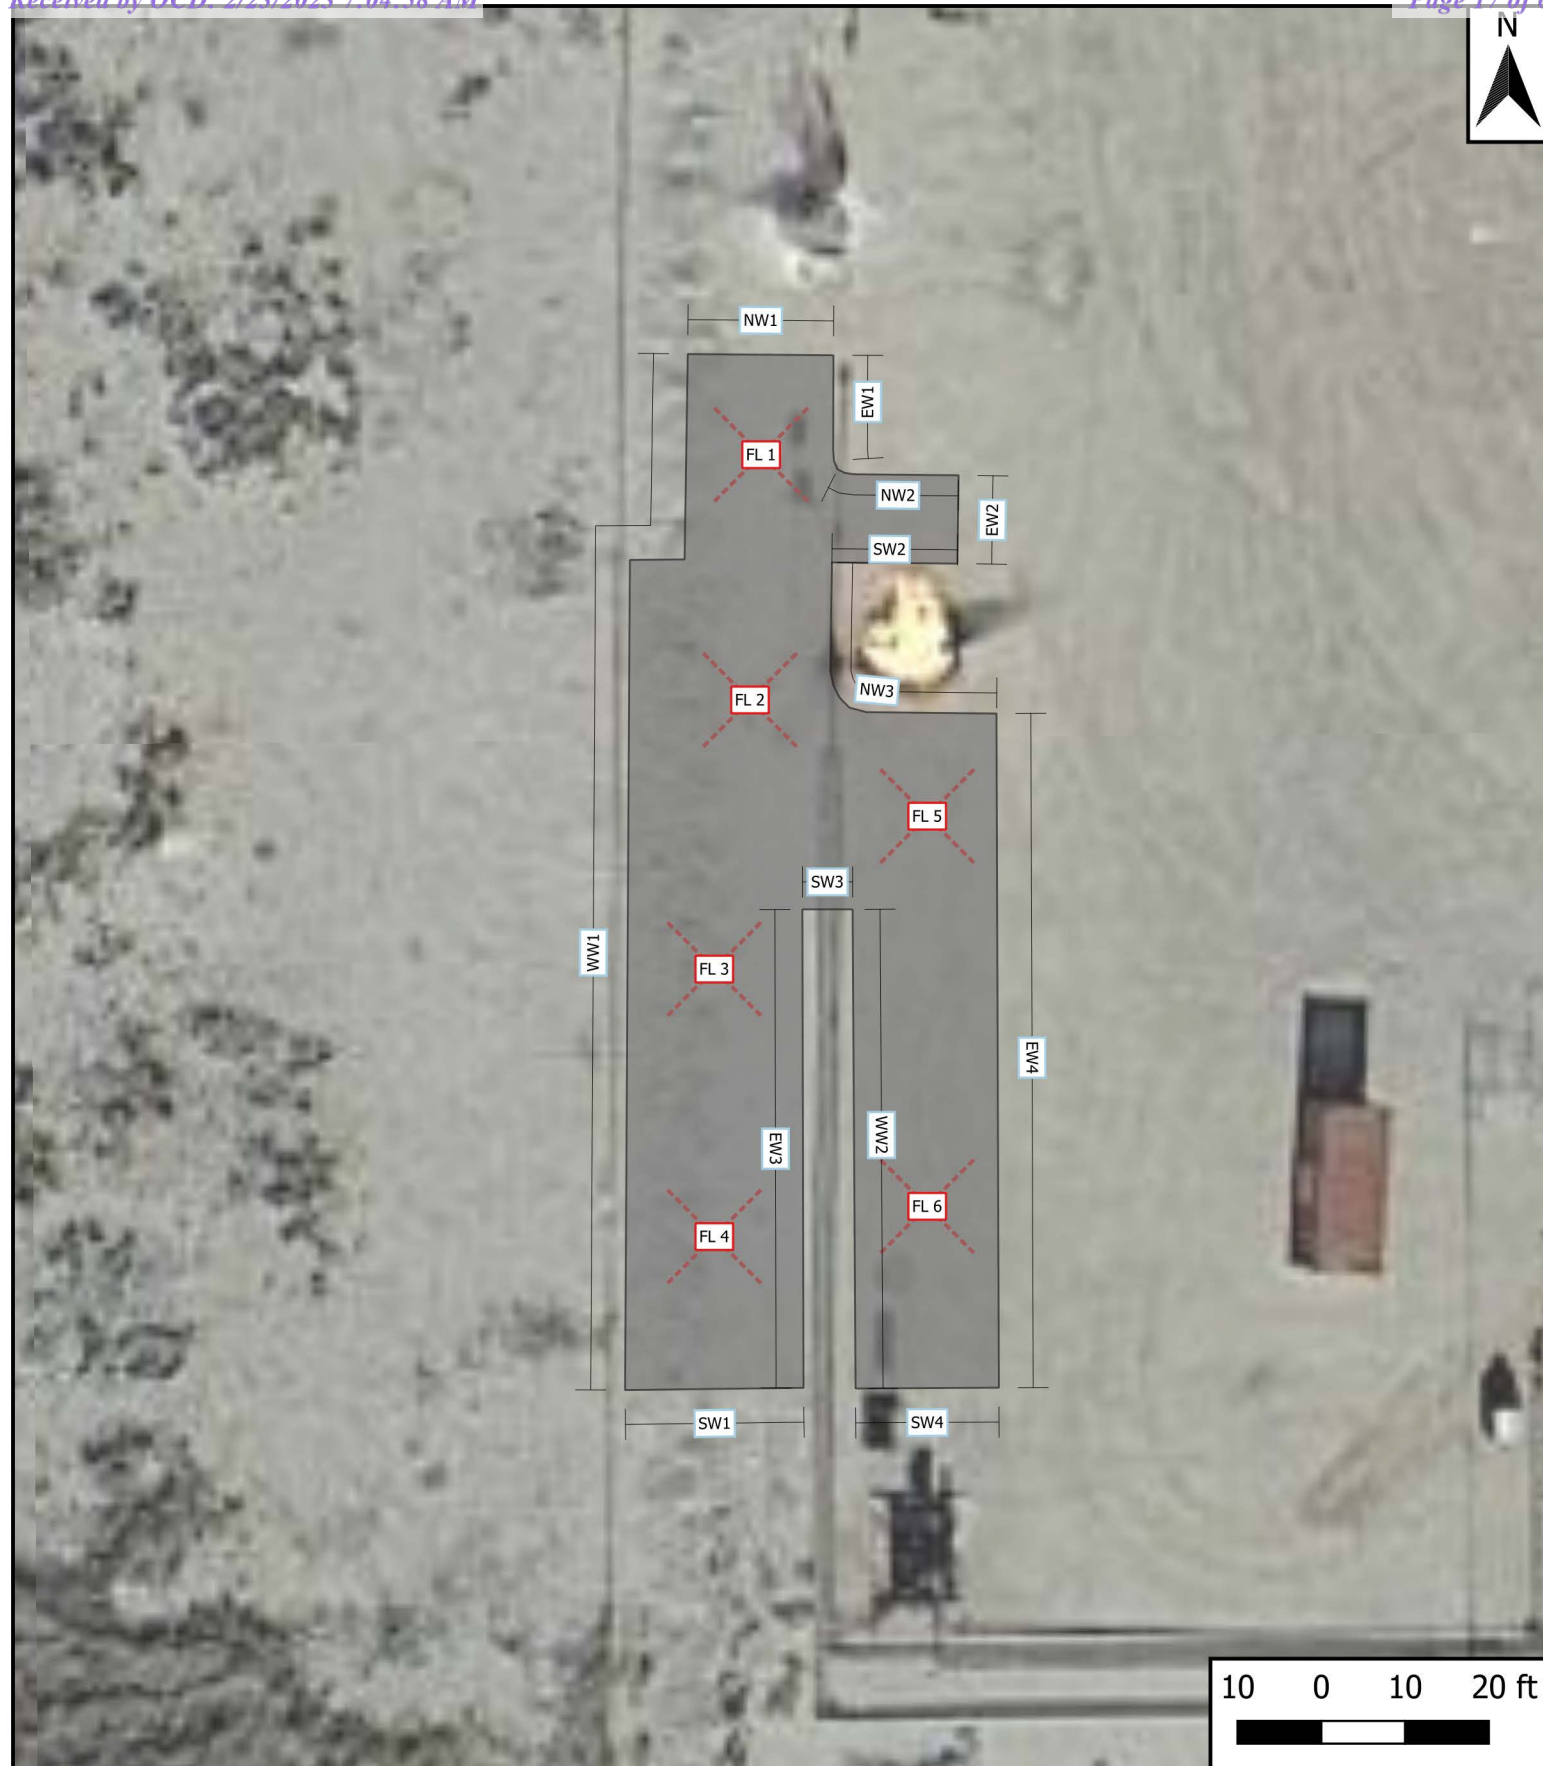
## **Figure 3**

### **Site & Sample Location Map**

- Excavation Extent
- X Composite Floor Sample
- Composite Wall Sample
